Report No. CDOT-DTD-R-93-6

CRACK-REDUCTION, PAVEMENT-REINFORCEMENT, GLASGRID

Final Report
APRIL 1993

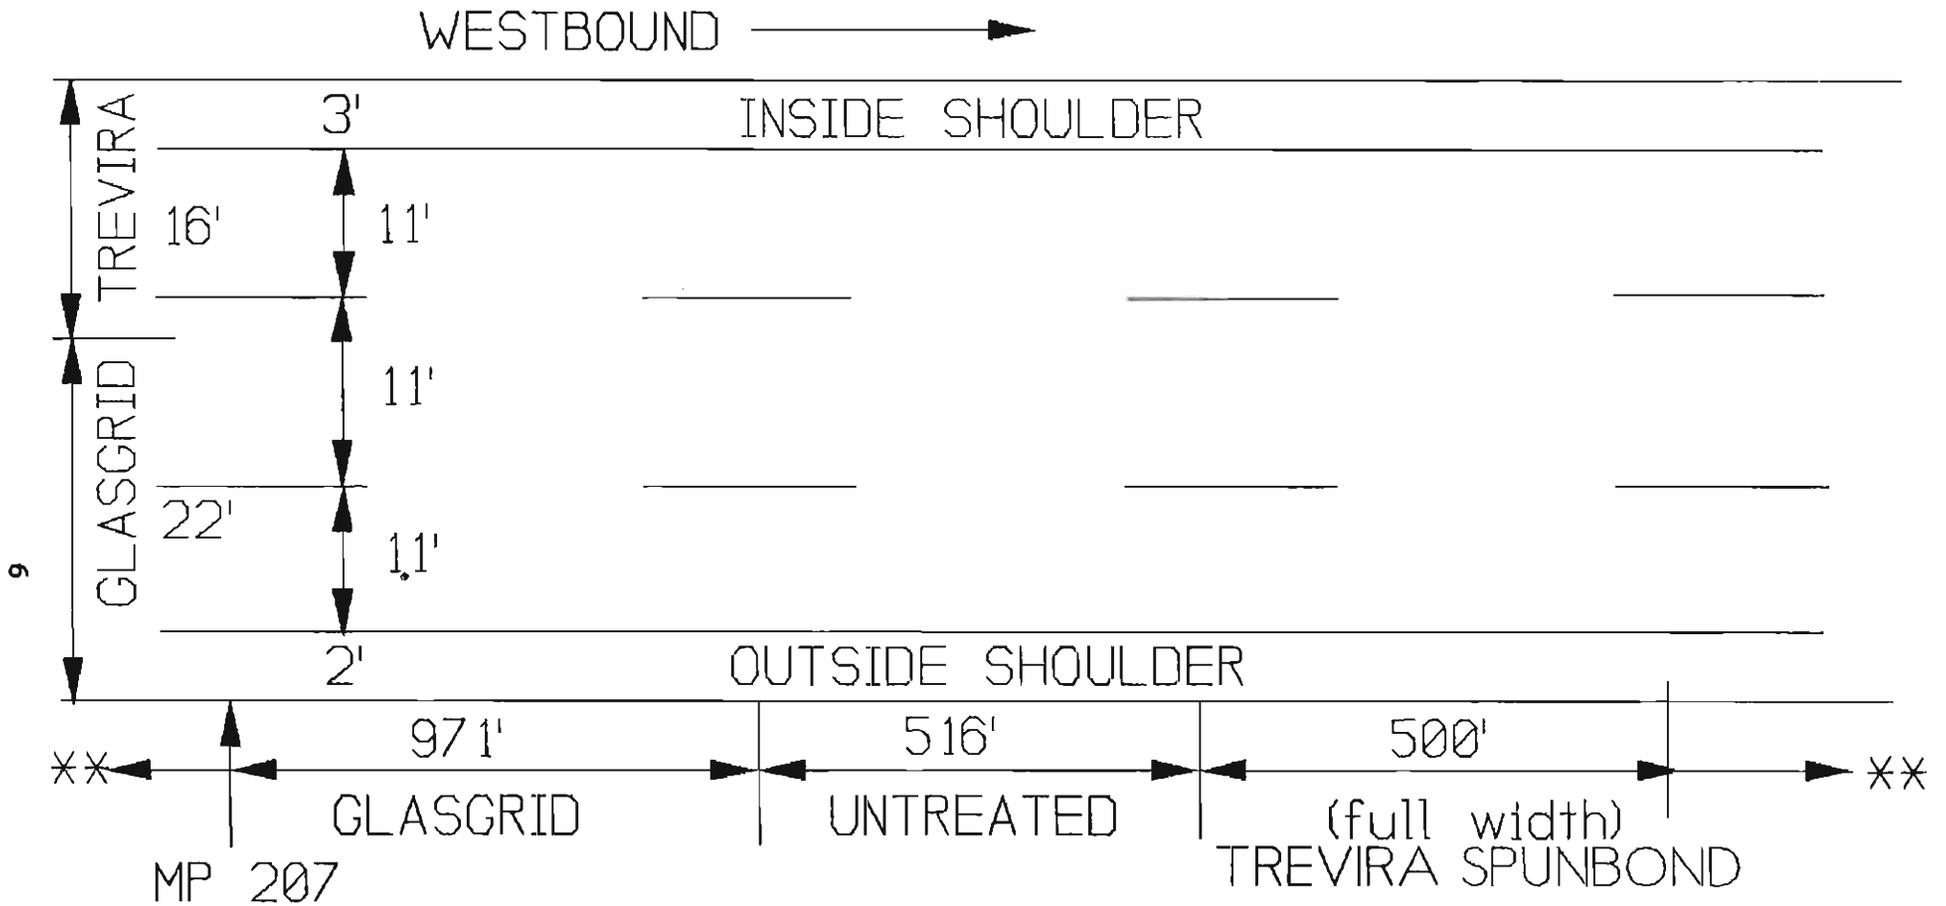
FIGURE 2. WEST OF EISENHOWER MEMORIAL TUNNEL

** THE REMAINDER OF THE WESTBOUND LANES
CONTAIN TREVIRA SPUNBOND

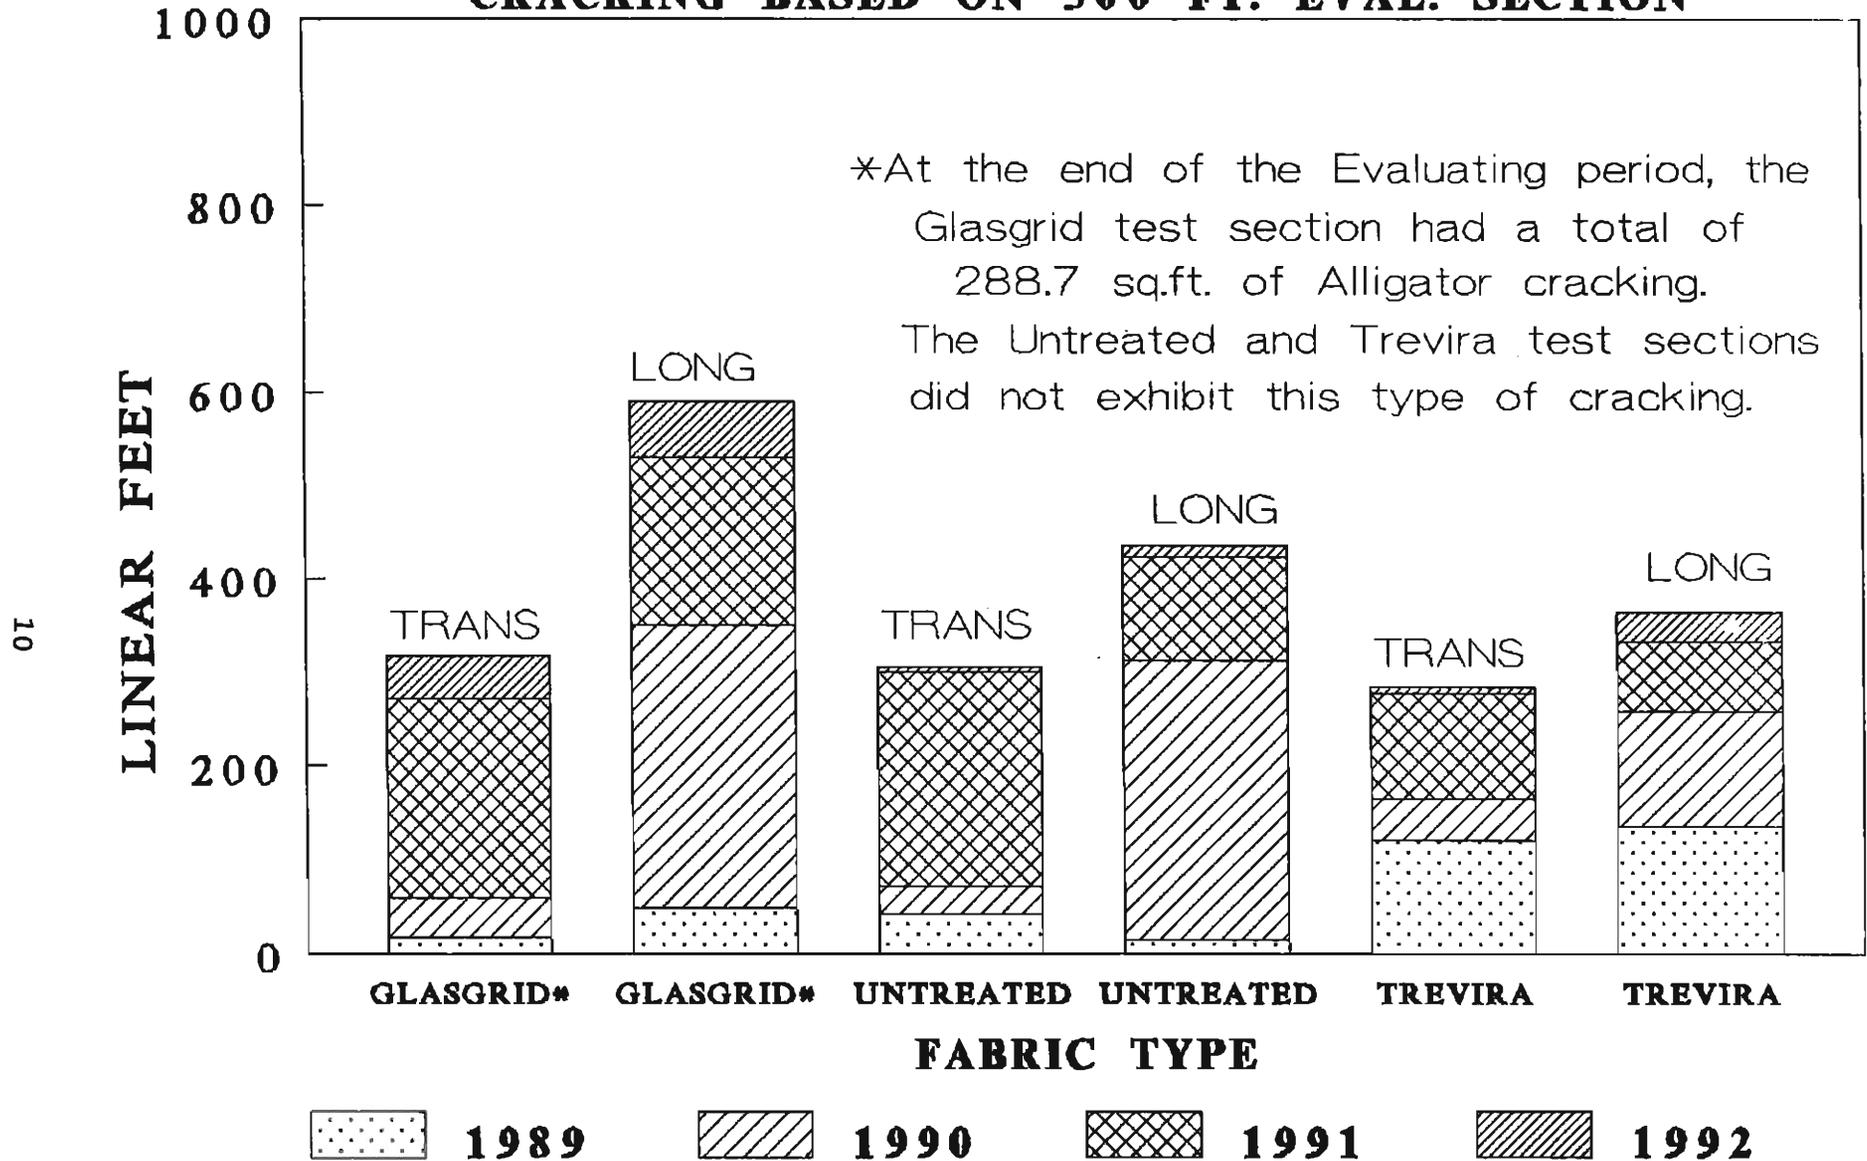
TABLE 1. CRACKING ON WESTBOUND I-70 WEST OF THE EISENHOWER MEMORIAL TUNNEL

Table 1 shows the comparison of the amount of cracking in the Glasgrid, untreated and Trevira evaluation sections over the evaluation period.

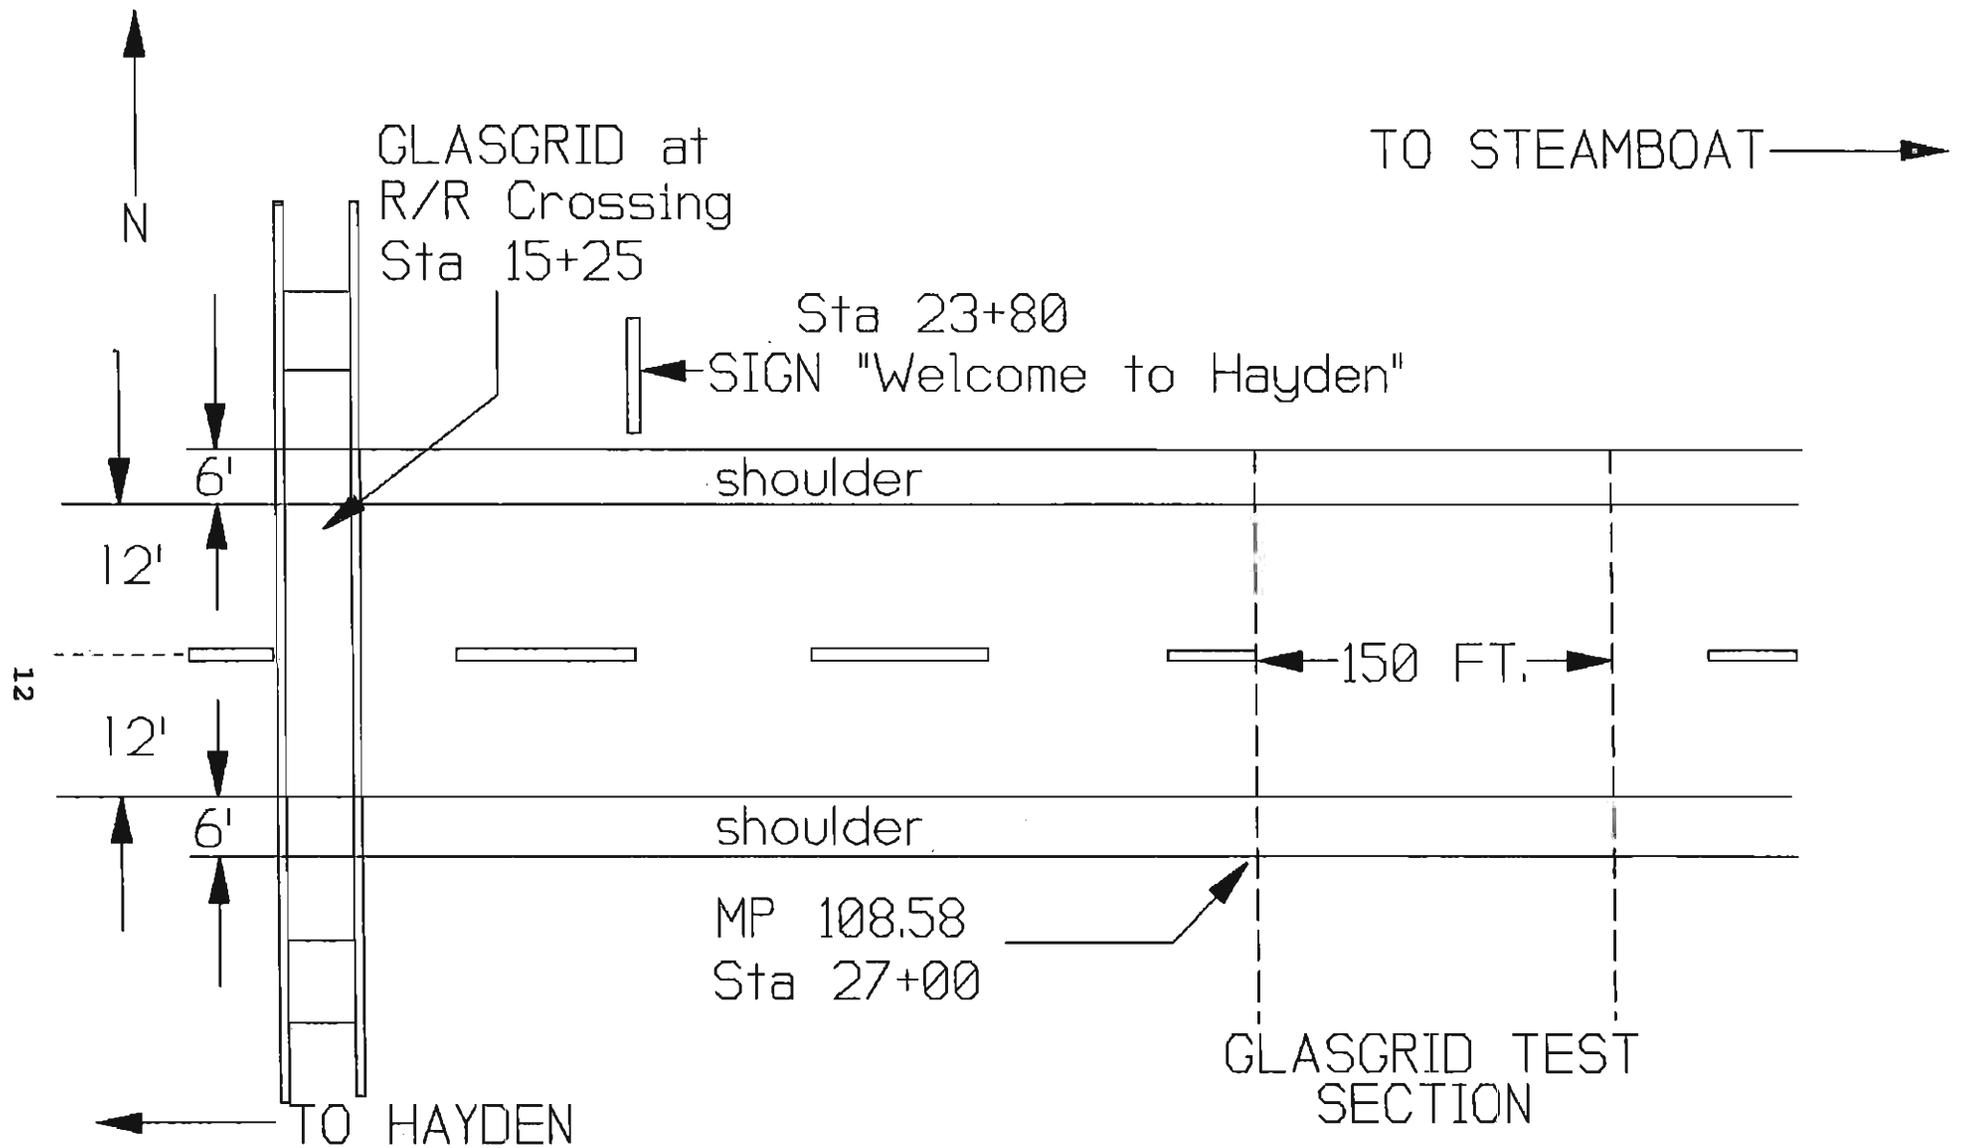
FIGURE 3. U.S. 40, EAST OF HAYDEN
(SITE MAP)

Material available from the I-70 project was incorporated on U.S 40 at two locations. The first location was installed over the abandoned railroad tracks. Although the Glasgrid is not marketed for this particular application the project personnel asked to use the Glasgrid to determine its effectiveness in retarding cracking over

the tracks. The second location was placed over the construction joint in the widened section.
