Report No. CDOT-DTD-R-93-8

**Rehabilitation of Rutted
Asphalt Pavements
Project IR-25-3(96)**

Final Report
June 1993

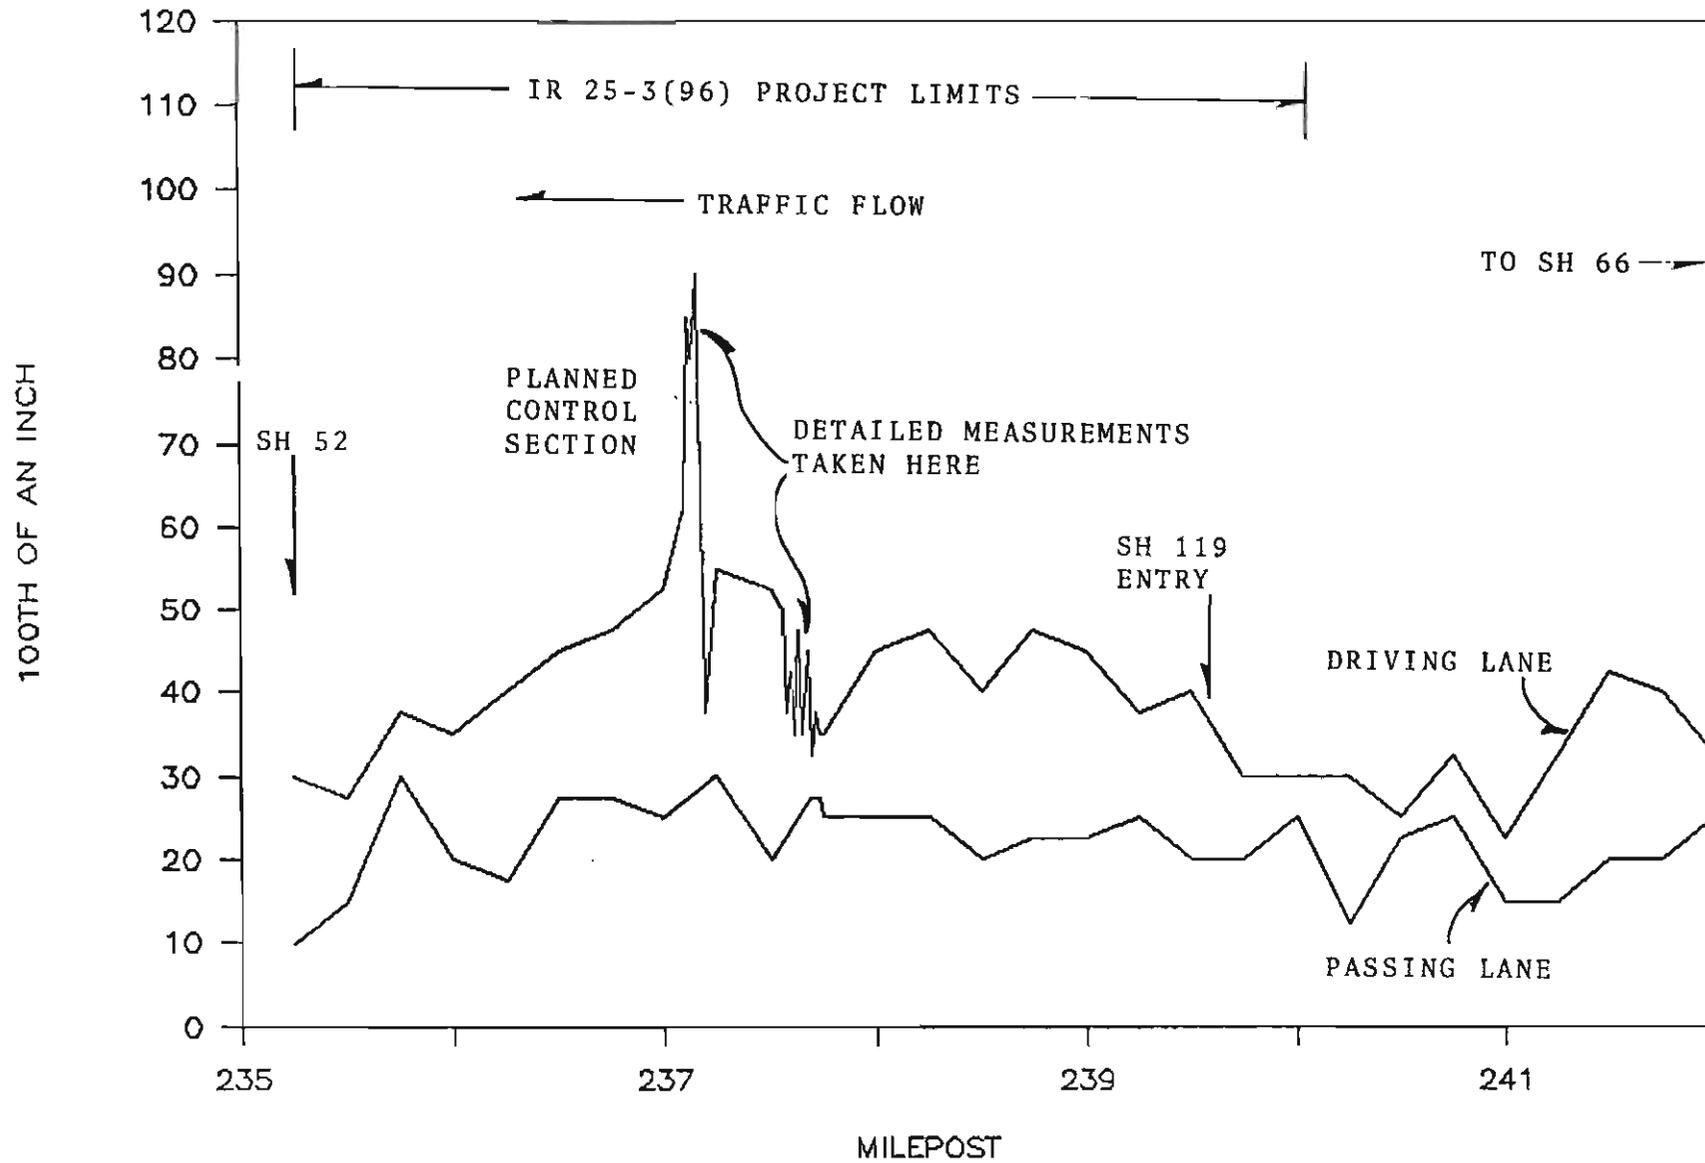
The primary mode of failure in the existing pavement appeared to be rutting. In general, the rutting was more severe on the southbound direction of the interstate and in the driving lane. The wheel ruts in the driving lane had a distinctive "dual-wheel" trace (see photographs 1 and 2). Figure 2 shows the rutting profile of the southbound direction for both the driving lane and the passing lane between MP 235 and MP 242 at the end of the 3-1/2 years of service (7).

125 SOUTHBOUND RUT PROFILES - FEB 1988

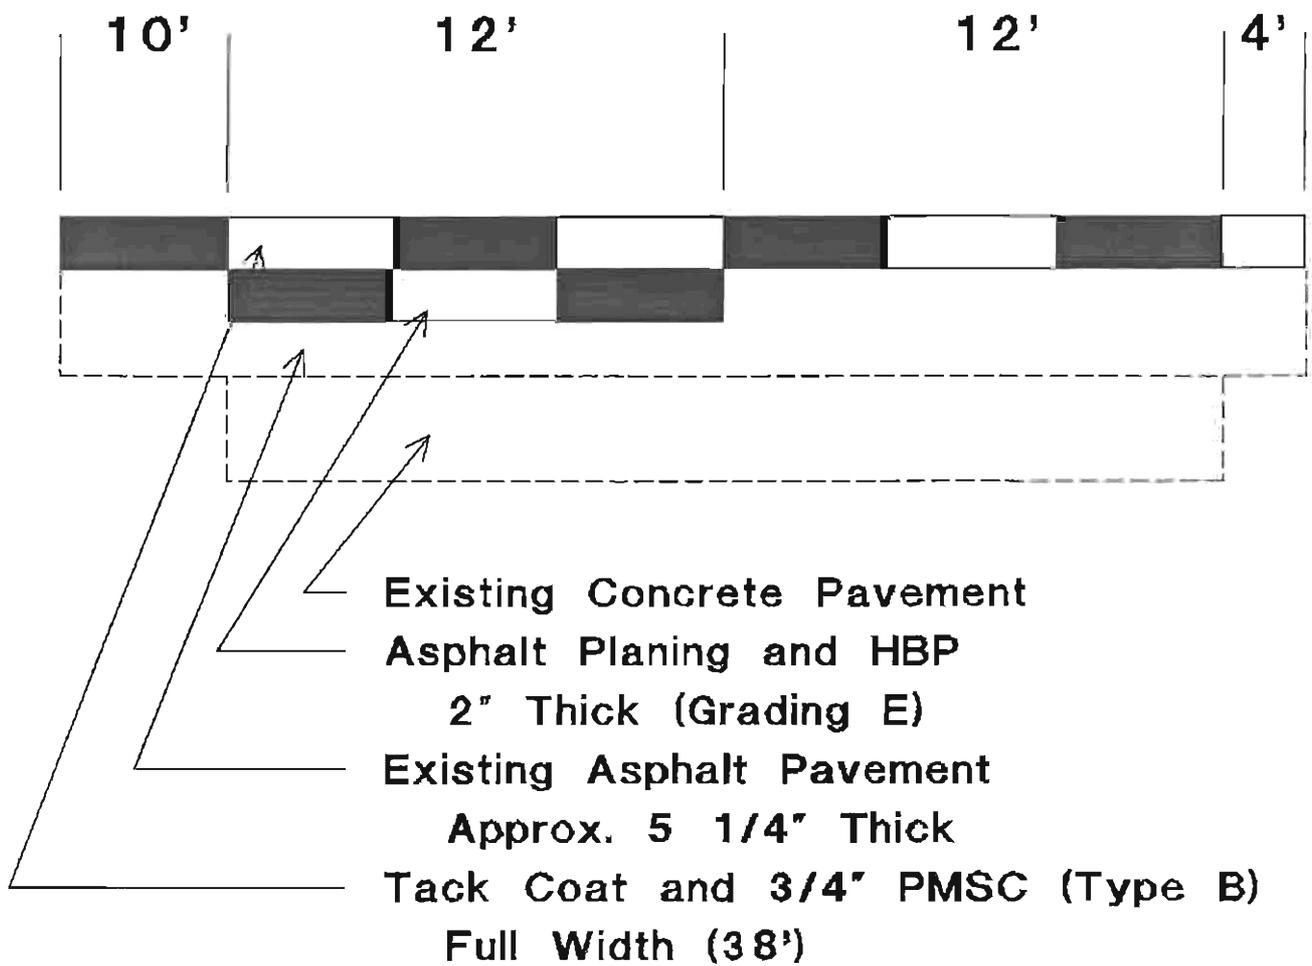
FIGURE 3
Project IR 25-3(96)
EXPERIMENTAL TEST SECTION

During the summer of 1988, five miles of the southbound lanes between MP 235 and MP 240 which contained the worst rutting were rehabilitated. The rehabilitation plan called for milling out two inches of the driving lanes and replacing it with modified hot bituminous pavement (HBP Gr E) that had a high modulus (475,000), higher voids (4-8), and a required Hveem of 40. This "super-stable" mix replaced the worst part of the rutted pavement. In order to protect the modified HBP, the entire width of the road was then covered with a standard 3/4 inch Plant-mixed seal coat (PMSC Type B). The PMSC also covered the 1/4 inch ruts that had developed in the passing lane. Typical sections are shown in Figure 3 and Figure 4.

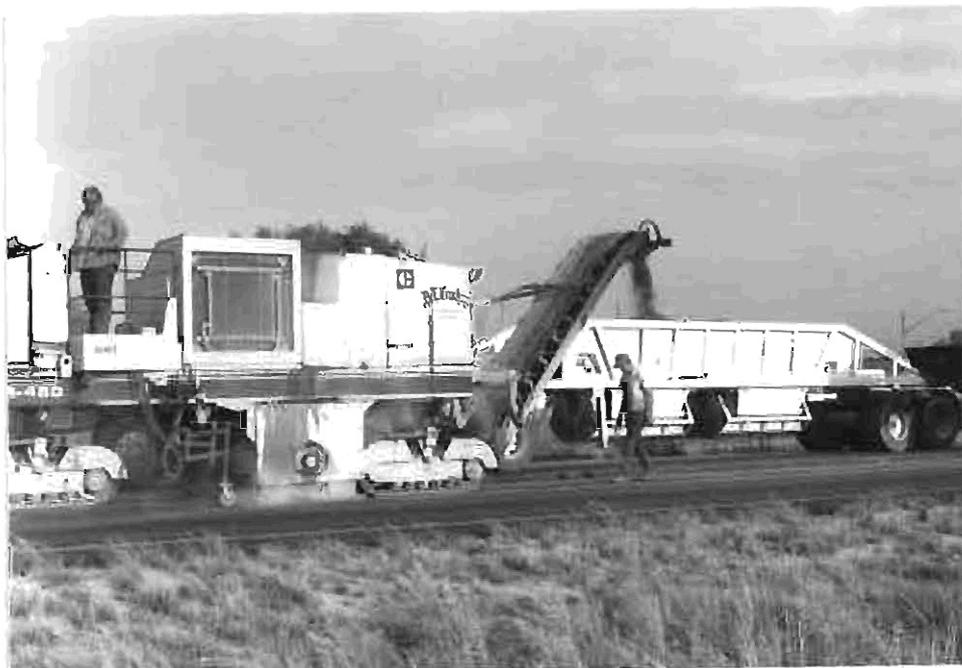
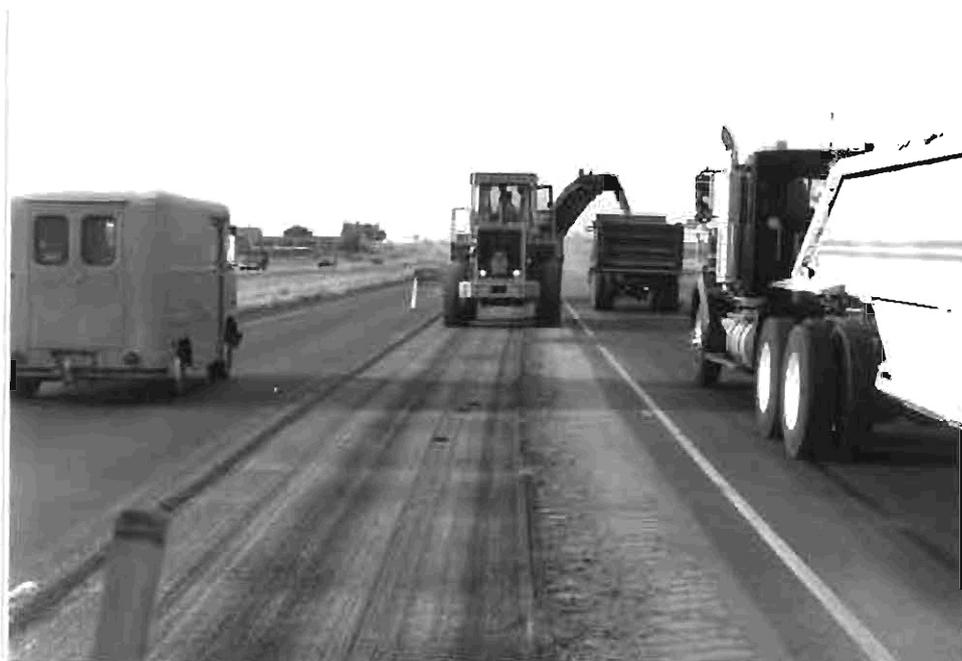
The roto-miller moved in the direction of the traffic with an average rate of 14 feet per minute. The mill tailings were effectively cleaned with several mechanical brooms and a loader (Photographs 5 and 6). The paving operation followed several hours behind. After all the milling and HBP placement had taken place, the contractor returned to the beginning of the project (MP 240) and placed plant-mixed seal coat (PMSC) on the passing lane and inside shoulder. Next, the driving lane and then the right shoulder was paved with PMSC. All three passes of PMSC were completed in three days.

Photo 5 & 6: View of the milling operation from behind and side.

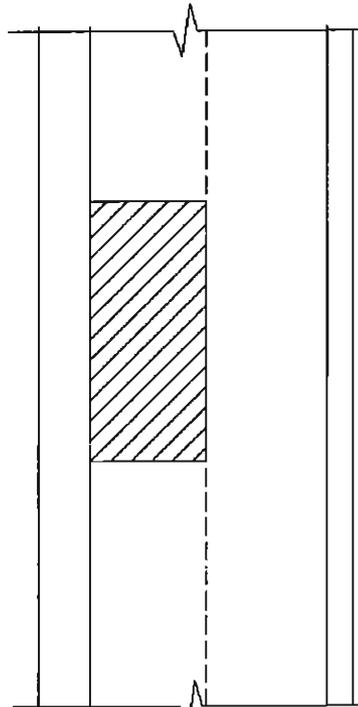
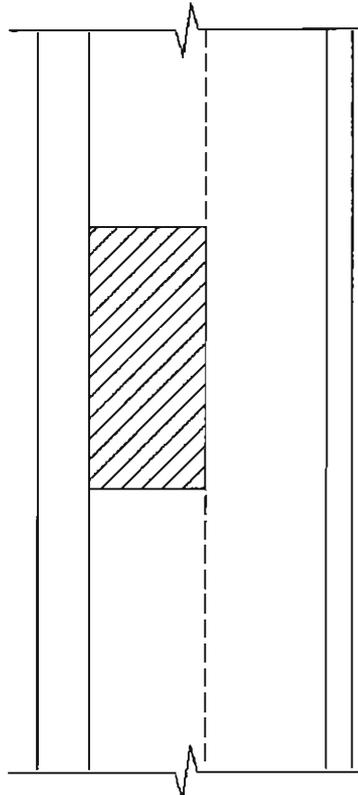
Figure 5
Project IR 25-3(96)
I 25 Southbound

A test section and a control section were established to monitor and evaluate the performance of the newly-paved overlay in the southbound lanes (Figure 5). In addition, a control section was also established to monitor the progress of rutting in the northbound lanes. The following is a brief description of the control and test sections:

- 1- The southbound test section was milled 1/2 inches and overlaid with 1-1/4 inch of PMSC.
- 2- The southbound control section was milled out 2 inches and overlaid with 2 inches of high stability asphalt and 3/4 inches of PMSC.
- 3- The northbound control section is the original 5-inch overlay with no rehabilitation.

TEST SECTION
MILLED UP TO
1/2" MAX

CONTROL SECTION
MILLED 2"

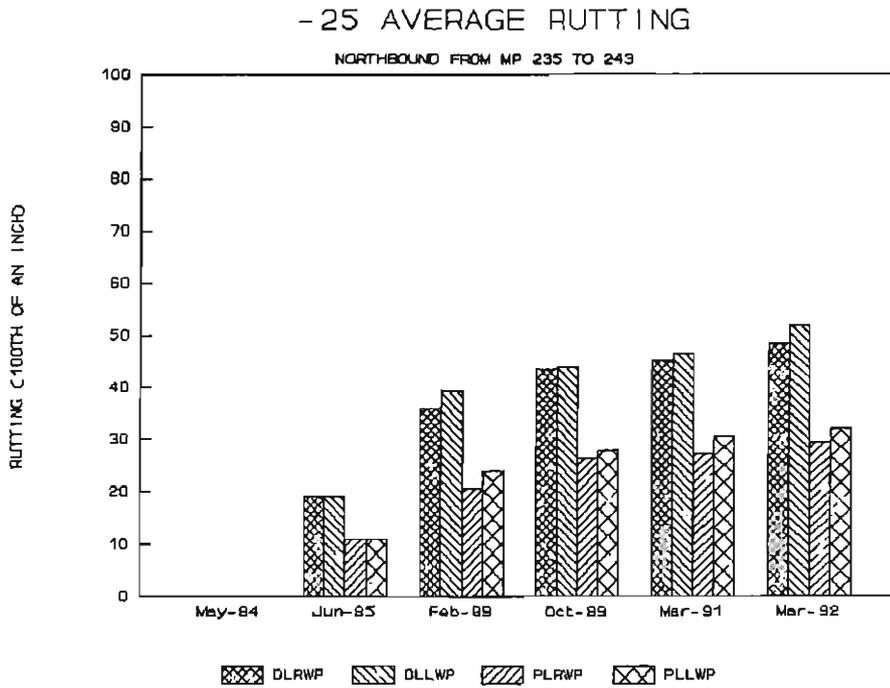
Figure 6

Rutting progression was used as the primary method of evaluating and monitoring the performance of the rehabilitated southbound lanes. A complete history of rut profile taken between 1988 and 1992 for the southbound lane, and between 1984 and 1992 for the northbound lanes are shown in figures 6 through figure 17. These rutting profiles were taken in the driving lane and in the passing lane for both the left-wheel-path and the right-wheel-path (DLRWP, and DLLWP, PLRWP, and PLLWP).

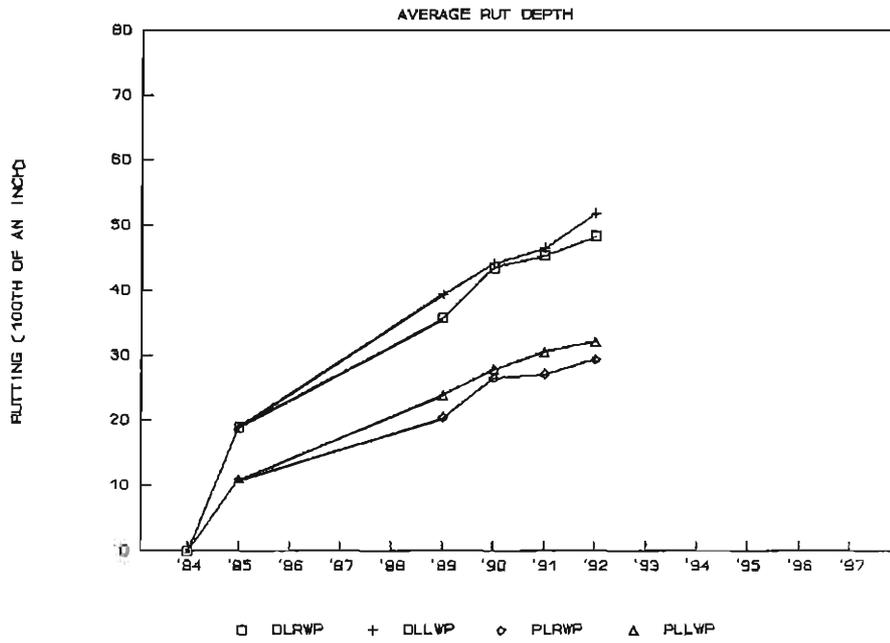
Figure 10

I-25 NORTHBOUND MP 235 - 243

average rut depth for the northbound lanes measured 0.40 inches during the 1989 season. However, occasional rut depth of up to 0.60 inches and many above 0.45 inches were detected.

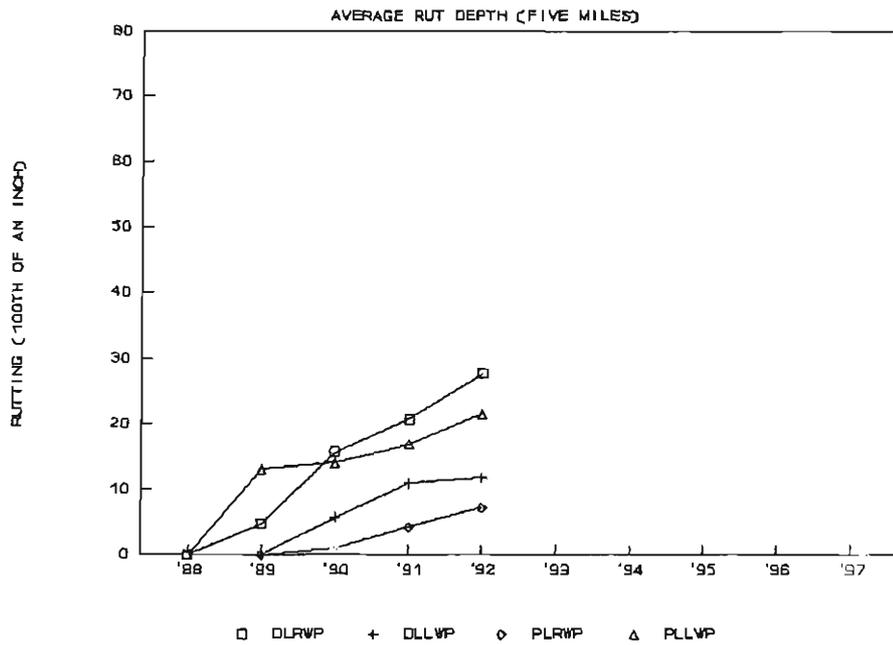
Figure 11

I-25 SOUTHBOUND MP 240 - 235

- Rutting is gradually but surely returning to the rehabilitated southbound lanes.
- Rutting is recurring faster in the test section (with minimal milling) than where the pavement was milled two inches and replaced with high-stability mix (control section).
- The early southbound rutting is largely in the outside wheel paths.
- Rutting on the unrehabilitated northbound lanes is continuing at a rate of 0.06 inches per year and now averages 0.5 inches with measured ruts up to 0.9 inches in one area.

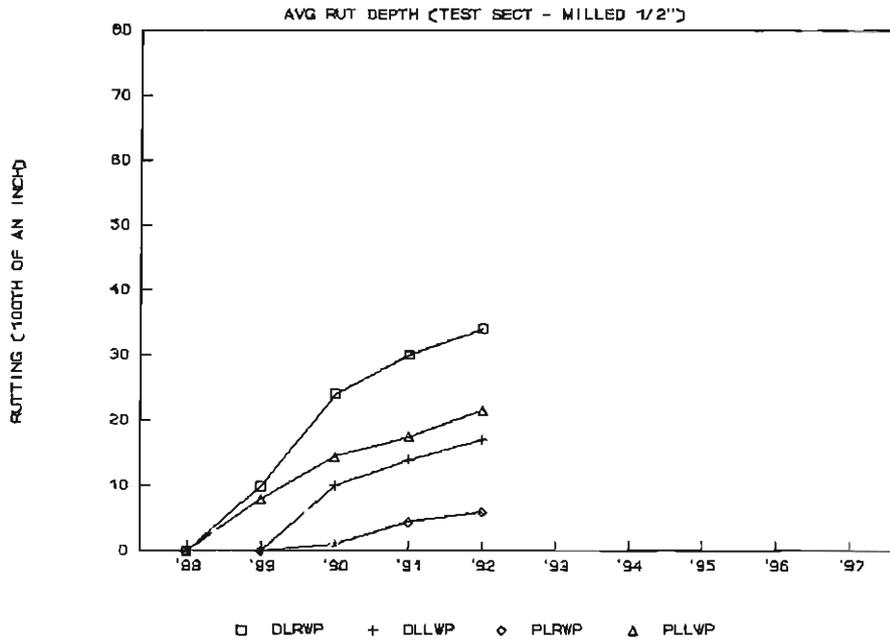
Figure 12

I-25 SOUTHBOUND MP 236.8 - 236.6

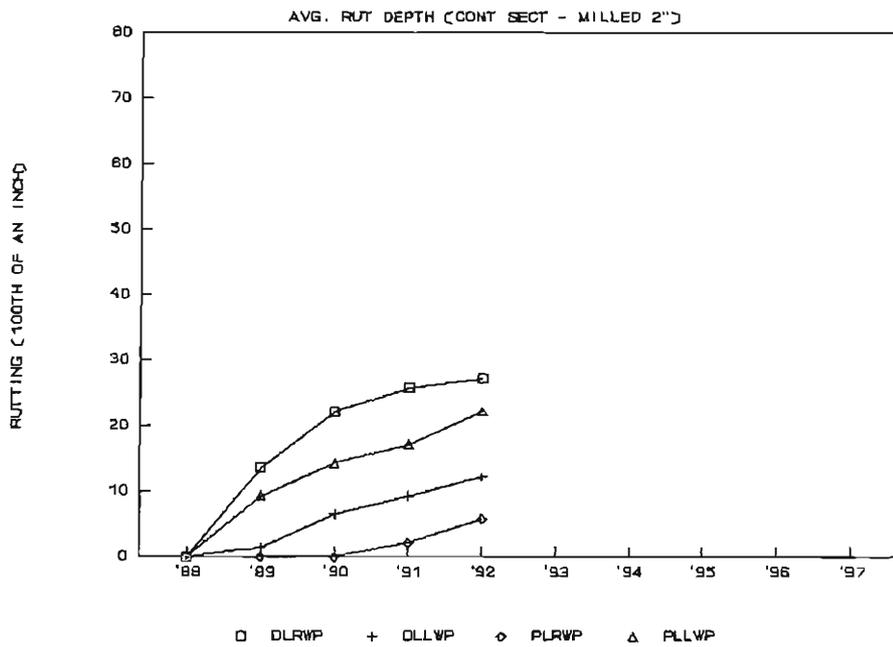
Figure 13

I-25 SOUTHBOUND MP 236.6 - 236.4

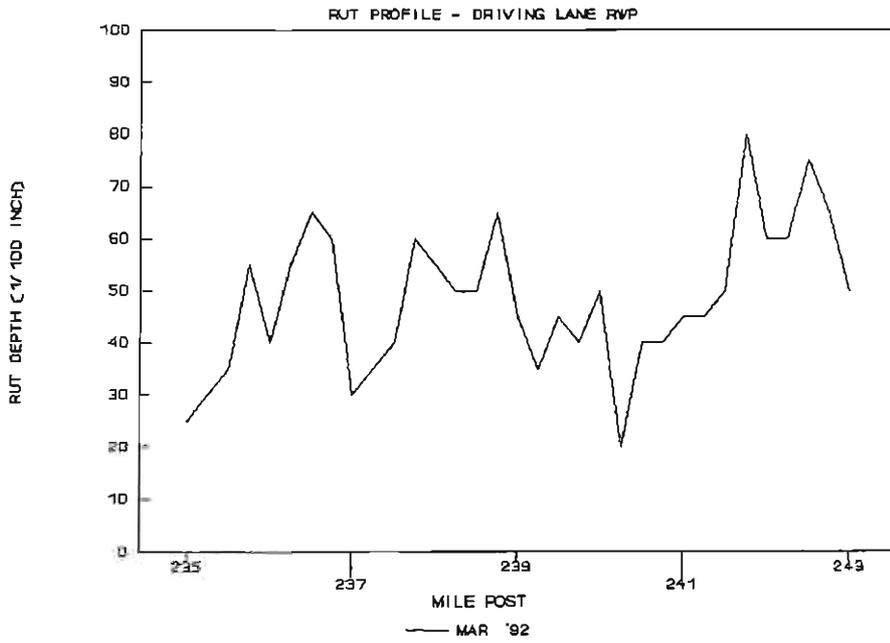
Figure 14

I 25 REHABILITATION - NORTHBOUND

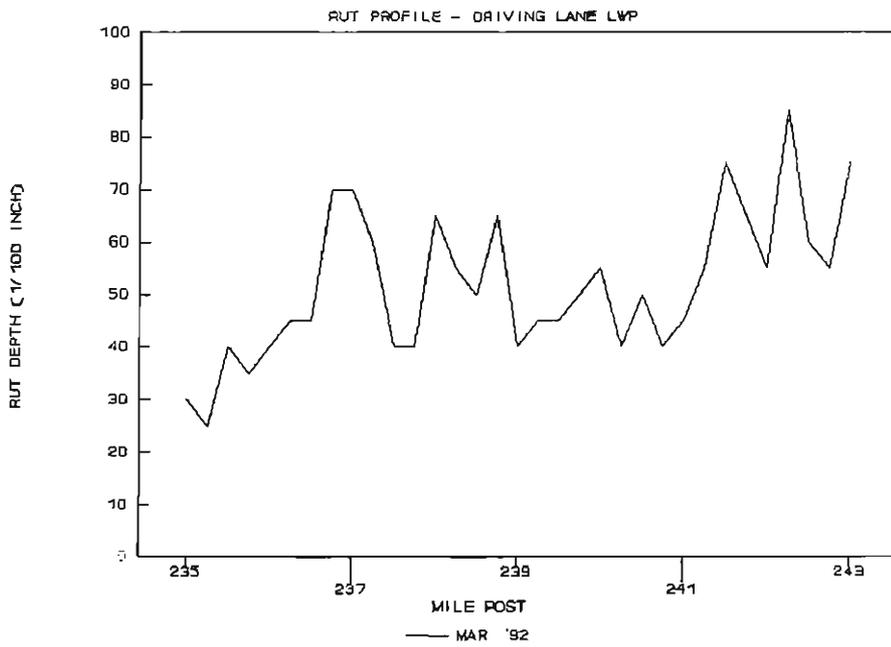
Figure 15

I 25 REHABILITATION - NORTHBOUND

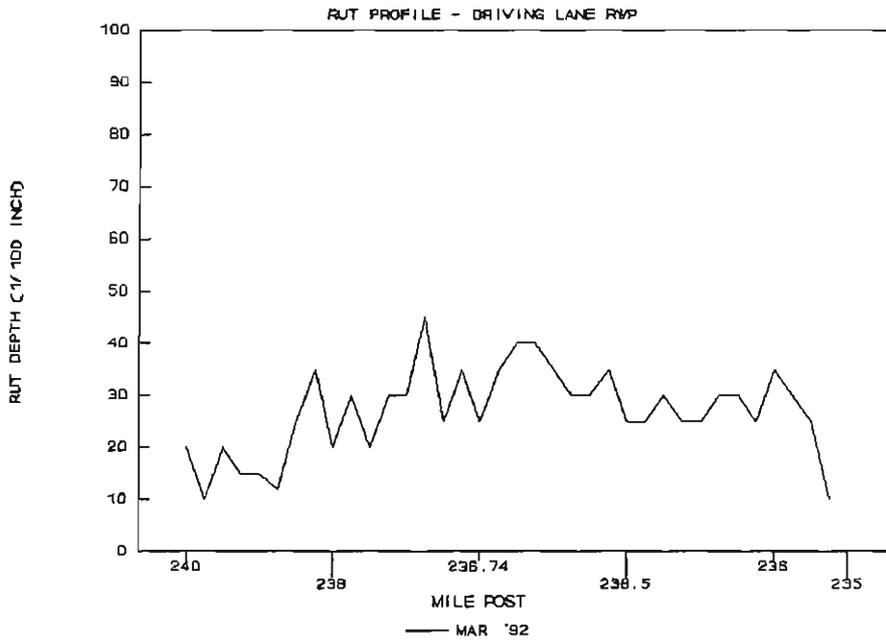
Figure 16

I 25 REHABILITATION - SOUTHBOUND

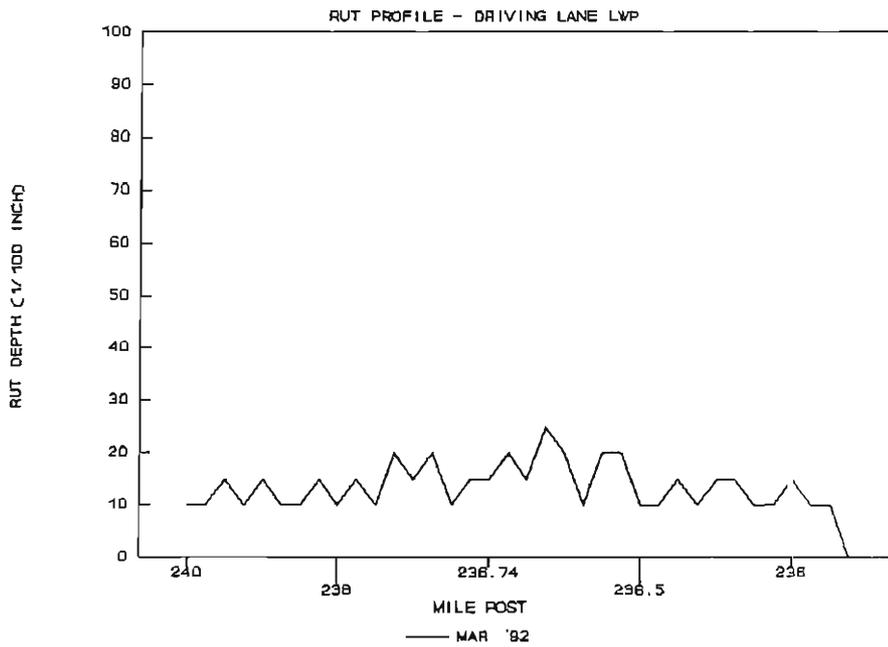
Figure 17

I 25 REHABILITATION - SOUTHBOUND
