Report No. CDOT-2009-9
Interim Report

SHORT-TERM CRACK SEALANT PERFORMANCE AND REDUCING BUMPS AND TRANSVERSE CRACKING IN NEW HOT MIX ASPHALT OVERLAYS OVER CRACK SEALANTS

November 2009

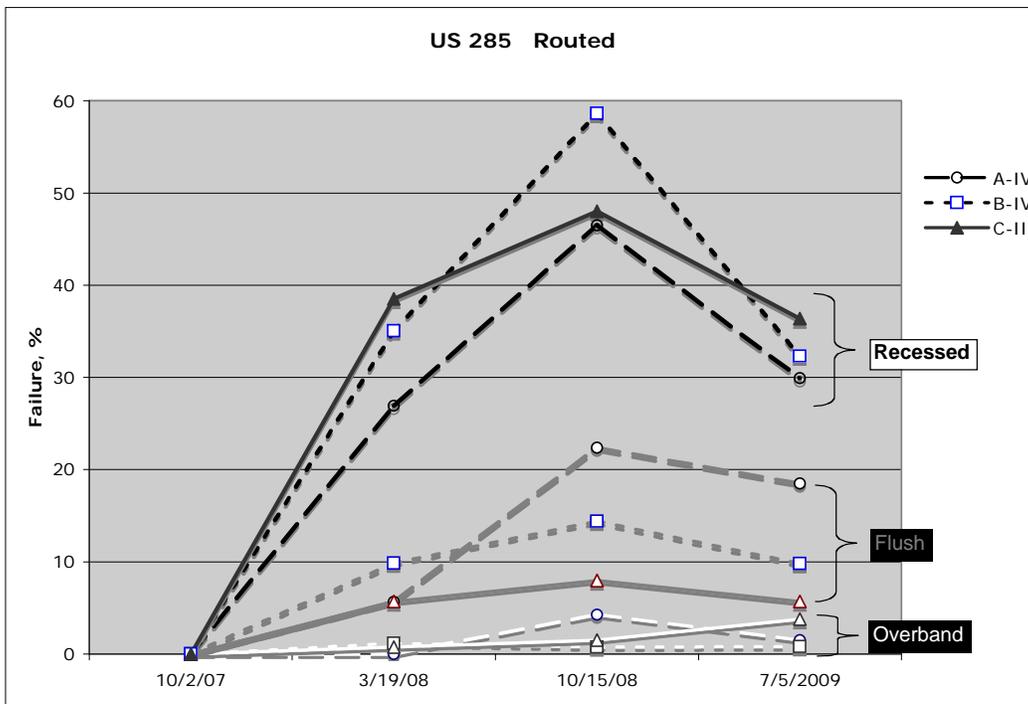
Figure 6. Sealant Performance on US285-Cracks Prepared by Routing

Analysis of the results from this study is challenging. There is variation in the data and few trends stand out consistently with the exception of one. It appears that for most of the conditions studied performance of the crack sealants has not followed a linear path of an increase in failure over time, as might be expected. Instead, the failures increased from installation in October 2007 to the first survey in March 2008, continued to increase until the second survey in October 2008, then declined at the third survey in July 2009 to levels of failure approximately equal to that observed in March 2008. There are eight exceptions to this. These are on Figure 3, where Supplier A for the flush, routed application shows a consistent increase in failure rate over time to a total of 10 percent failure and Supplier B for the flush and overband, routed application shows a consistent increase in failure rate over time to a total of 3 and 4 percent failure. Also, from Figure 4 Supplier C increases to approximately 7 percent failure for the hot air lance and recessed application. Products B and C in Figure 6 for routed and overbanded application on

US285 reach approximately 2 and 4 percent failure. And Figure 8 indicates that Supplier B reaches 15 percent failure for the air blow and overband process on US285. Supplier C reaches 4 percent failure on US350 in Figure 10 for a hot air lance and flush application and Supplier A-I has an 11 percent failure rate on US350 for the air blow and overband application shown on Figure 11.
