EVALUATION OF BRIDGE DECK
REPAIR AND PROTECTIVE SYSTEMS

Interim Report
December 1977

1. Report No. FHWA-CO-RD-77-8		2. Government Accession No.		3. Recipient's Catalog No.	
4. Title and Subtitle EVALUATION OF BRIDGE DECK REPAIR AND PROTECTIVE SYSTEMS				5. Report Date December 1977

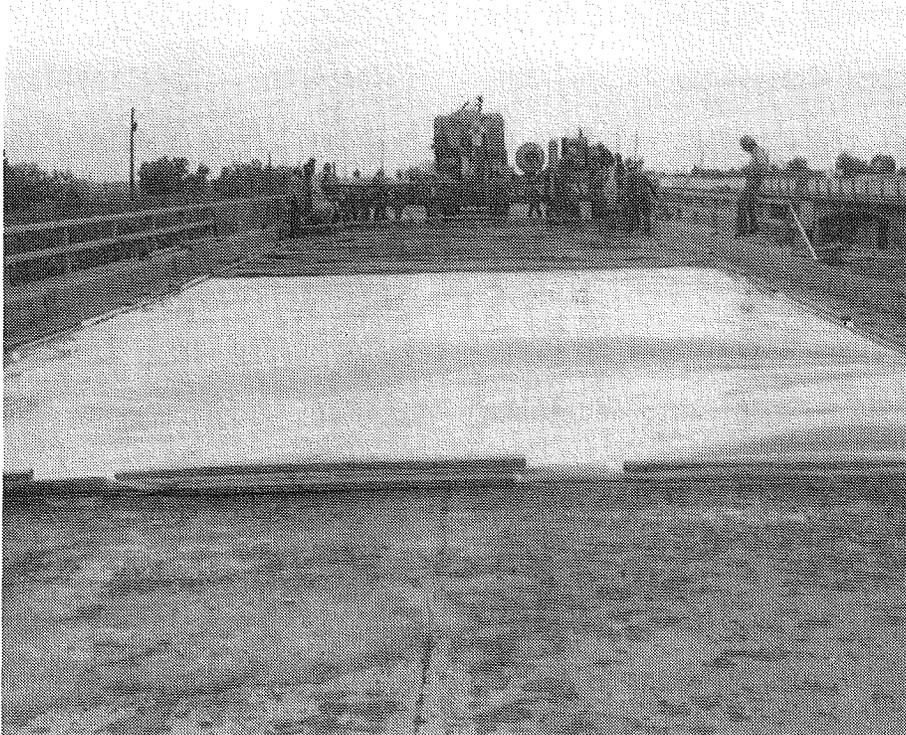
Photograph No. 8
Structure No. E-17-1B - I 76 Westbound Over I 270
Wet burlap and plastic sheeting are placed
immediately after the concrete is finished

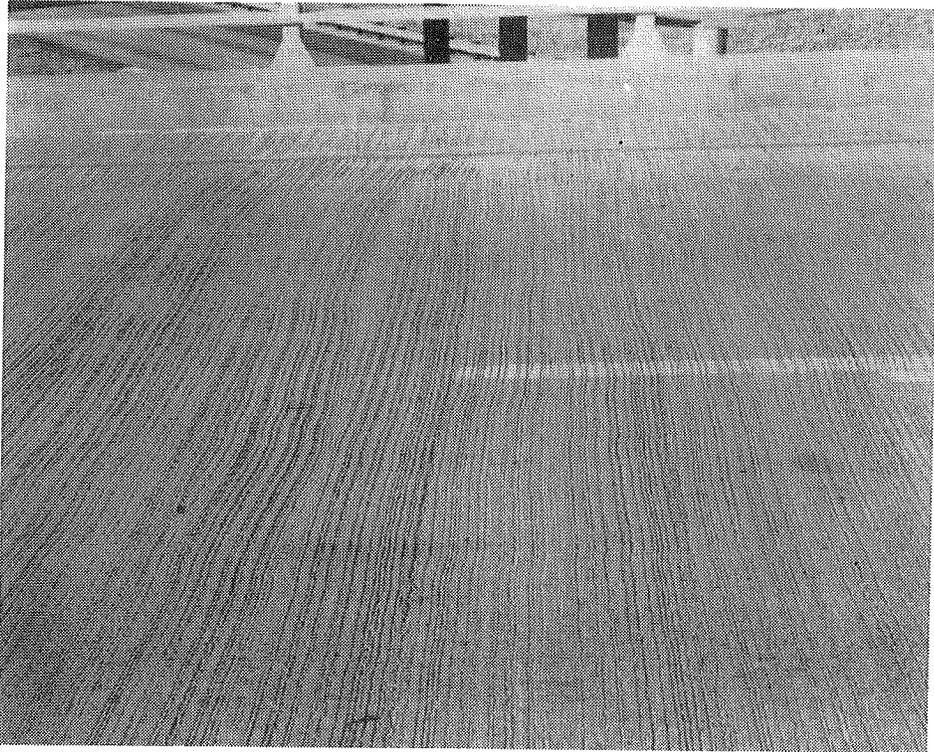
Photograph No. 13
Structure No. E-17-1B - I 76 Eastbound Over I 270
Completed latex modified concrete surface - Photograph
taken just after construction
A steel tined broom was used to create this texture.
