Report No. CDOH-DTD-R-90-4

PAVEMENT MARKING MATERIALS

Final Report
July 1990

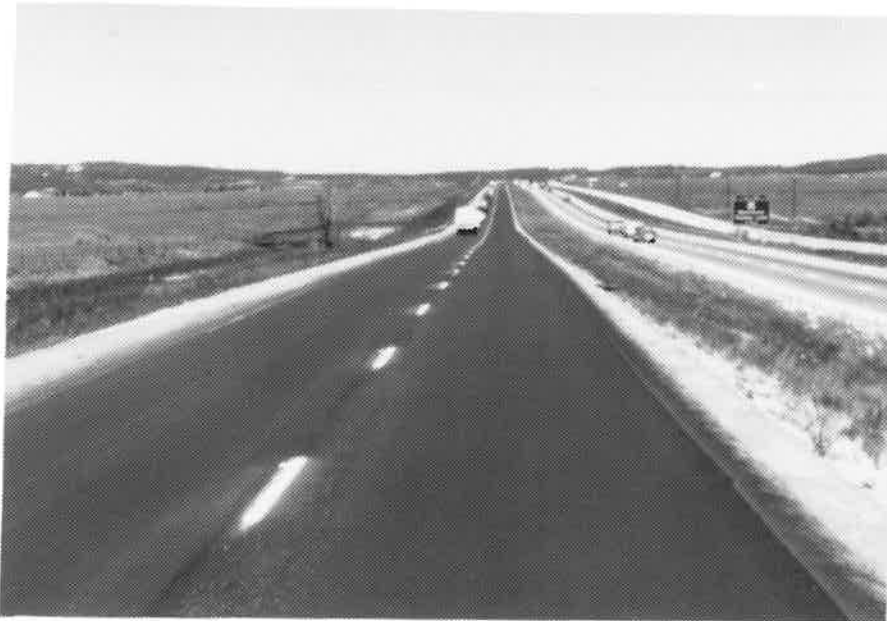
Photo 1. 6/28/84
I25 southbound, milepost
159, north of Monument,
1984 epoxy paint.

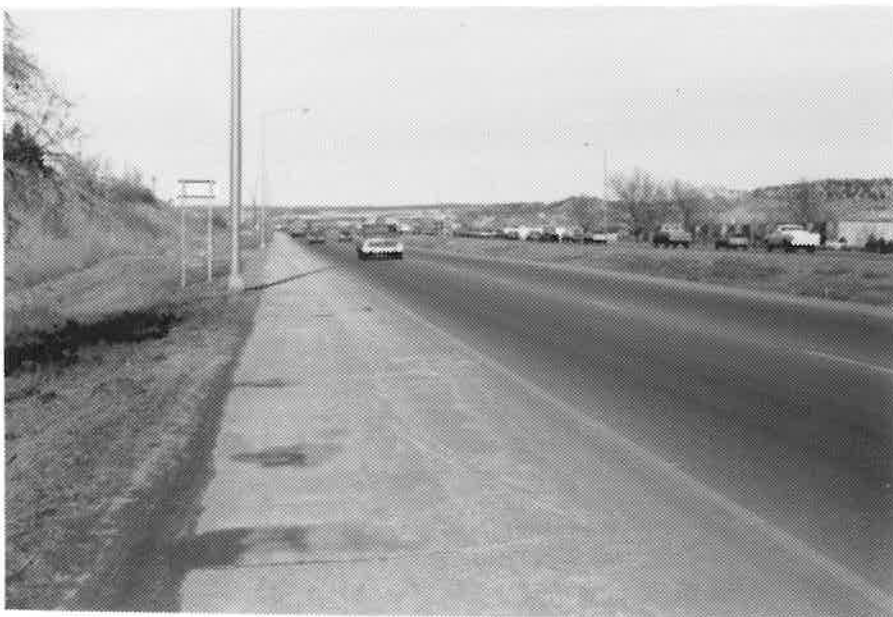
Photo 6. 1/25/88
I25 southbound, milepost
145, 1985 epoxy paint.

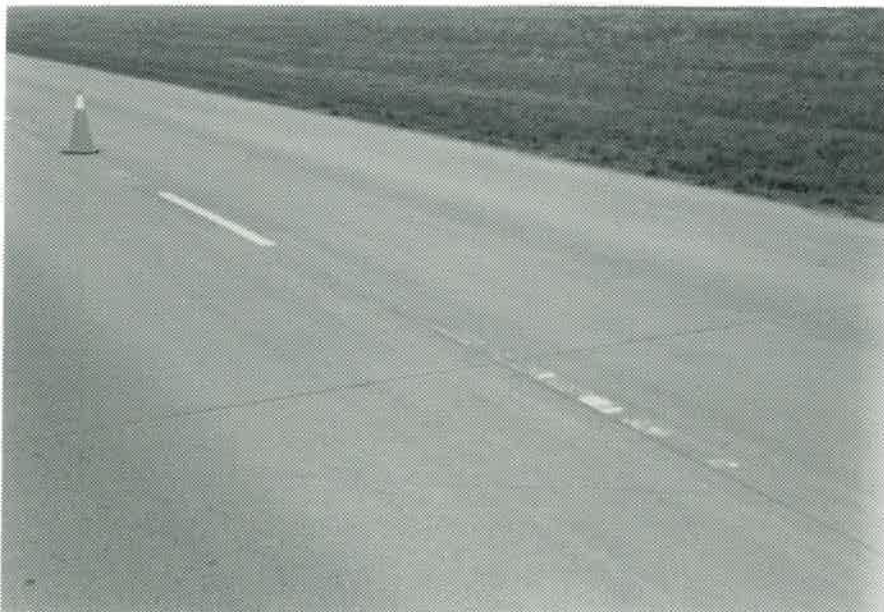
Photo 18. 2/27/89
I25 southbound, milepost
260 near Fossil Creek,
1986 extruded thermoplastic
skip stripe on lower right
and 1988 epoxy paint skip
stripe in upper left.

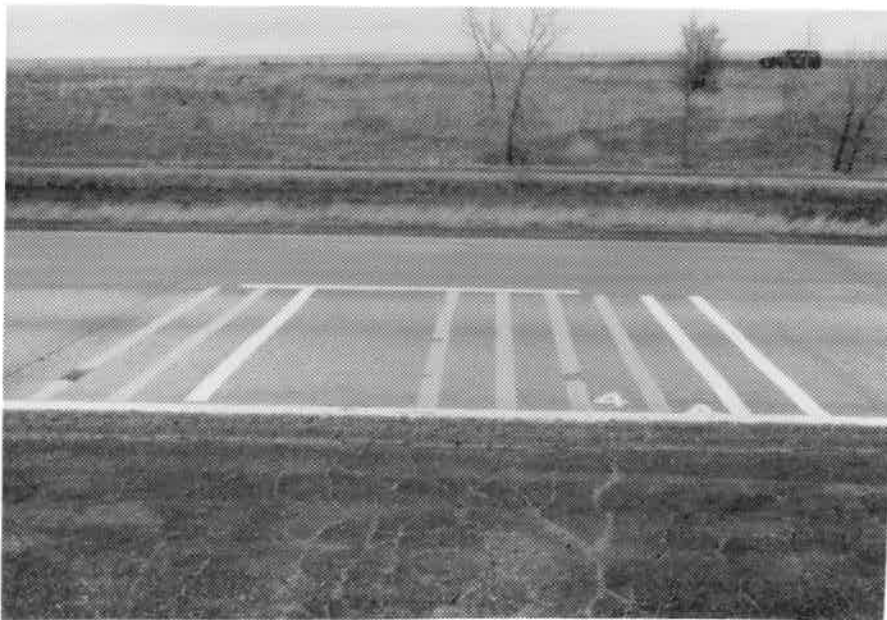
Photo 21. 3/29/88
Cataphote removable grade
preformed plastic on
concrete.

All the removable plastic materials tested remained over 94% intact for at least 120 days and are recommended.

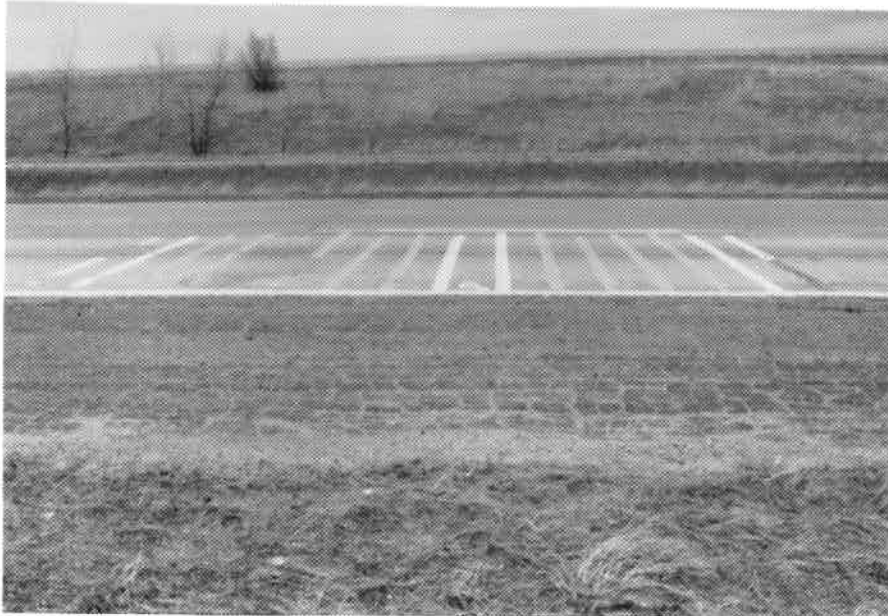
Photo 24. 3/29/88
Prismo removable grade
preformed plastic on
concrete.

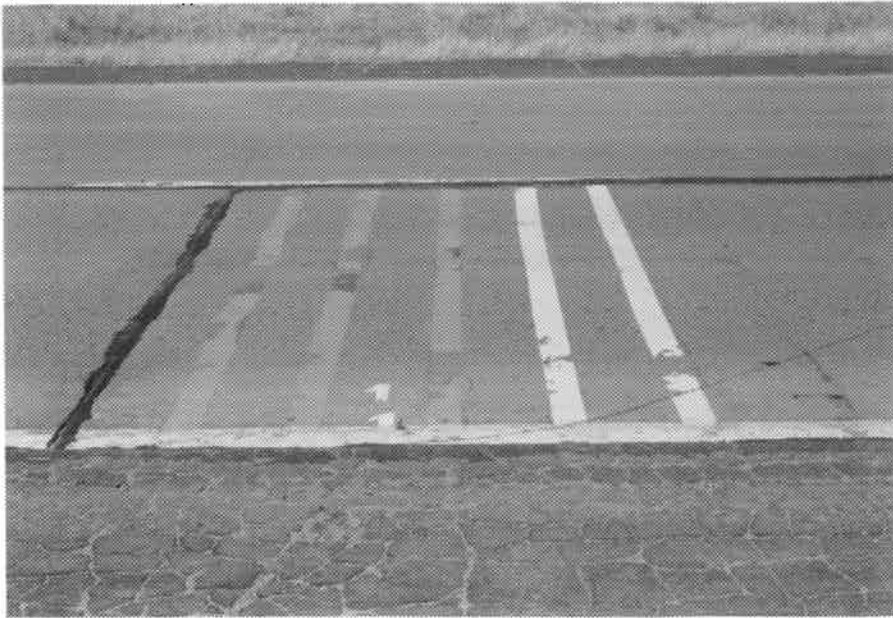
Photos 31 through 40 indicate the condition of the pavement marking at the end of the test on 3/8/89. Although the yellow materials appear as a dull gray in these black and white photos, they have good appearance with the naked eye. The percentage intact of each of the materials was estimated and is shown below.

Photo 31. 3/8/89
Pavemark permanent grade
preformed plastic on
concrete.

Of the permanent preformed plastic material installed on concrete, Pavemark, Volare, Cataphote, 3M-5730, and 3M-350 remained over 94% intact during the test and are recommended. Similarly on asphalt, Pavemark, Seibulite, Volare, Cataphote, 3M-5730, 3M-350, and Prismo primerless remained over 94% intact during the test period and are recommended.

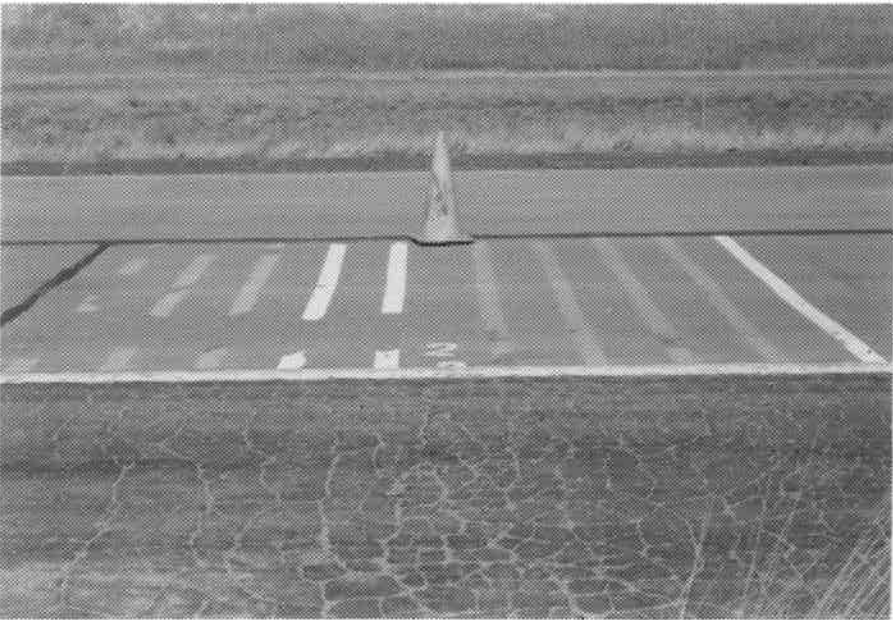
Photo 32. 3/8/89
Swarolite permanent grade
preformed plastic on
concrete.

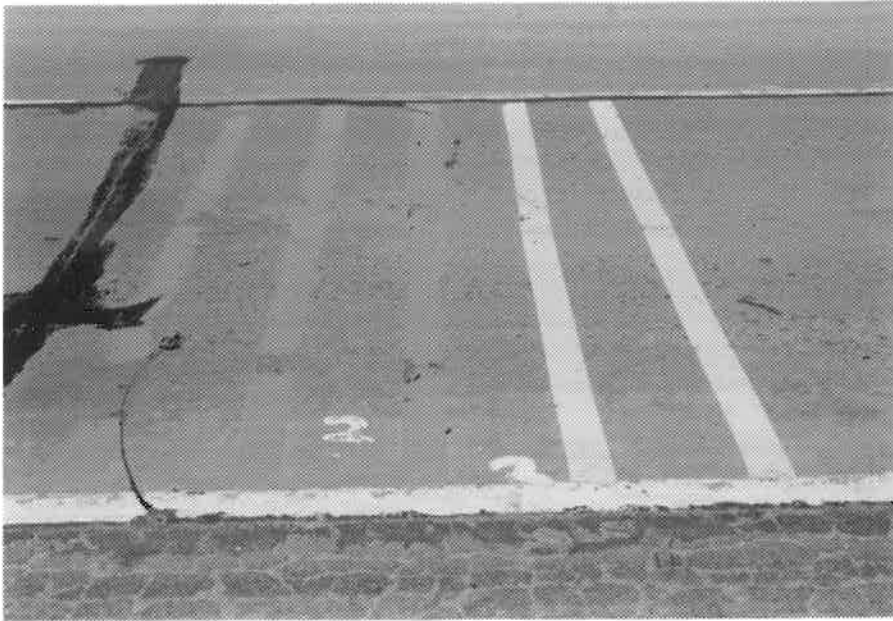
Photo 34. 3/8/89
Volare permanent grade
preformed plastic on
concrete.

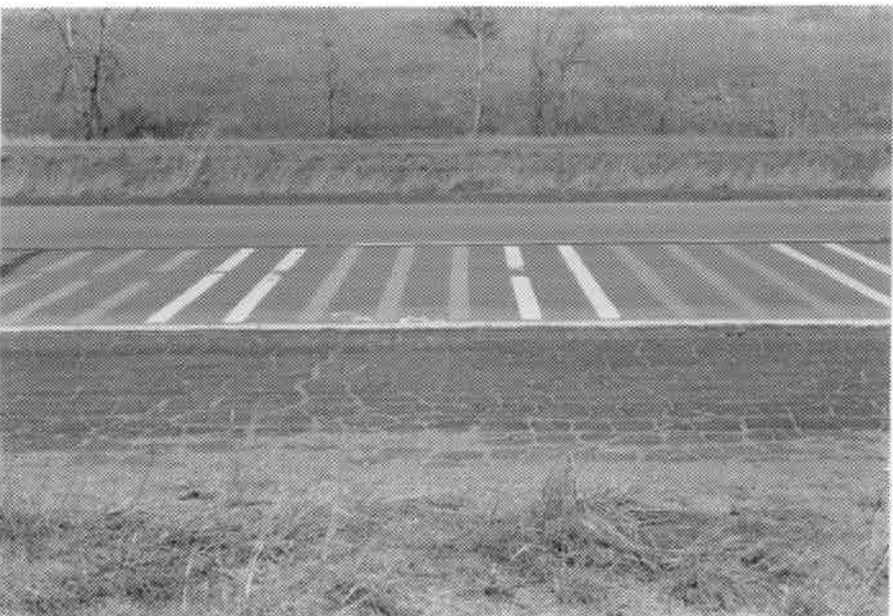
Photo 36. 3/8/89
3M-Std. permanent grade
preformed plastic on
concrete on left and 3M-
350 permanent grade
preformed plastic on
concrete.

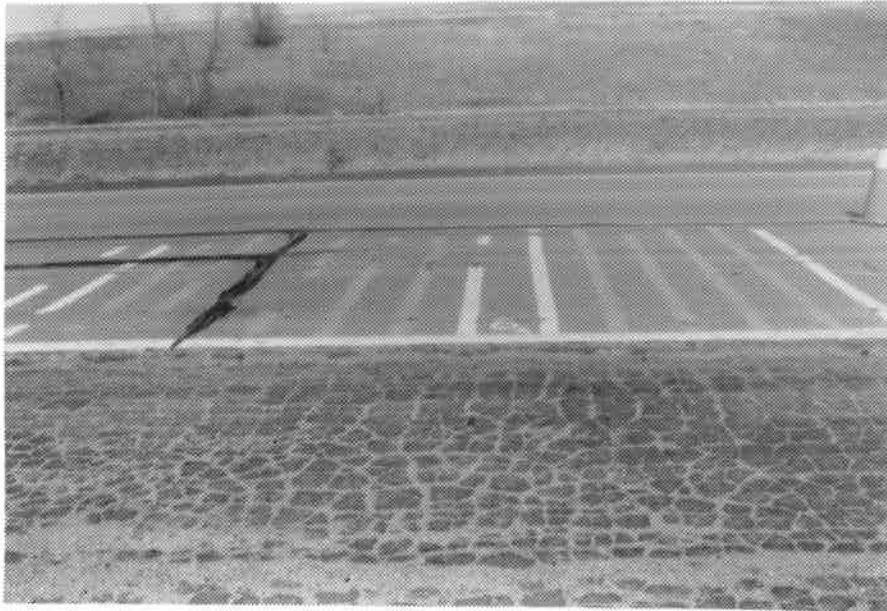
Photo 37. 3/8/89
Prismo permanent grade
preformed plastic on
concrete.

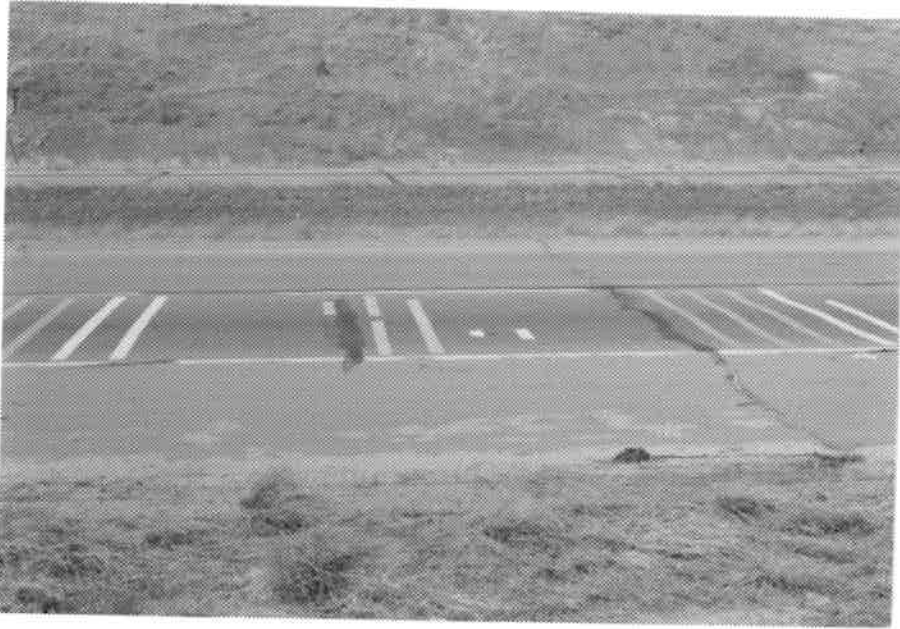
Photos 41 through 51 are photos that indicate the condition of the pavement marking at the end of the test on 3/8/89. The percentage intact of each of the materials was estimated and is shown below.

Photo 43. 3/8/89
Seibulite permanent grade
preformed plastic on
asphalt. (Far left four
stripes)

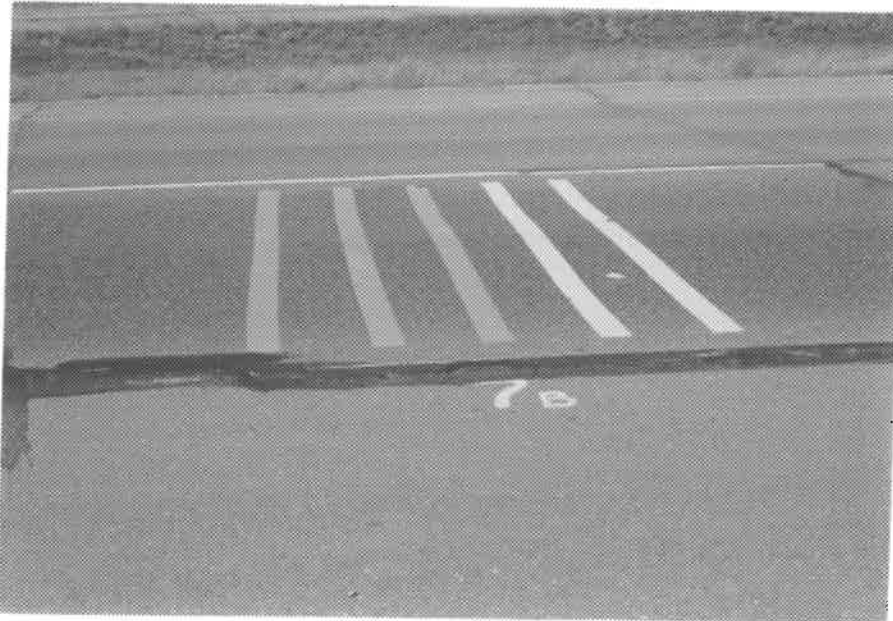
Photo 47. 3/8/89
3M0350 permanent grade
preformed plastic on
asphalt.

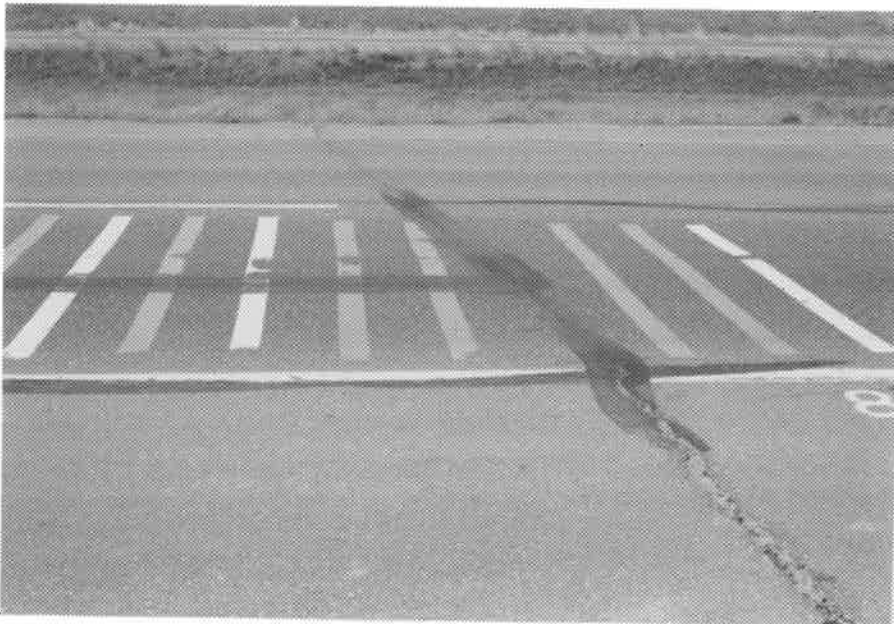
Photo 48. 3/8/89
Prismo permanent grade
preformed plastic on
asphalt.

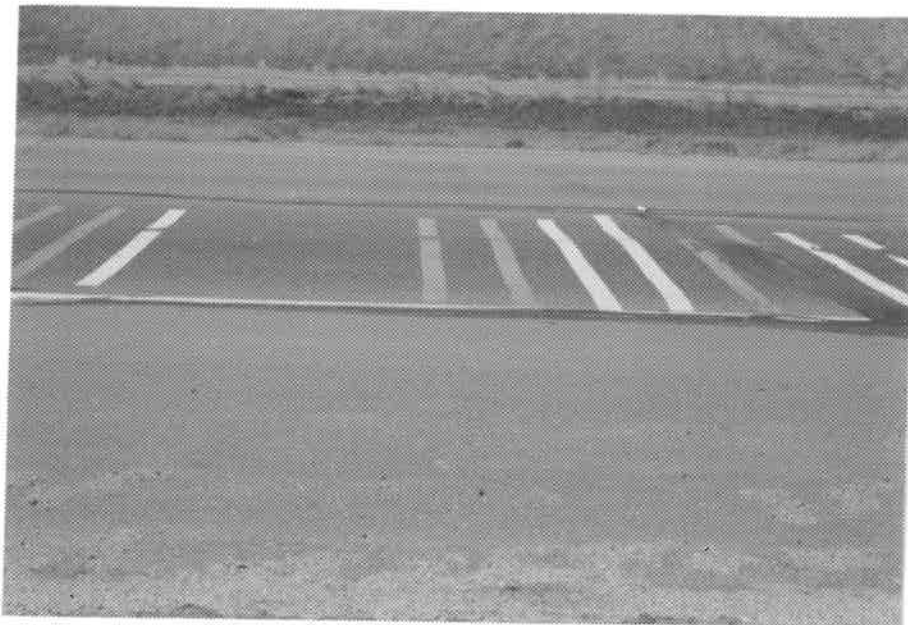
Photo 49. 3/8/89
Prismo permanent grade
preformed plastic on
asphalt.

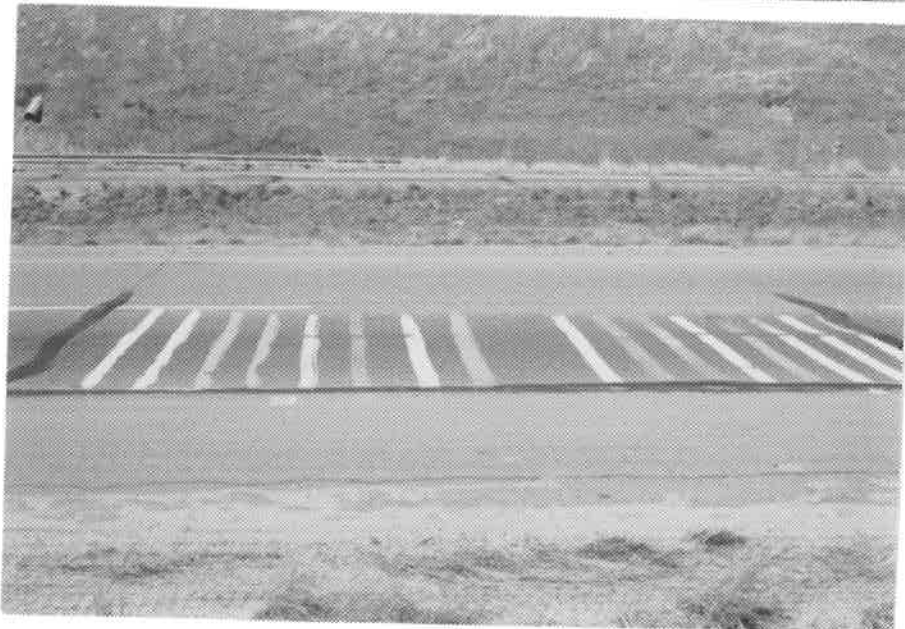
Photo 51. 3/8/89
Paints on asphalt.
