Report No.CDOT-DTD-R-93-9

Cold Hand Patching Materials

**Colorado Department of Transportation
4201 East Arkansas Avenue
Denver, Colorado 80222**

**Final Report
August, 1993**

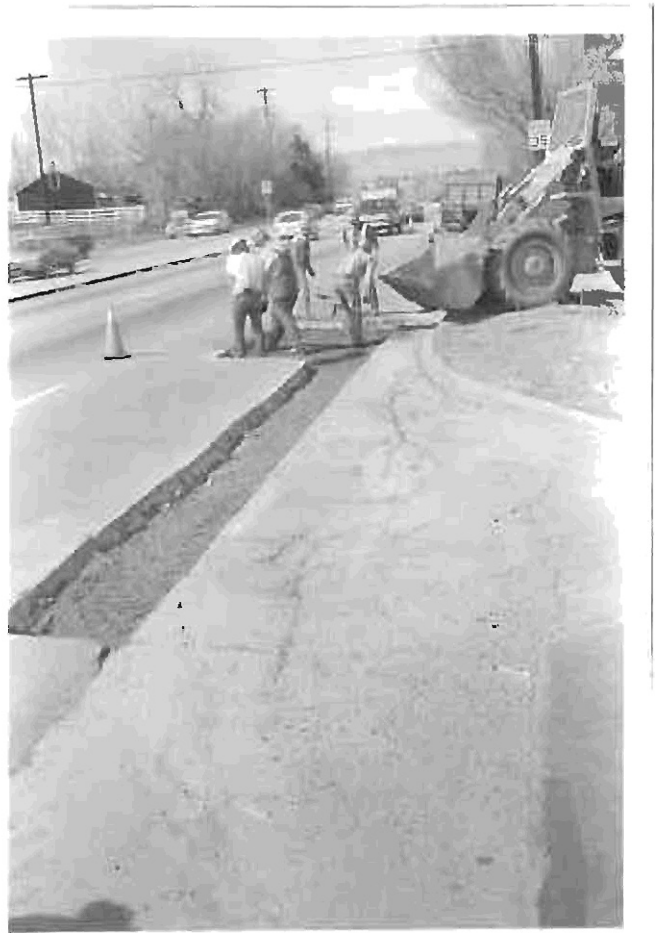
The damaged pavement was cut out down to the base. Then the entire area, about 100 square feet, was replaced using UPM for the west end and Styrelf for the east end of the patch. Since the asphalt was about six inches thick, the cold mix was laid in two lifts and compacted using a vibrating steel roller on each lift. The patch stood up well to traffic, which is heavy at this location, but it proved that even the expensive mixes are not invincible. About two months after the patch was made it began to fail because of the water that was able to penetrate the base from the cracks in the adjacent gutter. The photo on this page shows the UPM mix being removed. Notice the severe cracking in the concrete gutter to the right of the patch. There was water

standing in the gutter when the picture was taken. The patch appears to have been solid for about two inches on top and then loose gravel below. This type of failure has occurred in

other large patches using this type of cold mix in other parts of the state. Several large patches made with UPM cold mix were observed by research personnel during this study, both at test sites for the study and at other locations in the state. All of

the patches that failed had a poor base below the patch, either a consistently wet base, as was the case at US 285 and Downing St., or severely cracked asphalt which could not provide adequate support for the patch material.

This is an example of an emergency repair that can be made using cold mix. The surface was made usable for a short time so plans could be made to do the extensive necessary repairs to prevent a recurrence of the problem.
