Report No. CDOT-DTD-R-93-12

# **CURTAIN DRAINS**

Final Report  
December, 1993

U.S. Highway 550 near Electra Lake has had a history of problems with a muddy slope and moisture under the pavement. Project CXFC 20-0550-21 was initiated in 1986 to widen the roadway through this area. During the design process it was determined that slope stability and subsurface pavement moisture problems were likely. In order to mitigate these problems, it was decided to place curtain drains in the slope above the highway. These curtain drains were to intercept the groundwater at the top of the slope and conduct it to the opposite side of the roadway. Appendix A shows the plans and specifications for this project.

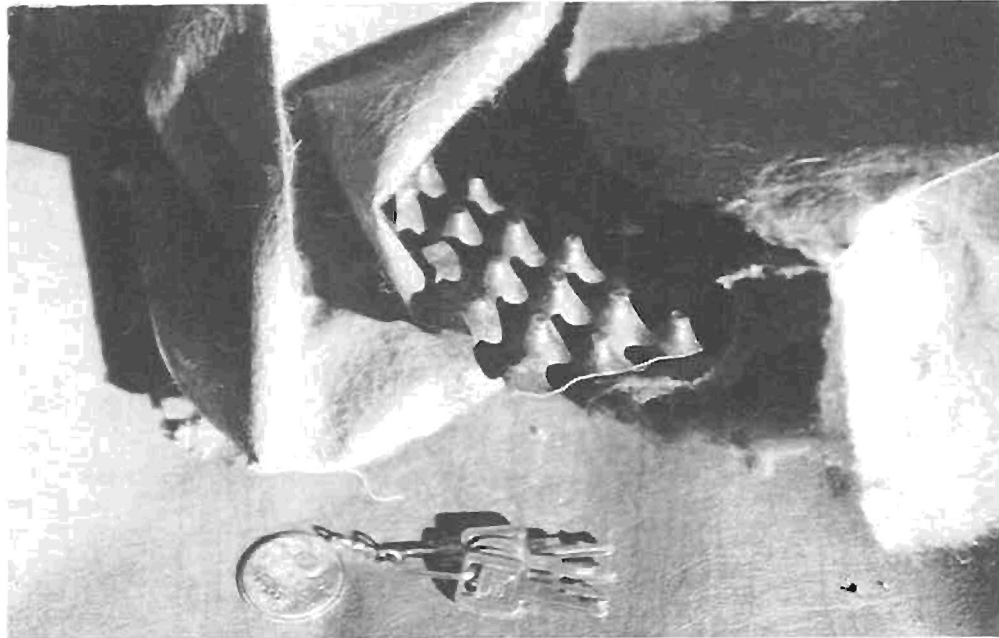
**Figure 1** This photo shows the "egg-crate" core of the curtain drain surrounded by the non-woven filter material.

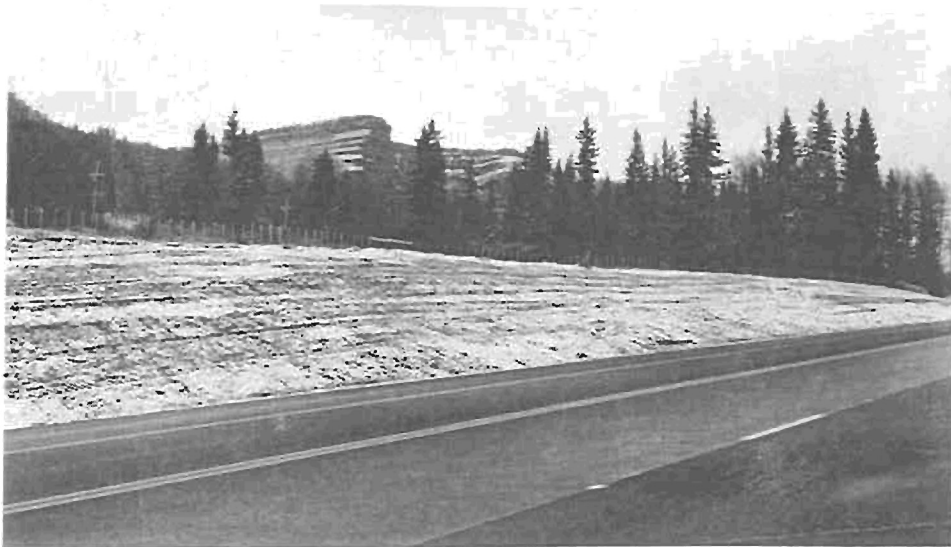
**Figure 2** The curtain drains were placed within this hill on the west side of US 550 south of the Purgatory Ski Area.

The curtain drains were placed to stabilize the slope at this location. From that standpoint, they have performed well. Only slight bulging in the slope was observed in 1993. Since the years in which this evaluation took place were relatively dry years until 1993, it is likely that the slope would have remained stable even without the curtain drains.

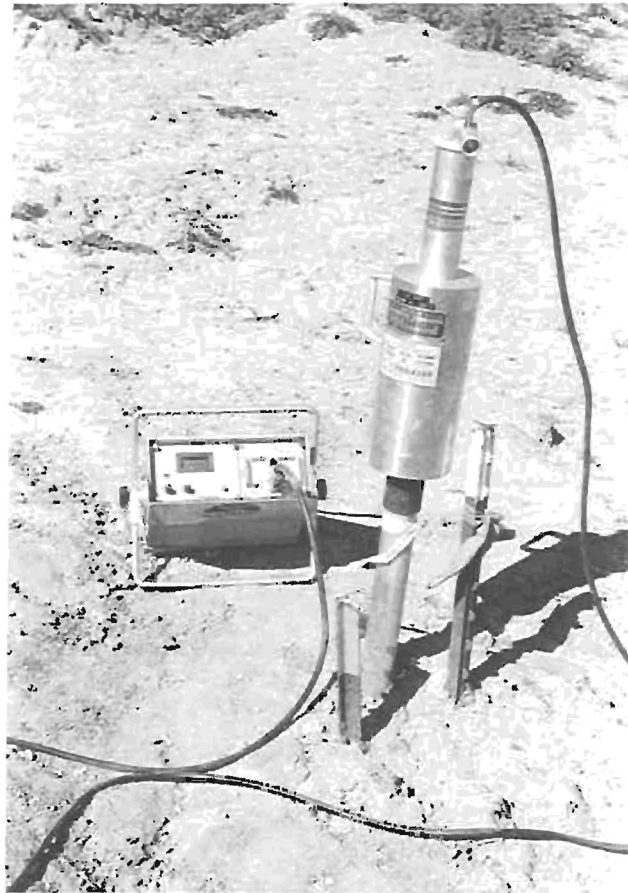
**Figure 13** This photo shows the nuclear device used to measure the moisture content of the soil. The nuclear source is in a cylinder attached to the end of the cable which can be lowered to the full 3.7 meter (twelve foot) depth of the tubes. Moisture content measurements were taken at one foot depth intervals the whole length of the tubes.

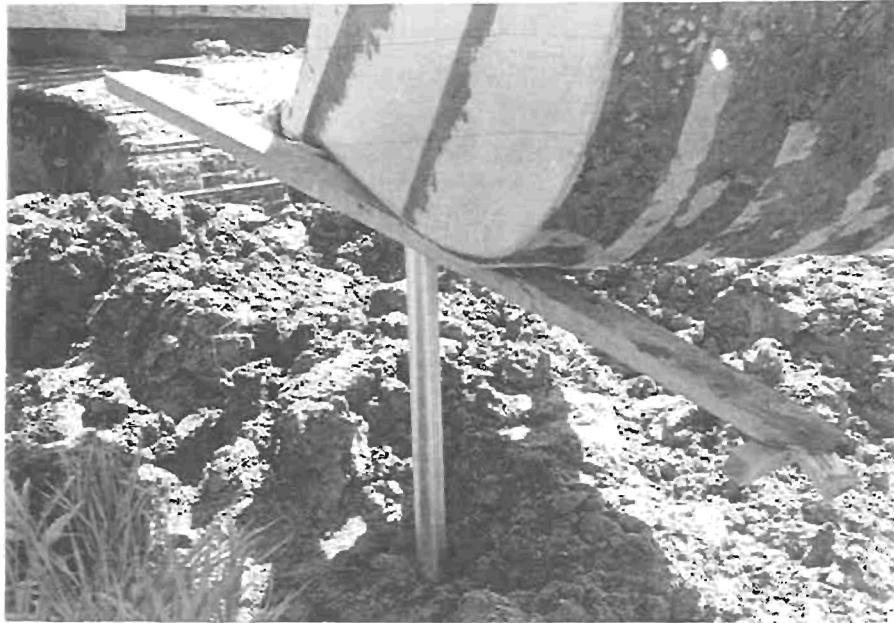
A pair of five centimeter (two inch) diameter rigid conduits was placed on each side of the crib-box in the open trench. However, as the box was pulled forward, the shear forces bent the conduit to such an extent that they were no longer usable. It was decided that because of the soft soil mass it would be easier to push the 3.7 meter (12 foot) tubes into the ground with the bucket of a backhoe. Four galvanized steel pipes were placed by this method, two on each side of the curtain drain. Figure 14 shows the final stage of the moisture tube installation, which went extremely well.

**Figure 14** The 3.7 meter (twelve foot) long galvanized pipes were capped at the bottom and pushed into the ground with the backhoe as seen here. Two tubes were placed on each side of the curtain drain. These were used throughout the project for moisture measurements.

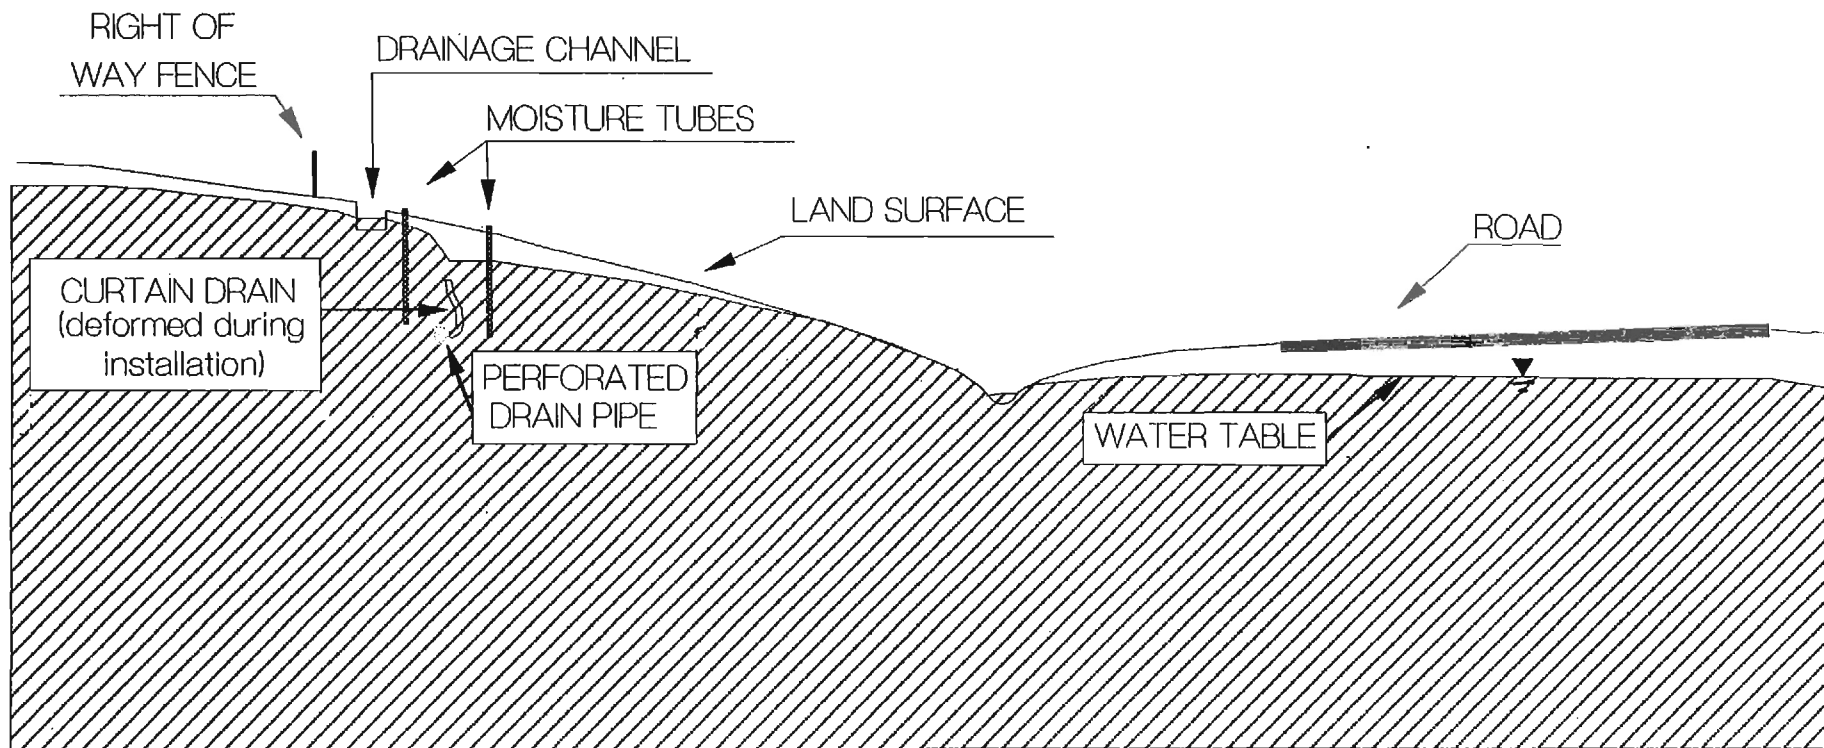
# CROSS-SECTION OF CURTAIN DRAIN STATION 434+50

Consistently throughout the testing period, the water table on the downhill side of the curtain drain was approximately 0.6 meters (two feet) lower from the ground surface than the water table above the curtain drain. Over three years of testing, the water table on either side varied by no more than one quarter to three quarters of a meter (one or two feet). The dense clay at this site makes groundwater transport very slow. Figure 17 is a cross section diagram that shows the location of moisture tubes, the curtain drain, the roadway, and representative water table at one of the two nuclear moisture tube locations.

**Figure 17** Moisture tube diagram

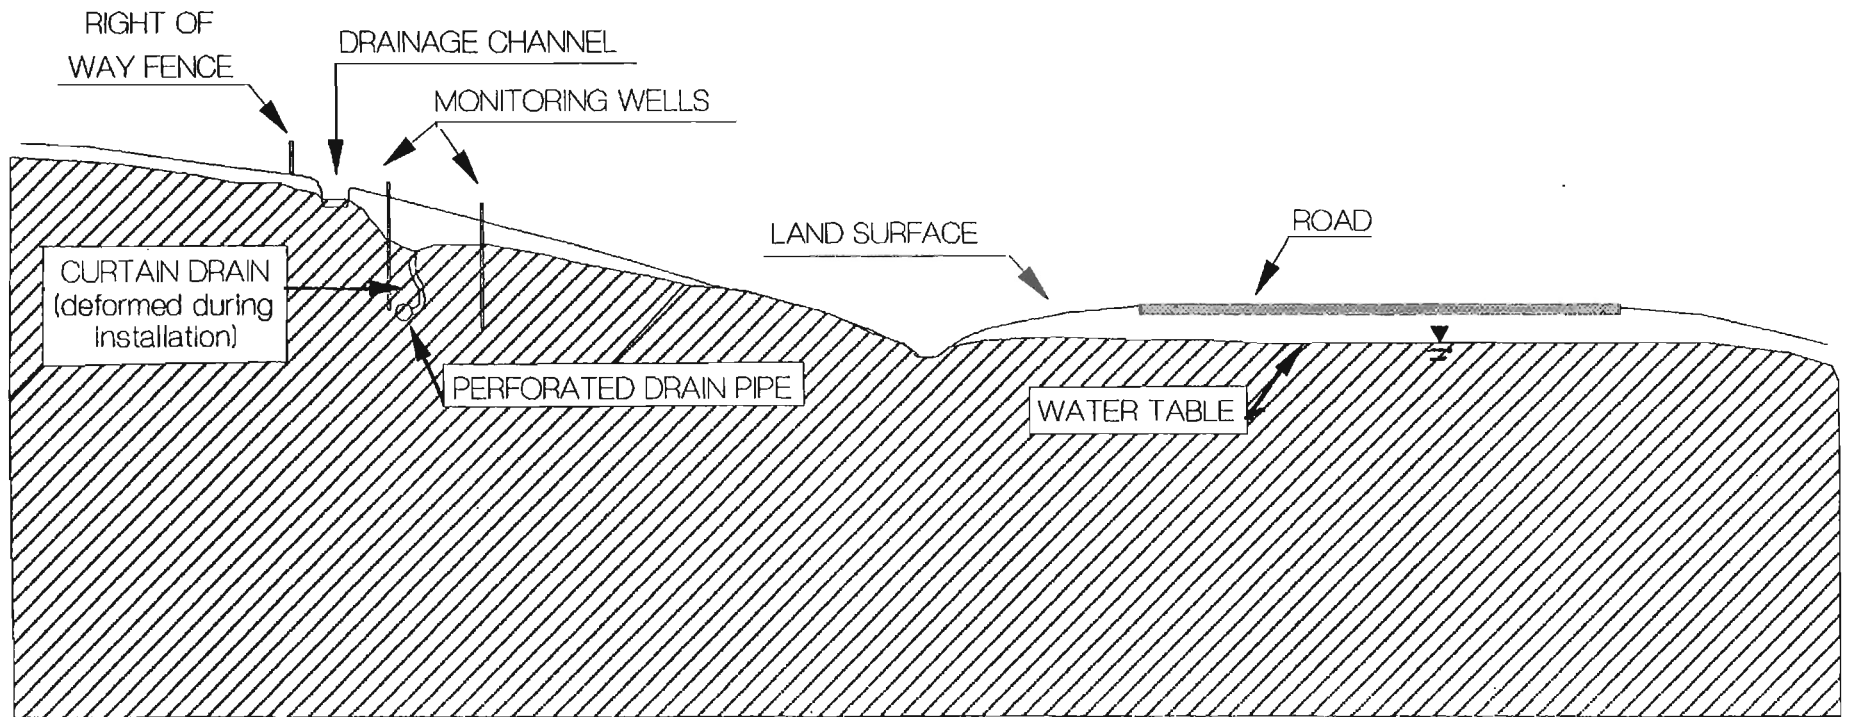
# CROSS-SECTION OF CURTAIN DRAIN STATION 433+00

As can be seen in the table, the set of wells to the south at station 433 do not exactly show the same information. The downhill hole at this location was placed further down the hill on a steeper section. The water in this hole is closer to the surface than the uphill hole. This is probably due to the groundwater coming closer to the surface due to the steepness of the slope. There are cattails and other wetland vegetation growing at the bottom of the slope where the groundwater daylight. Figure 19 shows the cross section of the roadway and roadside features at this location south of the moisture tubes.

**Figure 19.** Monitoring well diagram
