Report No. CDOT-DTD-R-93-17

# **In Service Evaluation of Highway Safety Devices Experimental Project No. 7**

Final Report  
April, 1994

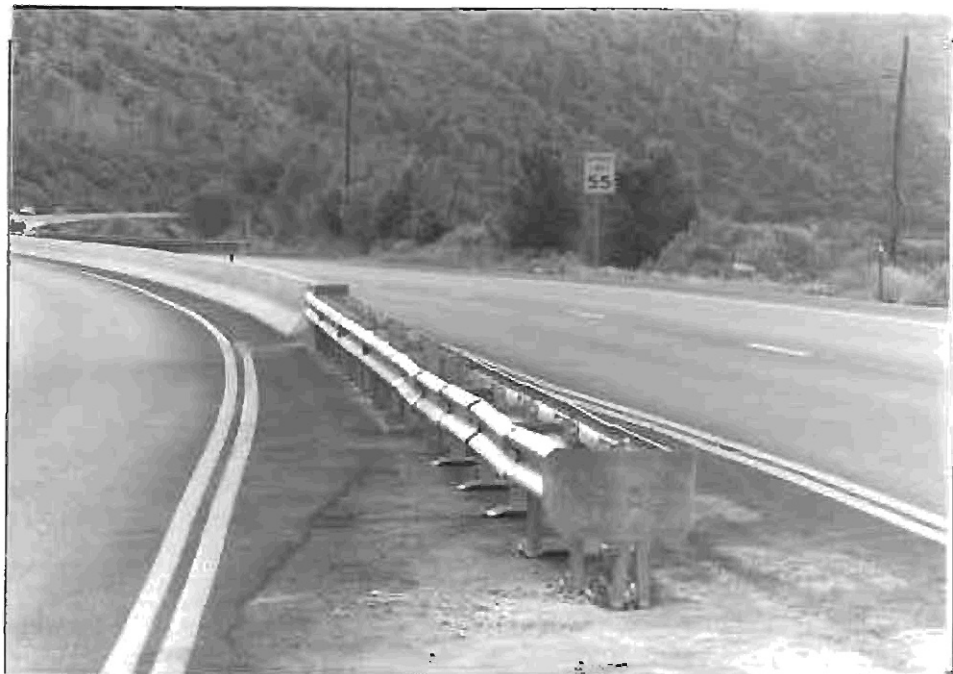
Figure 5

In an end on impact, the Brakemaster absorbs energy through the use of a cable braking mechanism that is anchored in concrete

buried below the nose of the terminal. The end of the cable anchor can be seen below the nose of the terminal in Figure 5.

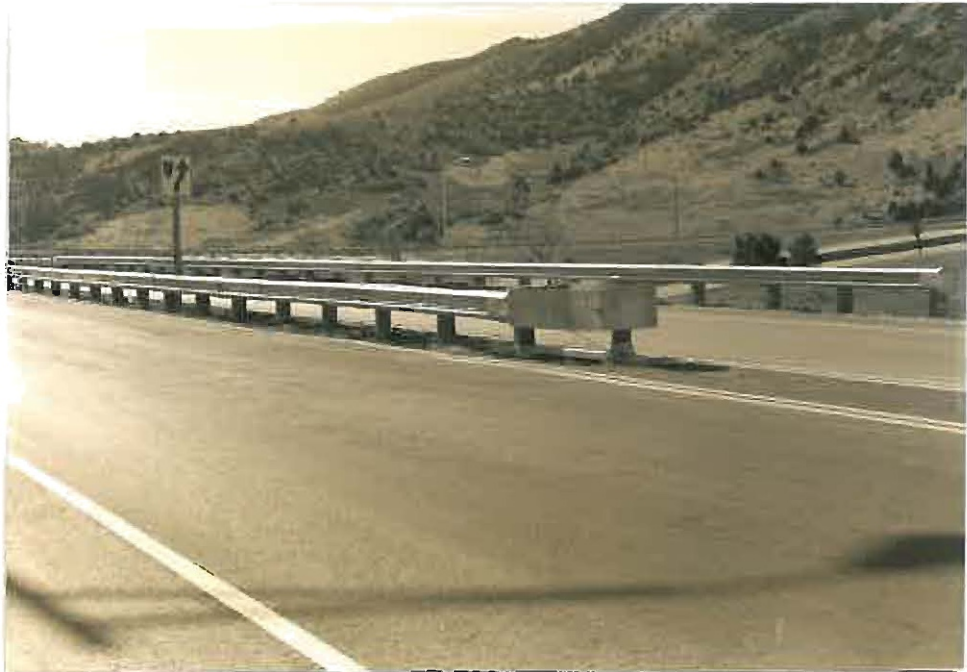
Figure 8 the slotted bolt holes in the first two sections of rail can be seen. The terminal is 31' 3" long and is made up of a nose section and two 13'- 6-1/2" sections of slotted w-beam guardrail. The first slotted section after the nose is 12 gauge rail; the second slotted section is 10 gauge (drawing page 12). Because the posts are set in tubes in the
