Report No. CDOT-DTD-R-97-6

# **Evaluation of the Iowa Vacuum Tester**

Interim Report  
July, 1997

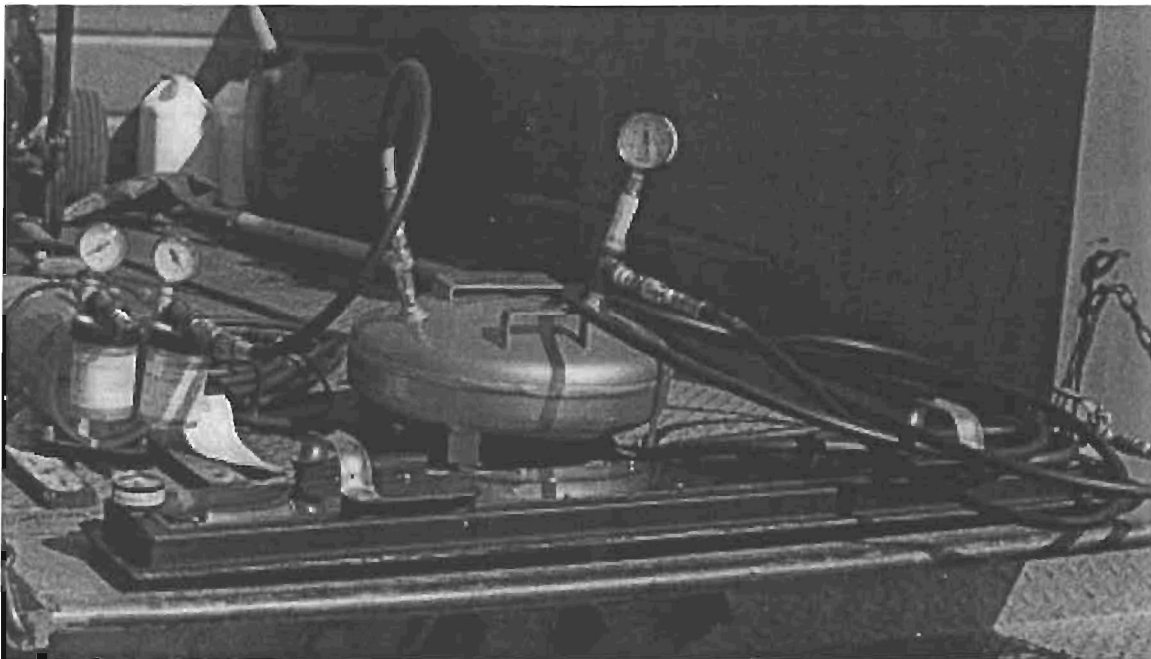
**Figure 1** The Iowa Vacuum Testing System. The pump, to the left, has two gauges, It can be used as either a compressor or a vacuum pump. The storage tank also has a gauge to show the pressure level in the tank. The test chamber is on the tailgate of the truck. The gauge on the left end lets the operator keep the vacuum at the proper level. Next to the silver handles are foot rests for the operator to stand on to help the chamber seal to the pavement. At the right end is the vacuum valve which is opened to apply vacuum to the chamber. The 10 ft. supply hose connects the storage tank to the chamber through the valve. A 6 ft. hose that is open at the end connects to the chamber side of the valve. The operator regulates the vacuum level in the chamber by opening and closing the end of the hose with his thumb.

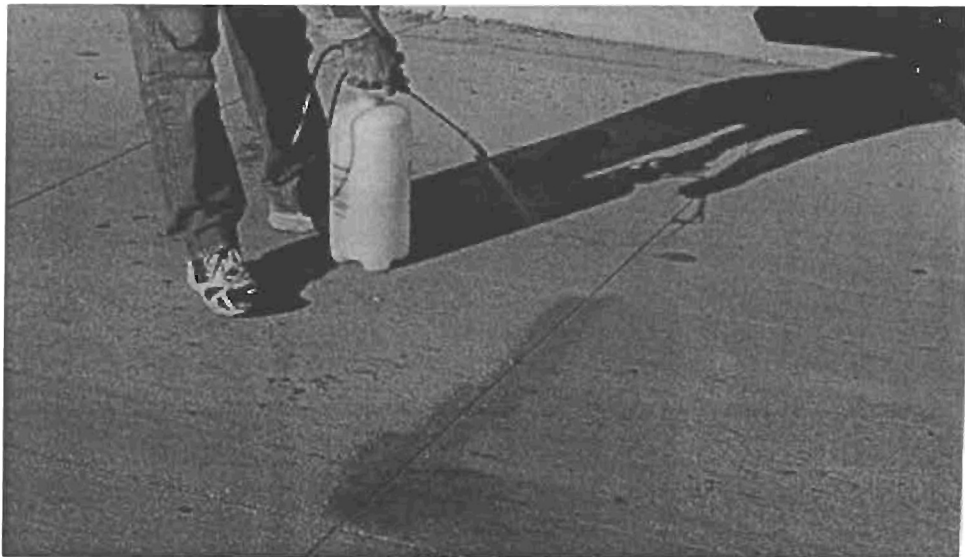
**Figure 2** Wet the joint and the pavement surface for about 4" on each side.

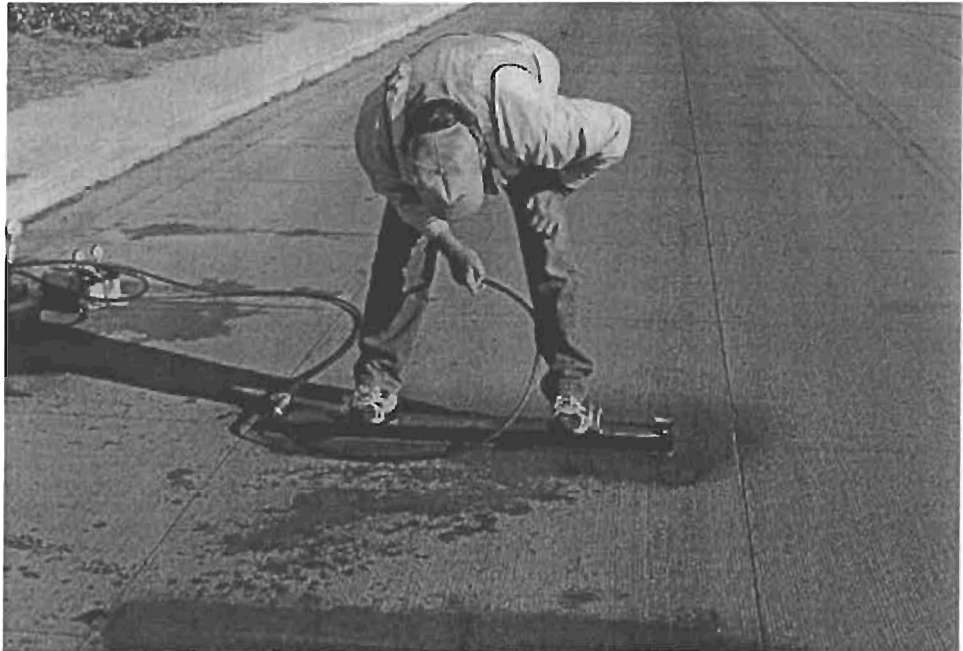
Open and close the end of the vent hose to regulate the vacuum in the chamber so it does not exceed 125 mm Hg (about 2.5 psi).

**Figure 3** The operator stands on the chamber to help it seal to the pavement. The hose in his right hand regulates the vacuum level in the chamber.
