Report No. CDOT-DTD-R-2001-6

Results and Recommendations of Forensic Investigation of Three Full-Scale GRS Abutment and Piers in Denver, Colorado

June 2001

**COLORADO DEPARTMENT OF TRANSPORTATION
RESEARCH BRANCH**

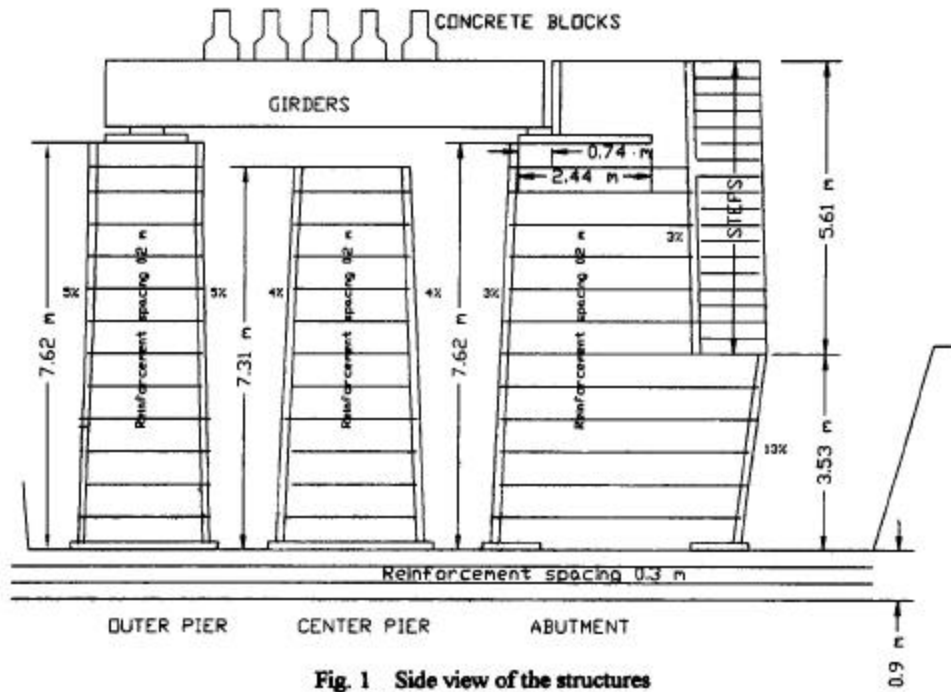
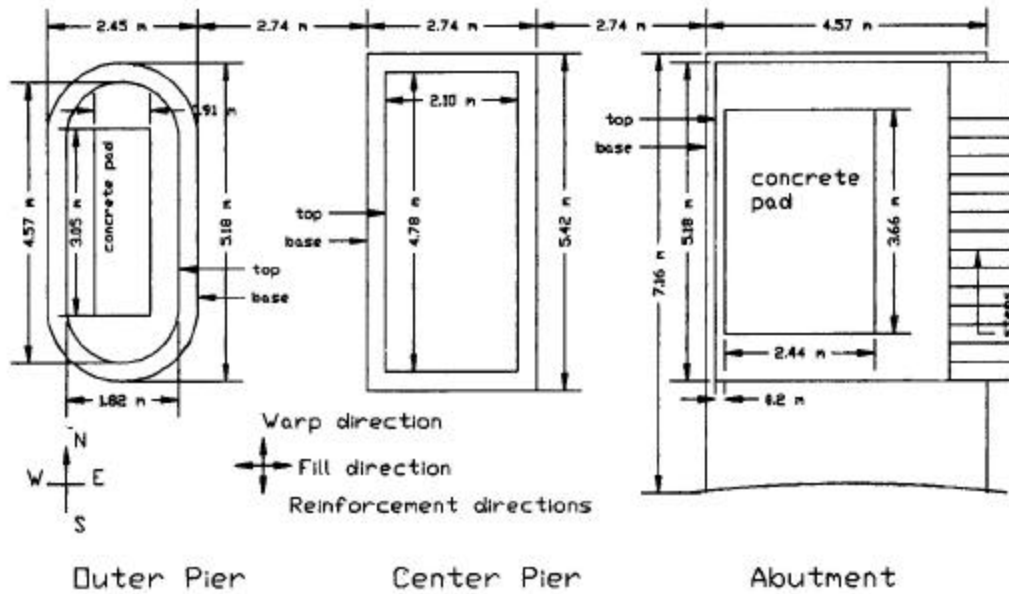
Figure 1 Side and Top Views of the Havana Yard Large Scale GRS Structures (from Ketchart and Wu, 1997)

Fig. 1 Side view of the structures

Fig. 2 Top view of the structures

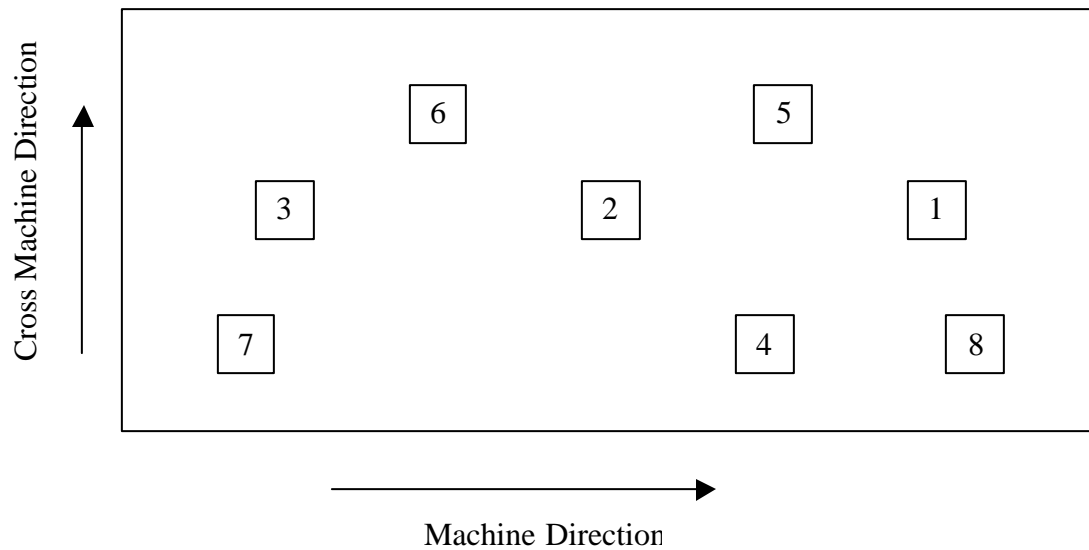
Figure 2 Schematic Diagram of Specimen Sampling Plan for the Center Pier Geotextile Sheets

direction (CMD) specimens and one machine direction (MD) specimen (# 8 in Figure 2) were sampled from each sheet (see Figure 2). Approximate location of these specimens is shown in Figure 2. Three center CMD specimens (1, 2, 3), and two CMD specimens (4, 5, 6, 7) on each side were collected, spaced along each line approximately 1.5 to 2 meters apart (Figure 2). One MD specimen was collected (#8) close to the corner edges (Figure 2). To ensure structural integrity, specimens were taken by cutting each specimen 216 mm wide, and removing an equal number of yarns from each side to obtain an 203 x 203 mm test specimens (Photo 14 in Appendix A). Specimens were then placed in the standard atmosphere (50% relative humidity, 70° F laboratory temperature) for a period of 24 hours to insure temperature and moisture equilibrium. One hundred twenty-eight specimens, (8 from each sheet), were prepared for the wide-width tensile tests.

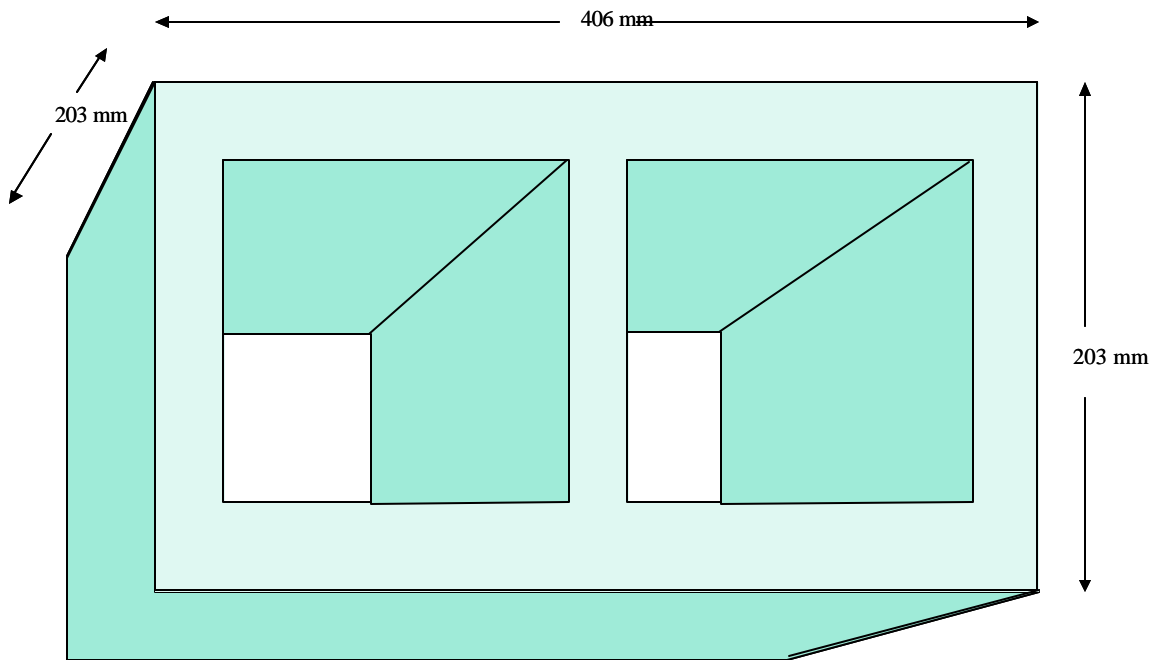
Figure 3 Typical Block from East Abutment Structure (133 to 182 N or 30 to 41 lb. in weight)

The blocks for the abutment structure (Figure 3, Photo 2 Appendix A) were supplied by several manufacturers (Amoco Fabrics & Fibers, Best Block, Clalite, Retaining Wall Systems, and Valley Block). The blocks were standard blocks (0.2m x 0.2m x 0.4m), made of lightweight concrete in the basic two-cell shape (Figure 3). Their weights varied from 133 to 182 newtons (30 to 41 pounds). There were few cracks visible in the external face before the dismantling began (Photo 8). During dismantling, a fairly large percentage – as high as 50% – of the blocks in some layers was internally broken. Most of the blocks on west face of the abutment (the side where surcharge load on the abutment was applied, see Figure 1) were broken. Most of the blocks on the north, east, and south faces of the abutment were unbroken. Many of the blocks that were broken did not have visible cracks before dismantling of the structure. A block that had a crack that ran completely from the top to the bottom and half way through the center web is shown in Photo 12 (Appendix A). There did not seem to be any correlation between the layer location (depth) and the percentage of broken blocks.

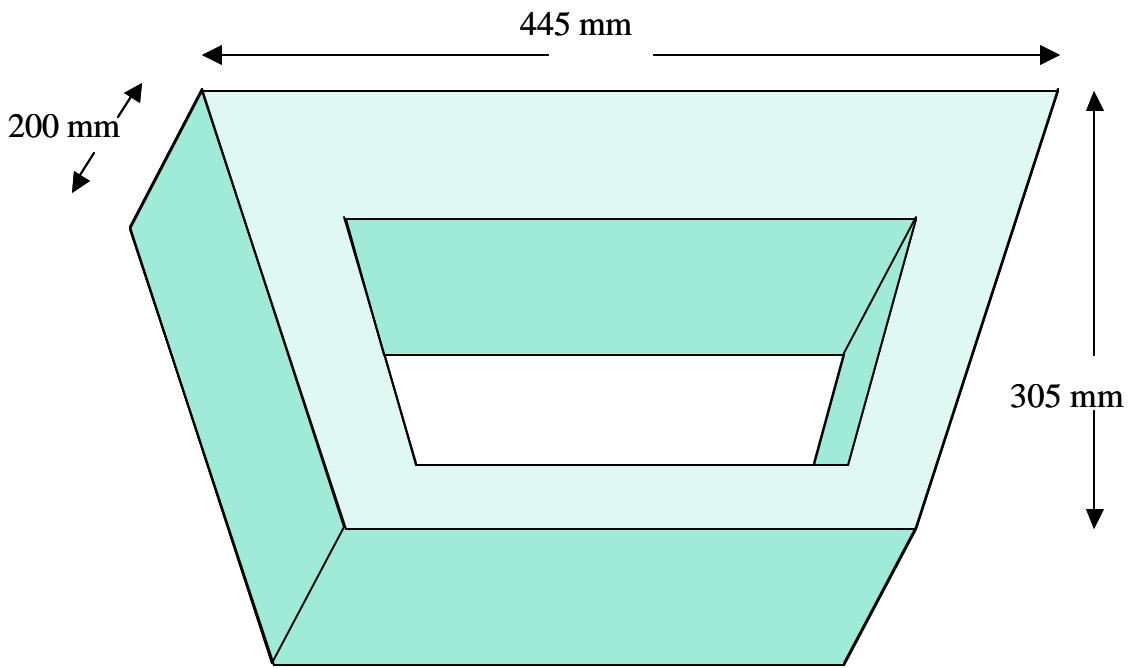
Figure 5 Block from Outer Pier Structure (258 N or 58 lb. in weight)

The outer pier was constructed of “D” shaped blocks – 203 mm high by 445 mm long and 305 mm wide (Figure 5). The outside faces of the blocks were 70 mm thick, the sides were 43 mm thick, and the backs were 60 mm thick. The same manufacturer supplied the blocks and there was no significant variation in the weight. The blocks used in the outer pier weighed 258 newtons (58 pounds). These blocks seemed to be denser than those used in the east abutment, and were most likely made of normal weight concrete. Because of the tapered sides the blocks can be placed in a curve easily. The ends of the outer pier were curved that way (Photo 10).
