**Report No. CDOT-DTD-R-2003-7
Final Report**

EXTENT OF TOP-DOWN CRACKING IN COLORADO

In 2000, a forensic evaluation was conducted on a project that was exhibiting early longitudinal cracking near the wheel paths. A team of national asphalt experts conducted this forensic evaluation. The forensic team concluded that the cracking on the project was surface initiated cracking and was caused by a number of contributing factors. One of the contributing factors to the early distress that was identified by the experts were the pockets of segregation that were observed at the bottom of the surface lift but were not apparent on the surface.

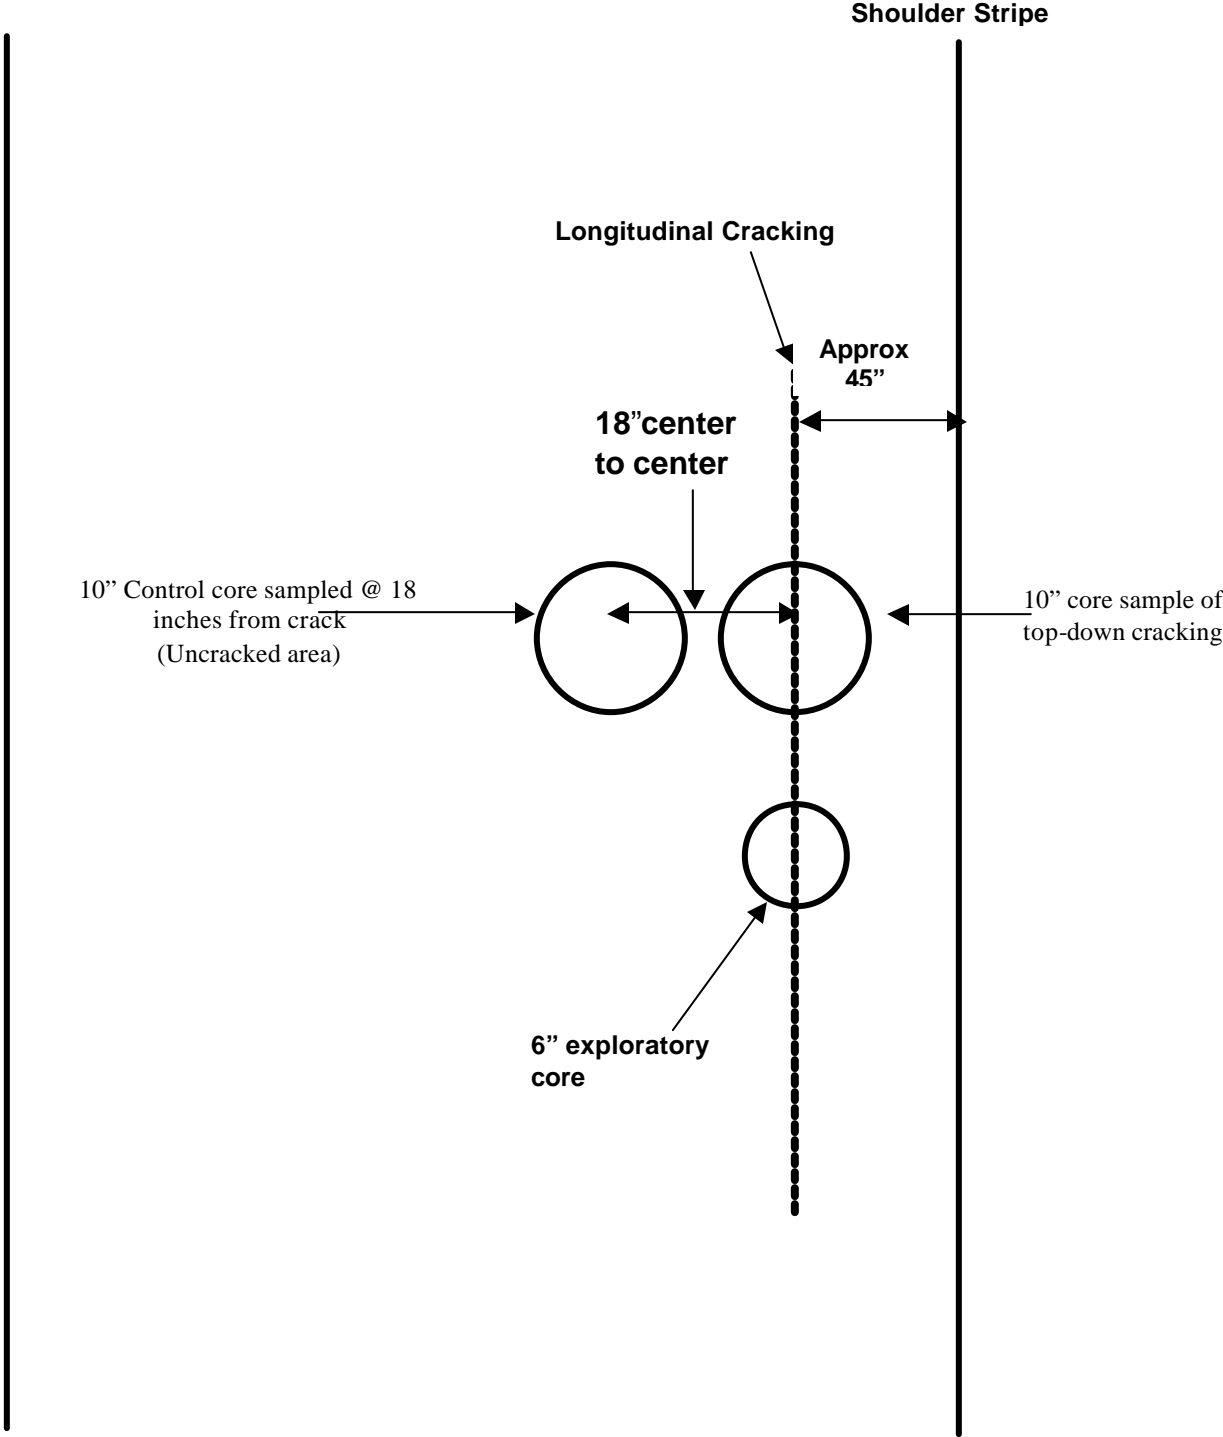
Figure 5. Diagram of typical coring configuration for top-down cracking sites

Figure 5 is a typical diagram of the core configuration taken during each project evaluation.

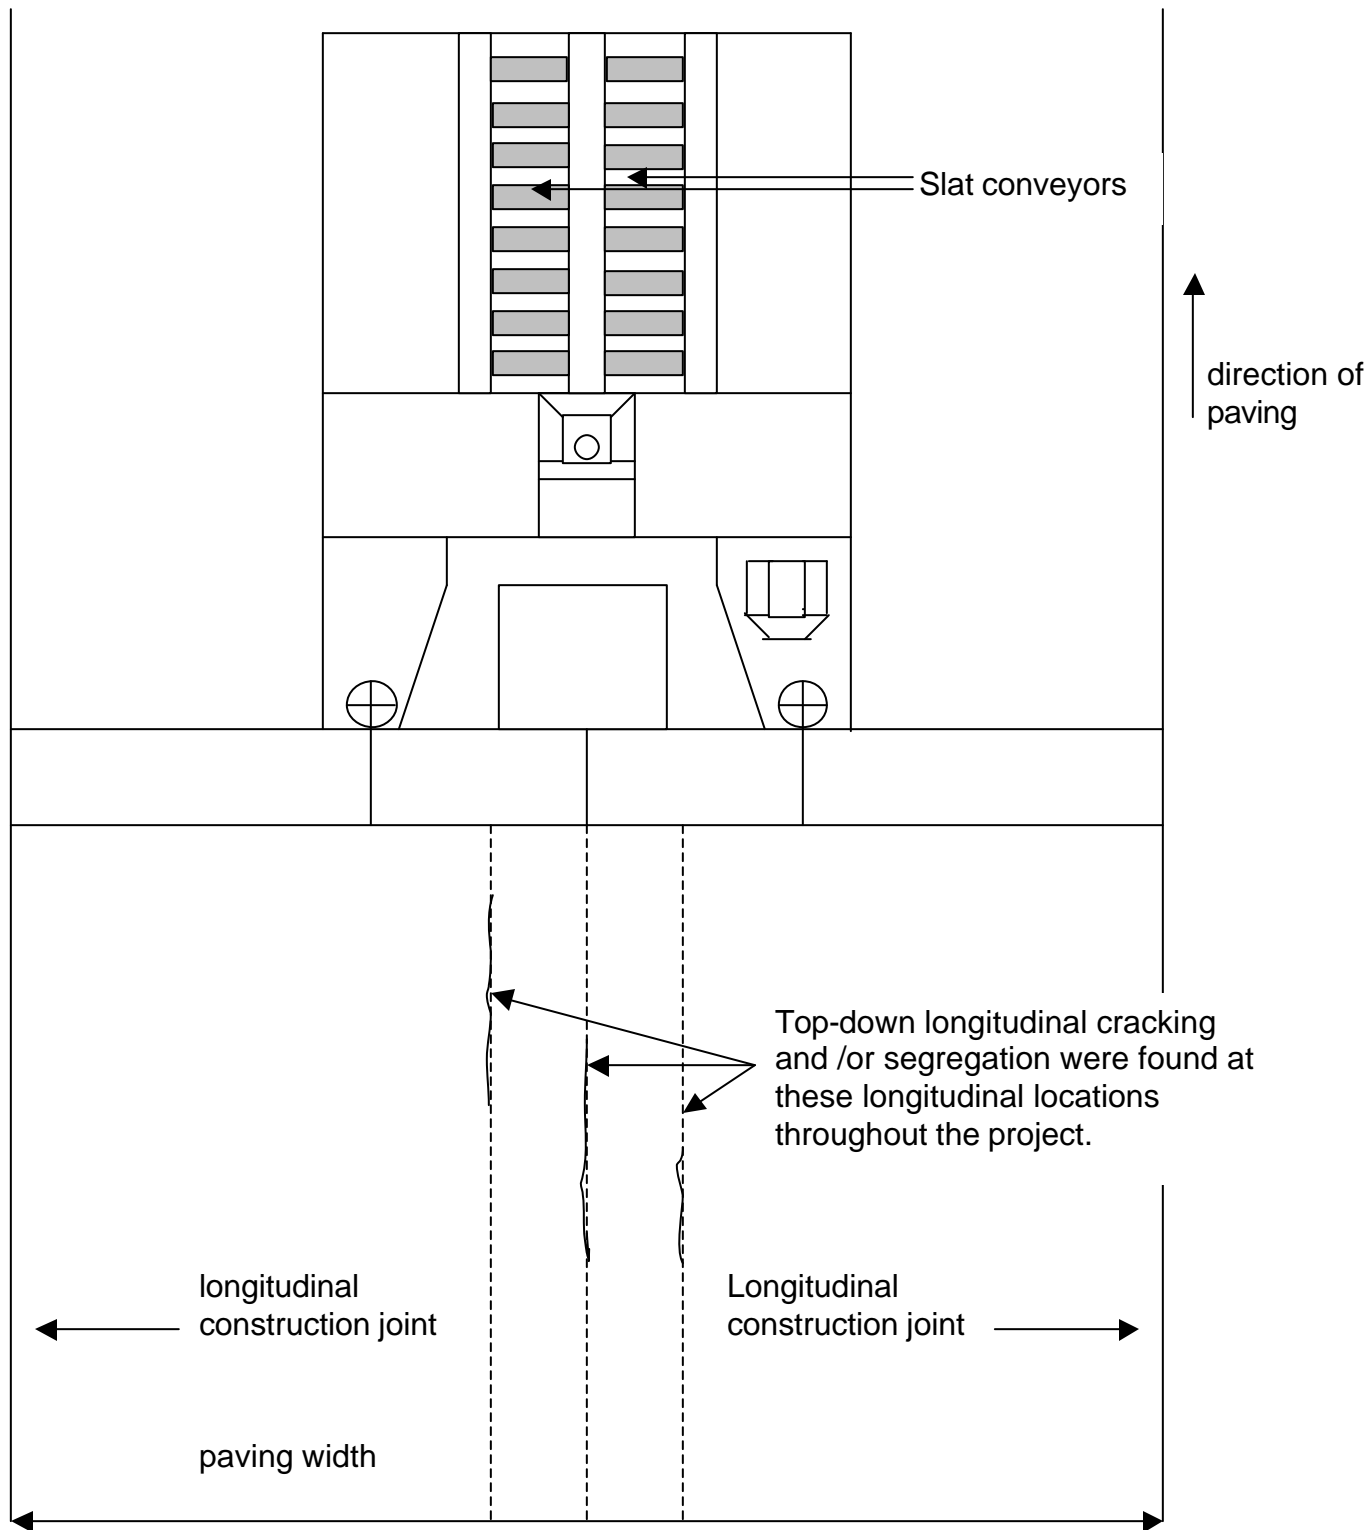
Figure 8. Top view of paver and mat

The slat conveyors, which are located at the bottom of the paver hopper, are used to carry the asphalt mix from the hopper to the augers and eventually to the screed. Figure 8 shows the geometry of the slat conveyors relative to the subsequent cracking that occurred on the pavement. This same relationship can also be seen in Figure 9. Superimposing a schematic of the configuration of the slat conveyors for the equipment used on a specific project over a drawing of the longitudinal cracks also helped to determine if specific points on the paver could be identified as areas where segregation and cracking were appearing within the mat. There are three locations where cracking has been observed, on the outside edges of the two slat conveyors and one under the gearbox between the two slat conveyors.

In 1993 the Illinois Department of Transportation conducted a study that detailed the history and investigation of longitudinal cracking in asphalt surfaces.³ Results from the Illinois study indicated that there is a high degree of correlation between the outside edges of the conveyors on the paver and the longitudinal cracking in the pavement. This study identified two pavers that demonstrated the correlation between the longitudinal cracking in the pavement and the outside edges of the conveyor slats.

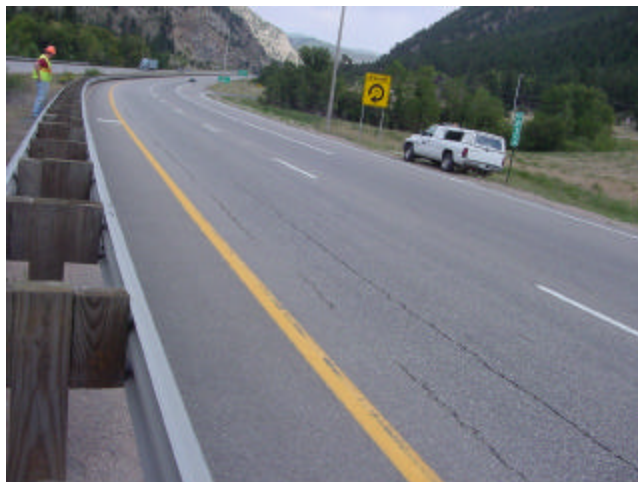
Site 4 (I-70, MP 232, Jct US40)

Top-Down Cracking

Unable to Core

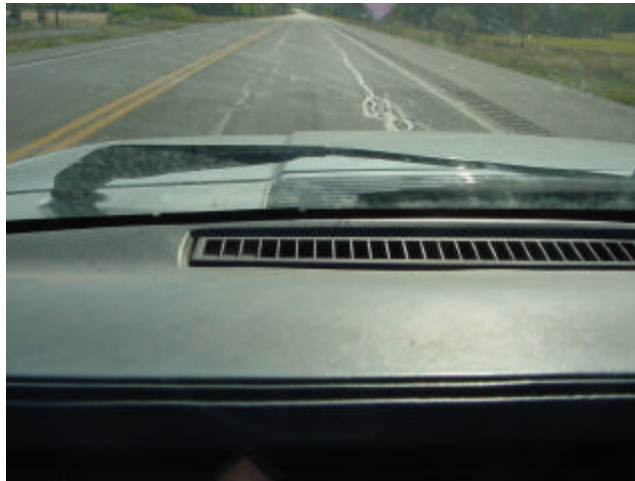
Site 11 (US160, E of Cortez)

Reflective Cracking

Unable to Core
