**Report No. CDOT-DTD-R-2006-2
Final Report**

**FLOWFILL AND MSE BRIDGE APPROACHES:
PERFORMANCE, COST, AND RECOMMENDATIONS
FOR IMPROVEMENTS**

February 2006

**COLORADO DEPARTMENT OF TRANSPORTATION RESEARCH
BRANCH**

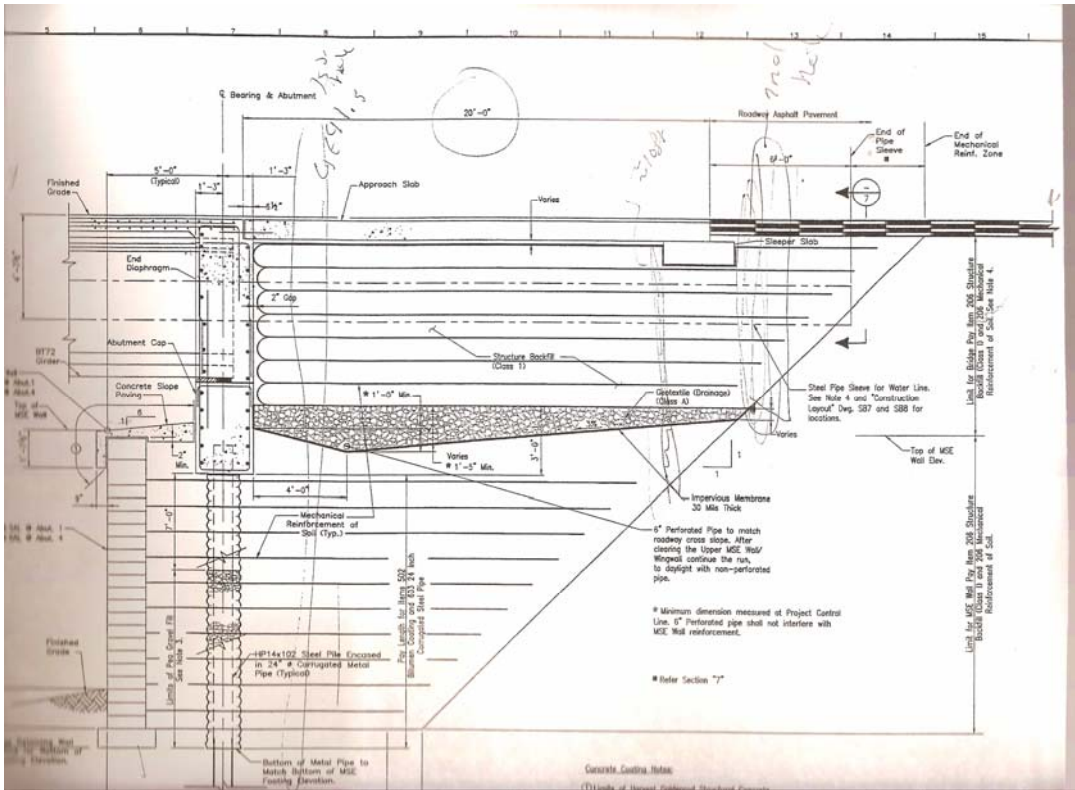
Figure 5.1. A Section along the Front MSE Wall of the Salt Creek Bridge.

The facing distress problem seems to be severe for the facing blocks located below the sleeper slab along the high areas of the upper and lower MSE walls. The facing problem is aggravated in this zone by the surcharge load applied on the sleeper slab that induces high vertical and lateral loads on the facing blocks. The influence of these high surcharge loads is magnified by the low compaction level of the granular fill in that zone which will increase the lateral earth pressures on the facing. Settlement of the fill relative to the wall facing may have resulted in the transfer of some of the vertical earth loads to the facing. Finally, the block-to-block connection capacity is

relatively low in the upper zones of the lower and upper MSE walls because part of that capacity is derived from the weight of the overlying blocks, which is relatively smaller in the upper zones.

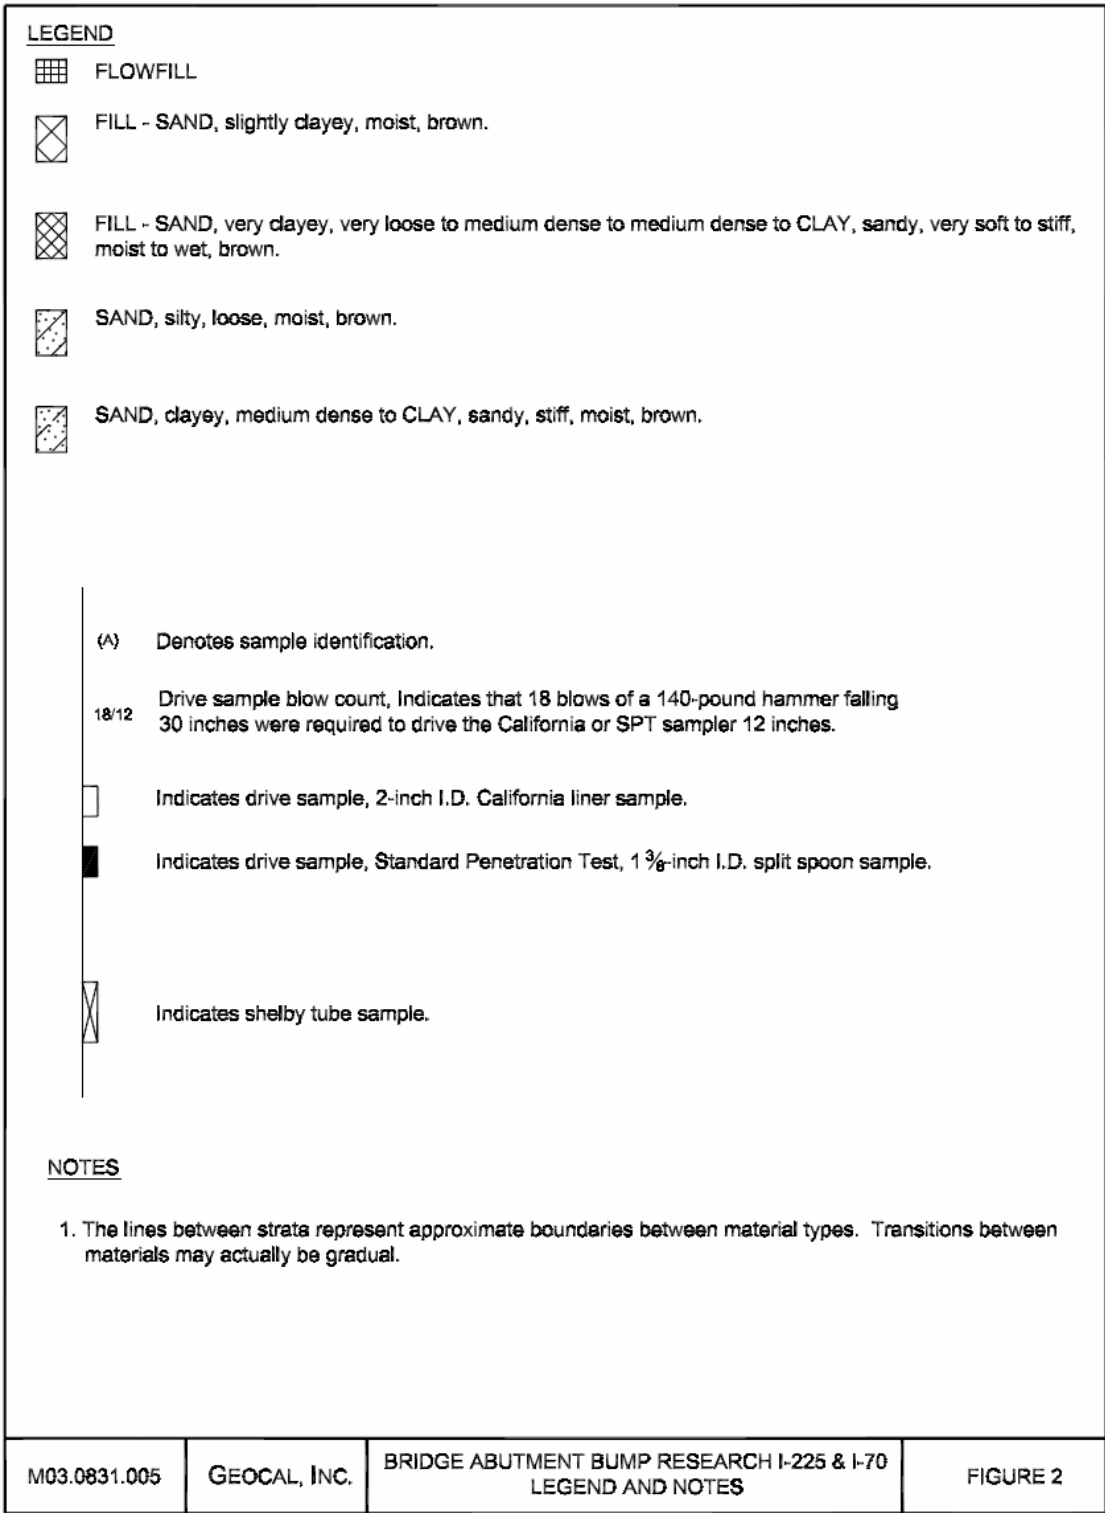
Figure 5.13. Boring Log for the I70/I225 Bridge Structure

Two borings were drilled along the eastern roadway approaches 9 ft from the northern side (north eastern corner of the I-70/I-225 interchange). Both holes were advanced, respectively, 6 ft and 35 ft east from the sleeper slab expansion joint. For these two borings, Figure 5.13 shows a log of subsurface materials encountered, driving resistance results in term of N-values collected from the SPT and California Sampler, and locations and types of all collected samples.

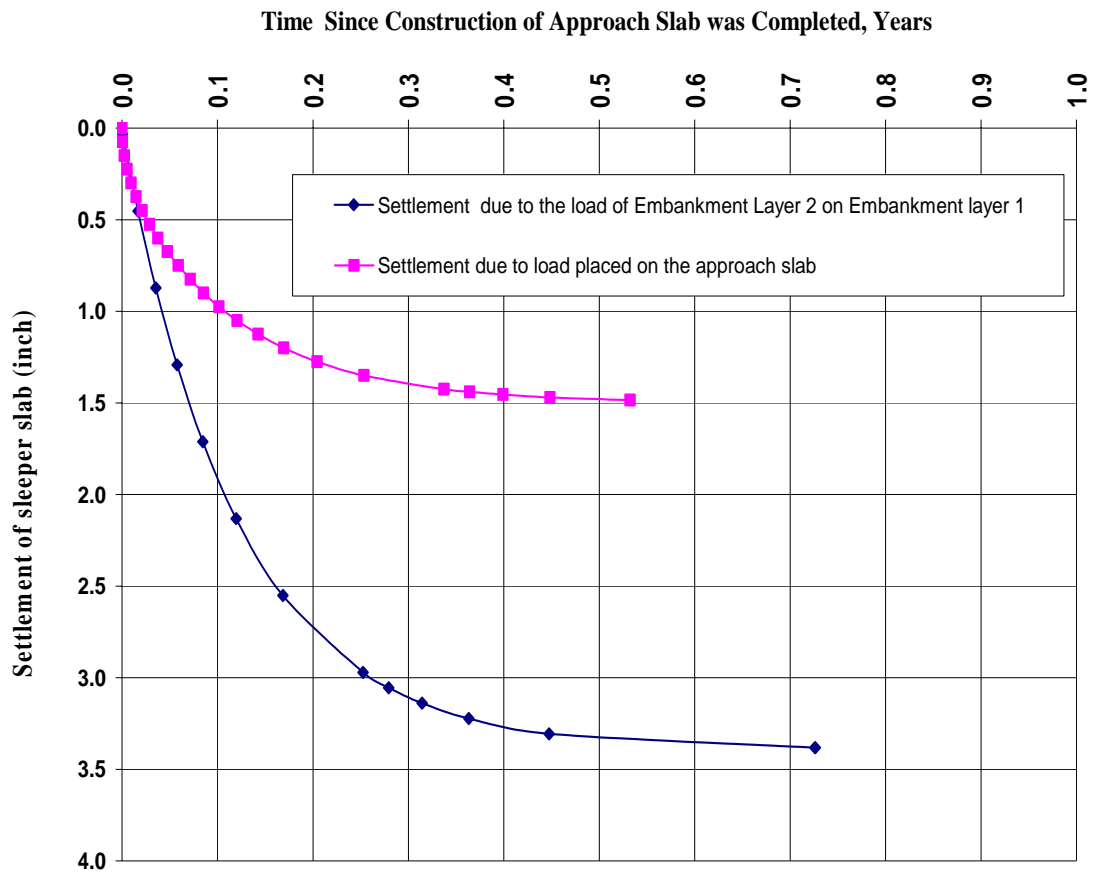
Figure 5.14. Predicted Sleeper Slab Consolidation Settlement of the I-70/I-225 Bridge Approaches.

The sources of settlement of the sleeper slab after construction was completed (see Figure 5.14 for the time progress results) are:

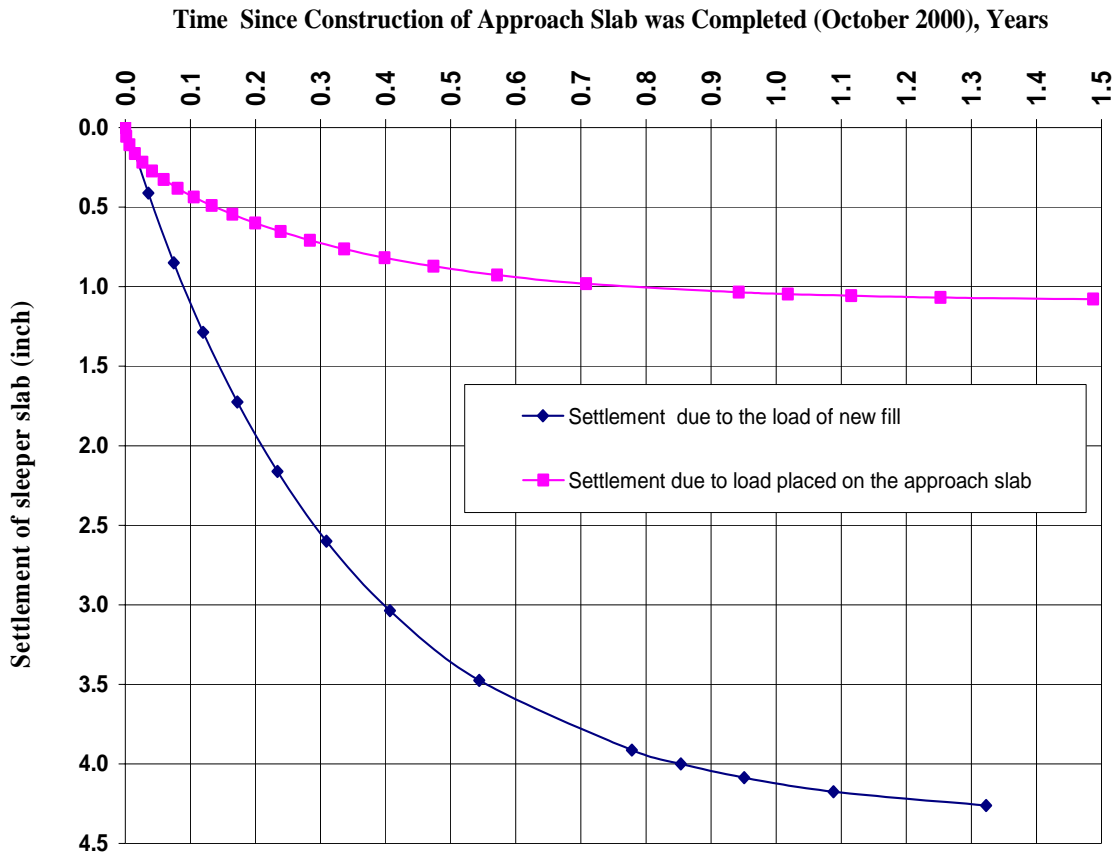
Figure 5.16. Predicted Settlement with Time at the Sleeper Slab of the SH 287 Bridge.

Results: settlements of 4.3". Most of this settlement will occur during the first 18 months after construction is completed (Figure 5.16).

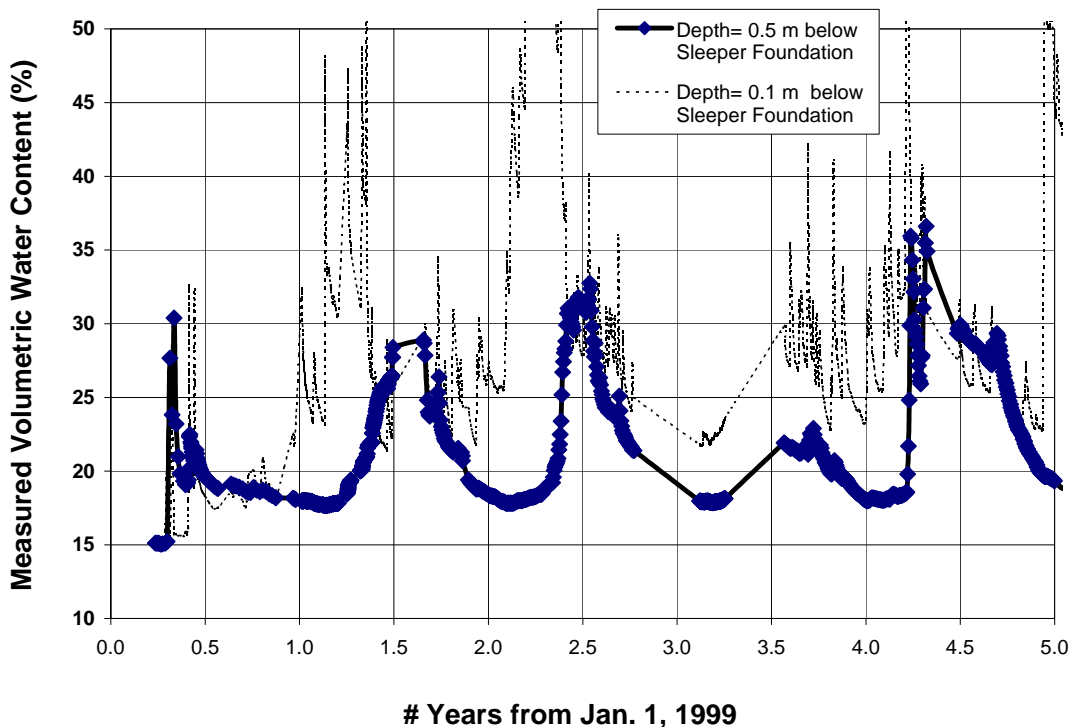
Figure 6.6. Measured Changes in Soil Moisture Before and After Placement of the Drainage Protection System.

- ❑ Install temporary drainage protection measures during the construction stage before placement of the permanent drainage protection system.
- ❑ *The placed drainage protection system **was not** fully effective in preventing the surface water from reaching deep inside the reinforced soil mass. The backfill beneath the sleeper slab becomes fully saturated during late June of each year and should be designed for these conditions. Signs of gradual softening of the backfill placed beneath the sleeper slab with time due to increase of retained water by soil every year are noticed. This will lead to gradual backfill settlement with time.*
- ❑ The impervious membrane was placed just beneath the approach slab and was not extended to protect the soil beneath the sleeper slab where a joint is placed. This membrane should be extended to protect the backfill beneath sleeper slab.

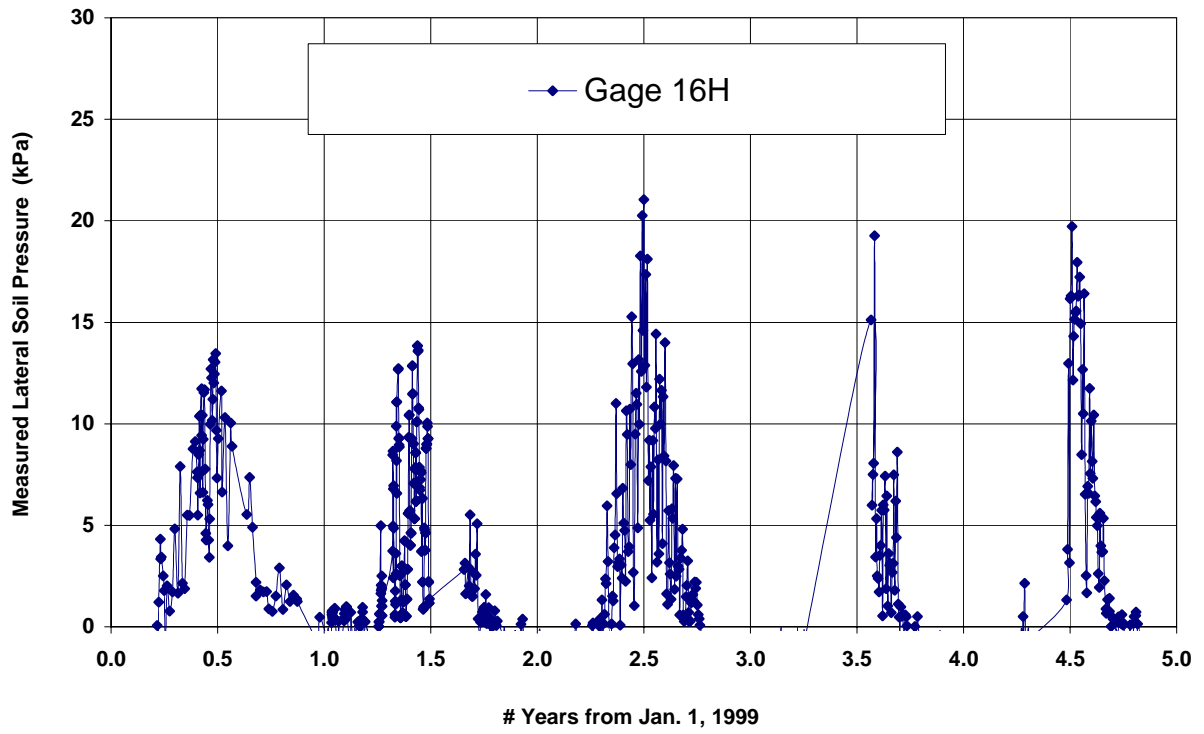
Figure 6.10. Measured Lateral Earth Pressure Against the Lower Portion of the Abutment Wall of the Founders/Meadows Bridge (see Figure 6.2) during Various Times.

- ❑ For the MSE abutment backfill systems as in the Founders/Meadows structure, the bridge abutment wall can designed safely for a relatively low and uniform passive earth pressure of 35 kPa (exerted during the summer time), not the passive earth pressure estimated for

conventional retaining walls with rigid facing and unreinforced soil backfill. The difference between the day and night measured horizontal earth pressures against the abutment wall can be as high as 25 kPa.

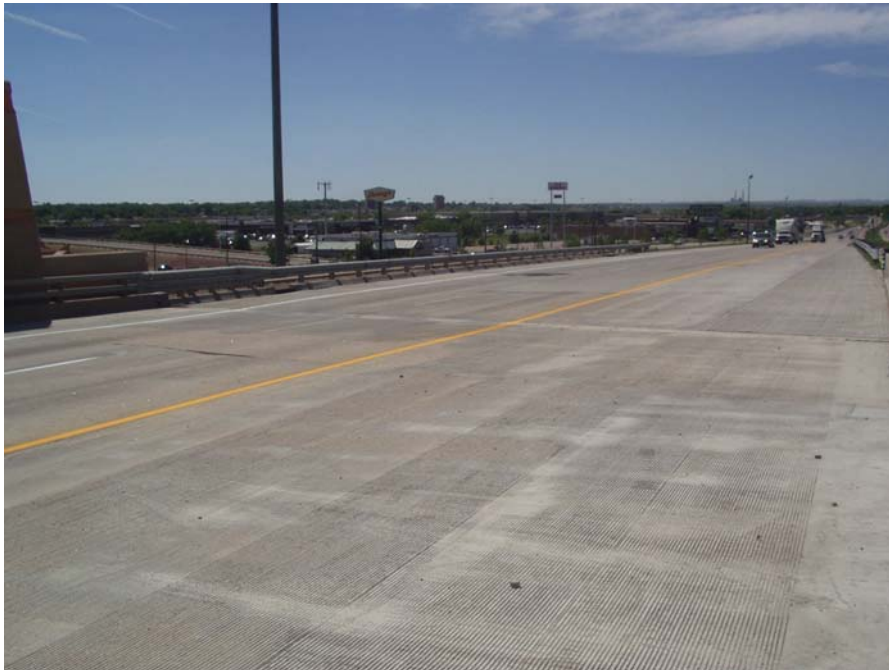
K-18-GG

Figure C17c. Photos of Bridge Structures in Region 2 Constructed with MSE Backfill
