**Report No. CDOT-DTD-R-2006-8
Final Report**

**PRECAST CONCRETE PAVING PANELS:
THE COLORADO DEPARTMENT OF
TRANSPORTATION REGION 4 EXPERIENCE,
2000 TO 2006**

Gary L. DeWitt, P.E.

August 2006

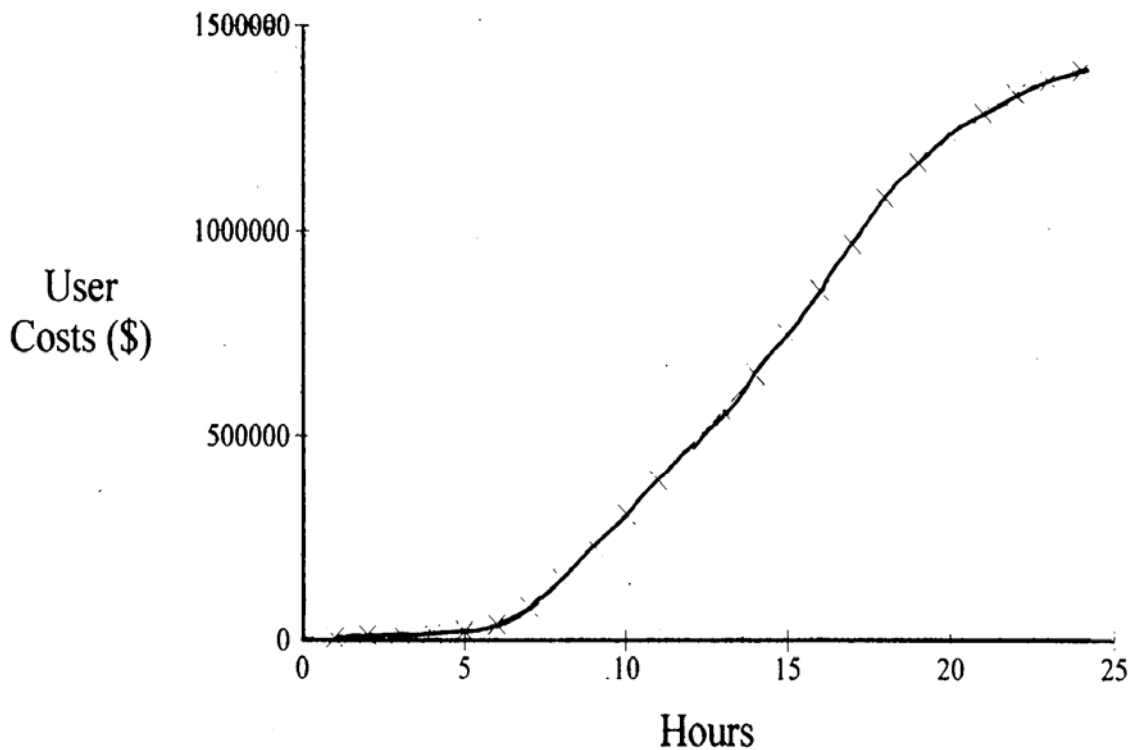
FIGURE 8
REMOVAL OF CONCRETE (Cost vs time)

The results of the Workzone program suggest a cost of \$63,673,596 for a 4 day shut down of one lane during a conventional concrete removal program whereas a normal user cost of \$71,482 would exist if the construction work wasn't being conducted. From Figure 6 User costs vs. hours the user cost is approximately \$25,000 for an 8 hour shut down of a lane for concrete removal and correspondingly \$145,000 for a 24 hour shut down.
