**Report No. CDOT-2007-3**  
**Final Report**

## **DURAFLEX CURB**

**February 2007**

**COLORADO DEPARTMENT OF TRANSPORTATION**  
**RESEARCH BRANCH**

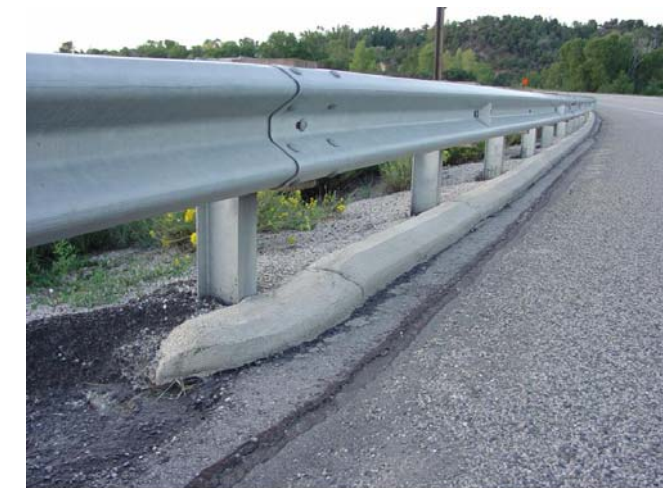
In the past, most of Colorado’s rural highway curbs were either extruded from pavement material or pressure treated lumber. Extruded curbs can be made by passing concrete or asphalt through specially designed slip form machines. Extruded curbs (**Figure 2**) are very

**Figure 2. Extruded curb - concrete in this case.**

effective, and are not easily damaged by traffic or normal maintenance operations such as snow removal. However, they are expensive. Repairs are difficult and installation of new extruded curb as part of an overlay project is very difficult if guardrail is already in place, because the machinery cannot operate below existing guardrail.

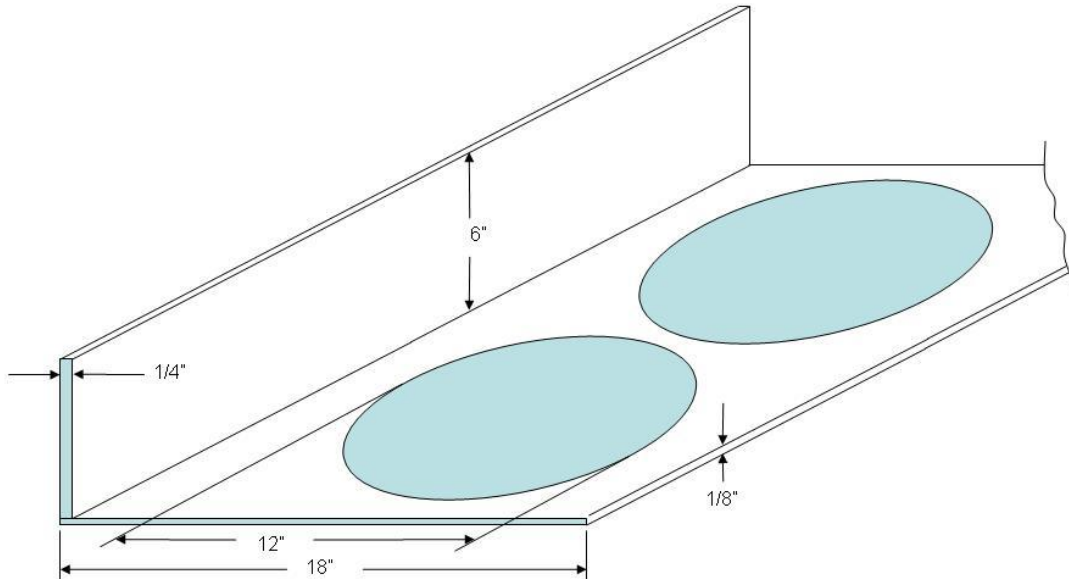
Before the Monarch Pass project, the DuraFlex Curb was extensively redesigned. The new curb is extruded with the 90° L-shape rather than a formed sheet. The curb has a 6-inch vertical leg – doubled in thickness to 1/4 inch, and is anchored into the asphalt by an 18-inch horizontal leg.

**Figure 16. Drawing of the modified DuraFlex Curb used on US-50.**

The horizontal leg is 1/8 inch thick and has a row of 12 inch diameter holes spaced one inch apart along its length. When the asphalt is laid over the curb, the larger diameter the holes provide more area to improve the bond between the asphalt lifts and help make the curb become a part of the pavement. The curb sections are light and easy to transport and handle - the entire quantity of ±2000 feet for the project was delivered on a 15 foot goose neck trailer.

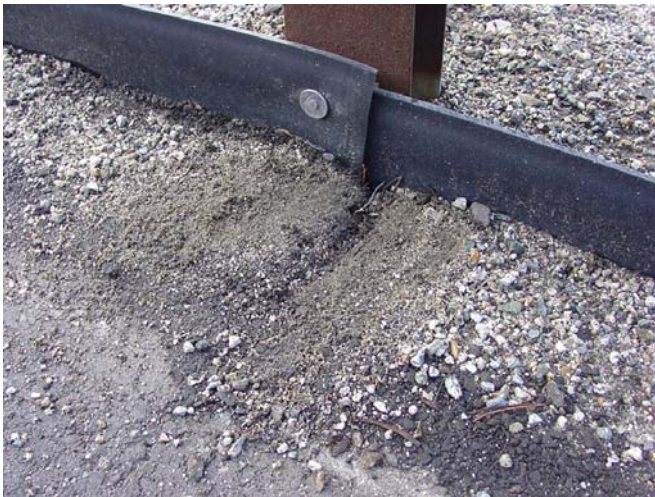
**Figure 17. DFC nailed to a guardrail post on US-50.**

the downhill one. For the Monarch project, the curb was nailed to the guardrail posts near the top of the curb (**Figure 17**).
