State Highway 9 Wildlife Crossings Monitoring – Annual Report Year 1

> Report No. CDOT-2017-04 Feb 2017

STATE HIGHWAY 9 WILDLIFE CROSSINGS MONITORING – PROGRESS REPORT

Phase 1 Pre-completion Monitoring December 2015 through March 2016

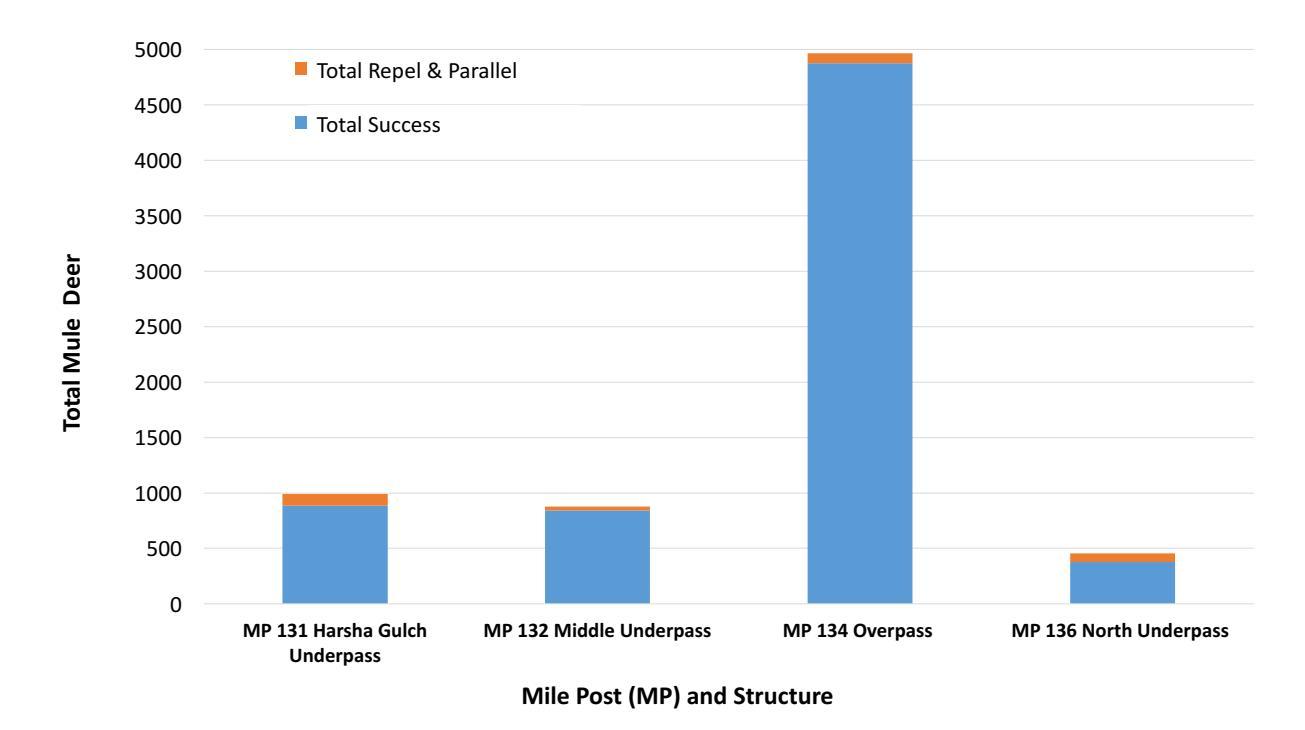
Figure 4. Comparison of mule deer movements across wildlife crossing structures. Total successful through-passages (success) and total repels and parallel movements at each crossing structure.

Mule deer successfully moved through all the crossing structures on multiple occasions during this first winter of pre-completion monitoring. Mule deer were recorded using the structures 7,013 times during this period. Deer were recorded at all structures nearly every week during this period, with most movements resulting in successful through-passage. The highest number of movements were captured at the North Overpass, and surpassed the number of successful movements at each of the underpass structures by a factor of five. The number of movements at the Middle Underpass and Harsha Gulch Underpass were similar, while the lowest numbers were reported at the North Underpass (Figure 4). Table 2 summarizes the success rates, repel rates and parallel rates at each crossing structure. Success rates were greater than 80% at each of the crossing structures. The highest success rate (98%) was observed at the North Overpass, while the lowest success rate was at the North Underpass (82%).

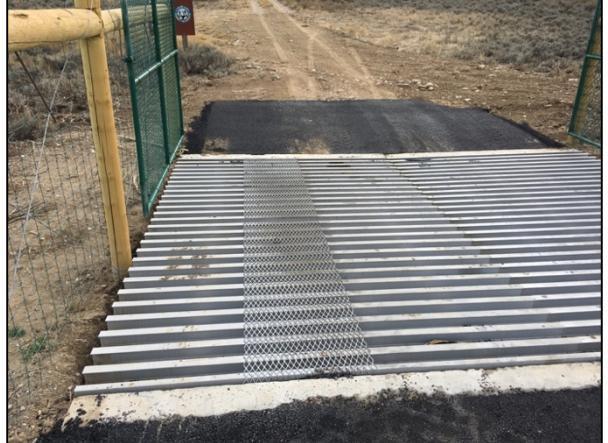
Figure 10. Example of a pedestrian grate across a deer guard.

Cameras were deployed at 6 deer guard locations in Phase 1 of the project area during precompletion monitoring. The guards are just under 16' (4.9-m) long with flat bars spaced 4" (2.5cm) apart, and of varying widths, corresponding to the width of the road or driveway. Some guards have a 2.5' (0.7-m) wide pedestrian grate across the bars per landowner requests (Fig. 10). The fence gate over the Rusty Spur deer guard was closed on January 21, 2016, and that

• Deer guards. Deer breaches observed in Phase 1 were hypothesized to be the result of 1) deer being able to easily walk on the flat bards, and 2) snow getting trapped between the flat bars and creating a packed surface for deer to walk across. As a result of these observations, CDOT developed a round-bar guard design that was installed at three locations in Phase 2 and was used to replace the flat-bar guards at two locations in Phase 1. This will enable the research team to study the relative effectiveness of the two designs in preventing incursions into the fenced right-of-way by deer and other wildlife

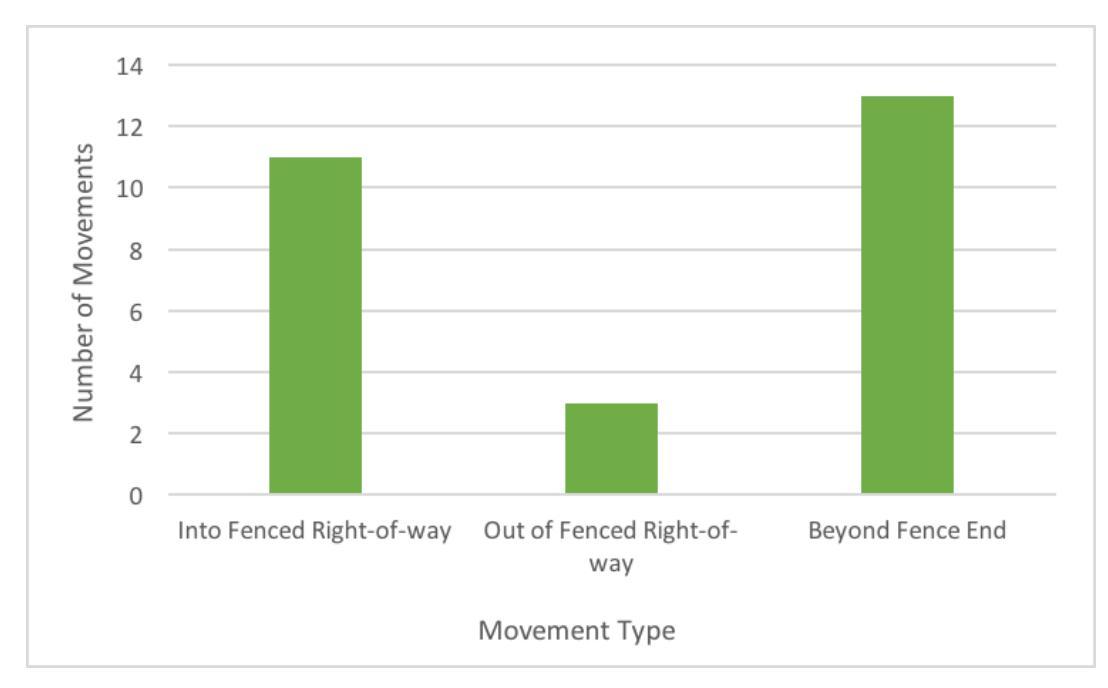
Figure 12. Mule deer movements at the temporary south fence end.

A total of 35 wildlife movements were recorded at the fence end, including 27 movements by mule deer and eight movements by red fox. The majority of mule deer movements occurred beyond the fence end (n=13), but 11 deer movements were documented moving from the habitat side of the fence into the fenced right-of-way (Fig. 12). Movements into the fenced right-of-way occurred when deer moved from the habitat side of the fence and either walked around the fence into the right-of-way or crossed the road and entered the right-of-way on the opposite side. Movements out of the fenced right-of way occurred when animals already inside the wildlife fence moved out to the habitat side of the fence. Movements beyond the fence includes movements where animals crossed the road beyond the fence end as well as those where the animal did not cross the road, but repelled from the road and remained beyond the fence end.

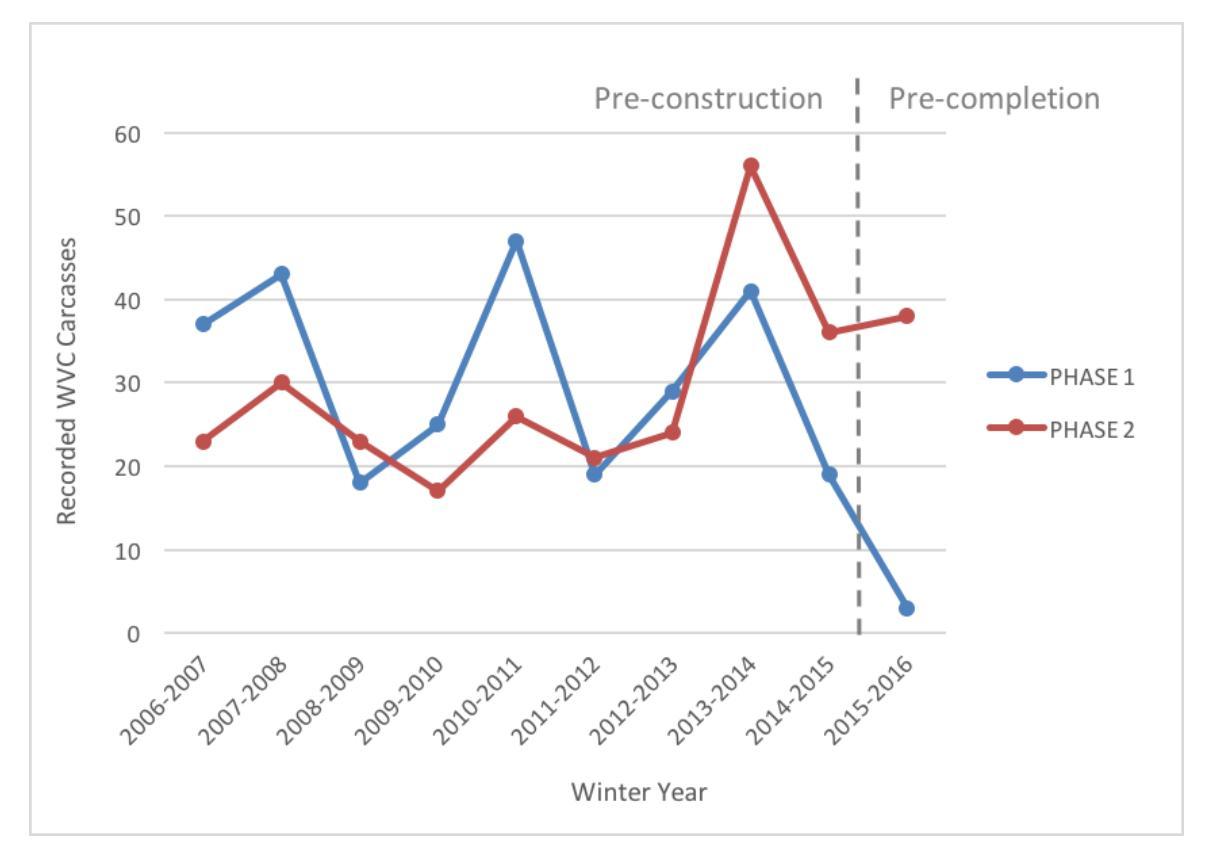
Figure 13. Reported WVC carcasses compiled by BVR and CPW in Phases 1 and 2 of the project area, nine years pre-construction (from winter 2006/07 through winter 2014/15) and one year pre-completion (winter 2015/16).

Blue Valley Ranch and CPW recorded a total of 575 WVC carcasses within the project area from the winter of 2006/07 through the winter of 2015/16. Ninety-eight percent of recorded carcasses were mule deer. One percent were elk, and the remainder are coyote, fox, mountain lion and turkey. Across the project area, there is considerable annual variation in the number of carcass reports. Pre-construction carcass reports in the six-mile long Phase 1 vary from a low of 18 WVC in the winter of 2008/09 to a high of 47 in 2010/11. The Phase 1 segment averaged 31 carcasses per winter from 2010/11 through 2014/15. In the Phase 2 segment (five miles long), pre-construction WVC range from 17 in the winter of 2009/2010 to 56 in 2013/14. The Phase 2 segment averaged 32.6 carcasses per winter over the last five winters pre-construction. In the

winter of 2015/16, Phase 1 had just three carcasses reported, and Phase 2 had 38 carcasses reported (Fig. 13).

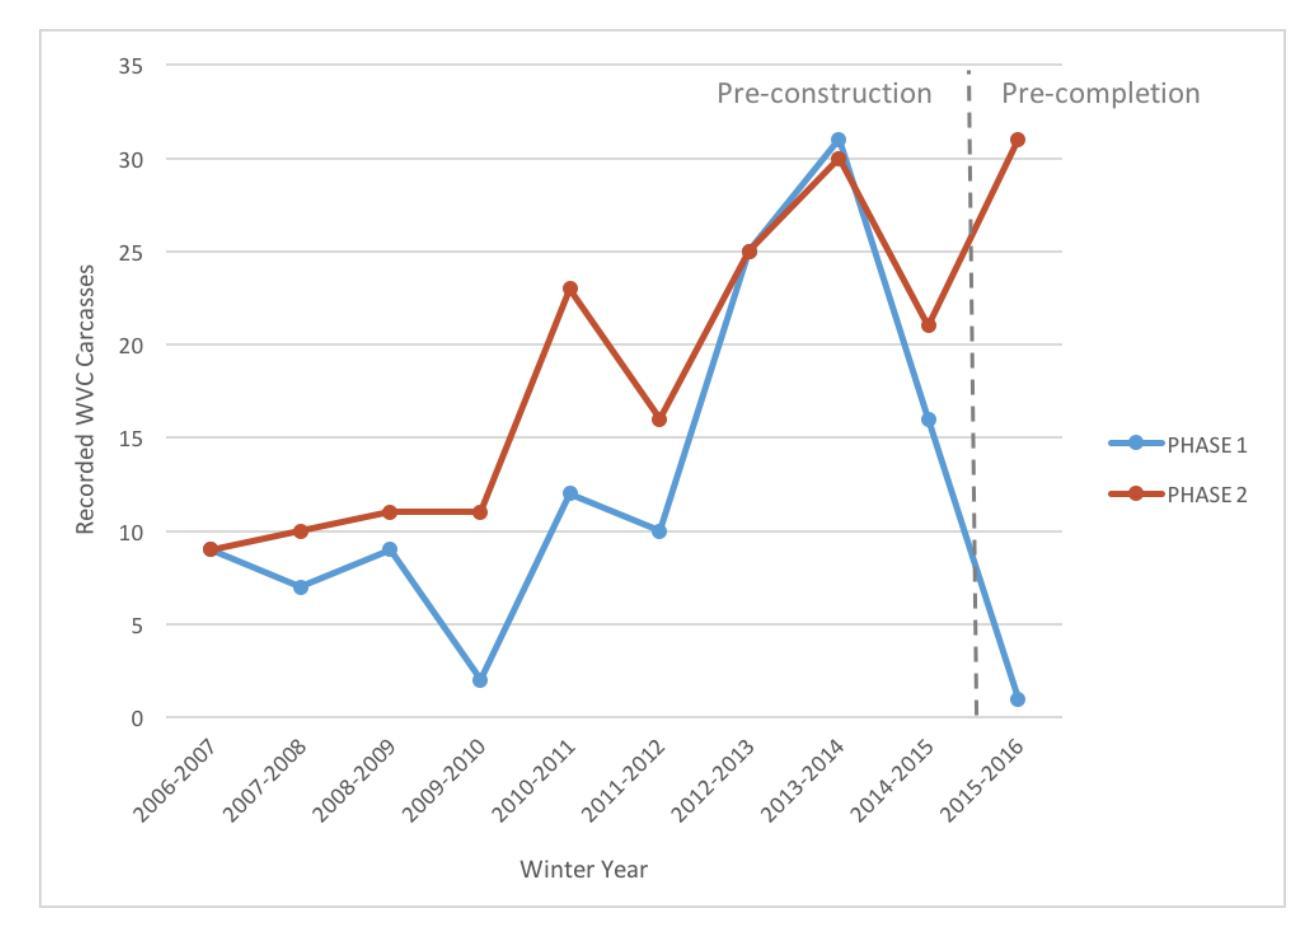
Figure 14. Reported WVC carcasses reported by CDOT Maintenance in Phases 1 and 2 of the project area, ten years pre-construction (from winter 2006/07 through winter 2014/15) and one year pre-completion (winter 2015/16).

CDOT maintenance units reported a total of 309 WVC carcass pickups in the project area from the winter of 2006/07 through the winter of 2015/16. Ninety-five percent of recorded carcasses were mule deer. Two percent were elk, and the remainder were fox, rabbit and unknown. As with the BVR/CPW carcass dataset, there was considerable annual variation in the number of carcass reports due to population fluctuations, weather factors and other impacts. Excluding the first three winters in the dataset (due to presumed inconsistencies in reporting effort in the early years of the CDOT carcass reporting program), pre-construction carcass reports in the Phase 1 segment varied from a low of 2 WVC in the winter of 2009/10 to a high of 31 in 2013/14. The five-year pre-construction average for the Phase 1 segment was 18.8. In the Phase 2 segment, pre-

construction WVC range from 9 in the winter of 2006/2007 to 30 in 2013/14. The five-year average for the Phase 2 segment was 23. One carcass was collected in Phase 1 during the first winter of pre-completion monitoring (2015/16). In Phase 2, there were 31 recorded carcass pickups in winter 2015/16 (Fig. 14).

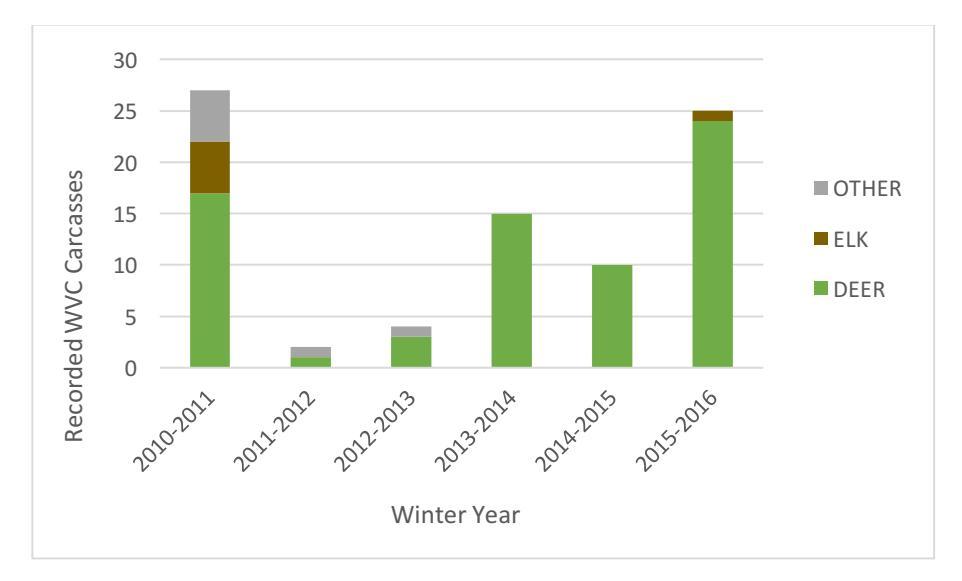
Figure 16. Deer and elk WVC carcass pickups by CDOT maintenance units on US 40 from MP 184, west of Kremmling, to MP 194 east of Kremmling.

In addition to WVC rates on SH 9, the researchers also analyzed the CDOT WVC carcass dataset from MP 184 to MP 199 on US 40, an east-west highway that runs through the town of Kremmling. Comparisons were made between the five-year pre-construction average number of mule deer and elk carcasses, and those reported during the winter of 2015/16, following mitigation construction in Phase 1. This comparison was made to determine whether the mitigation on SH 9 may have shifted wildlife movements, particularly elk, from SH 9 to US 40, with a resulting increase in WVC on US 40 (Fig. 16).

All reported elk carcass pickups in this segment were reported between MP 188-190, east of the town of Kremmling, with the most pre-construction elk carcass pickups in 2010/11 (n=5). Reported deer WVC carcasses were highest at MP 189. The most deer pickups were reported in Winter 2015/16, following the construction of Phase 1 on SH 9. One elk carcass was reported at MP 189.9 following the construction of Phase 1 on SH 9, in Winter 2015/16. Overall, WVC

carcass pickups in winter 2015/16 (n=25) were higher than the five-year pre-construction annual average of 16 WVC/year for this segment, but within the five-year range.
