COLORADO
Department of Transportation

EVALUATION AND PERFORMANCE OF HDPE PIPES UNDER CDOT HIGHWAYS, T-REX, AND OTHER LOCATIONS

Report No. CDOT-2018-09
March 2018

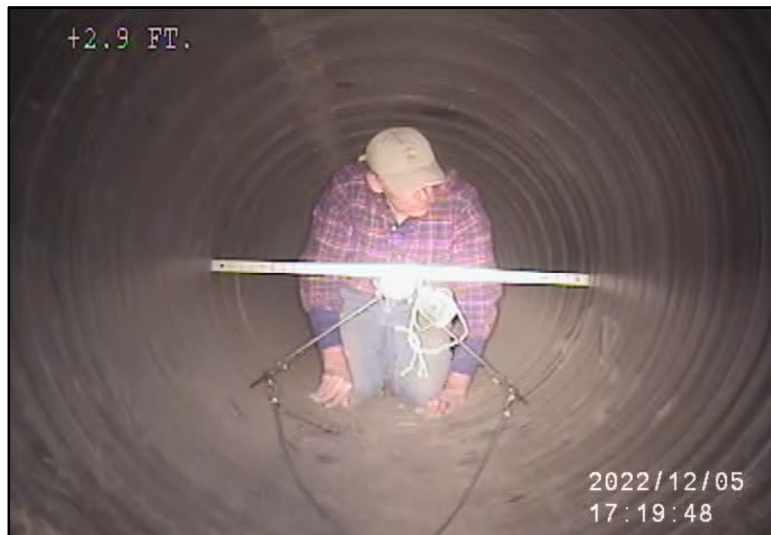
Figure 14. Setting up for laser-ring equipment inside an HDPE pipe under I-25

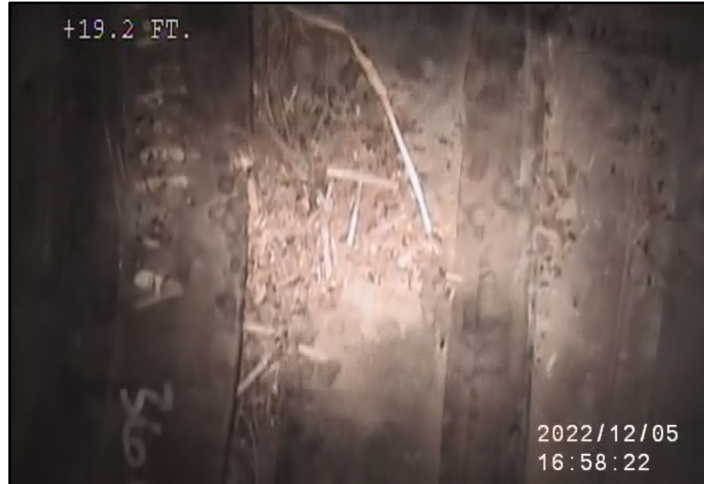
Figure 55. Close-up of a separated joint using CCTV recording

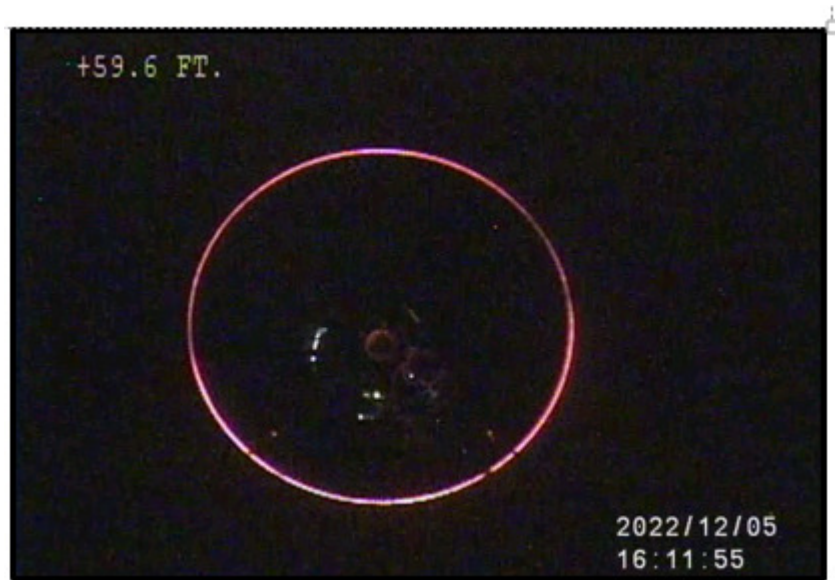
Figure 25. Laser ring reflected on the pipe surface under Interstate 25 at Fountain Creek

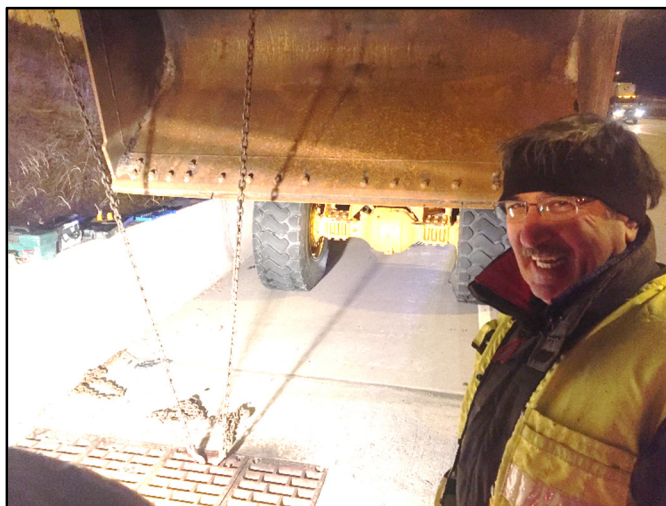
Figure 111. CCTV inspection of T-Rex HDPE pipes

A section of I-25 near the Quincy overpass was coned off on December 5, 2016 to conduct a performance inspection of the HDPE storm drains in the area. Several factors limited the amount of pipe that could be inspected, including difficulties in removing the bolts attaching the grates on the drop inlets, and removing the grates themselves. Also, heavy loads of sediment were in the inverts of the pipes. The inspection was limited to approximately 182 ft of estimated 36-inch HDPE. The pipe was inspected with a Cues robotic pipeline-inspection system. Figures 42 and 43 present photos from a CCTV inspection of HDPE pipes along CDOT's T-REX Project site and show the heavy loads of sediment. As stated above, this section of the drainage pipeline lies on the shoulder region of I-25 and therefore is not subject to heavy cyclic loading. The pipeline is buried 11 ft below the highway pavement and appeared to be sagging in areas. The overall shape of the structure appeared to be round, and the joints appeared to be performing as expected. A laser profile could not be conducted due to the amount of debris in the system. Some of the adjacent pipes coming into the two drop inlets were observed and appeared to be performing satisfactorily. It is recommended that the pipes be cleaned and fully inspected.

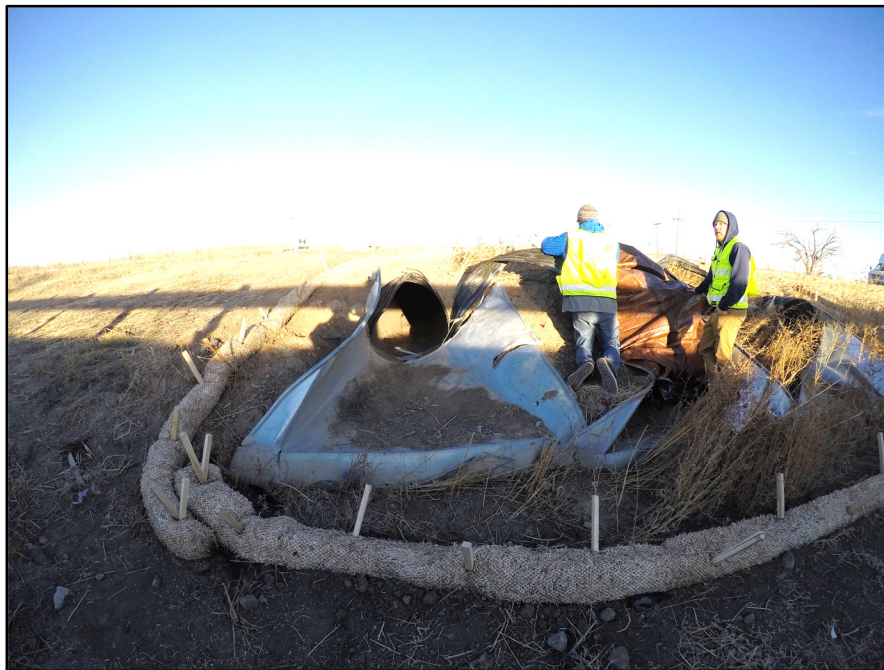
Figure 4412. Manual inspection of I-25 HDPE cross-culverts near Colorado Springs

77.2% of readings below 2.5%	<1.9% of readings above 5%	Max deflection approximately 5.30% near inlet end (approx. 90 to 88 ft). Pipe moderately racked in right crown. Remainder of pipe 4% or less. Small puncture due to stake near outlet, pipe slightly racked at 8 ft. Slight hump at right haunch at 46 ft. Slight dent in invert at 56 ft.
MP 122	9/30/2013	DuroMaxx	48-inch	103	Outlet	Inlet

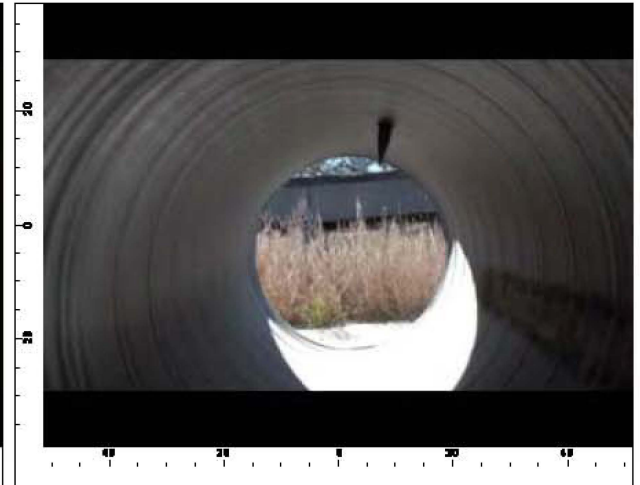
View of erosion control stake through crown of structure.

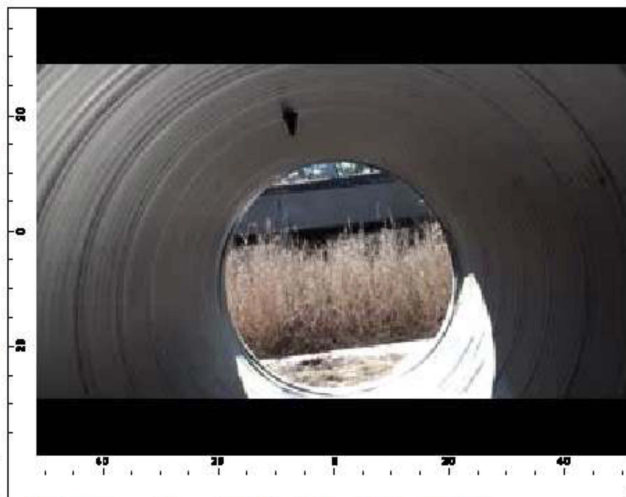
Stake for erosion control driven through crown of pipe.

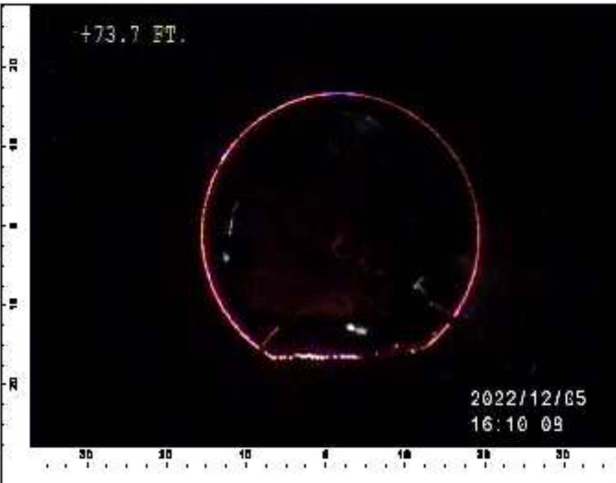
Debris in invert causing spike in vertical data.

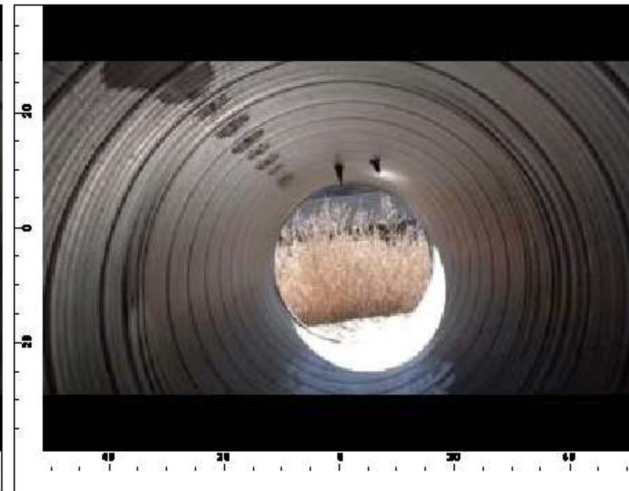
Slight dent at left springline at 78 ft.

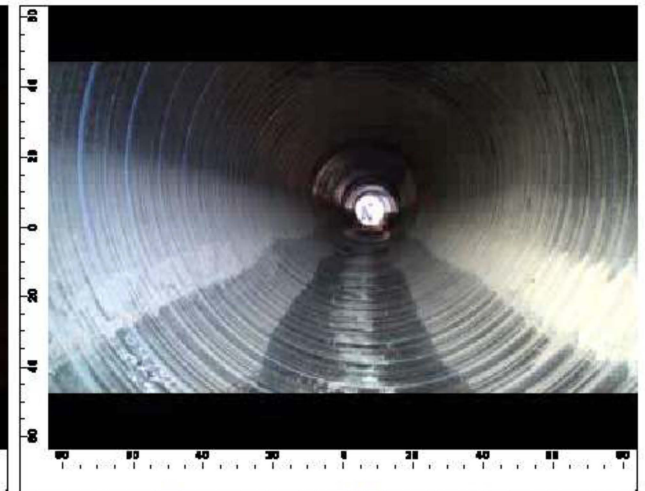
View from outlet end, pipe slight racked near outlet end not caught by laser.

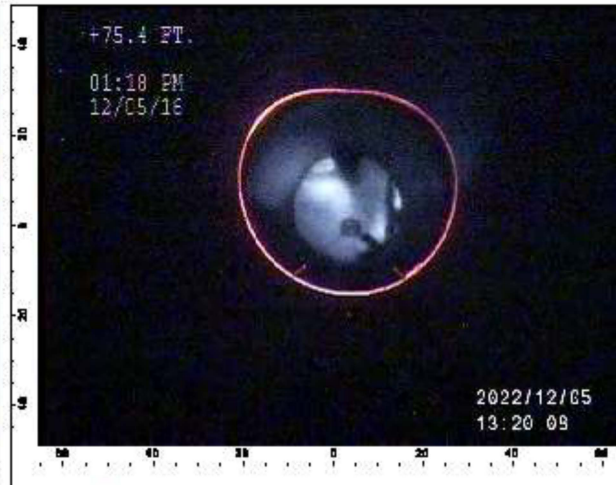
Pipe deflected approximately 5.8%.

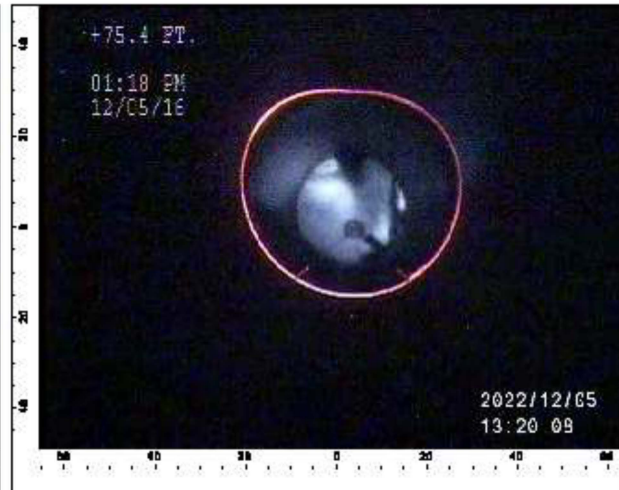
Pipe deflected approximately 5.8%.
