# Rock Cut Blasting Aesthetics Best Management Practices Phase II

## Technical Report Documentation Page

1. Report No. CDOT-2021-02	2. Government Accession No.	3. Recipient's Catalog No.	
4. Title and Subtitle ROCK CUT BLASTING AESTHETICS BEST MANAGEMENT PRACTICES PHASE II		5. Report Date June 2021

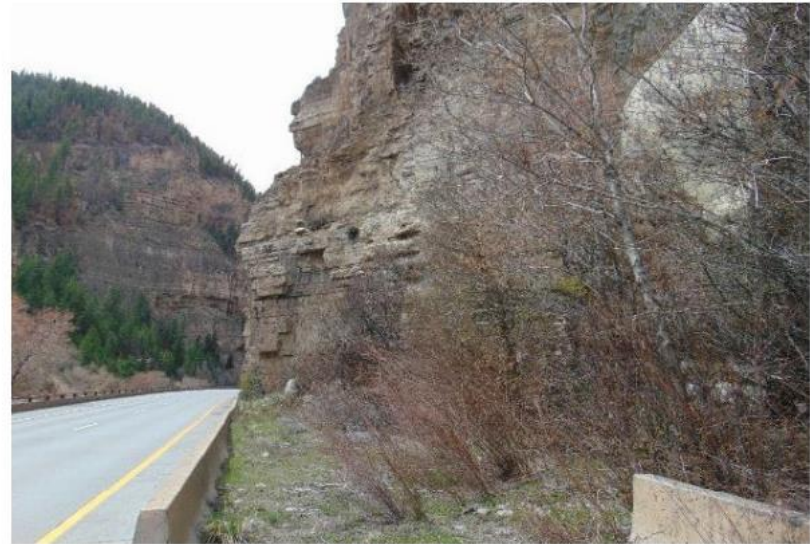
View to west-southwest; little to no ditch area behind barrier

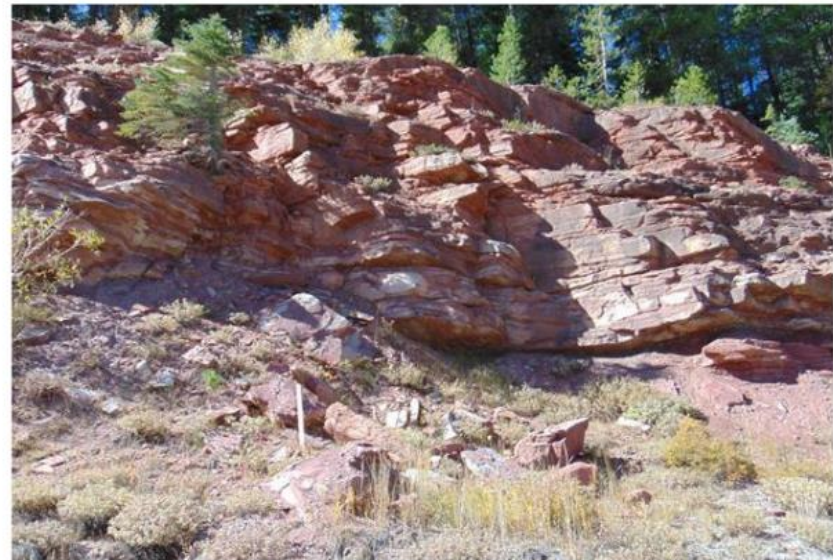
**Sandstone undercut by weaker shale; boulders at base of cut**

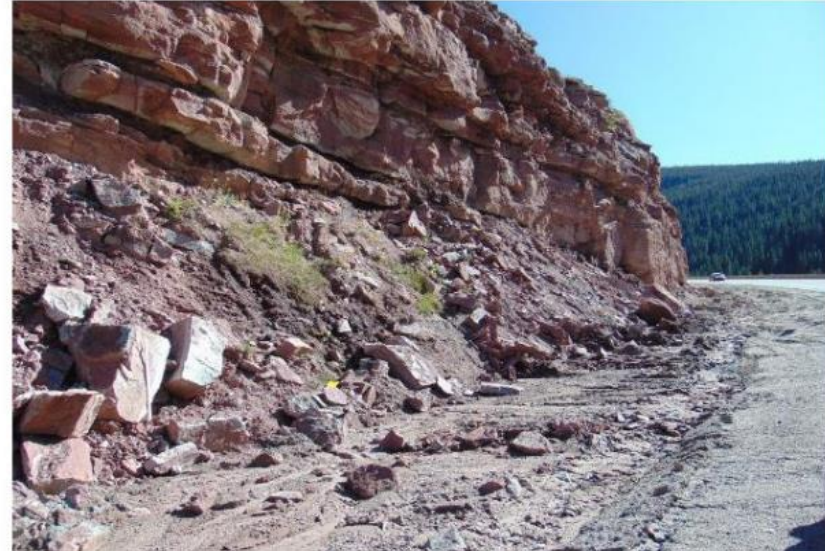
**Boulders at base of slope and in ditch**

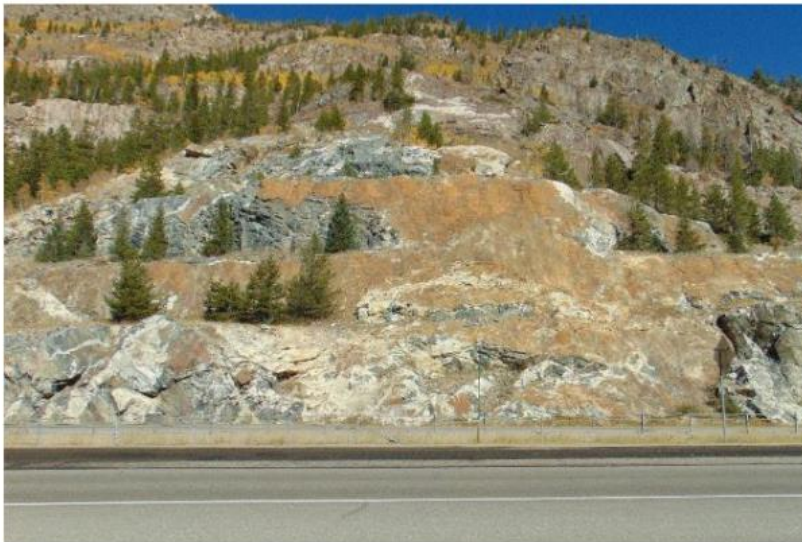
**Cut view to northwest of vegetated, terraced slope and iron staining**

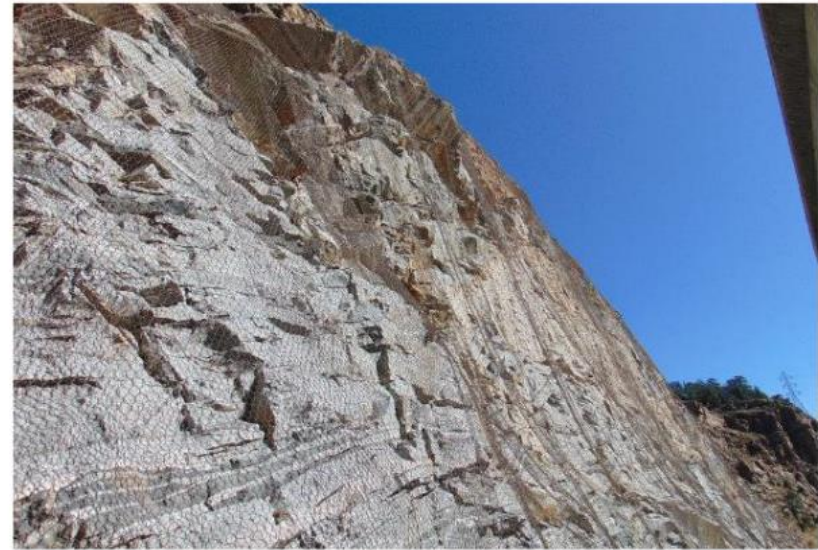
**View to northeast, mesh, bolts**

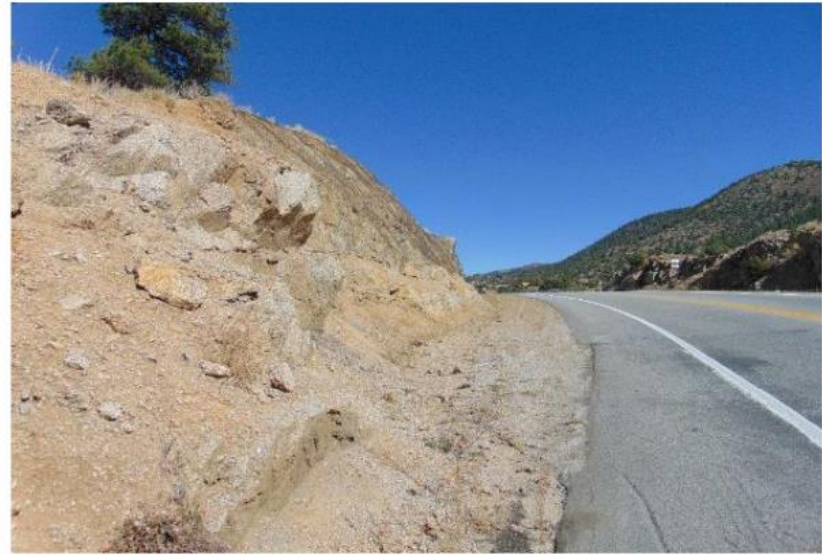
View to north-northeast, rock mesh and catchment ditch

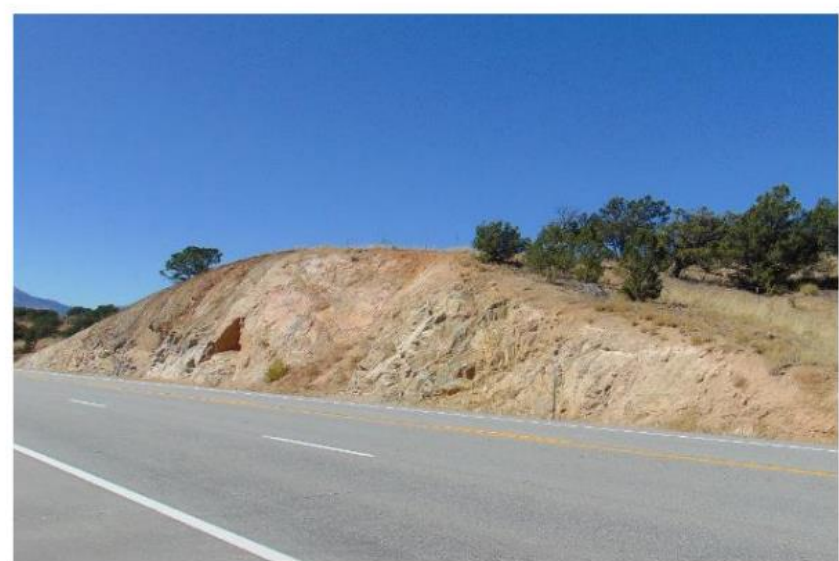
View to west-southwest, cut without mesh with angular gap

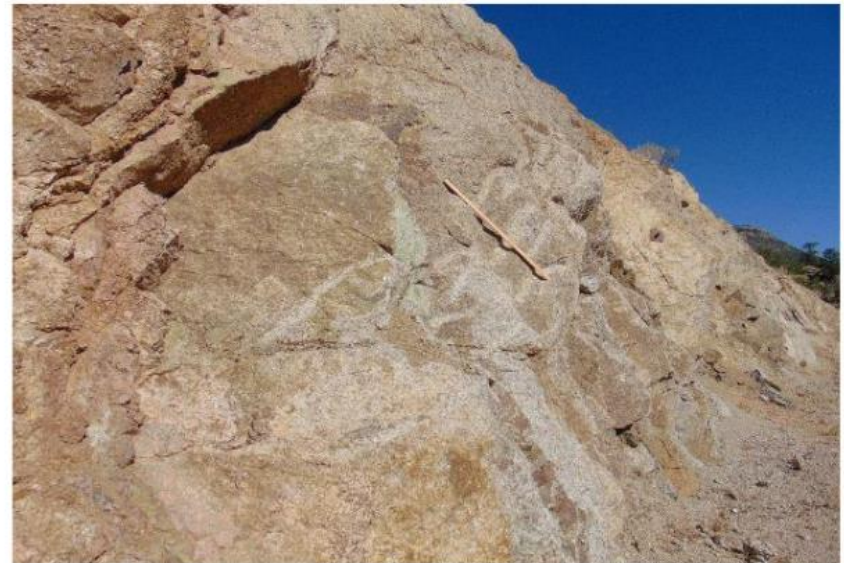
View to northeast with machine marks, bolt

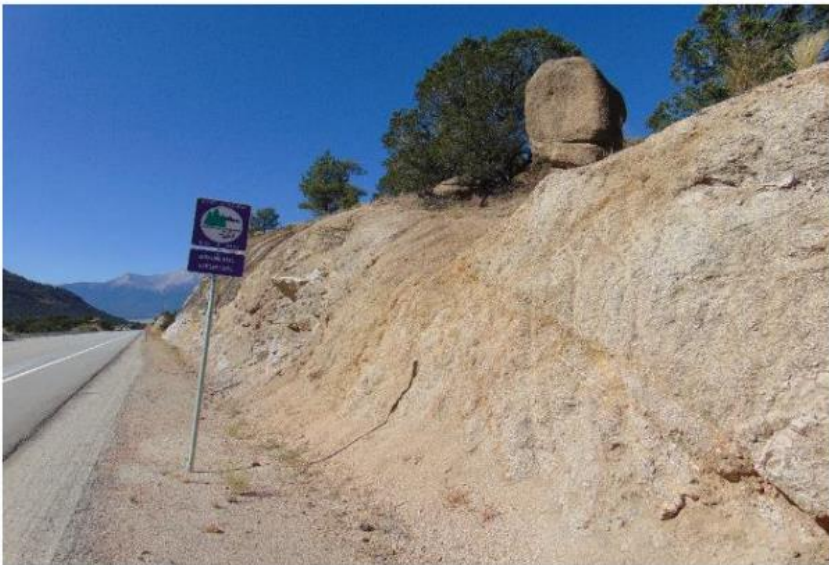
**Machine marks in cut below perched boulder**

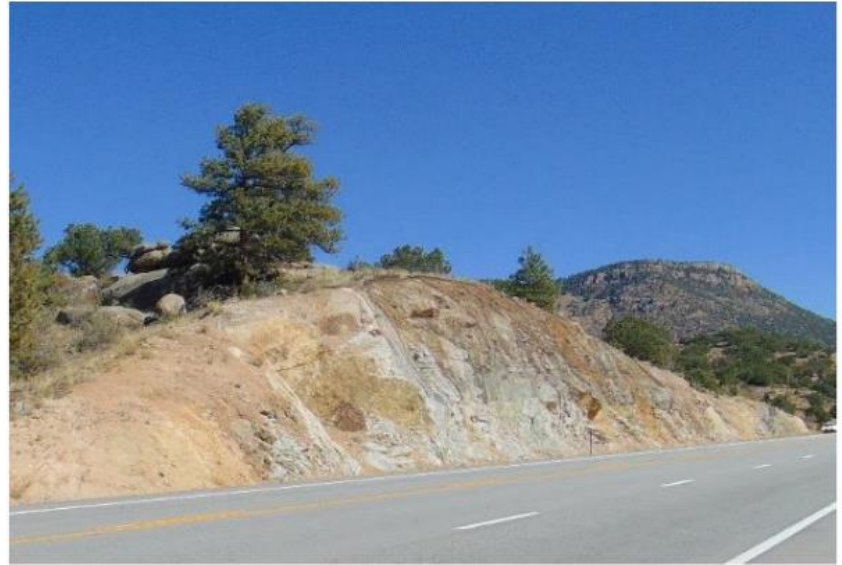
**View to northeast, draped mesh at west end**

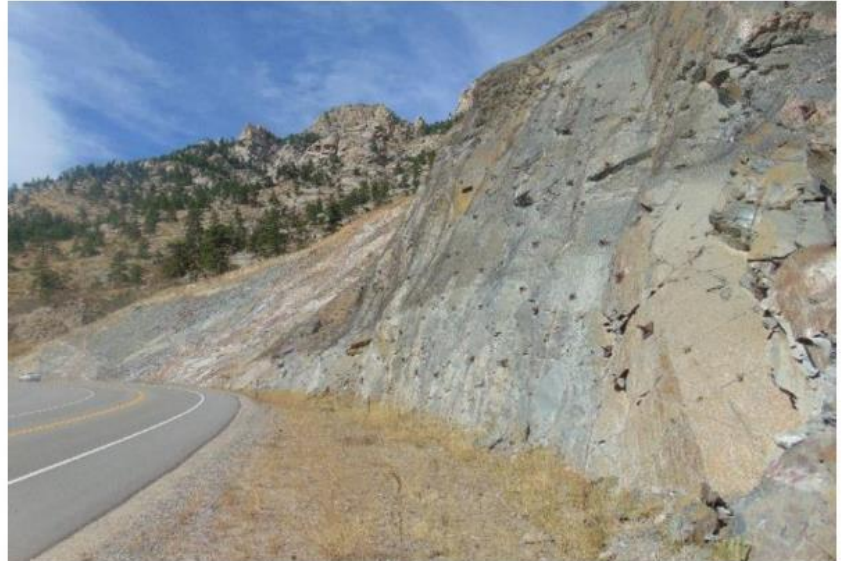
View to northwest, bolts, draped mesh, rocks caught behind mesh

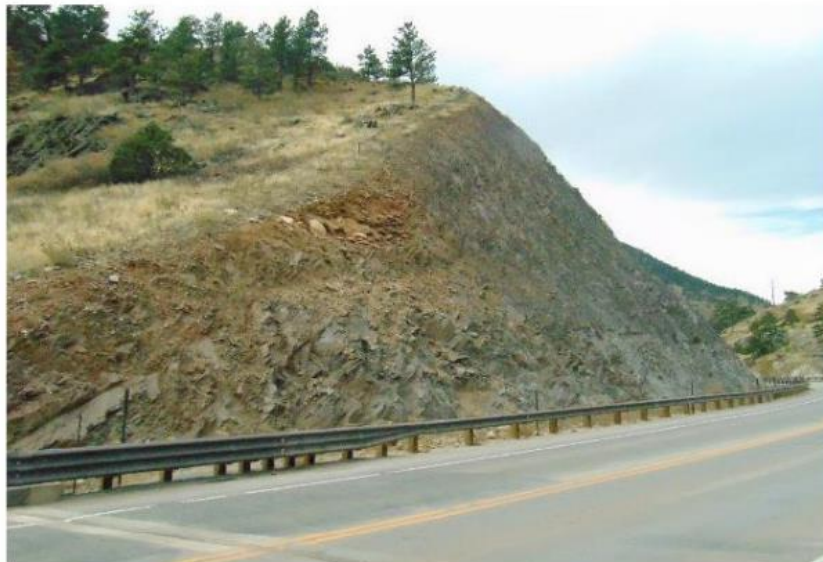
View to southwest, anchors at top of cut, draped mesh

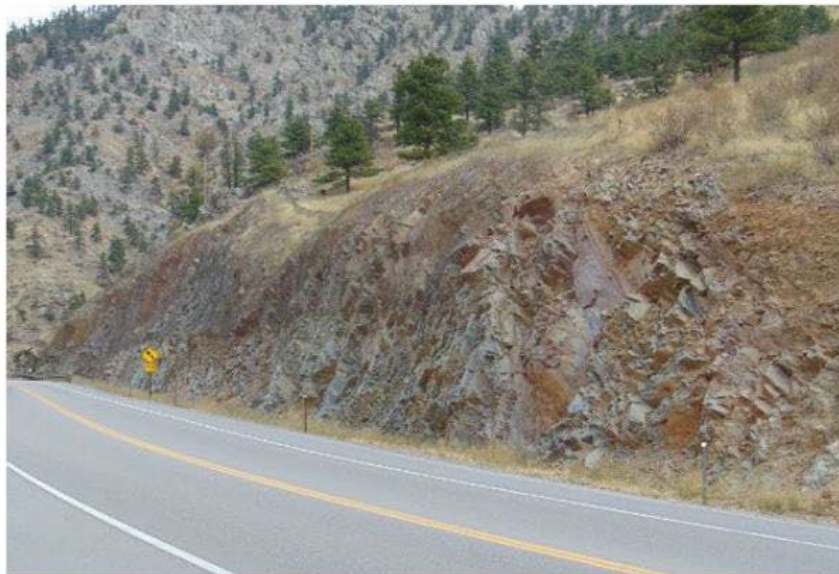
View to north-northwest, anchors at top of cut, draped mesh

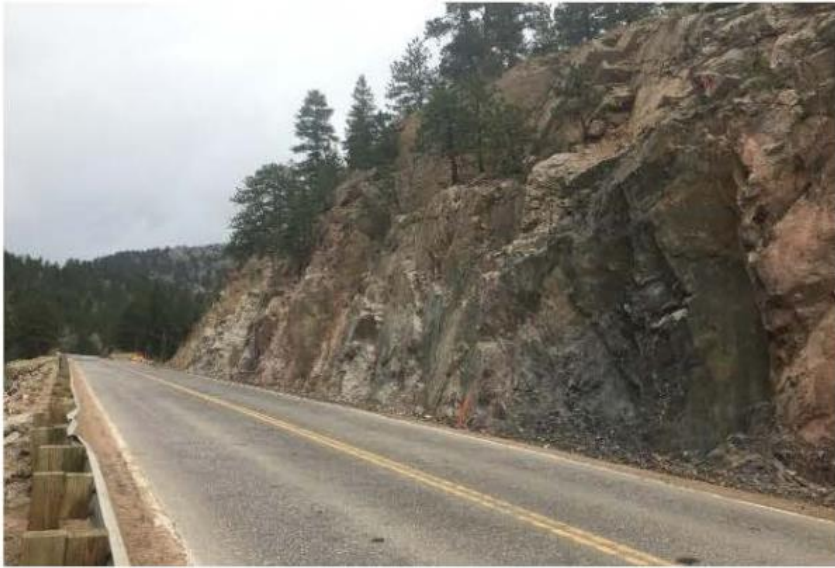
Vegetated benches in cut, view to north

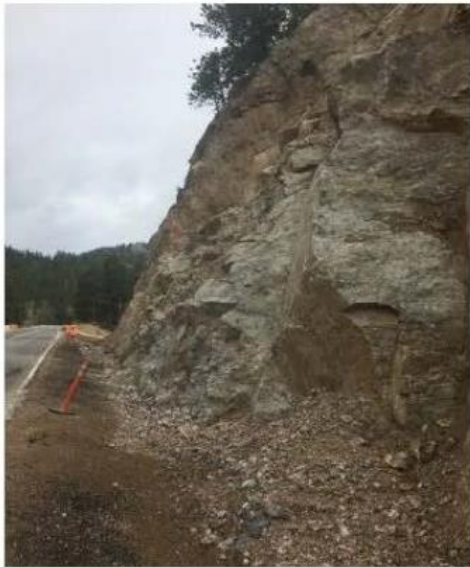
Cobbles at base of cut, view to northwest

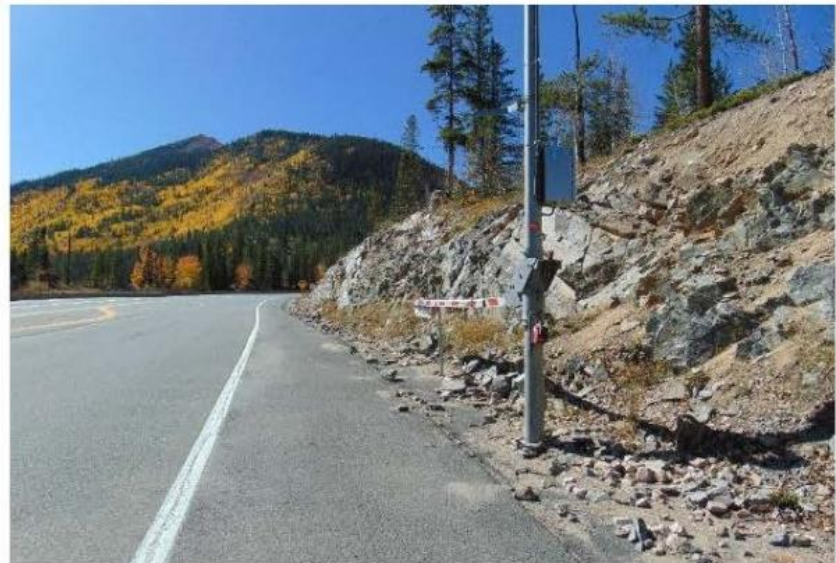
Soil cover and angular debris at shoulder, looking west

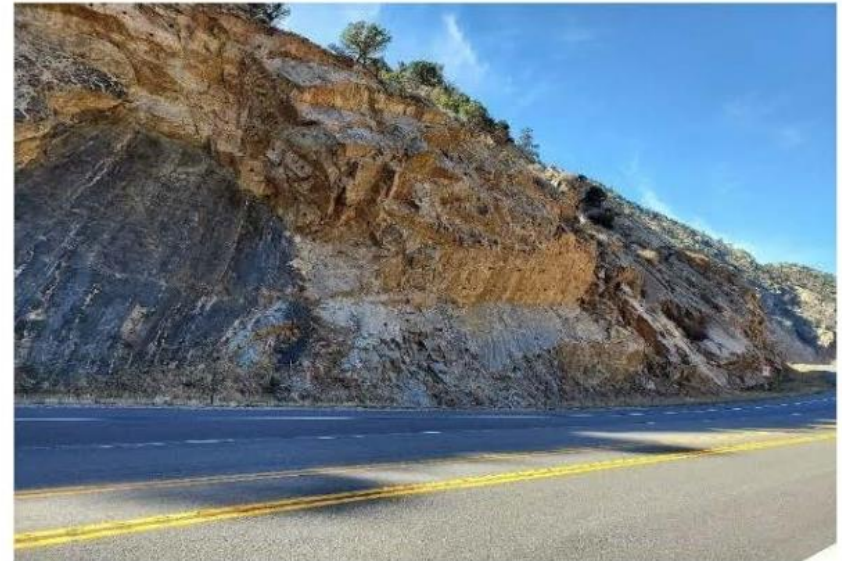
Westbound View, looking south-southeast at rock bolts, tilted rock

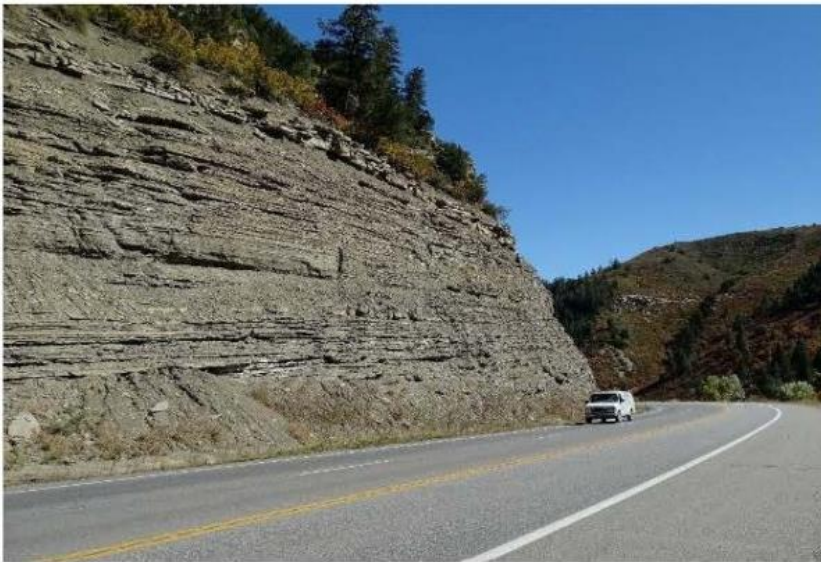
Rock and sediment debris at base of slope

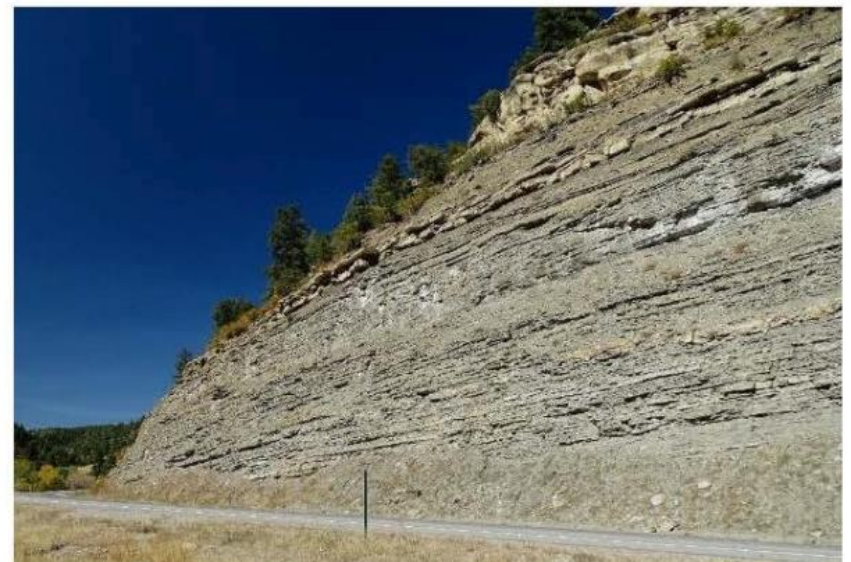
Debris fans at base; sandstone undercut by shale

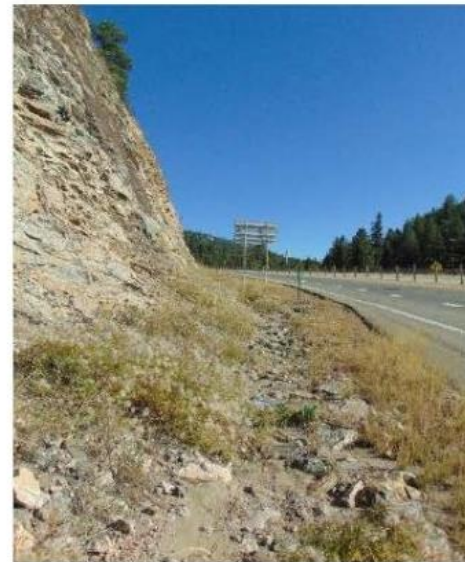
Rocks at base of cut slope

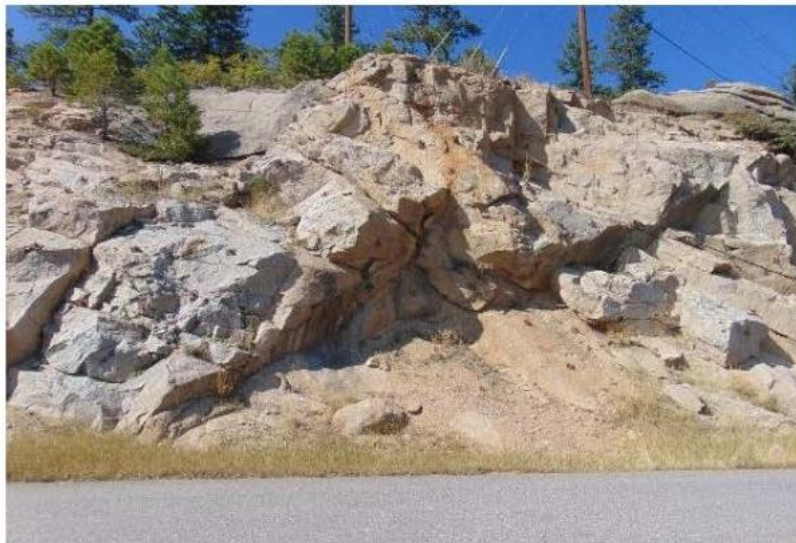
Rockfall mitigation, shotcrete, bolts

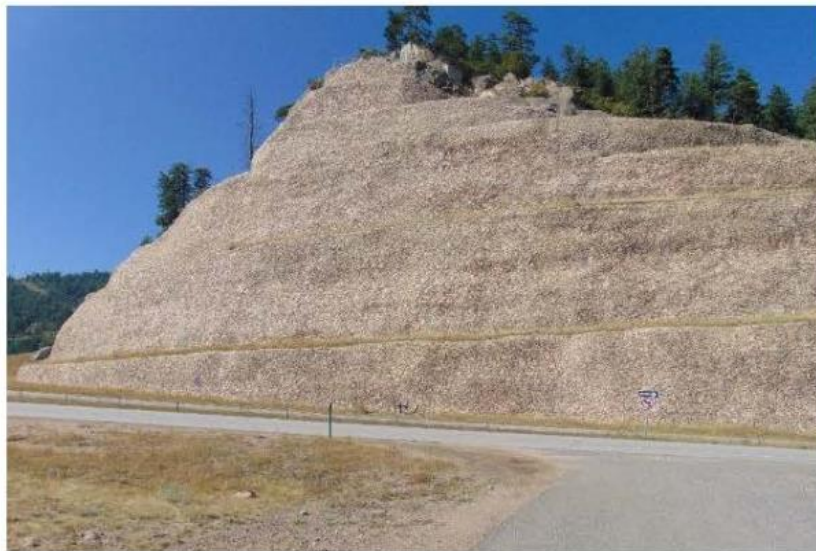
Cut area with terraces and rock facing

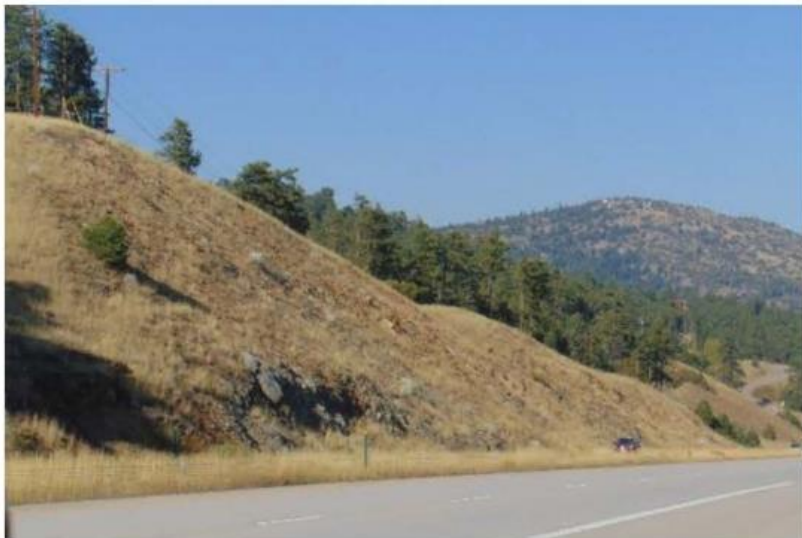
Cut slope mixed soil above rock

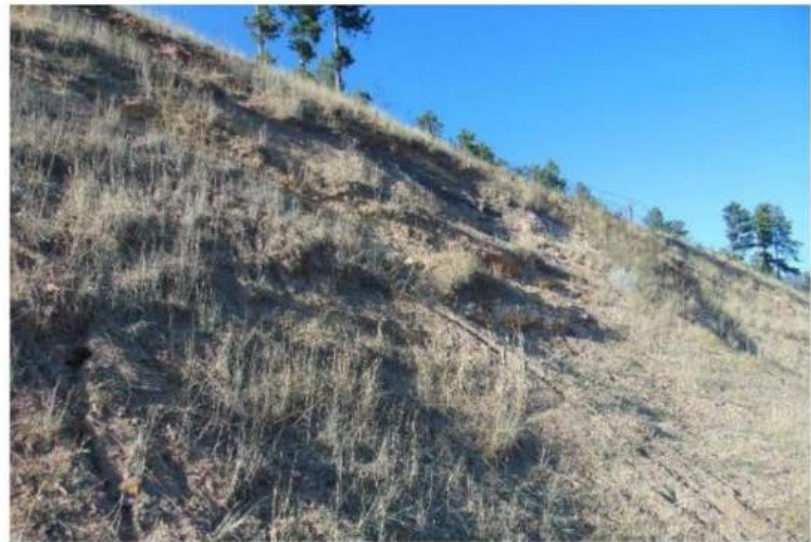
Rilling and gullying on upper soil covered slope

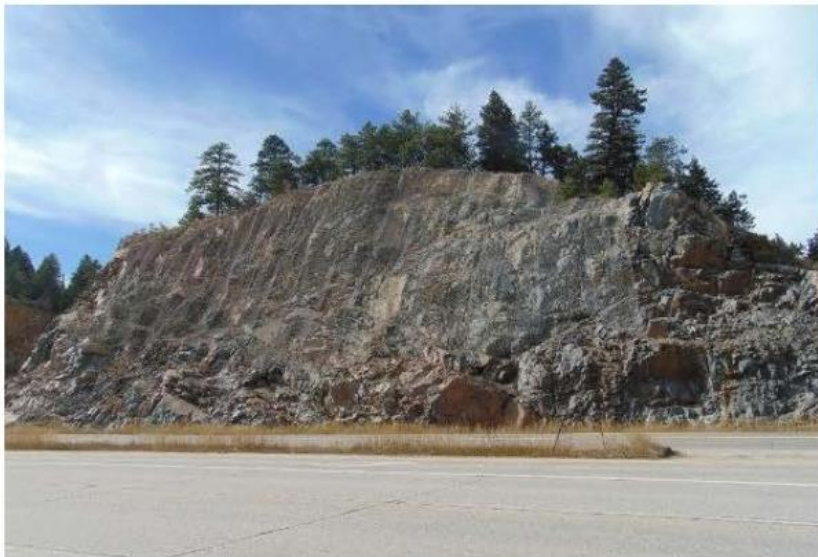
Draped mesh, view to northwest

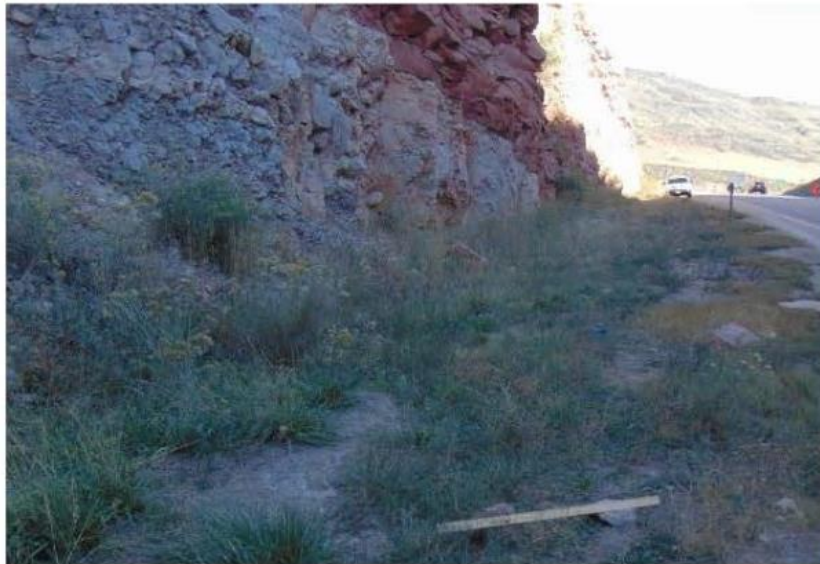
Change in rock type; rocks in ditch with red boulder near face of cut

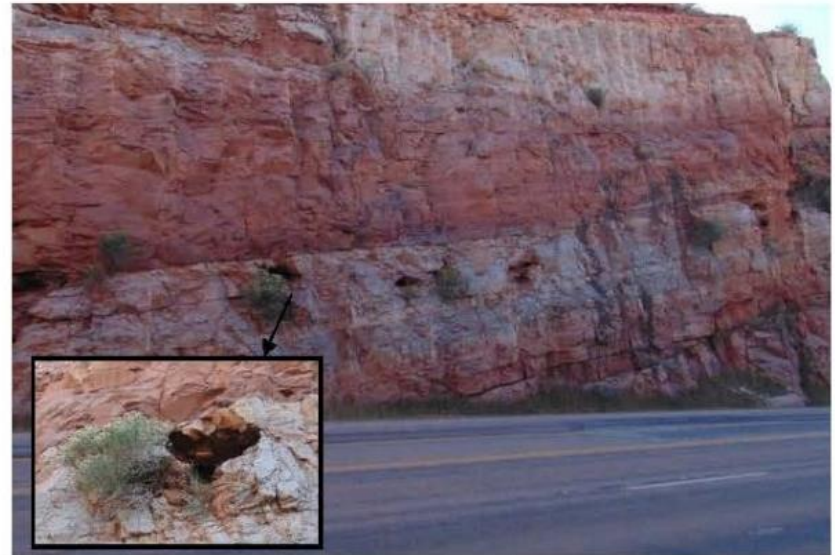
Dissolution cavities and boulders in ditch

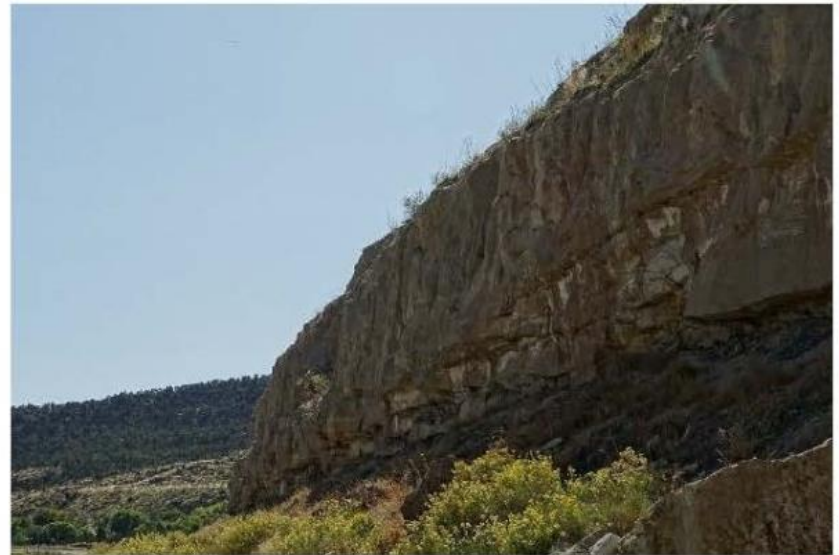
Buried shale layer

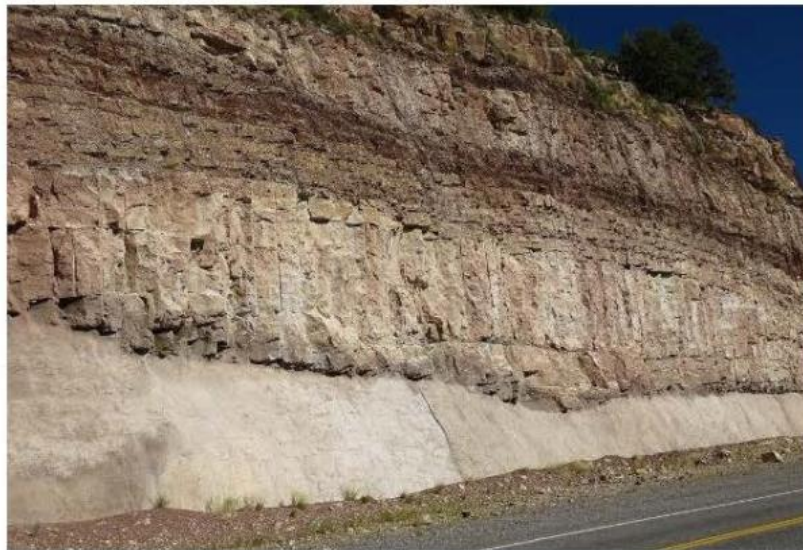
Draped mesh and shotcrete base

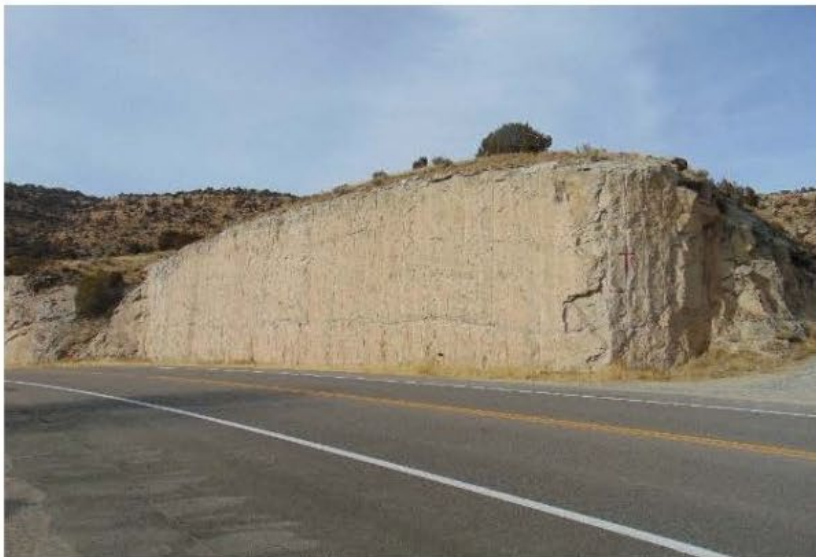
NW view of two different blast techniques (far left of photo and center)

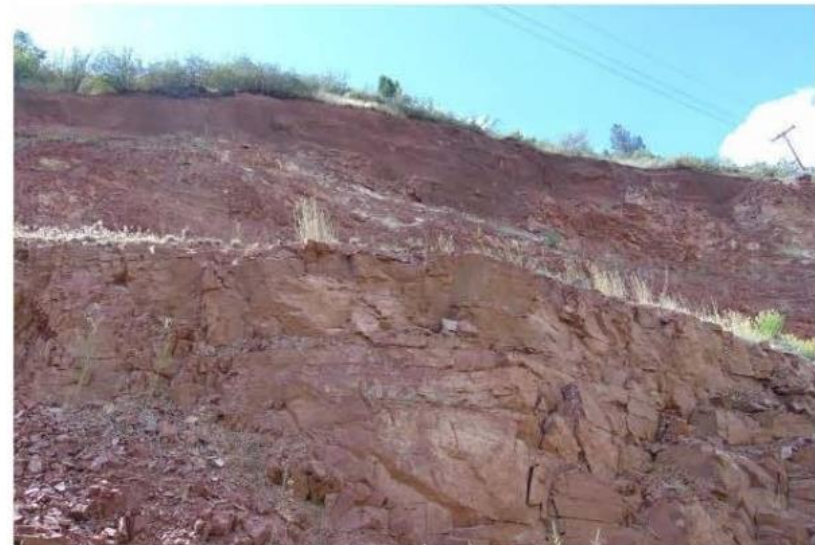
Shotcrete at top of cut

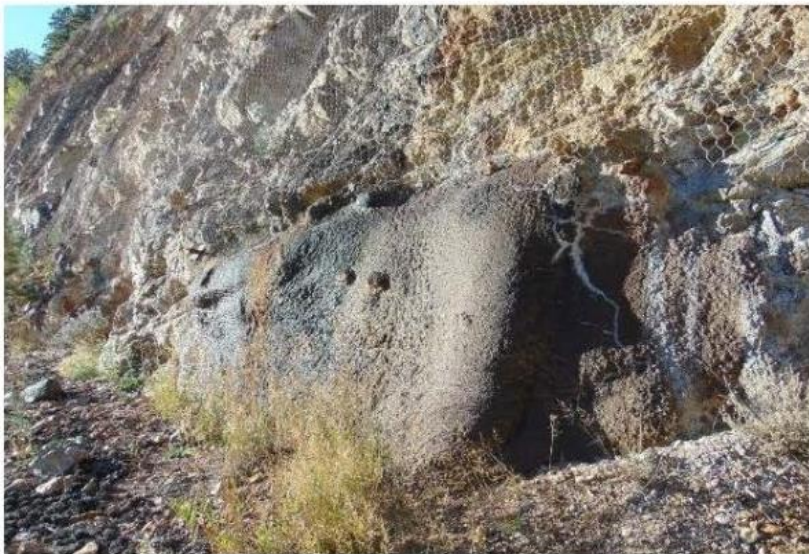
Drains in cut

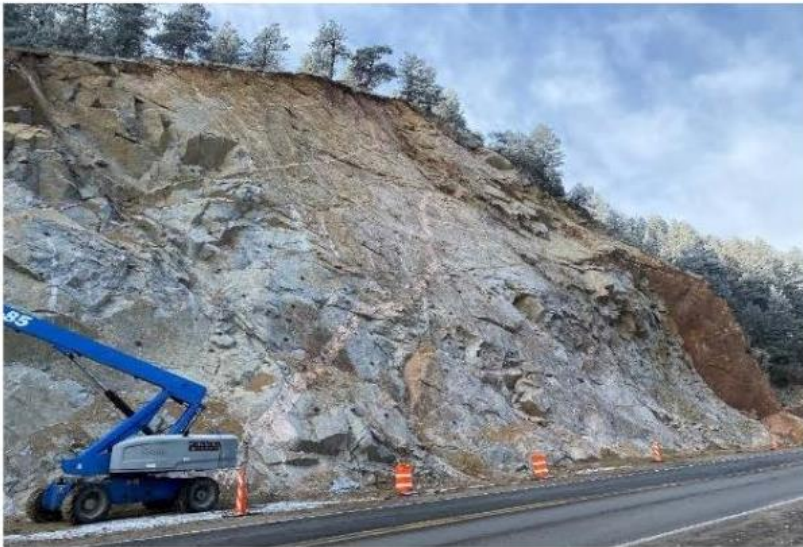
Cut slope post construction view to west

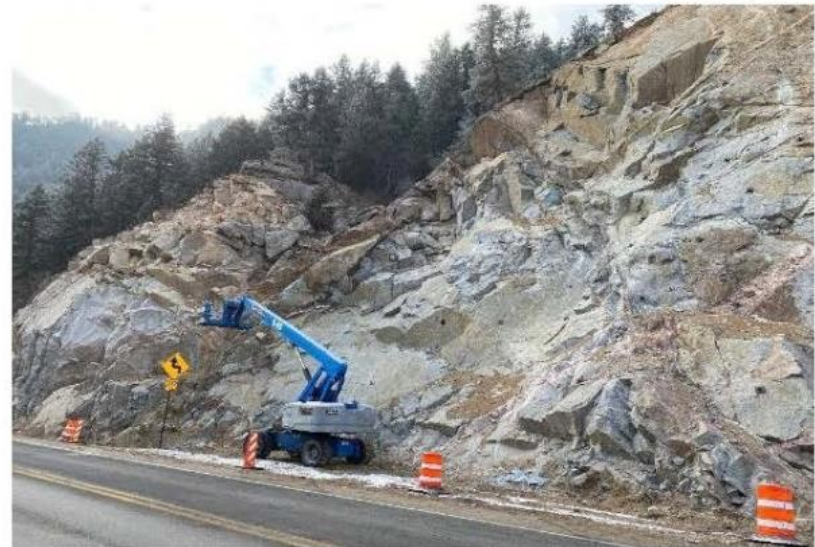
Cut slope post construction view to SSE

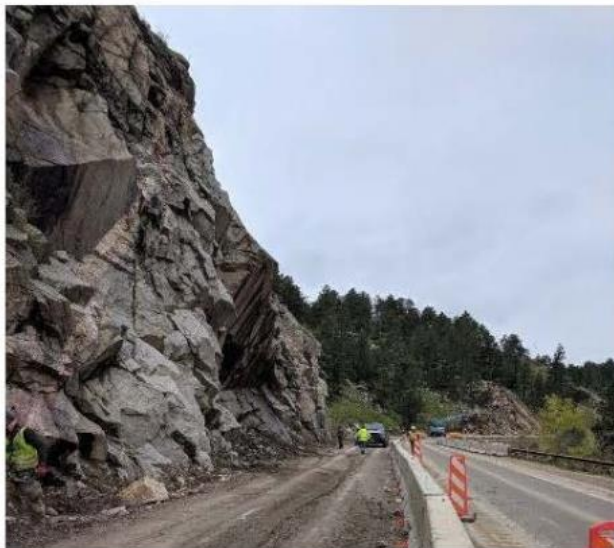
Cut slope early construction view to WNW

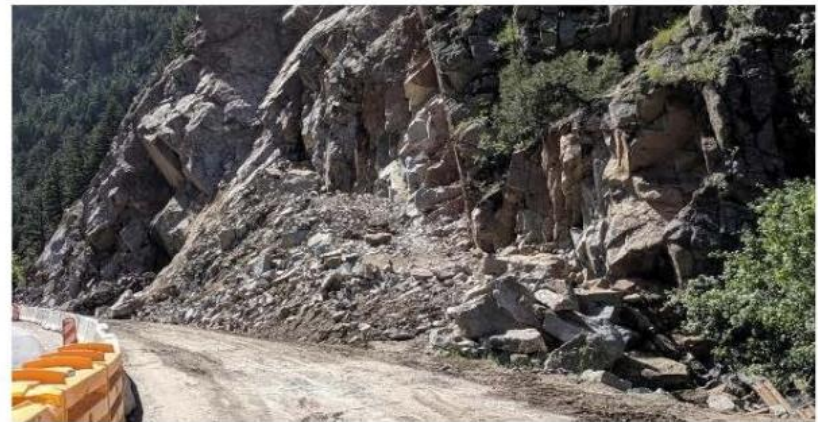
Cut slope early construction view to SSE

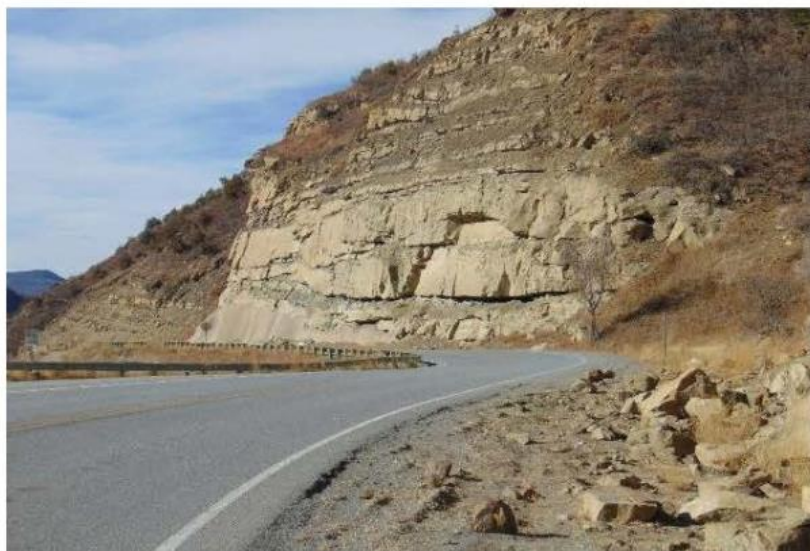
View to west, undercut sandstone, shotcrete lower slope

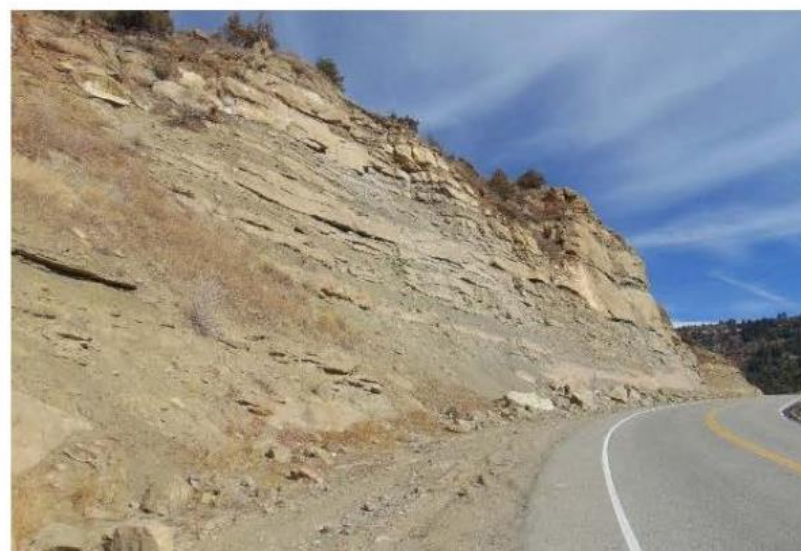
View to ENE, shotcrete lower slope, boulders up to 5 ft diam. In ditch
