Rehabilitation and Load Rating of Deteriorated Timber Bridges in Colorado: Parametric Investigations and Implementation

1. Report No. CDOT-2023-06		2. Government Accession No.		3. Recipient's Catalog No.	
4. Title and Subtitle Rehabilitation and Load Rating of Deteriorated Timber Bridges in Colorado: Parametric Investigations and Implementation				5. Report Date May 2023

Part III: Rating of Constructed Timber Bridges Repaired with Steel Beams

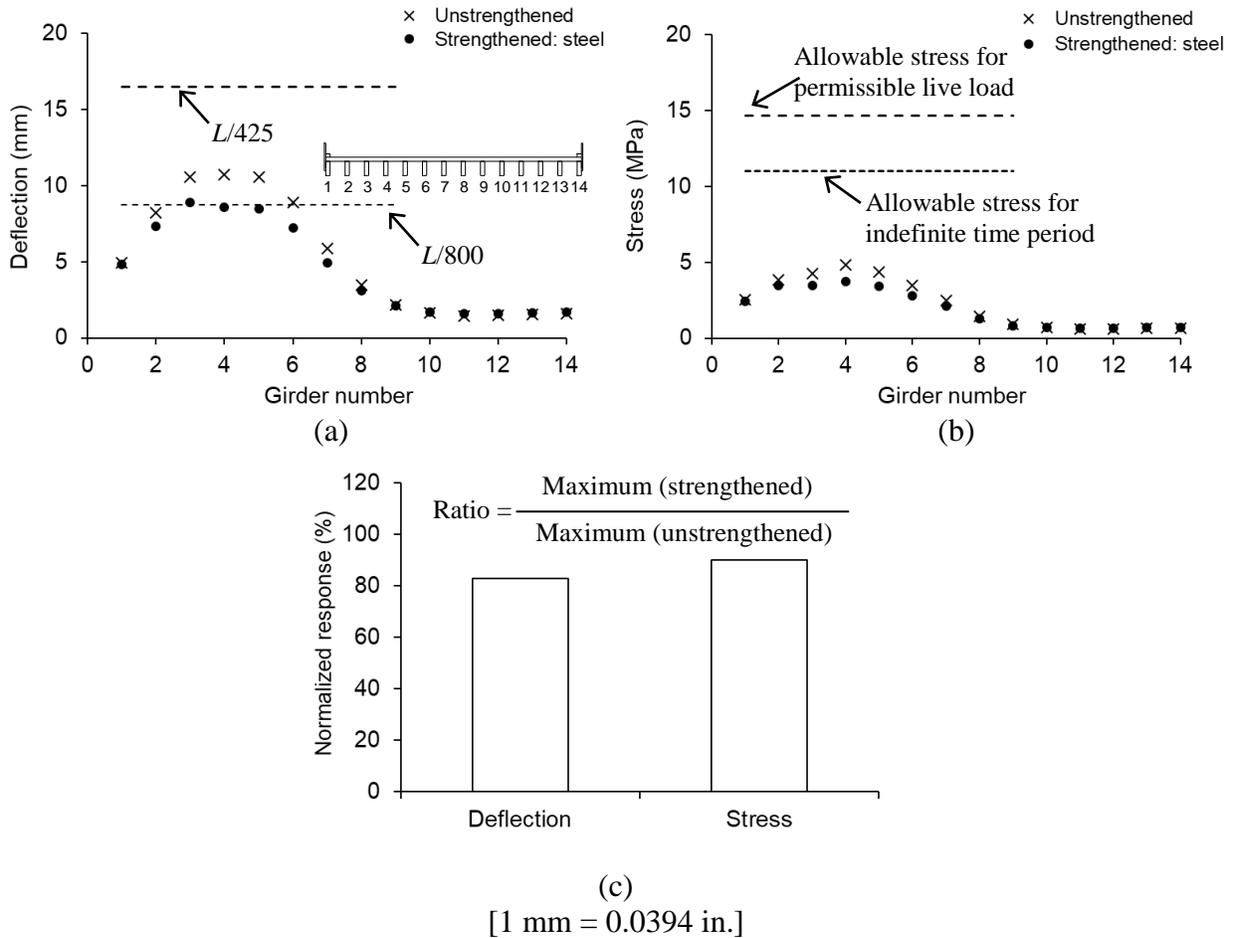
Fig. II.17. Effects of Colorado Permit Truck (live load-induced behavior at midspan of F-22-V, Span 1): (a) deflection; (b) stress; (c) normalized deflection and stress

Figure II.17(a) exhibits the deflection profiles of the bridge under the Colorado Permit Truck weighing 100 kips (Fig. II.3(a): P_1 to $P_4 = 25$ kips, each; $D_1 = 4$ ft, $D_2 = 12$ ft, and $D_3 = 4$ ft). In spite of the diminished deflections after the retrofit, the maximum value exceeded the limit of $L/800$ (the $L/425$ limit was still tolerable); hence, in order to avoid potential problems, a refined analysis seems necessary before allowing unordinary vehicles equivalent to the permit truck onto deficient timber bridges. As confirmed in Fig. II.17(b), the stresses of the girders were lower than the allowable stresses of $\sigma_I = 1,600$ psi and $\sigma_O = 2,128$ psi. The effectiveness of the

strengthening was akin with regard to the deflection and stress (Fig. II.17(c)); however, the serviceability requirements (Fig. II.17(a)) tended to govern the performance of the bridge, rather than the strength (Fig. II.17(b)).

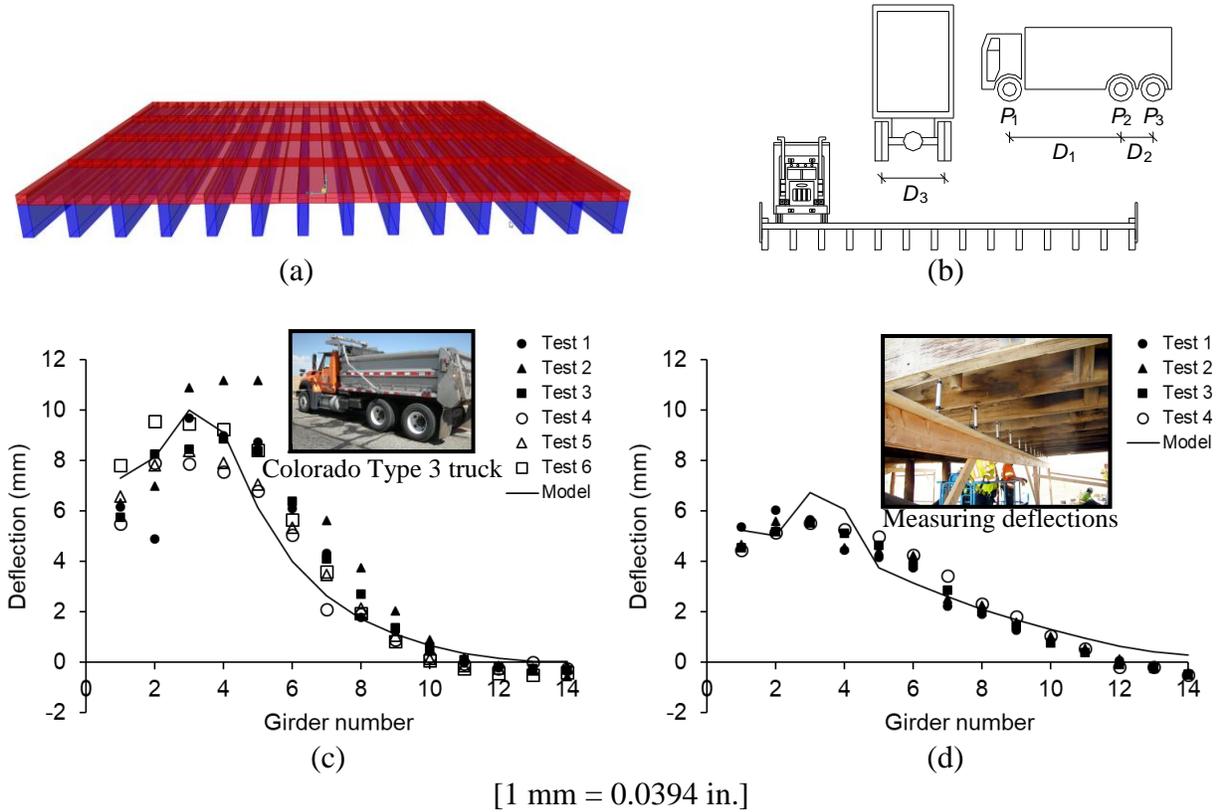
Fig. III.4. Finite element modeling of F-22-V: (a) bridge model; (b) loading scheme; (c) validation with unrepaired case under Colorado Type 3 truck; (d) validation with repaired case under Colorado Type 3 truck

The modeling approach was validated against the load test data of F-22-V. While a concise summary is given in this section, a full description about the site work can be found in Part II. The constructed bridge model (Fig. III.4(a)) was subjected to a single Colorado Type 3 Legal truck (Fig. III.4(b)). The measured truck weight was 60 kips ($P_1 = 15.5$ kips and $P_2 = P_3 = 22.25$ kips; $D_1 = 13.5$ ft, $D_2 = 4$ ft, and $D_3 = 6$ ft) and it was situated to generate the maximum bending of the bridge (Fig. III.4(c), inset). The test was repeated 10 times (6 times without repair and 4 times with repair) and the bridge response was logged by linear variable displacement transducers at midspan (Fig. III.4(d), inset). The average distance between the inside curb face and the rear axle outside tire was 25.4 in. As shown in Fig. III.4(c), the deflections of the unrepaired girders underneath the loaded region (Girders 1 to 5) were greater than those of others. An analogous trend was noticed for the repaired girders (Fig. III.4(d)); however, the magnitude of the deflections was lower than their unrepaired counterparts. This observation was attributed

to the fact that the applied truck load was shared by the timber girders and the steel beams (i.e., a redistribution of the live load). Despite some discrepancies, the model prediction agreed with the site data: the average absolute margin between the measured and computed deflections of Girders 1 to 5 was 17.0% and 16.6% for the unrepaired and repaired cases, respectively.

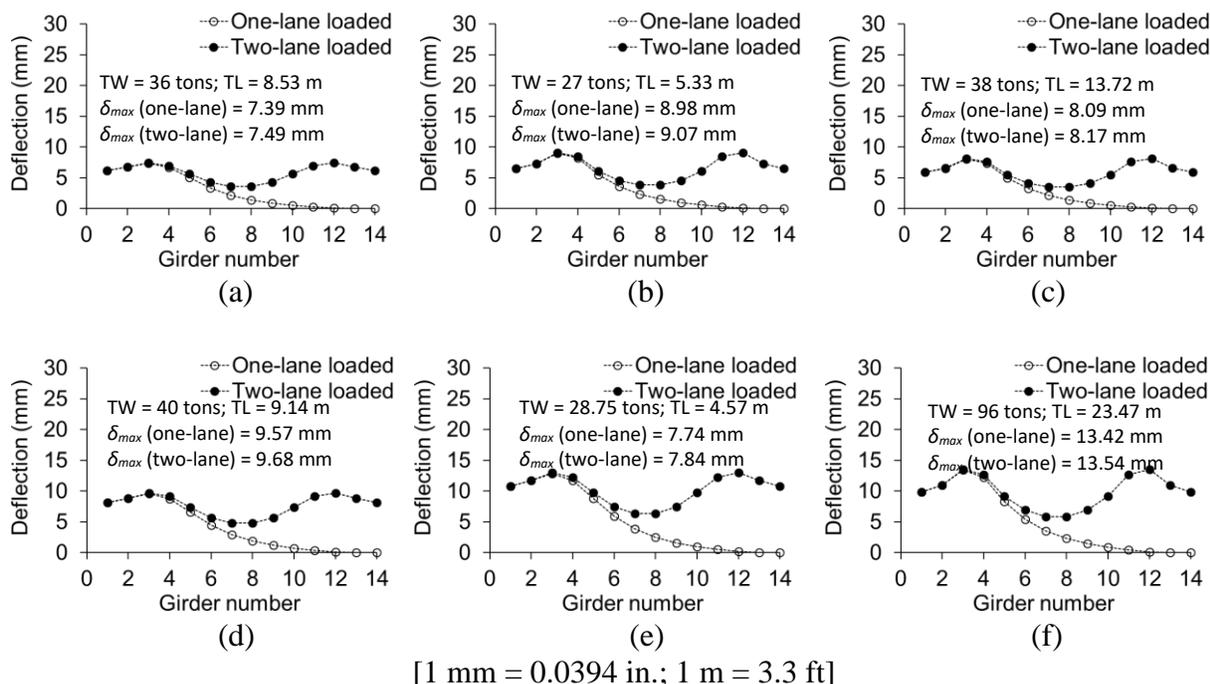
Fig. III.5. Deflection profiles of unrepaired F-22-V under selected truck loads (TW = truck weight in total; TL = truck length from front to rear axles): (a) HS20; (b) Colorado Legal Type 3; (c) Interstate Type 3S2; (d) Hauling Vehicle A; (e) Emergency Vehicle 2; (f) Colorado Permit

Figure III.5 exhibits the deflection profiles of the unrepaired F-22-V bridge under selected live loads. The HS20 truck generated the maximum deflections of 7.39 mm (0.291 in.) and 7.49 mm (0.295 in.) for the one- and two-lane loaded cases, respectively (Fig. III.5(a)), and the individual configurations were dependent upon the position of the truck. Although the total weight of Colorado Legal Type 3 (27 tons) was less than that of HS20 (36 tons), the deflections increased by 21.5% and 21.1% for the one- and two-lane loaded cases, respectively (Fig. III.5(b)). This is due to the reduced distance between the front and rear axles (5.33 m (17.6 ft) for Colorado Legal Type 3 vs. 8.53 m (28 ft) for HS20), which resulted in the so-called concentrated load effect. A similar tendency was found between Interstate Type 3S2 and Hauling Vehicle A in Figs. III.5(c)

and (d), where a reduction of 33.4% in the axle-to-axle distance was responsible for the increased deflections of 18.3% and 18.5% belonging to the one- and two-lane loads, respectively. Such observations, however, are not always valid as can be seen in Figs. III.5(e) and (f). Even if the axle-to-axle distance of Emergency Vehicle 2 (4.57 m (15 ft)) was much shorter than the distance of Colorado Permit (23.47 m (77 ft)), the deflection under Colorado Permit was 173.4% higher than the instance of Emergency Vehicle 2 (13.42 mm (0.528 in.) vs. 7.74 mm (0.305 in.)) owing to a significant difference in the total weights (96 tons vs. 28.75 tons). It is, thus, recommended that sophisticated modeling be carried out when the ramifications of nonconforming features (other than the customary design loads of HS20 and HL93) are examined. The flexural responses of H-20-T with the steel beams are plotted in Fig. III.6. For facilitating discussions on the effectiveness of the repair, the predicted results were normalized to show a ratio between deflections with and without the steel beams. The responses before and after the repair entailed inappreciable variations without regard to the types of the live loads and the number of the loaded lanes. This signifies that a single methodology can be used to generate consistent evaluation outcomes for timber bridges repaired with steel sections.

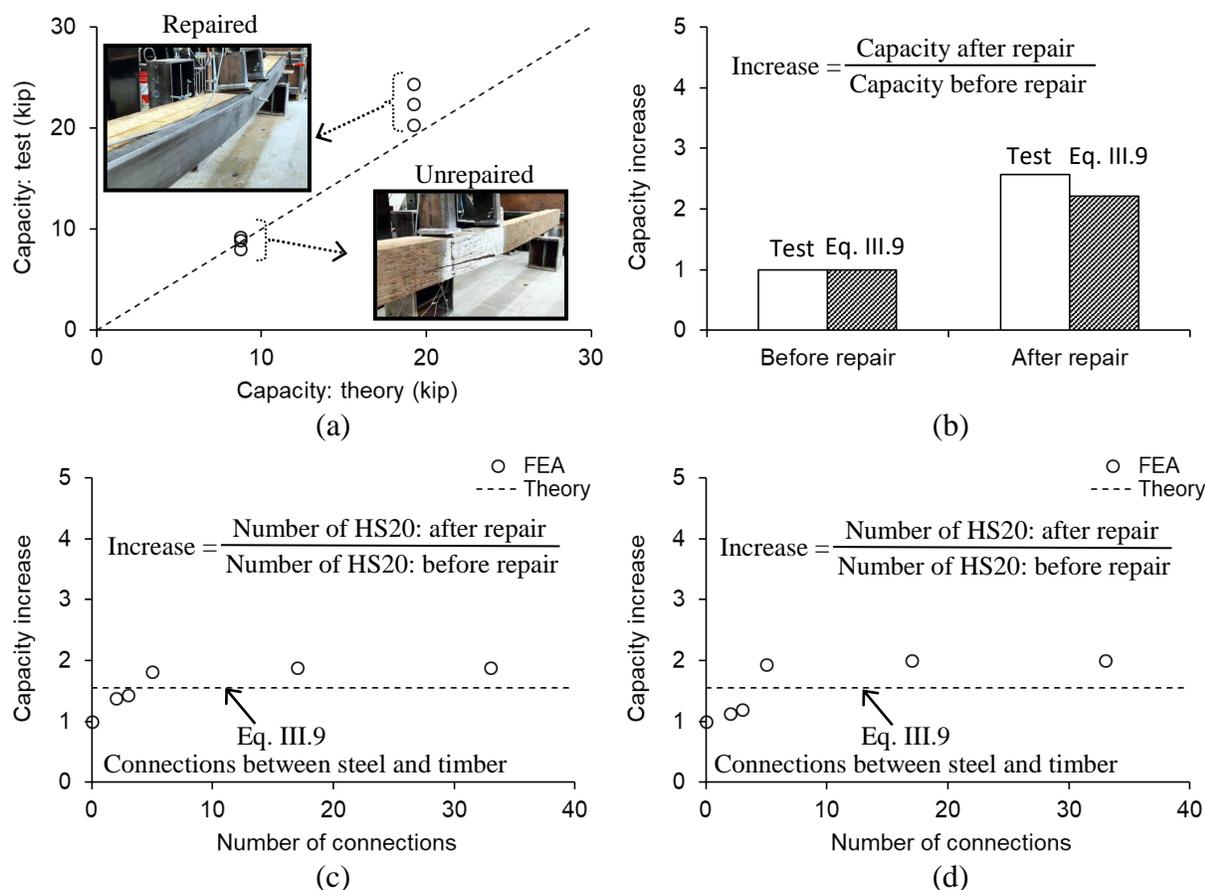
Fig. III.7. Flexural capacity of timber girders before and after repair (FEA = finite element analysis): (a) comparison with tests; (b) assessment with test data; (c) F-22-V; (d) H-20-T

Prior to executing the capacity adjustment approach, its relevance was appraised. Figure III.7(a) displays test data excerpted from Part I, which loaded Douglas Fir beams with and without repair (inset pictures in Fig. III.7(a)), and predicted results from the proposed approach. For the unrepaired case, the average ultimate loads of the experimental and theoretical beams were 8.72 kips and 8.70 kips, respectively; in contrast, the calculated capacity of the repaired beam was lower than the measured capacities by 14.1%, on average. This discrepancy can be ascribed to the fact that the actual modular ratio n in Eqs. III.7 and III.8 might be higher than the nominal value and that the applied load might not be uniformly distributed to the timber and steel during the test. The increased capacities of the experimental and theoretical beams after the repair were 2.56 and 2.21 times the capacities of the unrepaired beams, respectively (Fig. III.7(b)).

The efficacy of the repair for the F-22-V and H-20-T bridges is charted in Figs. III.7(c) and (d), respectively. To determine the capacity of the bridges, the weight of the HS20 truck (Fig. III.3(a)) was incrementally raised in the finite element analysis (FEA) until the maximum tensile stress of the timber girders reached the modulus of rupture. Subsequently, the number of the trucks was counted before and after the repair to attain a capacity increase ratio, as indicated in Figs. III.7(c) and (d). The ratio was contingent upon the number of connections between the timber and steel at uniform spacings (i.e., the number of the link elements delineated in Sec. III.4.1). When the number of the connections was more than five, increases in the capacity were alike between the FEA and theory (Eq. III.9), which means that full composite action took place. On the site application with three connections at both ends and midspan (Fig. III.2), the average capacity increase was 1.32 (41.9% lower than that of the five connection cases). It is hence stated that the capacity increase after the repair with at least three connections varied from 1.32 to 1.94 and, for practical ratings in the field, the capacity increase is suggested to be 10% lower than the capacity increase estimated by Eq. III.9, stemming from the difference between the theory and the lower bound value of 1.32. Therefore, including the capacity reduction factor (κ) given in Table III.3 to reflect in-situ degradation over time (MDT 2019), the adjusted nominal capacities of the repaired timber girder for rating become (F_r is in MPa for Eq. III.13):

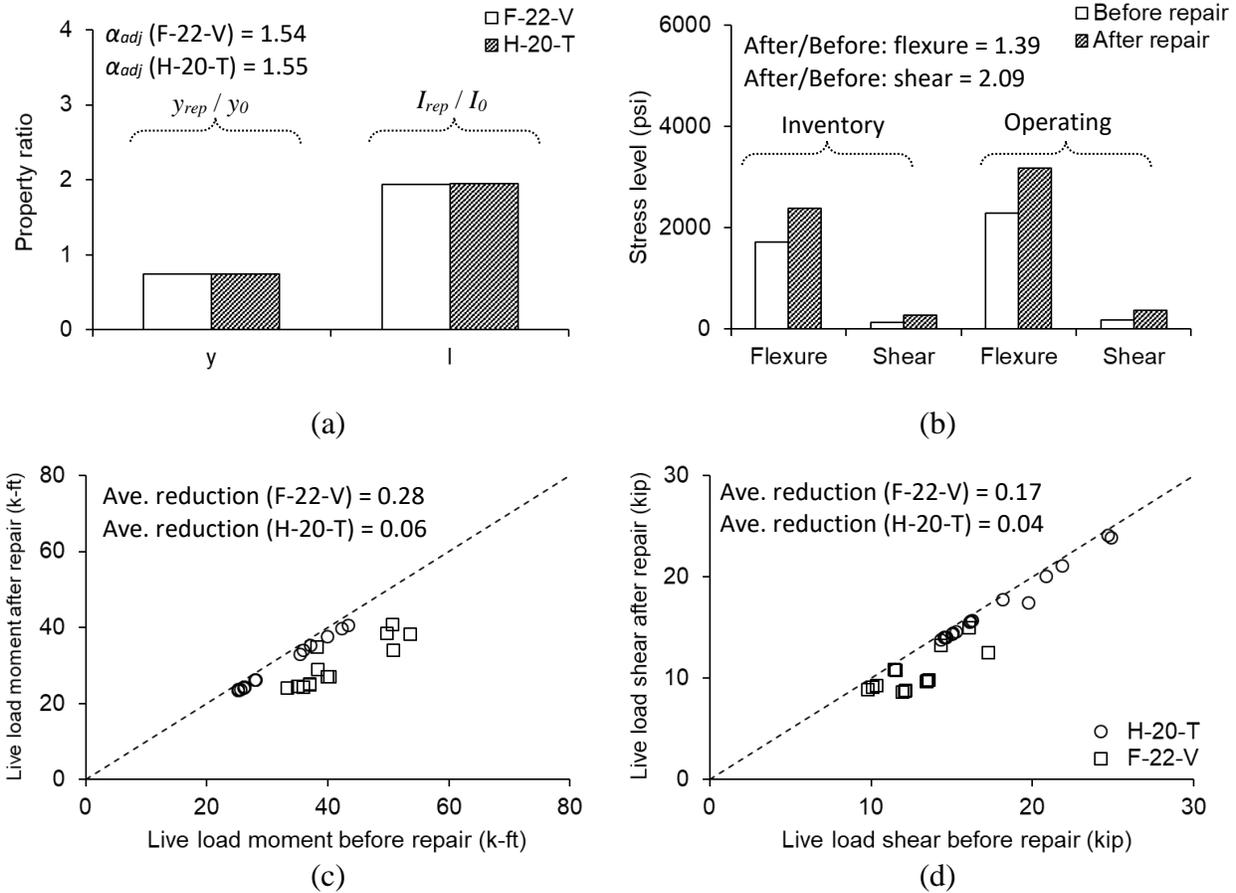
Fig. III.8. Consequences of repair: (a) sectional property; (b) stress level; (c) live load moment; (d) live load shear

The ramifications of the repair are provided in Fig. III.8. The geometric-property ratios of the two bridges were virtually identical (Fig. III.8(a)); consequently, there was an insignificant difference in their capacity adjustment factors ($\alpha_{adj} = 1.54$ and 1.55 for F-22-V and H-20-T, respectively). The stress levels of these bridges before and after the repair are shown in Fig. III.8(b). The allowable stresses of the timber girders (F_r and F_{VO}) increased by 1.39 and 2.09 for flexure and shear, respectively. Figures III.8(c) and (d) reveal the effects of the live loads (Fig. III.3) with and without the steel beams, which are necessary to compute rating factors. Since more girders were repaired and the steel beams were grouped in F-22-V relative to H-20-T (Fig. III.2(b)), the former experienced better load distributions than the latter; for example, the average reduction of the live load moment was 0.28 and 0.06 for F-22-V and H-20-T, respectively (Fig. III.8(c)). It should be declared that the shear values in Fig. III.8(d) are the maximum forces

collected from the finite element models, rather than design shear at a specific location away from supports (lesser of 3 times the girder depth or at the quarter span point, whichever is less, AASHTO 2002). A comprehensive comparison is made for the rating factors of the bridges with $\kappa = 1.0$ when subjected to the Design, Legal, and Permit loads (Figs. III.9(a) to (d): Inventory and Operating levels are valid for the Design loads and only Operating is usable for the Legal and Permit loads, CDOT 2022). Regardless of the load types and rating levels, the rating factors were improved; scilicet, all factors after the repair were positioned above the one-to-one reference line. Figures III.9(e) and (f) enumerate rating ratios between the repaired and unrepaired states of the bridges. Overall, the efficacy of the repair was pronounced and F-22-V outperformed H-20-T due to the grouped placement of the steel beams (supplementary information to follow).

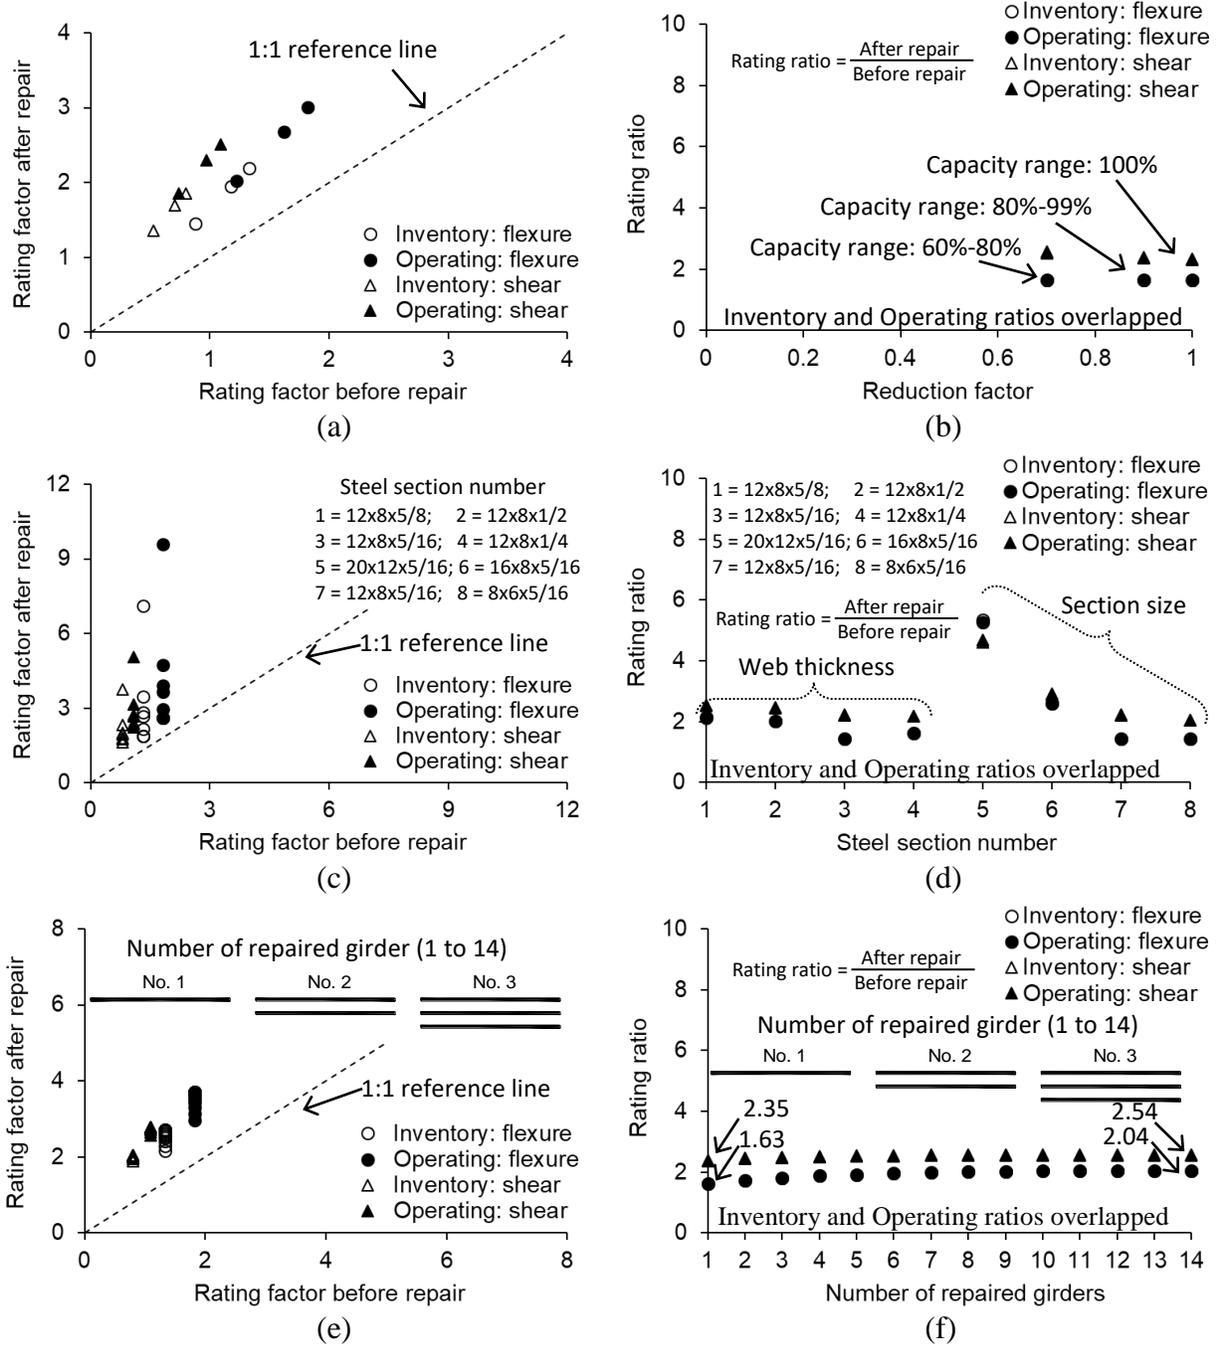
properties of the bridge were taken as the defaults, unless otherwise noted. Figures III.10(a) and (b) illustrate the effects of deterioration levels. Complying with the reduction factors listed in Table 3, the capacity of the timber girders varied from 100% to 60%. The enhanced ratings after the repair were prominent (Fig. III.10(a)) and the efficaciousness of the repair went up as the reduction factor declined (Fig. III.10(b)). This fact implies that timber bridges that have suffered considerable deterioration can be suitable candidates for upgrading their ratings with the steel sections. The influence of the steel beam size is shown in Figs. III.10(c) and (d). The first group (the 12×8 series, steel section numbers 1 to 4 in Fig. III.10(c)) was focused on the wall thickness of the beams, spanning from $t = 0.291$ in. to 0.581 in., while the second group (the 5/16 series, steel section numbers 5 to 8 in Fig. III.10(c)) was related to the depth and width of the beams with a constant wall thickness of $t = 0.291$ in. A wide breadth of rating factors were predicted from 2.59 to 9.60, contingent upon the size of the steel beams (Fig. III.10(c)), which corroborates that the selection of an adequate beam is instrumental for the repair method. The impact of the web thickness was marginal with an average rating increase of 1.80 and 2.33 for flexure and shear, respectively (Section numbers 1 to 4 in Fig. III.10(d)); however, that of the section size was noteworthy up to 5.27 and 4.61 for flexure and shear, respectively (Section numbers 5 to 8 in Fig. III.10(d)). The number of repaired girders was influential in rating the bridge (Fig. III.10(e): No. 1 = the first girder with steel; No. 2 = the second with steel, and so forth, Fig. III.2(b)). As the number increased from 1 to 14 (Fig. III.10(f), inset), the rating ratio steadily rose from 1.63 to 2.04 for flexure and from 2.35 to 2.54 for shear (Fig. III.10(f)). Accordingly, placing the steel beams across the entire superstructure do not seem to be necessary in practice and the designer's discretion is needed to determine the level of improvement; nonetheless, as discussed previously, grouped steel beams will benefit the performance of repaired timber bridges.

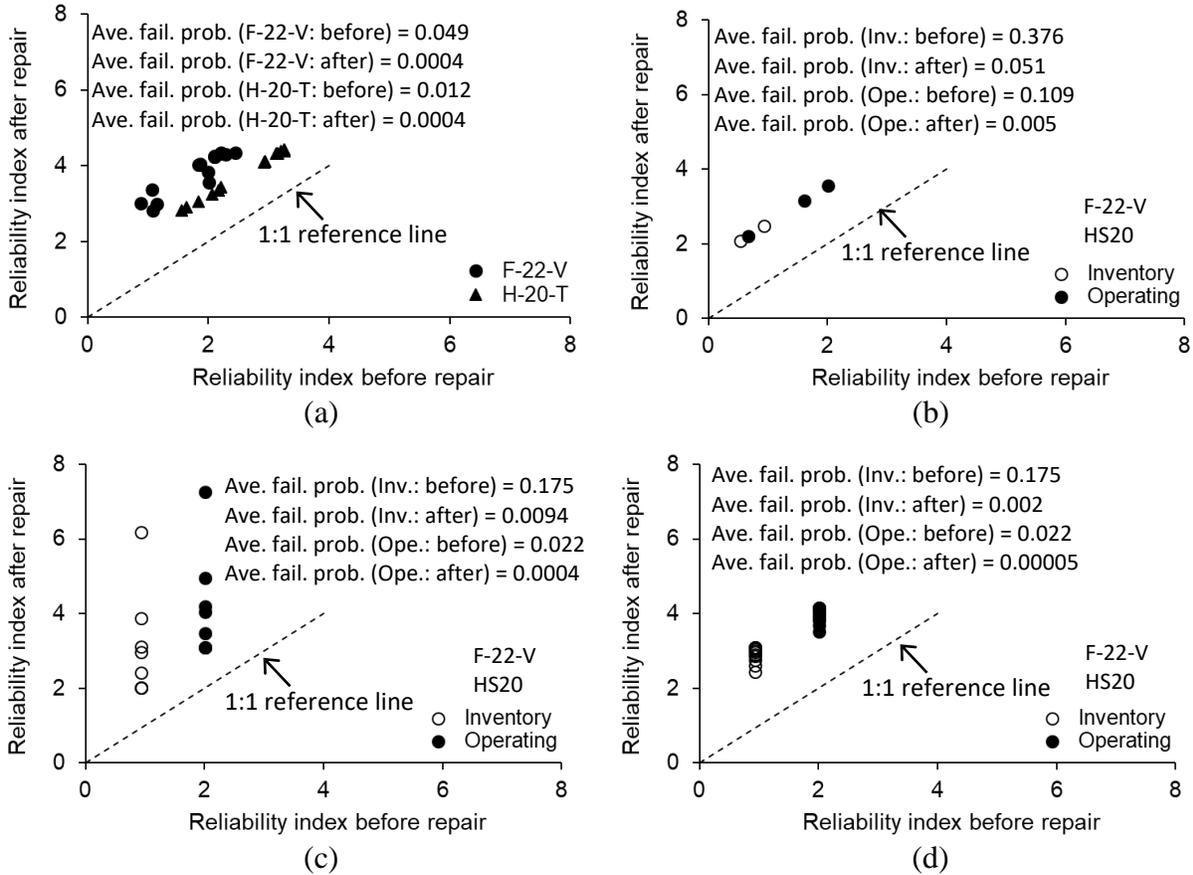
Fig. III.11. Safety analysis: (a) Operating level under 17 rating live loads; (b) deterioration level; (c) steel section size; (d) steel section arrangement

where $\Phi(\cdot)$ is the standard normal cumulative distribution. Figure III.11(a) demonstrates the reliability indexes of F-22-V and H-20-T (the Operating levels in flexure are shown, controlling traffic restrictions in most agencies, Wang et al. 2011). The degree of reliability rose owing to the steel beam repair and the probability of failure remarkably diminished by 99.2% and 96.7% for F-22-V and H-20-T, respectively. The reliability indexes and corresponding failure probabilities associated with the parametric studies are given in Figs. III.11(b) to (d). On all occasions, the use of the steel beams was more effective for the Operating levels than the Inventory levels in terms of reducing the failure probability; in other words, the repair method is expected to preclude the catastrophic collapse of decrepit timber bridges.
