report no. CDOT-DTP-R-86-3

CRUMB RUBBER CHIP SEAL East of Punkin Center

Final Report
March 1986

Project RS 0094(7)
East of Punkin Center

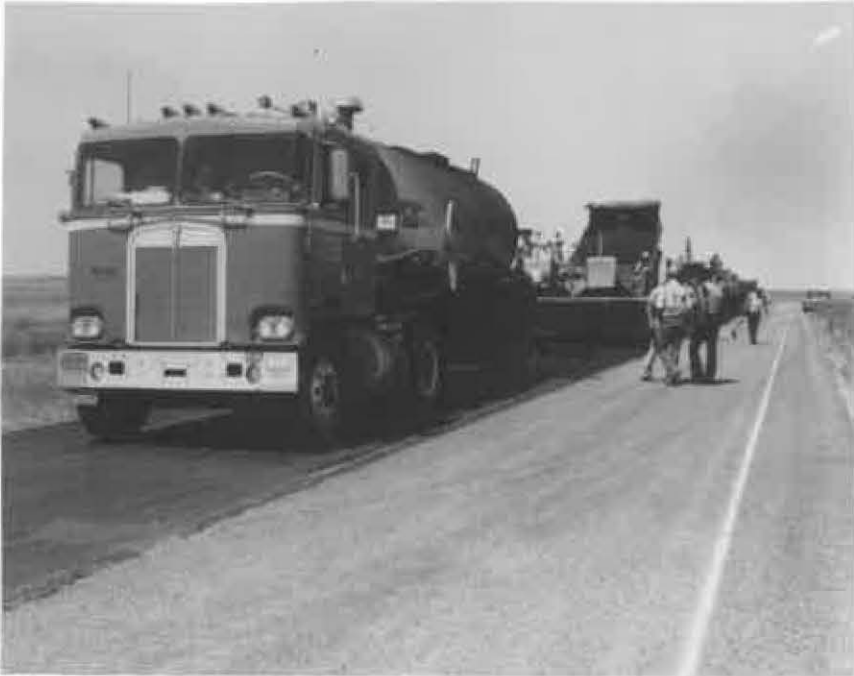
Photograph No. 3

Placement of the chip seal went smoothly with the large distributor truck, chip spreader, and staggered haul trucks.

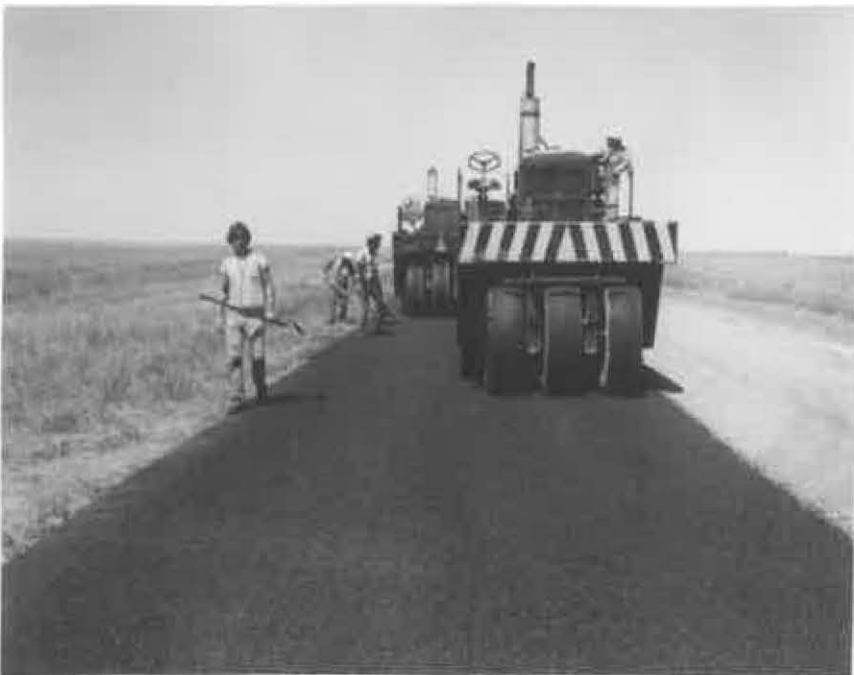
Photograph No. 4

Pneumatic rollers were used immediately behind the haul trucks. At least three roller passes were required over the entire sealed area.
