# REHABILITATION OF CONCRETE PAVEMENTS

**COLORADO DEPARTMENT OF HIGHWAYS**

Final Report  
January, 1983

1. Report No. CDOH-R-83-1		2. Government Accession No.		3. Recipient's Catalog No.	
4. Title and Subtitle Rehabilitation of Concrete Pavements				5. Report Date

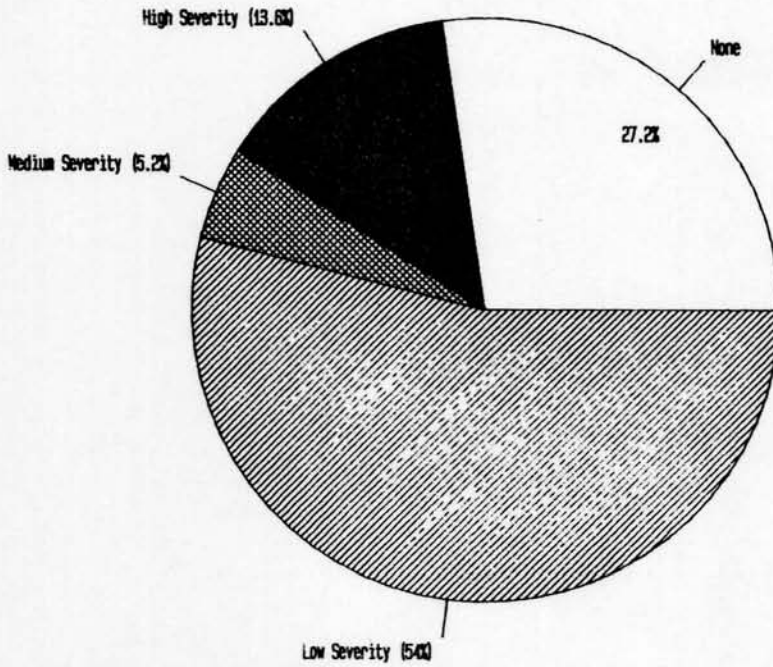
The bar graph on Figure 11 lists the nine types of distress and the accumulated miles of each on a state wide basis. Since many of the projects contained more than one type of distress the sum of the data listed exceeds the observed mileage. The most frequently occurring distress type is shown to be rutting however, the severity is relatively low in most cases. Reactive aggregates and faulting are most frequently occurring in the high severity category documenting Colorado's most serious distress type. Medium severity longitudinal cracking was observed quite frequently however, it was often observed in conjunction with reactive aggregate or other types of distress.

Distribution of Distress on Interstate Concrete Pavements in Colorado.
