Report No. CDOH-DTD-R-89-4

# **VERGLIMIT EVALUATION (BOULDER)**

Final Report  
February, 1989

## VERGLIMIT EVALUATION (BOULDER)

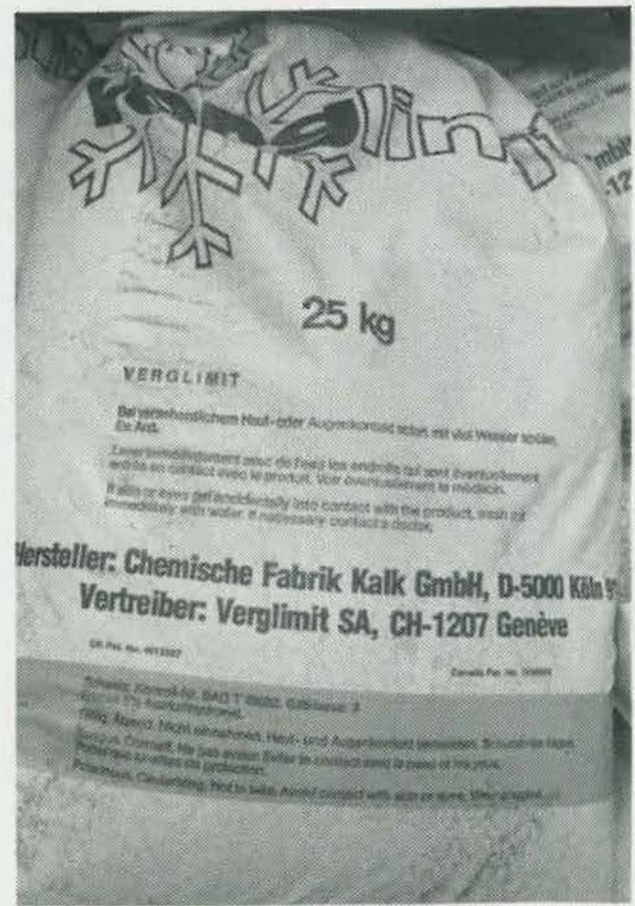
(D) Verglimit sacks

The asphalt mix was produced by Flatiron Paving at the local Valmont plant in Boulder. It was a coal-fired batch-type plant. The Verglimit came in 67 pound waterproof bags that were marked poisonous in three languages (see Photo D). A note in German identifies it as a Class 3 poison containing 5% sodium hydroxide (Natriumhydroxide). In English the warning reads "Poisonous. Cauterizing. Do not take. Avoid contact with skin or eyes. Wear goggles."

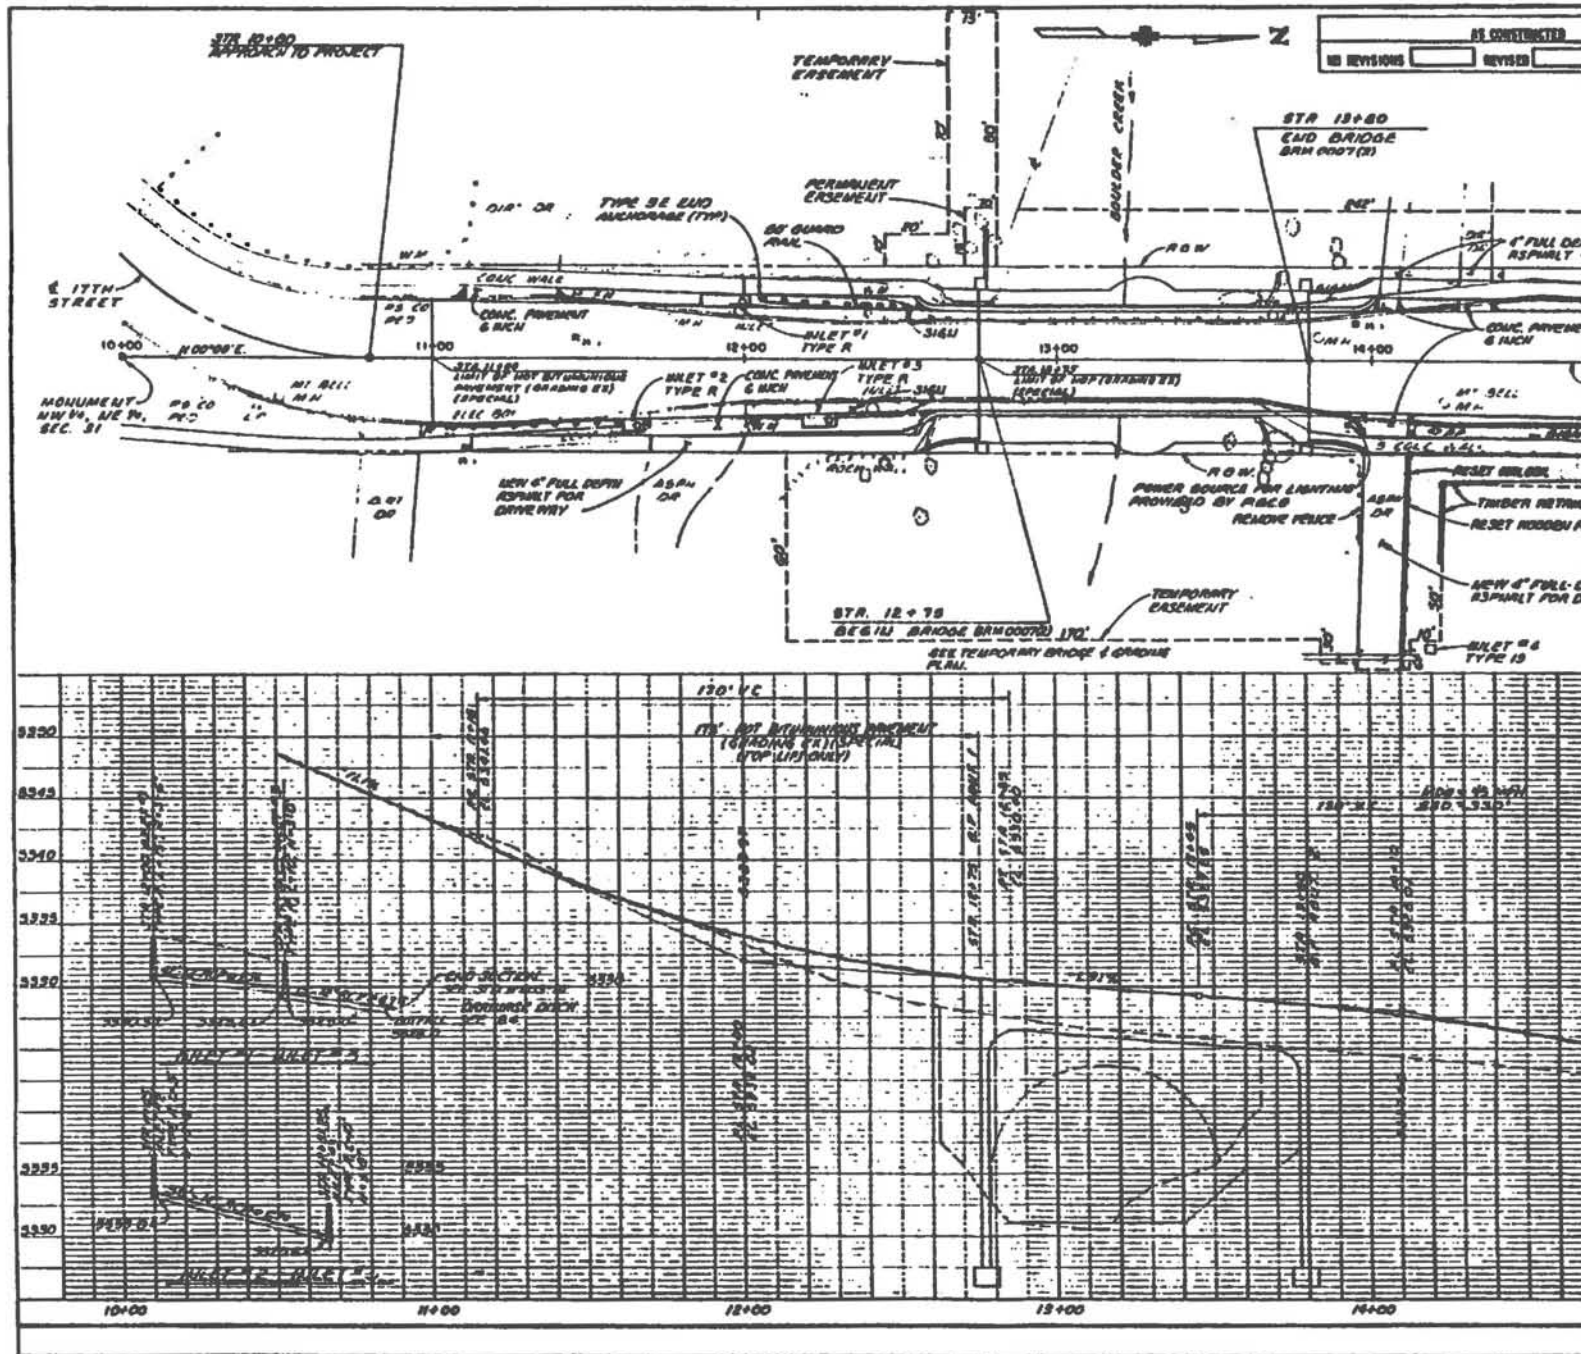
Figure #1

VERGLIMIT TEST SITE BRM 007(2) IN BOULDER

Generally, the paving operation went well with few difficulties. The ambient temperature at the site was 90°F. The preceding mat was placed in the same operation; nevertheless, the mat was tacked with an emulsified asphalt. As shown in the sketch in Figure 1, three passes were needed to complete the 36 foot width of the test section. The first pass had a laydown temperature of 285°F which was as recommended. The next two passes were placed at lower temperatures — 250°F and 265°F, respectively.

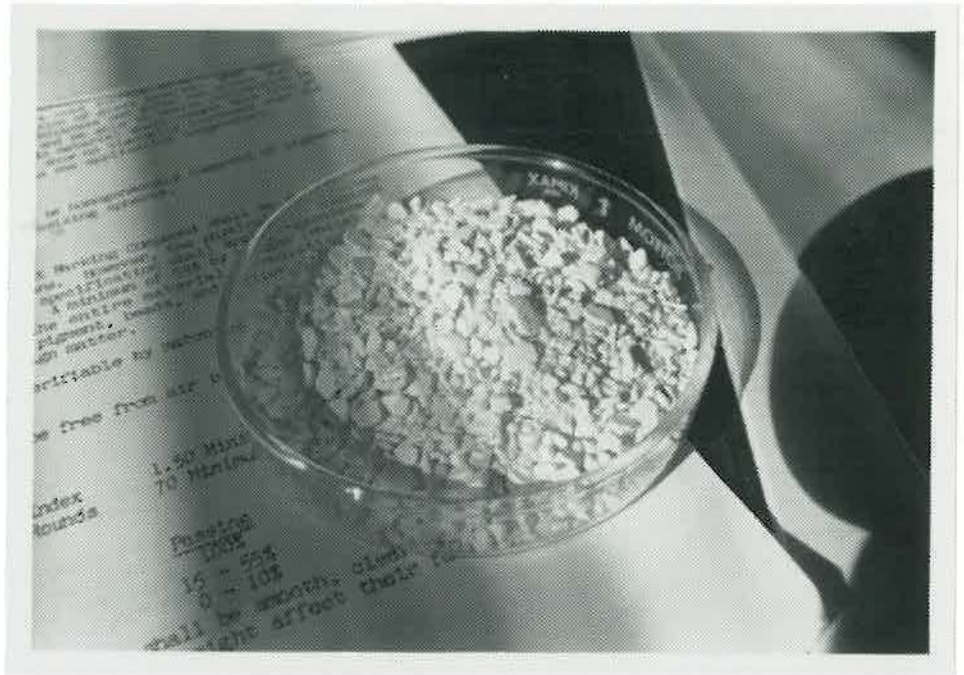
One of the bags that had been left open absorbed moisture from the air or possibly from a light rain. These flakes had begun to swell and look wet and partially dissolved as shown in the petri dish sample in Photos E and F. When handled (something that is not recommended), the flakes left the hands feeling slippery and caused a burning sensation after several minutes. The material was difficult to wash off and felt like fresh chicken fat on the skin.

(E) Fresh sample of Verglimit flakes

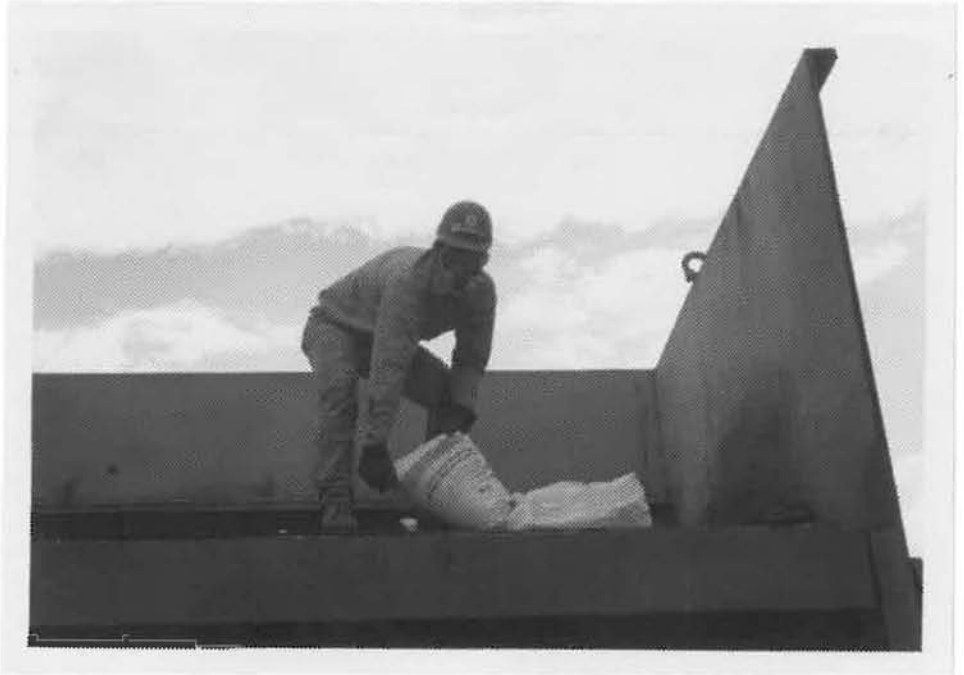
Using protective clothing, goggles, gloves, and a respirator, workers emptied the bags through a half-inch screen onto the batch plant conveyor (Photos G and H). The screening was recommended by

(G) Loading Verglimit into the hopper. Note the use of protective clothing, goggles, and gloves.

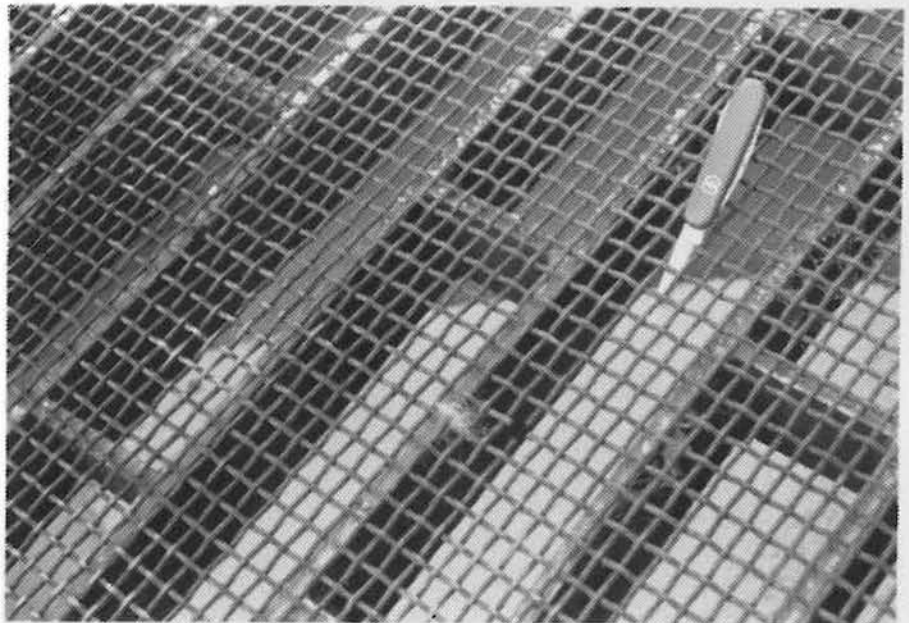
(H) Screen over the loaded hopper

the vendor, who was present during the batching operation, but this was probably only a precaution since no material was retained on the screen. Although the material looked clean, it did release some dust when the bags were emptied.

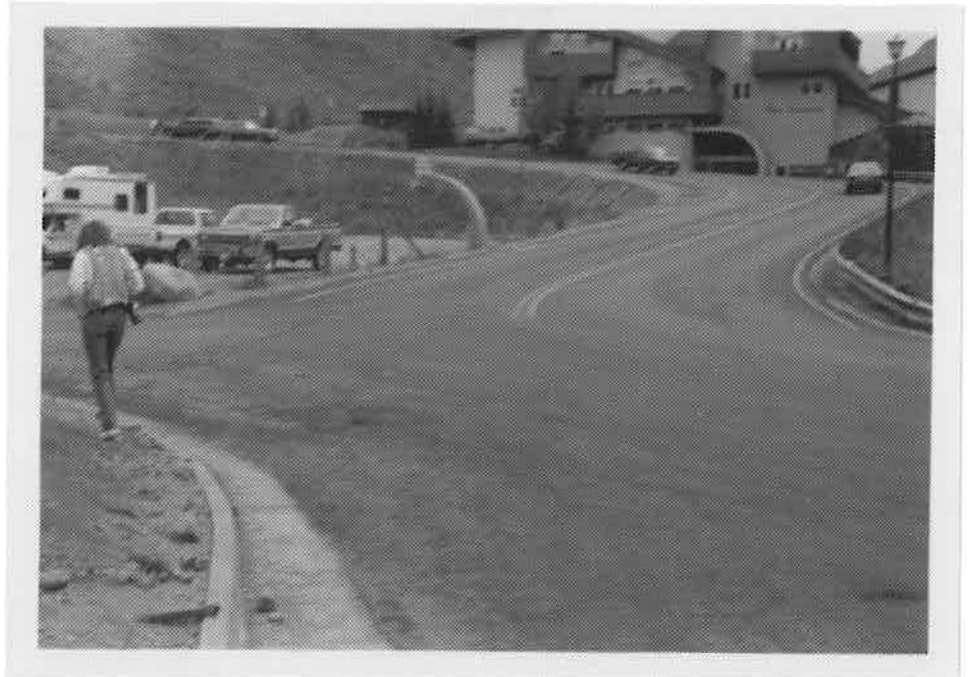
(O) Blue Cow Shute

The work was contracted to B&B Excavating. They batched from a nearby plant in Edwards, Colorado. The placement temperature was estimated to be 280°F on the average with a truck at the lower end of the Blue Cow Chute being placed at 250°F. This load was reported to be noticeably more difficult to compact. A single truck was also reported as having been rejected because it was too cold to be placed.

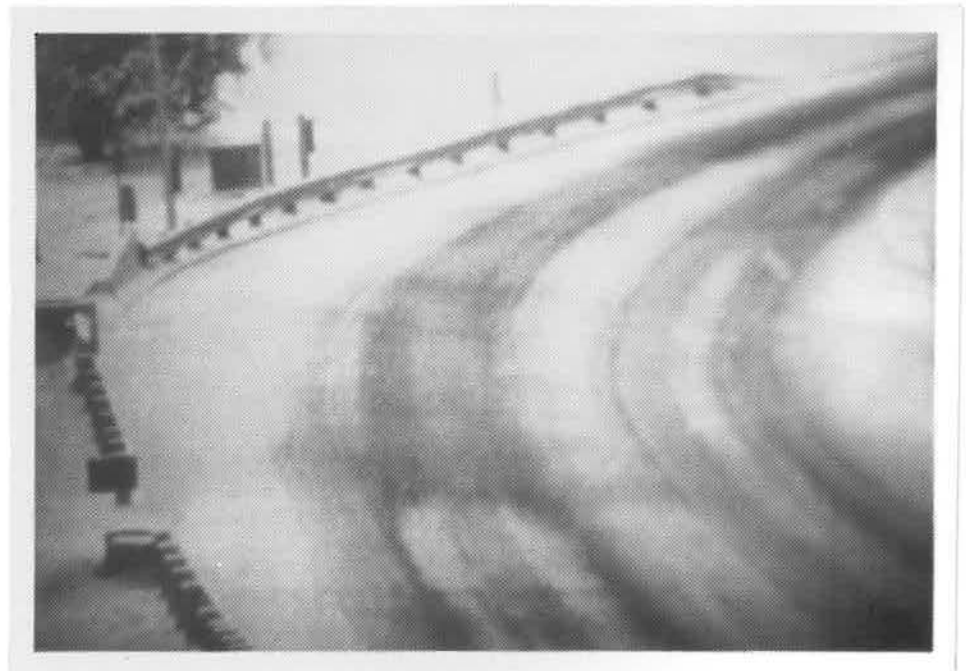
(T) Time-lapse frame showing salting  
by city maintenance

All of the usable cine film was condensed into a 30 minute video tape. The tape shows that the city frequently sanded and salted the site during snow and ice conditions (see Photo T). Exposures that showed the Verglimit was actually working to melt snow or ice before the adjacent untreated sections were rare. Of 55 potential occurrences where preferential test section melting could have been shown, only four showed definite signs of preferential melting. Most of these only lasted for two or three exposures (less than 30 minutes). Two photographs of "working" pavement are shown in Photos U and V.

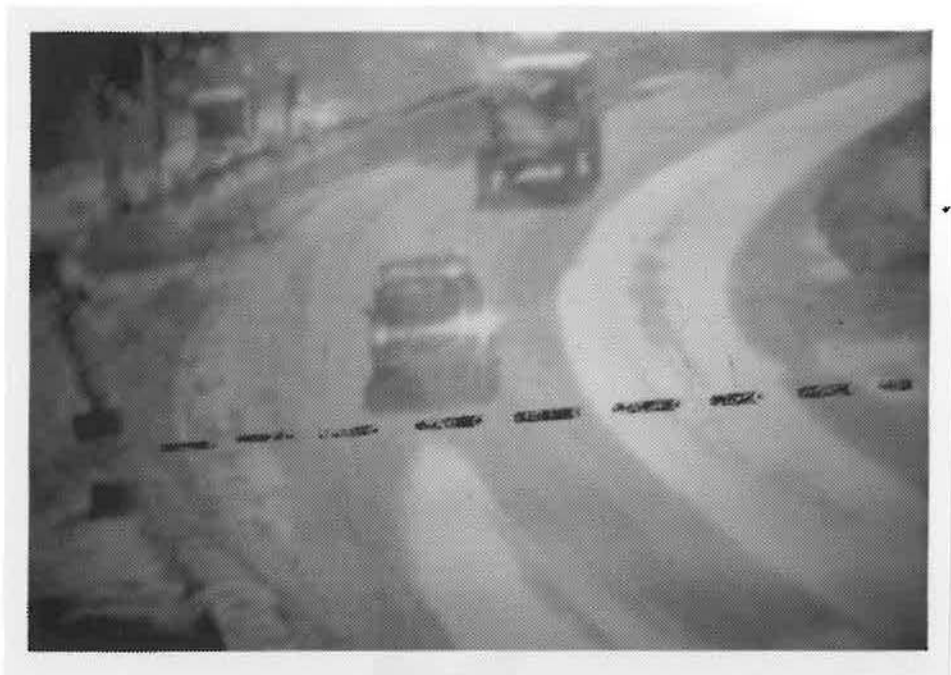
(U) Time-lapse frame showing early melting  
Approximate boundary is marked
