**US 6/Wadsworth**

**Environmental  
Assessment**

# Existing Conditions Report of Engineering Design Elements

CDOT Project STU #0062-019 (15215)  
CH2M HILL Project No. 358660

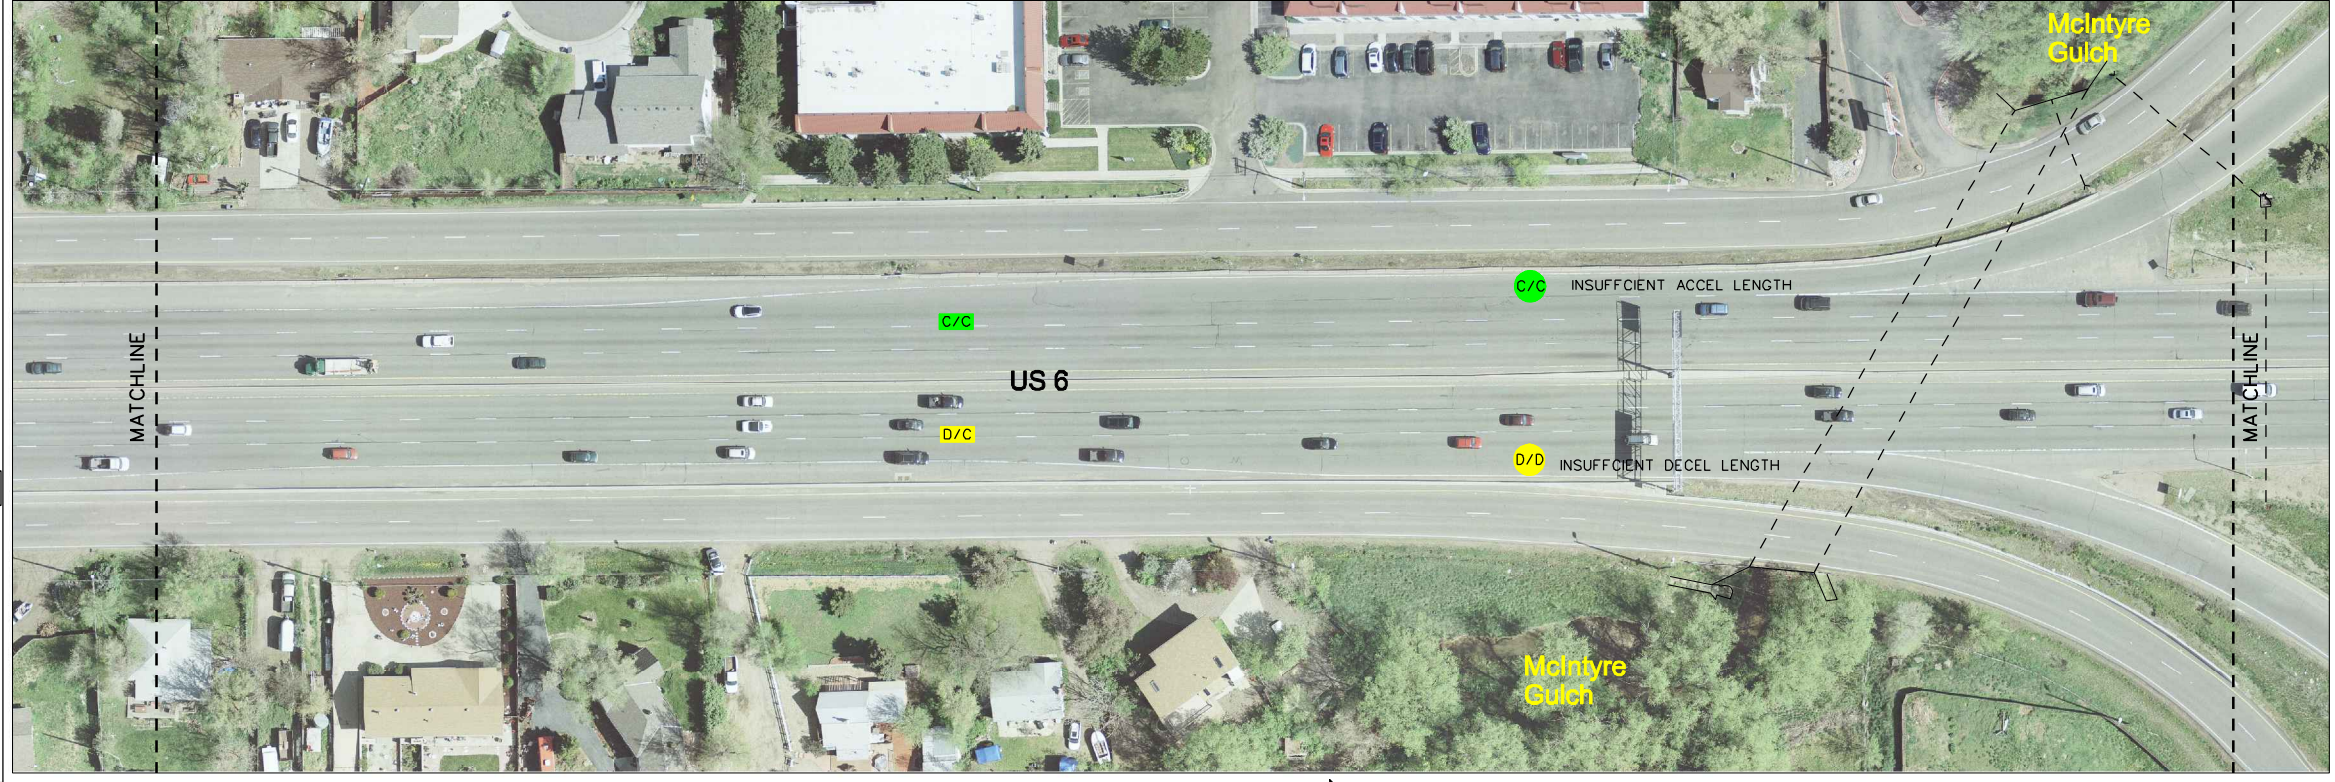
- **McIntyre Gulch (Structure F-16-L)** - Existing concrete box culvert (CBC) (3 - 10 feet by 10 feet) that is rated as "fair." The CDOT Structure Inspection and Inventory Report shows the condition rating of this structure as a 5, on a scale of 1 to 10. A rating of 5 is defined as "Fair Condition - all primary structural elements are sound but may have minor section loss, cracking, spalling, or scour." According to the same report, this structure has a sufficiency rating of 63.8.

GEOMETRIC FEATURES	HORIZONTAL ALIGNMENT	
	HORIZONTAL SIGHT STOPPING DISTANCE	
	VERTICAL ALIGNMENT	
	VERTICAL ALIGNMENT CRITICAL LENGTHS	
	VERTICAL SIGHT STOPPING DISTANCE	
	ACCESS CONTROL/MEDIAN TREATMENT	K <sub>50g</sub> = 100/181 (EXISTING/STANDARD)
	CROSS-SECTIONAL ELEMENTS	
	SPACING OF INTERSECTING STREETS	
	EXIT AND ENTRANCE DESIGN	
RAMP DESIGN		
OPERATIONAL FEATURES	WEAVE DISTANCE	
PERFORMANCE MEASURES	LEVEL OF SERVICE (AM/PM)	
	ACCIDENT RATES	42
PEDESTRIAN	CONNECTIVITY	
STRUCTURAL	CLASSIFICATION	FAIR CONDITION MILD EFFLORESCENCE
DRAINAGE	MAJOR	(3)-11.2'x10' CBC MCINTYRE GULCH CONVEYANCE

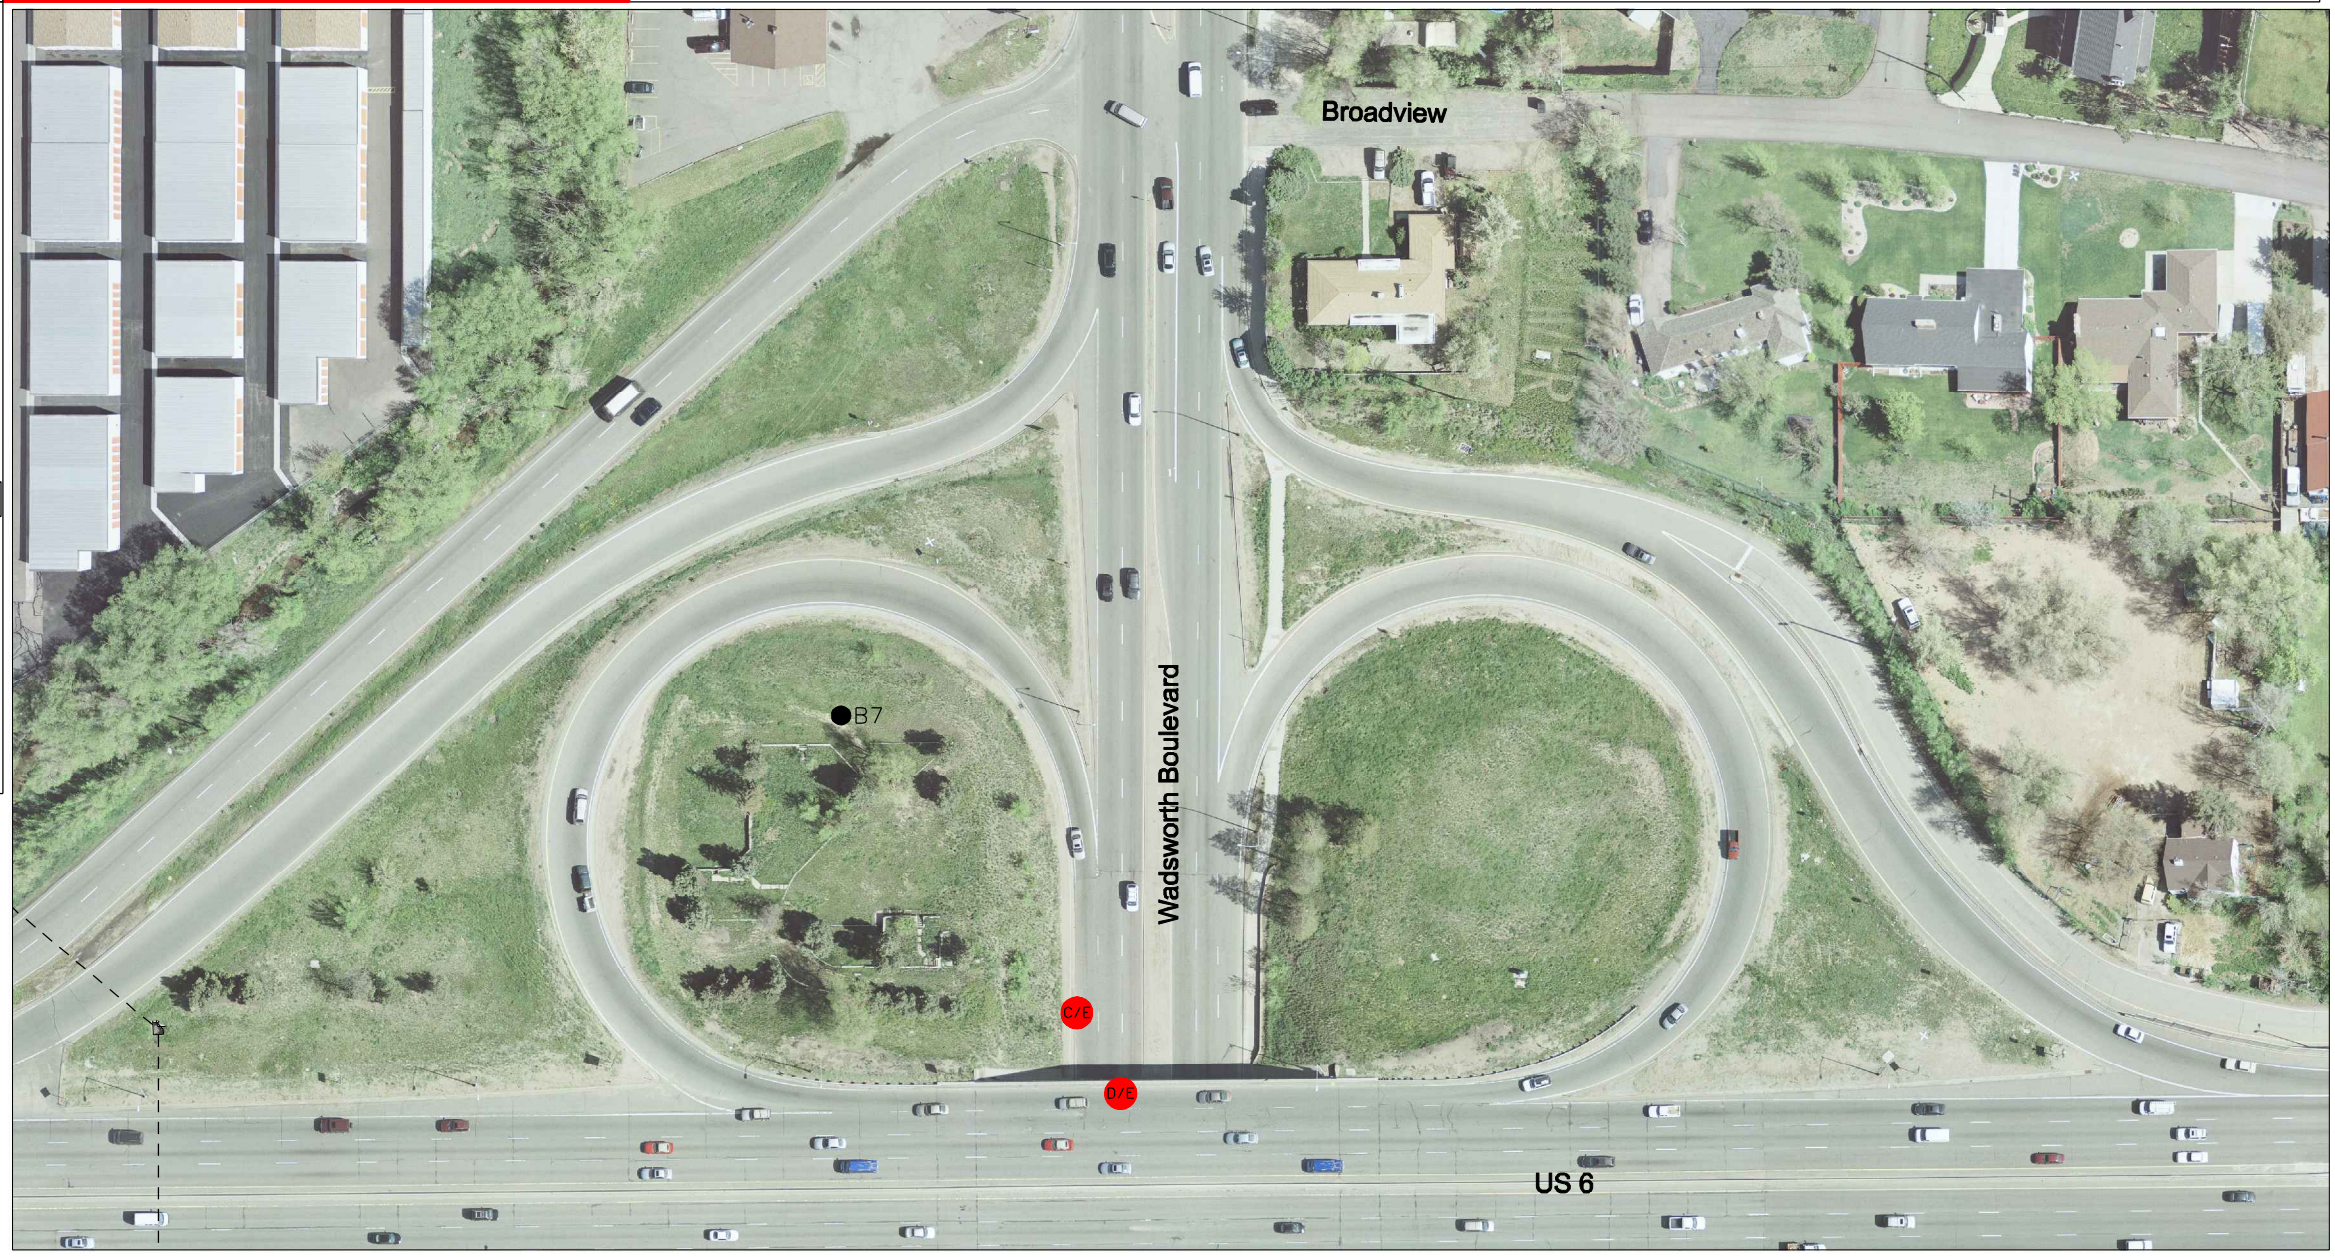
- **US 6 Bridge over Wadsworth Boulevard (Structure F-16-O)** - Existing four-span concrete girder structure. The structure is rated as "structurally deficient" based on the deck condition rating of 4, and superstructure and substructure condition ratings of 5. FHWA defines a condition rating of 4 as "Poor Condition - advanced section loss, deterioration, spalling, or scour." A condition rating of 5 is defined as "Fair Condition - all primary structural elements are sound but may have minor section loss, cracking, spalling, or scour."

GEOMETRIC FEATURES	HORIZONTAL ALIGNMENT	
	HORIZONTAL SIGHT STOPPING DISTANCE	
	VERTICAL ALIGNMENT	
	VERTICAL ALIGNMENT CRITICAL LENGTHS	
	VERTICAL SIGHT STOPPING DISTANCE	
	ACCESS CONTROL/MEDIAN TREATMENT	K <sub>crest</sub> = 170/247 (EXISTING/STANDARD)
	CROSS-SECTIONAL ELEMENTS	
	SPACING OF INTERSECTING STREETS	
OPERATIONAL FEATURES	EXIT AND ENTRANCE DESIGN	
	RAMP DESIGN	
PERFORMANCE MEASURES	WEAVE DISTANCE	
	LEVEL OF SERVICE (AM/PM)	
PEDESTRIAN	ACCIDENT RATES	42
	CONNECTIVITY	
STRUCTURAL	CLASSIFICATION	F-16-0, STRUCTURALLY DEFICIENT
DRAINAGE	MAJOR	MCINTYRE GULCH CONVEYANCE

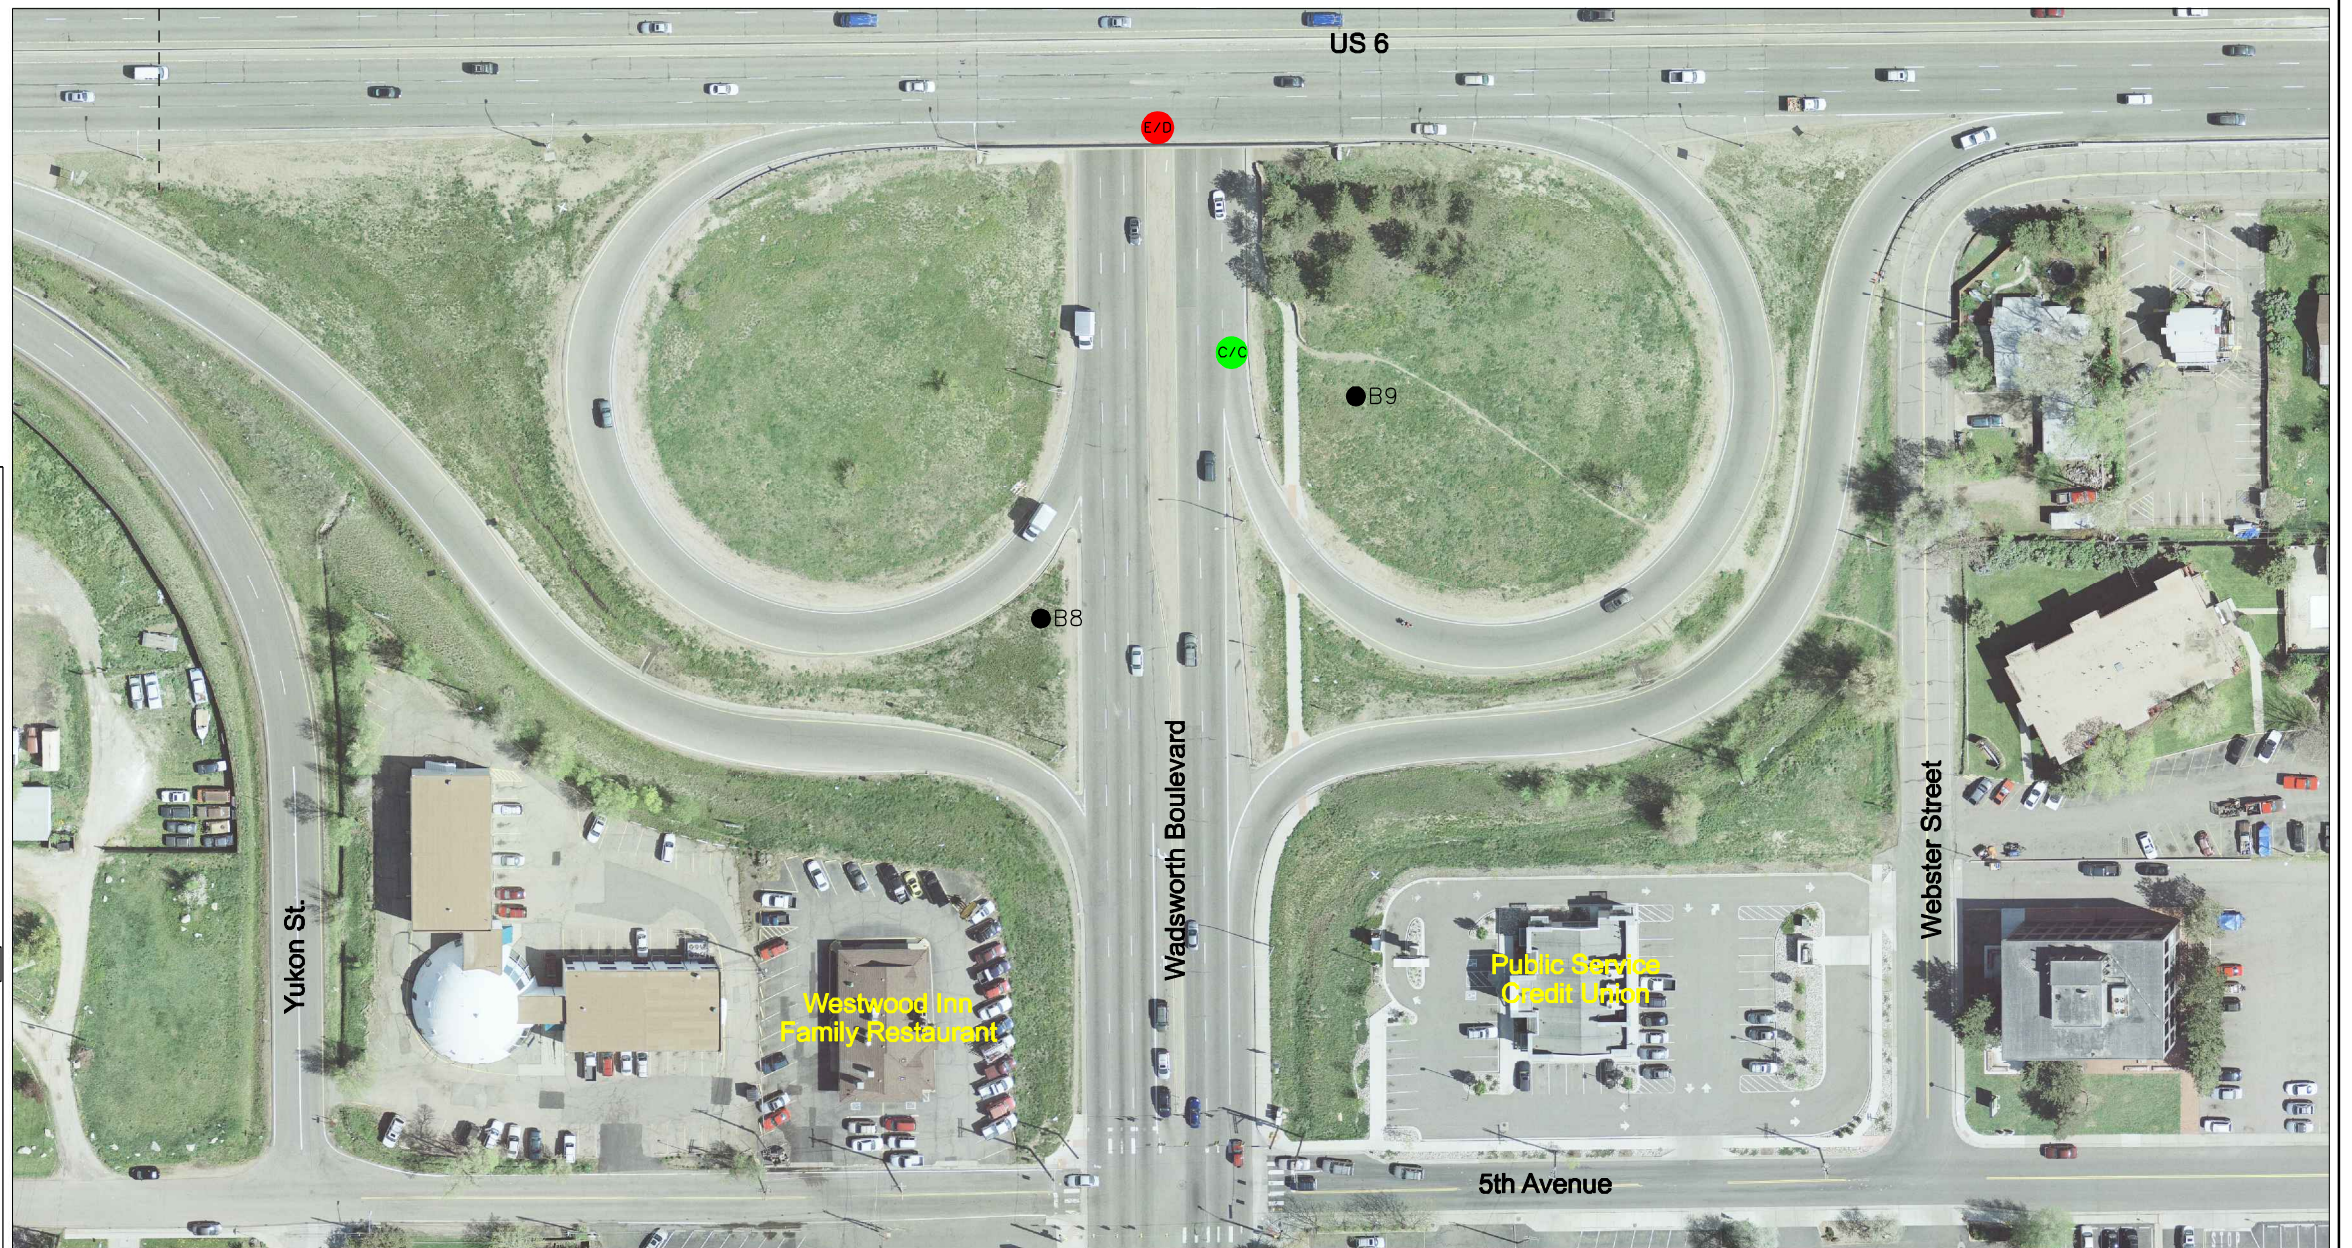
<b>GEOMETRIC FEATURES</b>	HORIZONTAL ALIGNMENT	Green
	HORIZONTAL SIGHT STOPPING DISTANCE	Green
	VERTICAL ALIGNMENT	Green
	VERTICAL ALIGNMENT CRITICAL LENGTHS	Red
	VERTICAL SIGHT STOPPING DISTANCE	Green
	ACCESS CONTROL/MEDIAN TREATMENT	Green
	CROSS-SECTIONAL ELEMENTS	Yellow
	SPACING OF INTERSECTING STREETS	Red
	EXIT AND ENTRANCE DESIGN	Red
	RAMP DESIGN	Yellow
<b>OPERATIONAL FEATURES</b>	WEAVE DISTANCE	Red
<b>PERFORMANCE MEASURES</b>	LEVEL OF SERVICE (AM/PM)	Yellow
	ACCIDENT RATES	Yellow
<b>PEDESTRIAN</b>	CONNECTIVITY	White
<b>STRUCTURAL</b>	CLASSIFICATION	F-16-0 STRUCTURALLY DEFICIENT
<b>DRAINAGE</b>	MAJOR	White

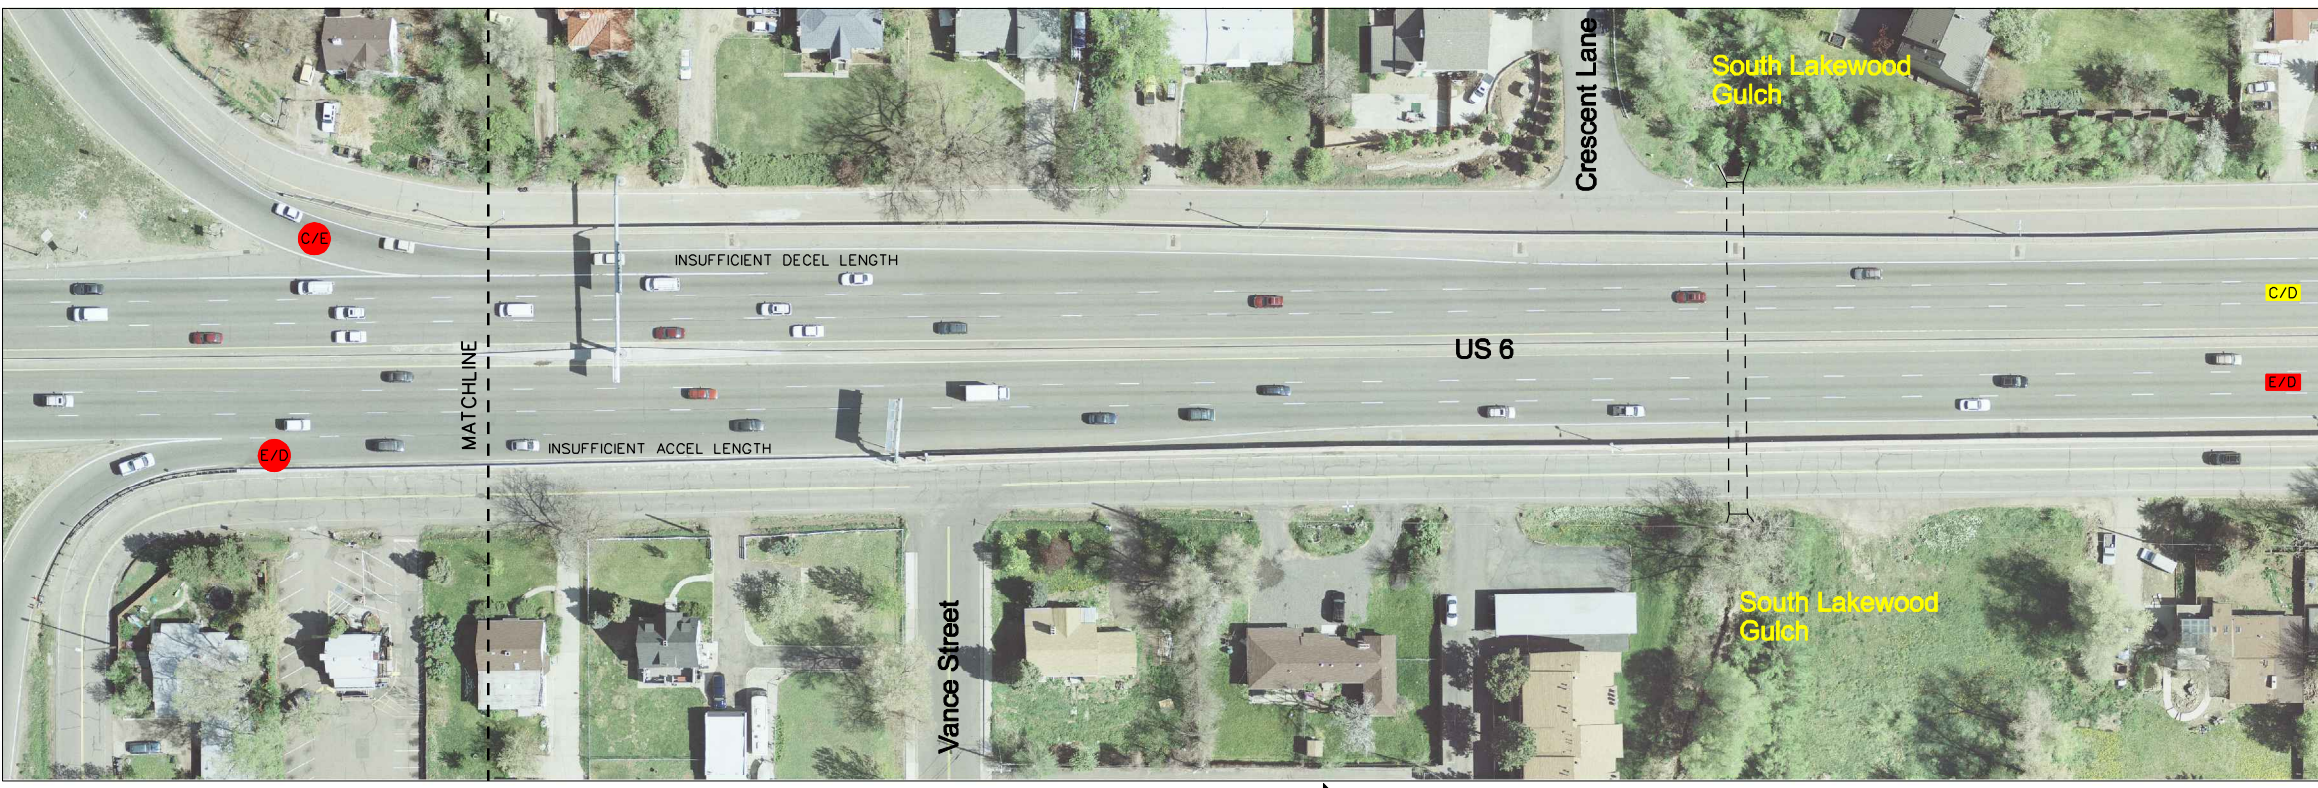
GEOMETRIC FEATURES	HORIZONTAL ALIGNMENT	
	HORIZONTAL SIGHT STOPPING DISTANCE	
	VERTICAL ALIGNMENT	
	VERTICAL ALIGNMENT CRITICAL LENGTHS	
	VERTICAL SIGHT STOPPING DISTANCE	
	ACCESS CONTROL/MEDIAN TREATMENT	
	CROSS-SECTIONAL ELEMENTS	
	SPACING OF INTERSECTING STREETS	
EXIT AND ENTRANCE DESIGN		
RAMP DESIGN		
OPERATIONAL FEATURES	WEAVE DISTANCE	
PERFORMANCE MEASURES	LEVEL OF SERVICE (AM/PM)	
	ACCIDENT RATES	42
PEDESTRIAN	CONNECTIVITY	
STRUCTURAL	CLASSIFICATION	
DRAINAGE	MAJOR	8'x8' CBC, EXCEEDS HEADWATER CRITERIA

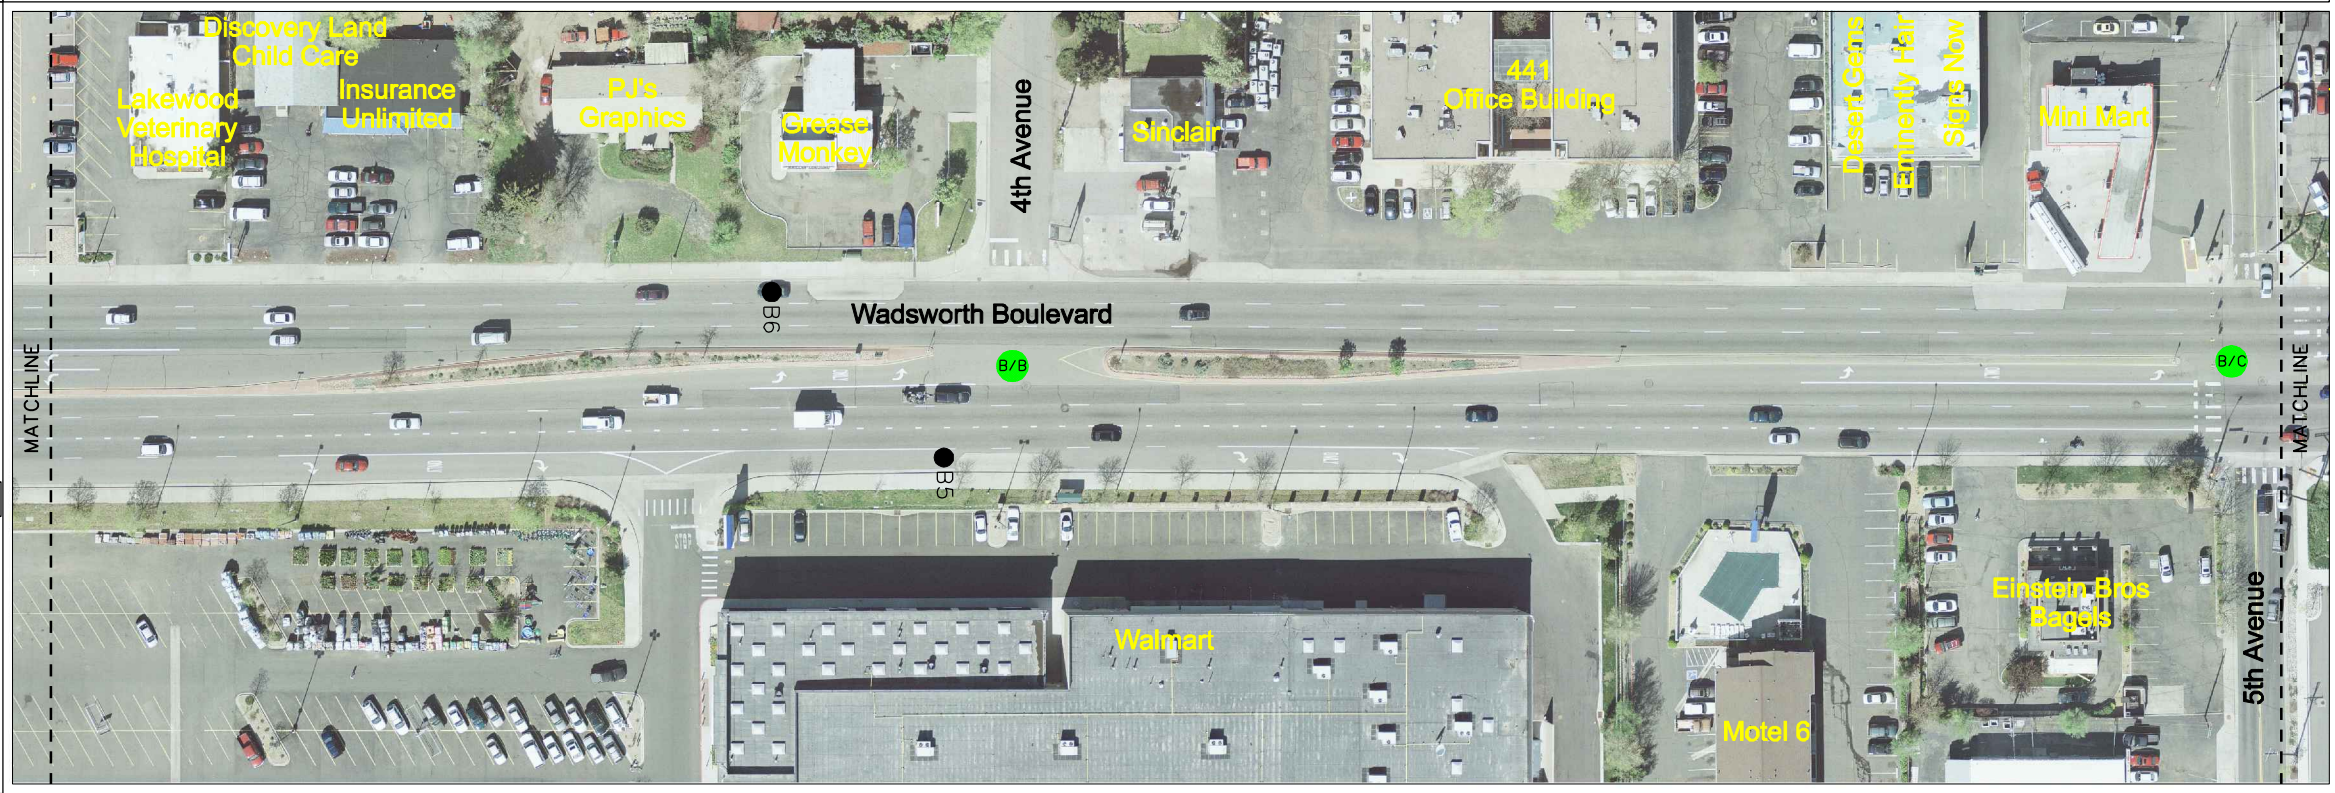
GEOMETRIC FEATURES	HORIZONTAL ALIGNMENT	
	HORIZONTAL SIGHT STOPPING DISTANCE	
	VERTICAL ALIGNMENT	
	VERTICAL ALIGNMENT CRITICAL LENGTHS	
	VERTICAL SIGHT STOPPING DISTANCE	
	ACCESS CONTROL/MEDIAN TREATMENT	
	CROSS-SECTIONAL ELEMENTS	
	SPACING OF INTERSECTING STREETS	SIGNALIZED < 1/2 MILE (1250')
	EXIT AND ENTRANCE DESIGN	
	RAMP DESIGN	
OPERATIONAL FEATURES	WEAVE DISTANCE	
PERFORMANCE MEASURES	LEVEL OF SERVICE (AM/PM)	NB-A/A NB-A/B WB-D/E
	ACCIDENT RATES	5.70
PEDESTRIAN	CONNECTIVITY	NARROW ATTACHED S/W
STRUCTURAL	CLASSIFICATION	
DRAINAGE	MAJOR

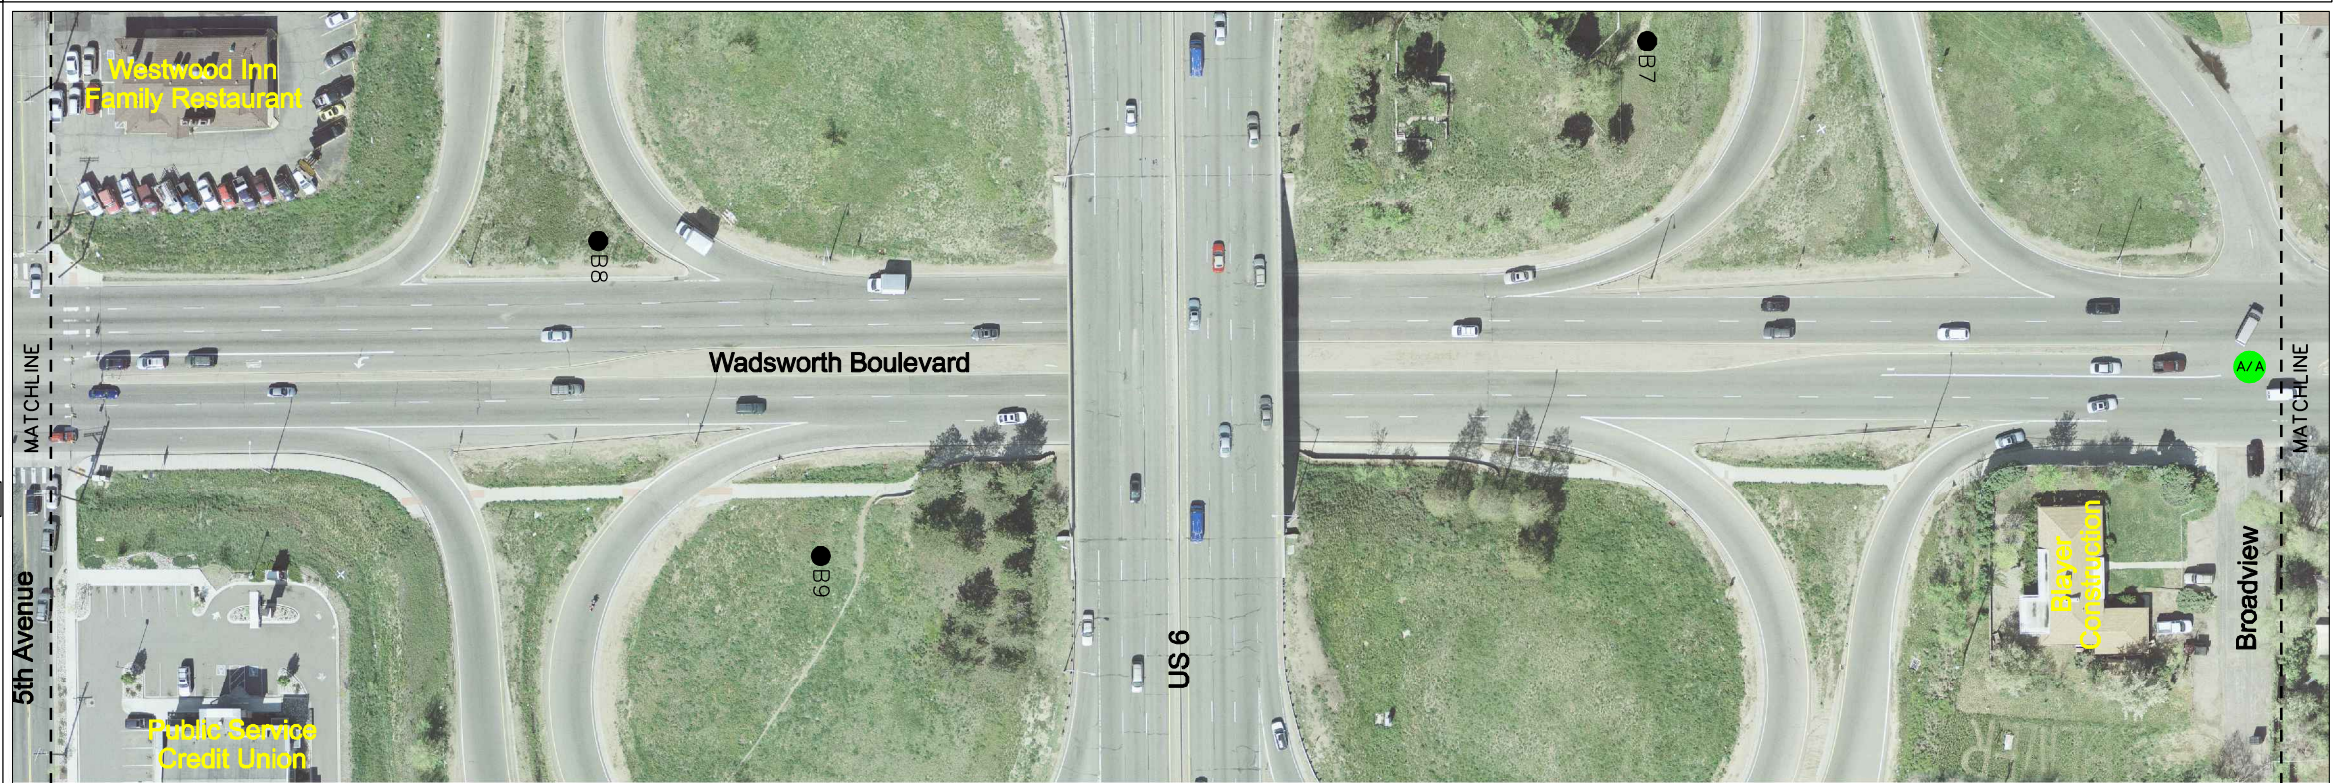
GEOMETRIC FEATURES	HORIZONTAL ALIGNMENT	
	HORIZONTAL SIGHT STOPPING DISTANCE	
	VERTICAL ALIGNMENT	GRADE < 0.5%
	VERTICAL ALIGNMENT CRITICAL LENGTHS	
	VERTICAL SIGHT STOPPING DISTANCE	K <sub>sag</sub> = 71/79 (EXISTING/STANDARD)
	ACCESS CONTROL/MEDIAN TREATMENT	
	CROSS-SECTIONAL ELEMENTS	
	SPACING OF INTERSECTING STREETS	150' 100'
EXIT AND ENTRANCE DESIGN		
RAMP DESIGN		
OPERATIONAL FEATURES	WEAVE DISTANCE	
PERFORMANCE MEASURES	LEVEL OF SERVICE (AM/PM)	NB-A/A WB-A/A
	ACCIDENT RATES	10.91
PEDESTRIAN	CONNECTIVITY	CROSSINGS OF HIGH VOLUME, FREE FLOW RAMPS NARROW S/W UNDER BRIDGE
STRUCTURAL	CLASSIFICATION	RETAINING WALL
DRAINAGE	MAJOR

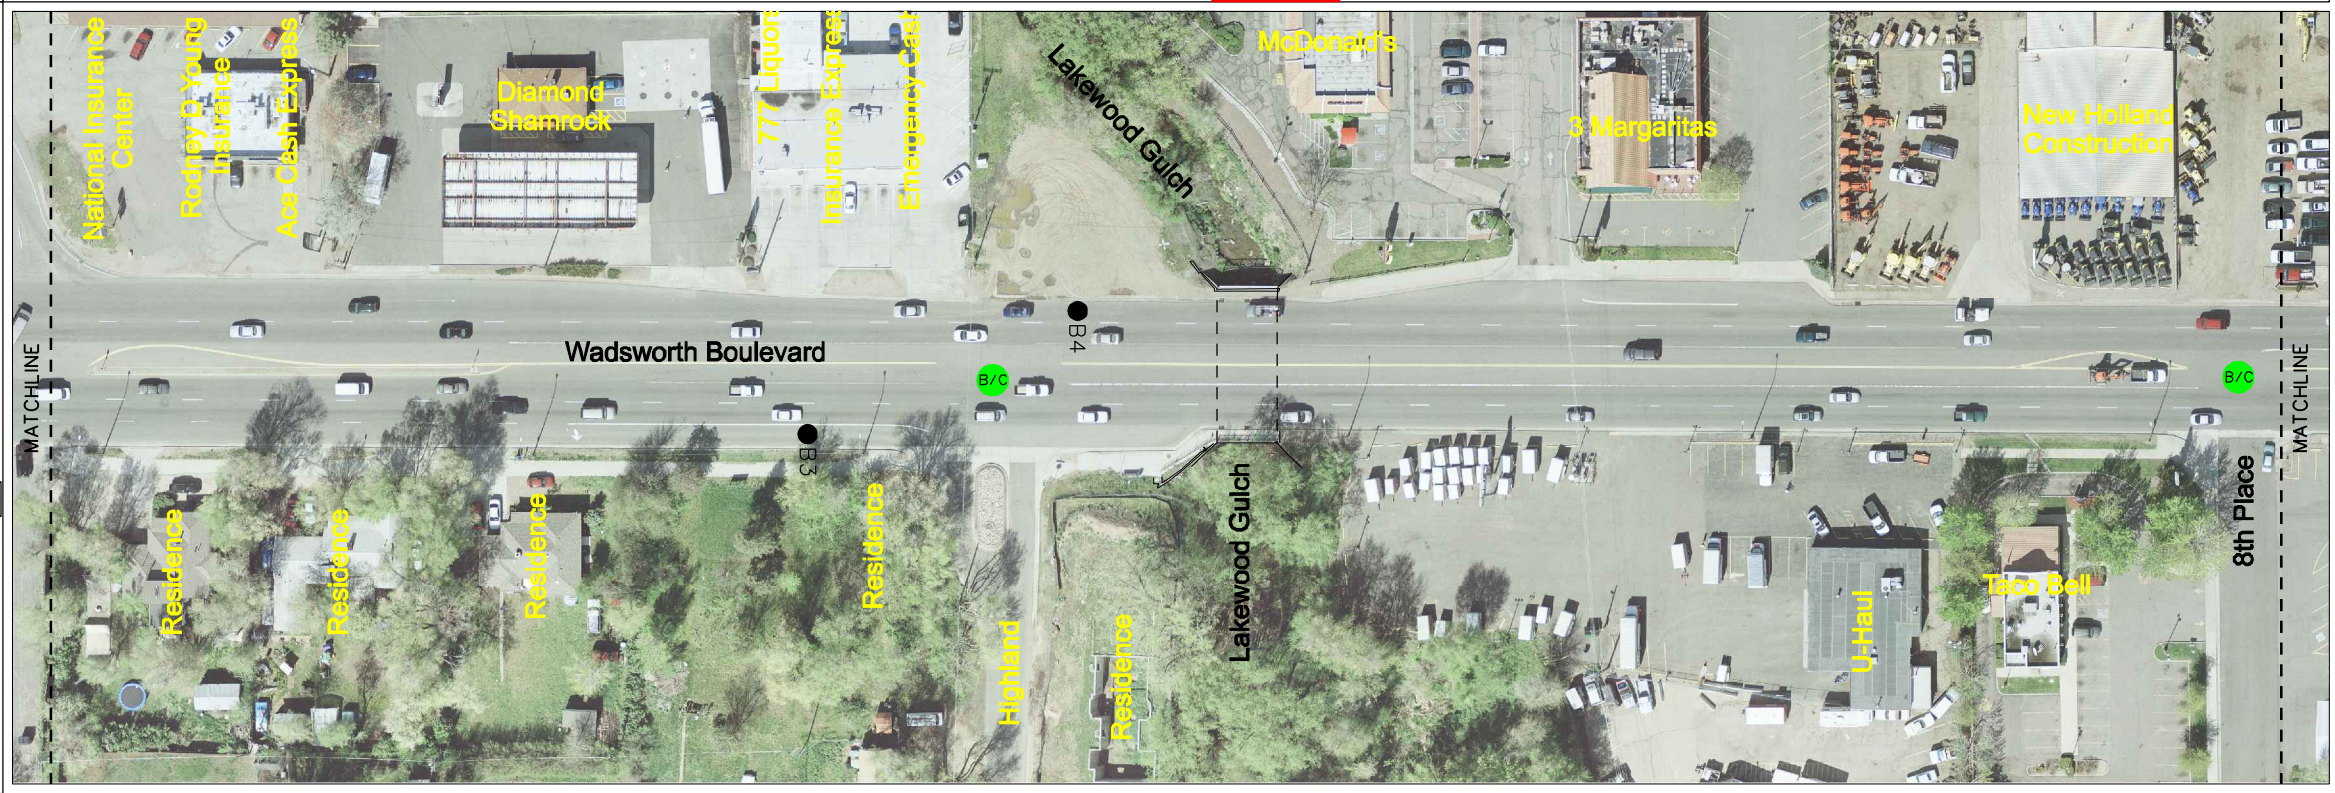
- **Lakewood Gulch (Structure F-16-AK)** - Existing box bridge structure (3 - 32 feet by 8 feet). Rated in "fair condition."

GEOMETRIC FEATURES	HORIZONTAL ALIGNMENT	[Green]	
	HORIZONTAL SIGHT STOPPING DISTANCE	[Green]	
	VERTICAL ALIGNMENT	[Yellow]	[Red]
	VERTICAL ALIGNMENT CRITICAL LENGTHS	[Green]	[Red]
	VERTICAL SIGHT STOPPING DISTANCE	[Green]	[Red]
	ACCESS CONTROL/MEDIAN TREATMENT	[Green]	[Yellow] Ksag= 36/79 (EXISTING/STANDARD) [Red] Kcrest= 56/61 (EXISTING/STANDARD)
	CROSS-SECTIONAL ELEMENTS	[Red]	[Red]
	SPACING OF INTERSECTING STREETS	[Yellow] 500'	[Green]
EXIT AND ENTRANCE DESIGN	[Green]		
RAMP DESIGN	[Green]		
OPERATIONAL FEATURES	WEAVE DISTANCE	[Green]	
PERFORMANCE MEASURES	LEVEL OF SERVICE (AM/PM)	[Green] NB-A/A	[Red] WB-F/F [Green] NB-A/A [Red] WB-F/F
	ACCIDENT RATES	[Red] 4.81	
PEDESTRIAN	CONNECTIVITY	[Green] NARROW	[Red] MISSING S/W LUMINAIRE POLES IN PED TRAVEL WAY
STRUCTURAL	CLASSIFICATION	[Green] FAIR CONDITION MILD EFFLORESCENCE	
DRAINAGE	MAJOR	2 SPAN 32'X8', NB & SB ROADWAY OVERTOPS FOR 100YR

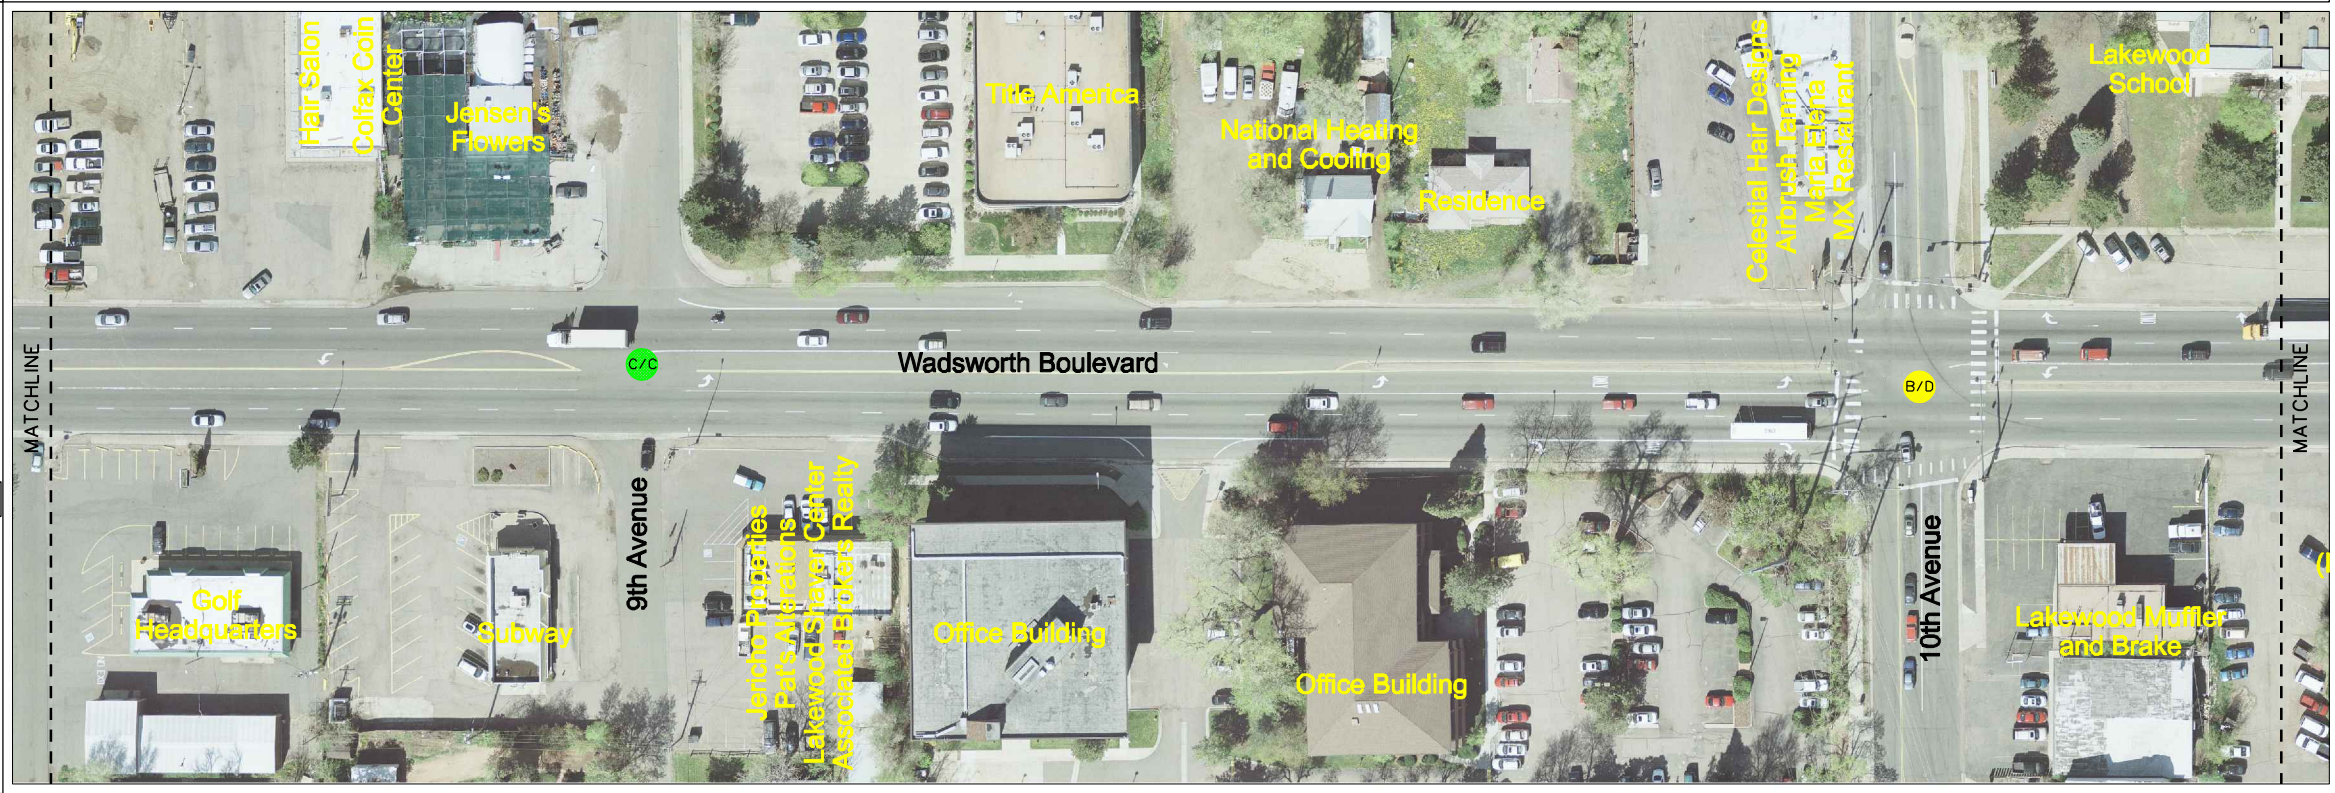
GEOMETRIC FEATURES	HORIZONTAL ALIGNMENT	[Green]
	HORIZONTAL SIGHT STOPPING DISTANCE	[Green]
	VERTICAL ALIGNMENT	GRADE < 0.5% [Yellow]
	VERTICAL ALIGNMENT CRITICAL LENGTHS	[Green]
	VERTICAL SIGHT STOPPING DISTANCE	[Yellow] Ksag- 51/79 (EXISTING/STANDARD) [Green] Ksag- 47/61 (EXISTING/STANDARD) [Red]
	ACCESS CONTROL/MEDIAN TREATMENT	[Red]
	CROSS-SECTIONAL ELEMENTS	[Red] 325'
	SPACING OF INTERSECTING STREETS	[Green]
EXIT AND ENTRANCE DESIGN	[Green]	
RAMP DESIGN	[Green]	
OPERATIONAL FEATURES	WEAVE DISTANCE	[Green]
PERFORMANCE MEASURES	LEVEL OF SERVICE (AM/PM)	NB-A/A [Green] WB-F/F [Red] NB-B/B [Green] WB-E/F [Red]
	ACCIDENT RATES	4.81 [Red]
PEDESTRIAN	CONNECTIVITY	NARROW, MISSING CURB RAMP [Red] MISSING S/W [Red] NARROW, ATTACHED S/W DRIVEWAY ISLAND OBSTRUCTS PED/BIKES [Yellow]
STRUCTURAL	CLASSIFICATION	[Green]
DRAINAGE	MAJOR	[Green]

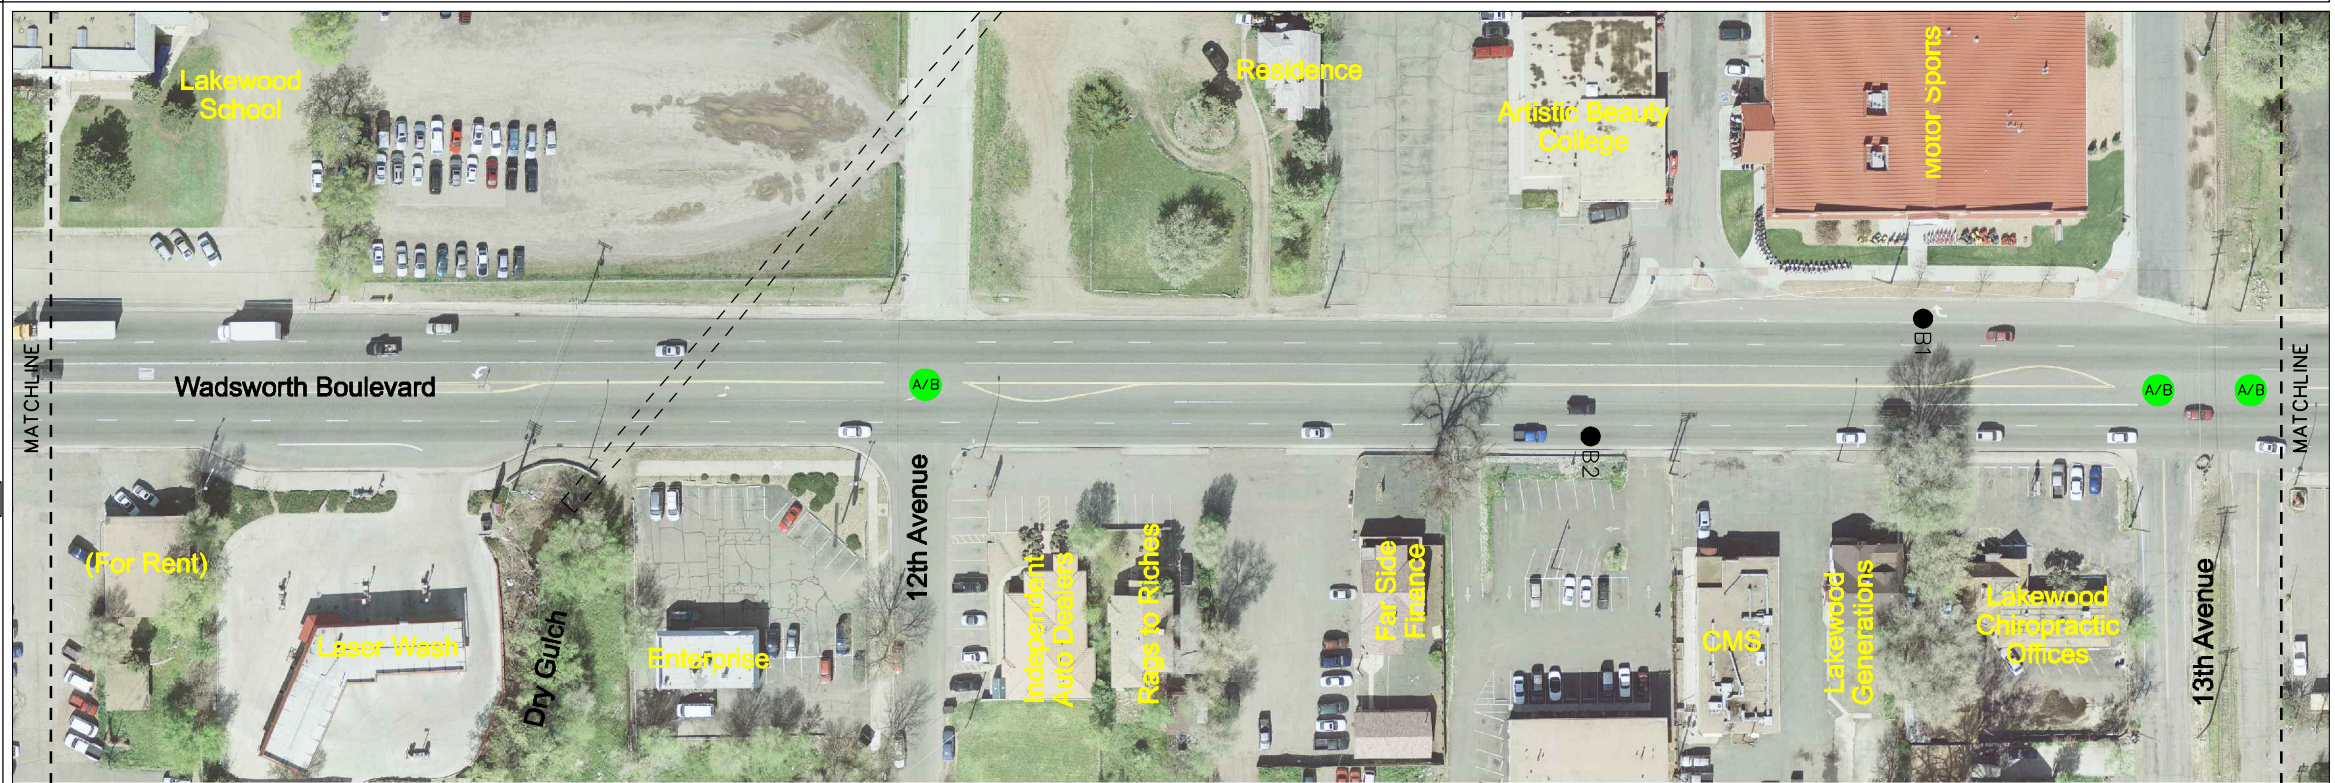
GEOMETRIC FEATURES	HORIZONTAL ALIGNMENT	[Green]		
	HORIZONTAL SIGHT STOPPING DISTANCE	[Green]		
	VERTICAL ALIGNMENT	[Green]		
	VERTICAL ALIGNMENT CRITICAL LENGTHS	[Green]		
	VERTICAL SIGHT STOPPING DISTANCE	[Green]		
	ACCESS CONTROL/MEDIAN TREATMENT	[Yellow]		
	CROSS-SECTIONAL ELEMENTS	[Red]		
	SPACING OF INTERSECTING STREETS	[Yellow]		
EXIT AND ENTRANCE DESIGN	[Yellow]			
RAMP DESIGN	[Yellow]			
OPERATIONAL FEATURES		WEAVE DISTANCE		
PERFORMANCE MEASURES	LEVEL OF SERVICE (AM/PM)	[Green] NB-A/A	[Red] WB-F/F	[Green] NB-A/A [Red] WB-D/E [Red] WB-E/F
	ACCIDENT RATES	6.40		
PEDESTRIAN	CONNECTIVITY	[Red] MISSING S/W	[Green] MISSING S/W	[Red] MISSING AND/OR VERY NARROW ATTACHED S/W [Yellow] NARROW ATTACHED S/W
STRUCTURAL	CLASSIFICATION	[Red] 90"x58" ELLIPTICAL NB & SB ROAD OVERTOPS FOR 100YR

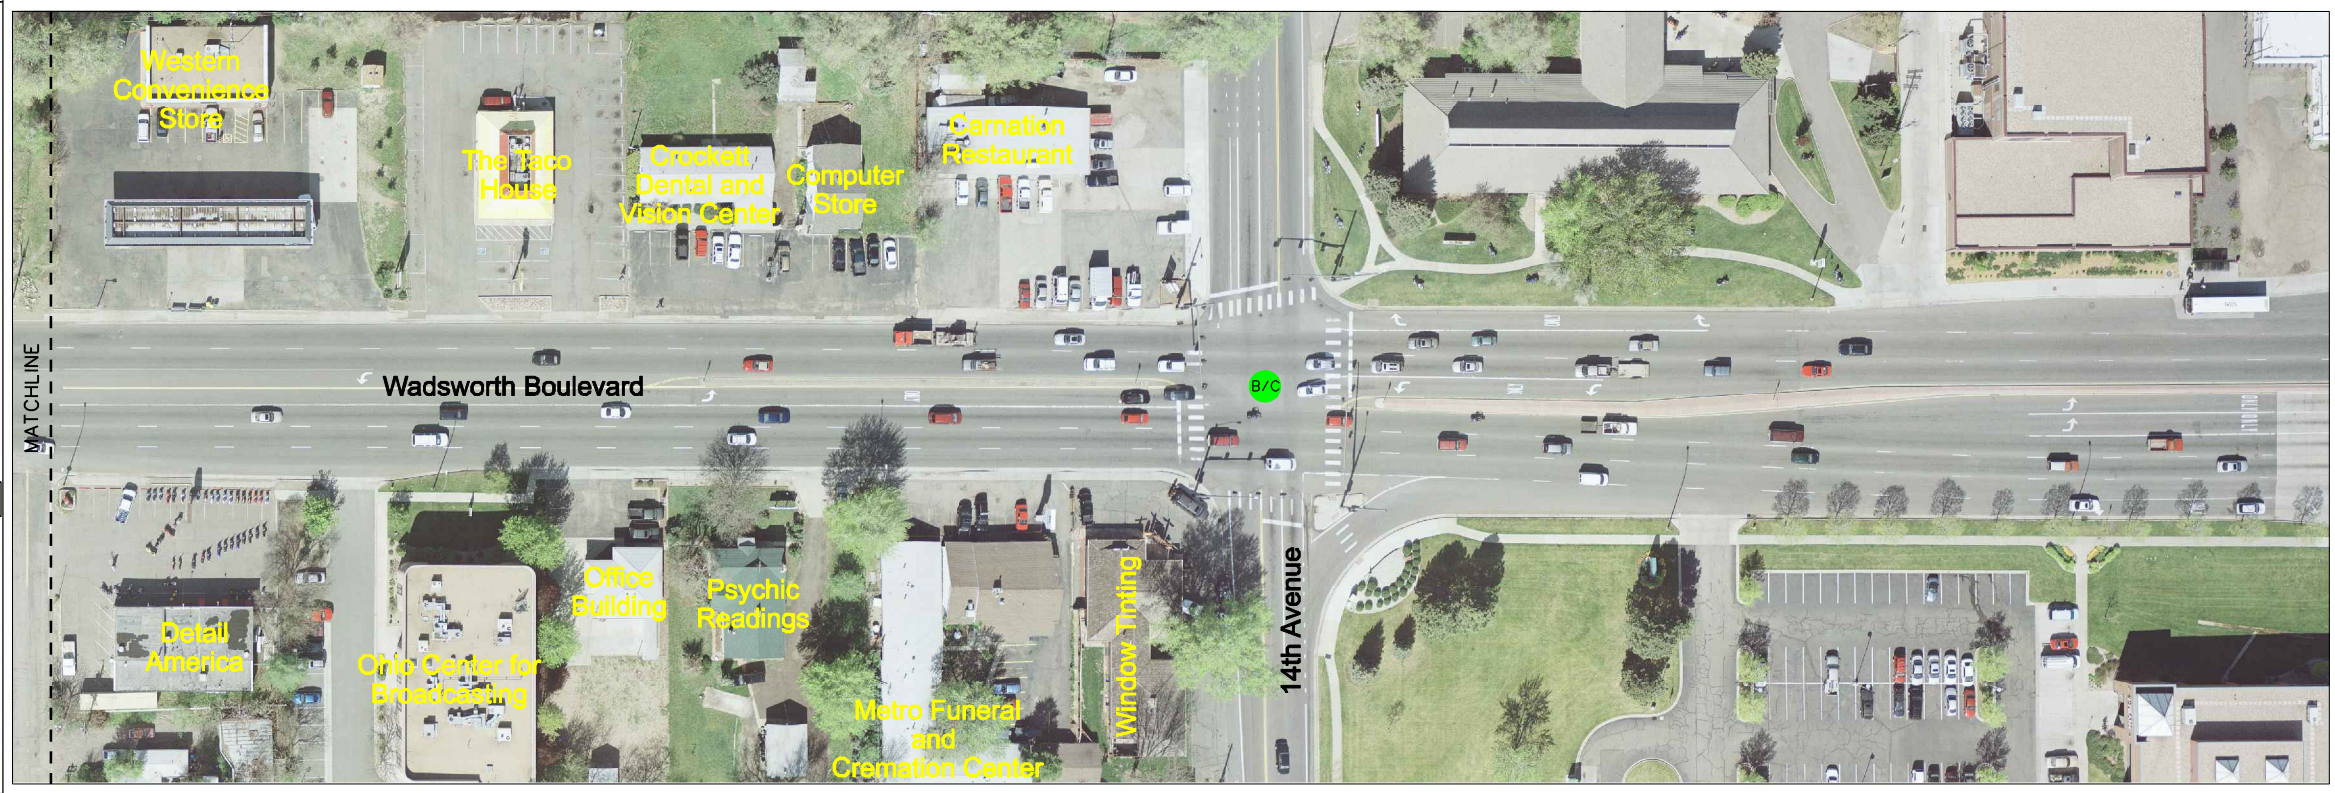
GEOMETRIC FEATURES	HORIZONTAL ALIGNMENT	[Green Bar]
	HORIZONTAL SIGHT STOPPING DISTANCE	[Green Bar]
	VERTICAL ALIGNMENT	[Red Bar] GRADE < 0.25%
	VERTICAL ALIGNMENT CRITICAL LENGTHS	[Green Bar]
	VERTICAL SIGHT STOPPING DISTANCE	[Green Bar]
	ACCESS CONTROL/MEDIAN TREATMENT	[Red Bar]
	CROSS-SECTIONAL ELEMENTS	[Red Bar]
	SPACING OF INTERSECTING STREETS	[Yellow Bar] SIGNALIZED < 1/2 MILE (2000')
	EXIT AND ENTRANCE DESIGN	[Green Bar]
RAMP DESIGN	[Green Bar]	
OPERATIONAL FEATURES	WEAVE DISTANCE	[Green Bar]
PERFORMANCE MEASURES	LEVEL OF SERVICE (AM/PM)	[Green Bar] NB-B/B [Yellow Bar] WB-C/D
	ACCIDENT RATES	[Red Bar] 6.40
PEDESTRIAN	CONNECTIVITY	[Red Bar] MISSING S/W [Green Bar] [Yellow Bar] NARROW ATTACHED S/W
STRUCTURAL	CLASSIFICATION	[Green Bar]
DRAINAGE	MAJOR	[Green Bar]
