**US 6/Wadsworth**

**Environmental  
Assessment**

# Existing Conditions Report of Engineering Design Elements

CDOT Project STU #0062-019 (15215)  
CH2M HILL Project No. 358660

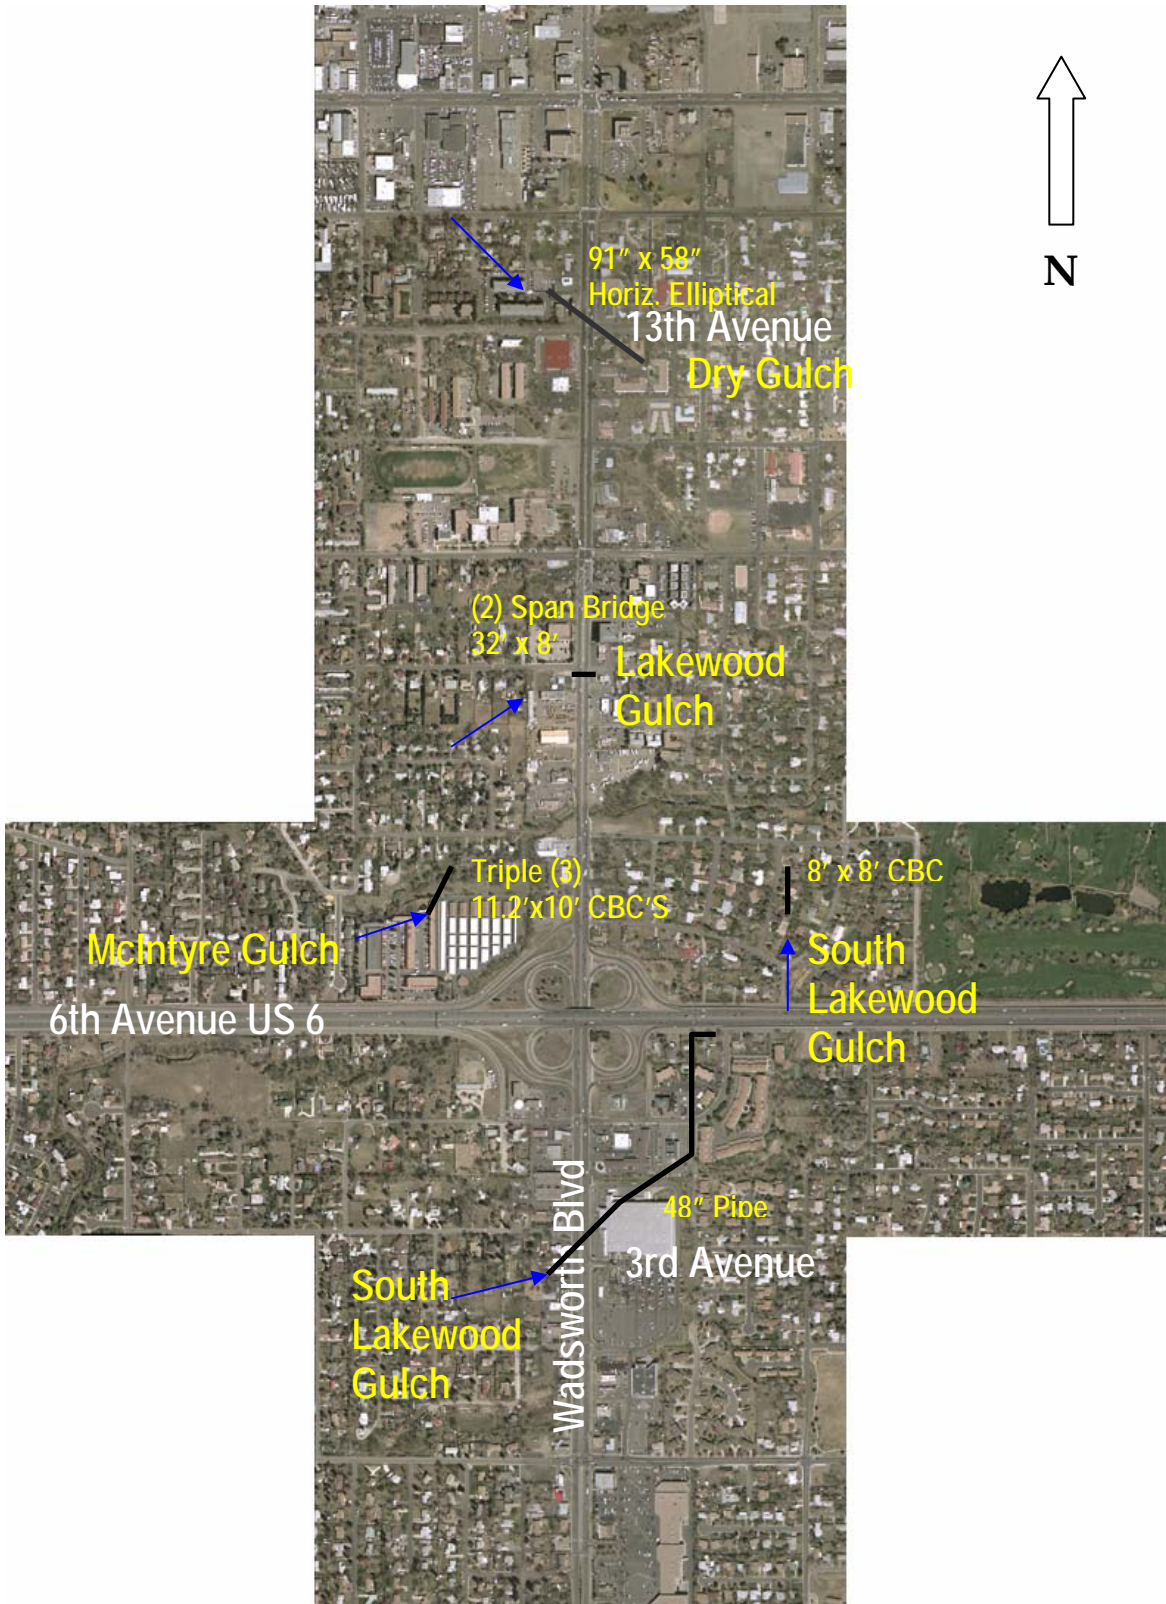
FIGURE 1: MAJOR DRAINAGE STRUCTURES

Conveyance issues exist in the portion of McIntyre Gulch between the frontage road and the storage facility located in the northwest quadrant of the 6th Avenue and Wadsworth Boulevard intersection. Several existing culverts and channels along Wadsworth Boulevard, within the project limits, have insufficient capacity to convey the 100-year flood. As a result, the 100-year flood overtops Wadsworth Boulevard at South Lakewood Gulch (existing 48-inch pipe at Second Street), Lakewood Gulch (existing bridge near Highland), and Dry Gulch (existing 91-inch by 58-inch elliptical pipe between 10th Avenue and 12th Avenue). Additionally, an existing 8-foot by 8-foot concrete box culvert located at South Lakewood Gulch and Sixth Avenue, east of Wadsworth Boulevard, is undersized and creates significant ponding on the south side of Sixth Avenue. The overtopping and conveyance information was obtained from Federal Emergency Management Agency (FEMA) floodplain maps, City of Lakewood drainage master planning maps, and correspondence with the City of Lakewood. See Figure 1 A, "Major Drainage Structures," for details of existing drainage structures within the project vicinity.

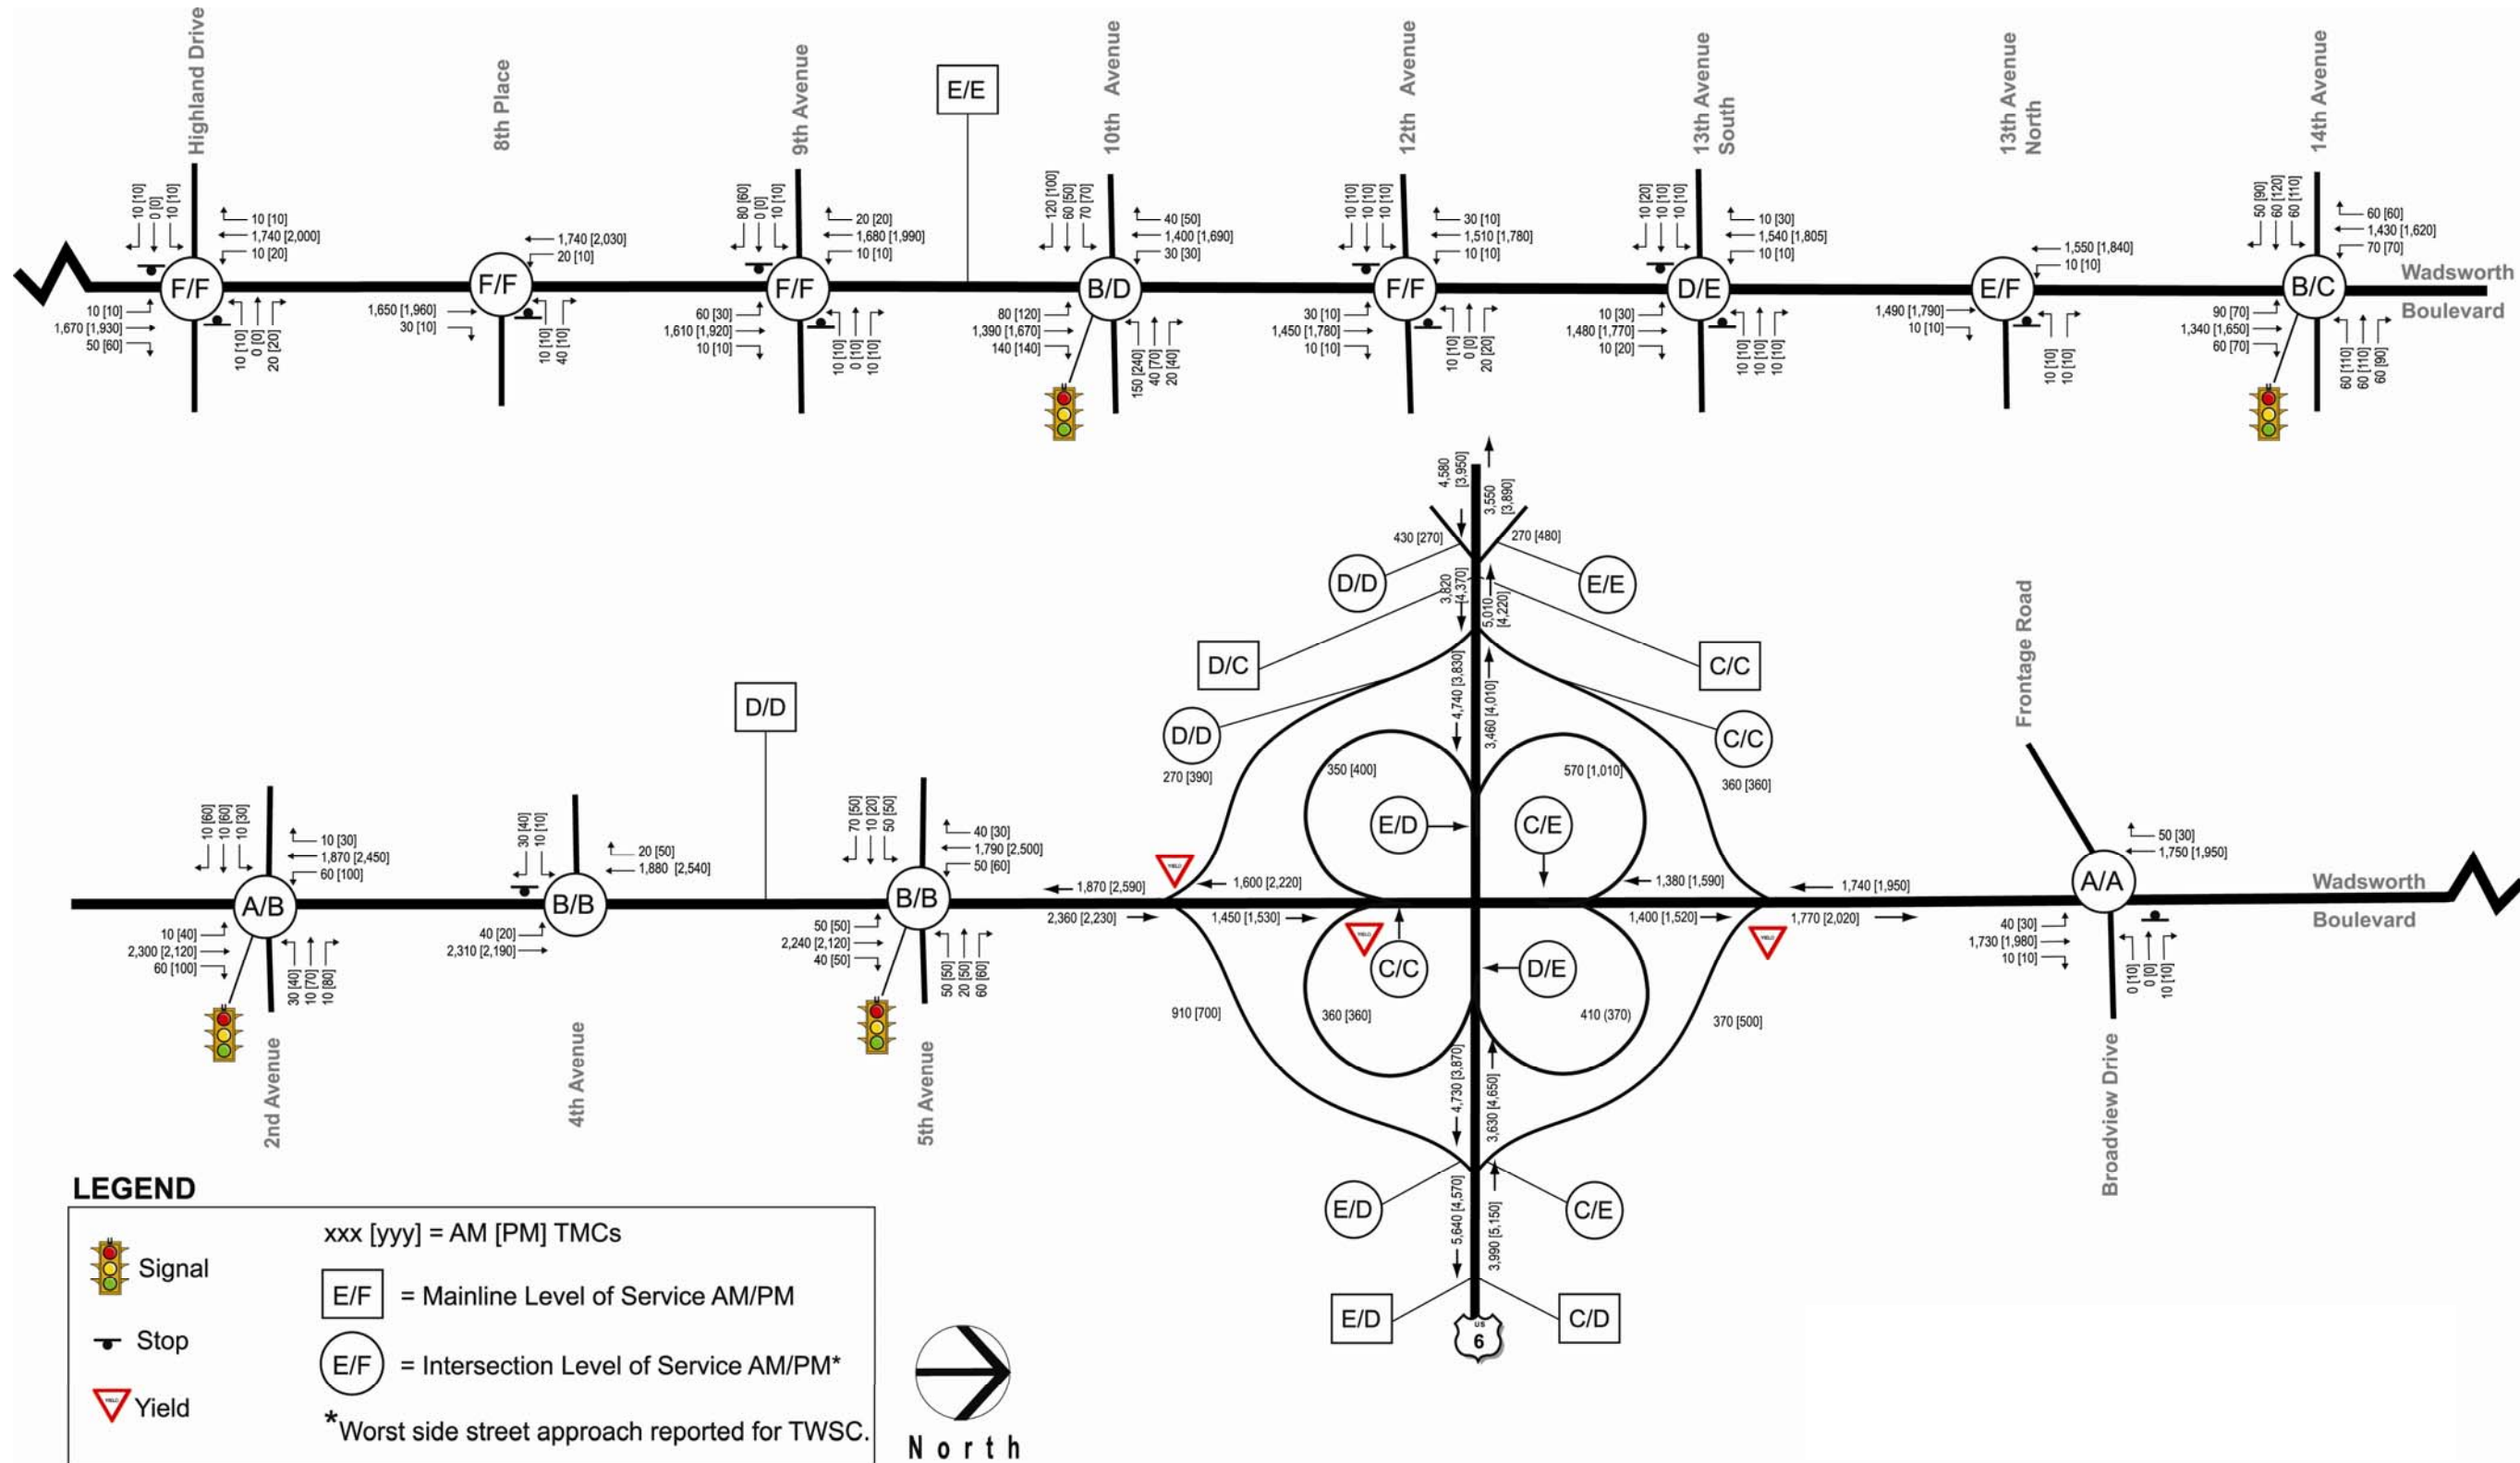
FIGURE 2  
2007 Existing Traffic Conditions

South of US 6, a raised median aids in controlling access to Wadsworth Boulevard. Some accesses have been consolidated and others have been modified to right in/right out. North of US 6, the median is striped to provide two side-by-side, continuous left-turn lanes serving major intersections and driveway accesses. A sight distance problem results when there are opposing left-turning vehicles at or near the same location. The uncertainty of when and where drivers will enter the median lane(s) contributes to mainline congestion and adds to the difficulty of entering or crossing Wadsworth Boulevard from the side streets. The numerous driveway accesses also contribute to mainline turbulence. Due to the heavy through traffic on Wadsworth Boulevard, vehicles from both side streets and driveways are forced to pull into gaps that are inadequate.

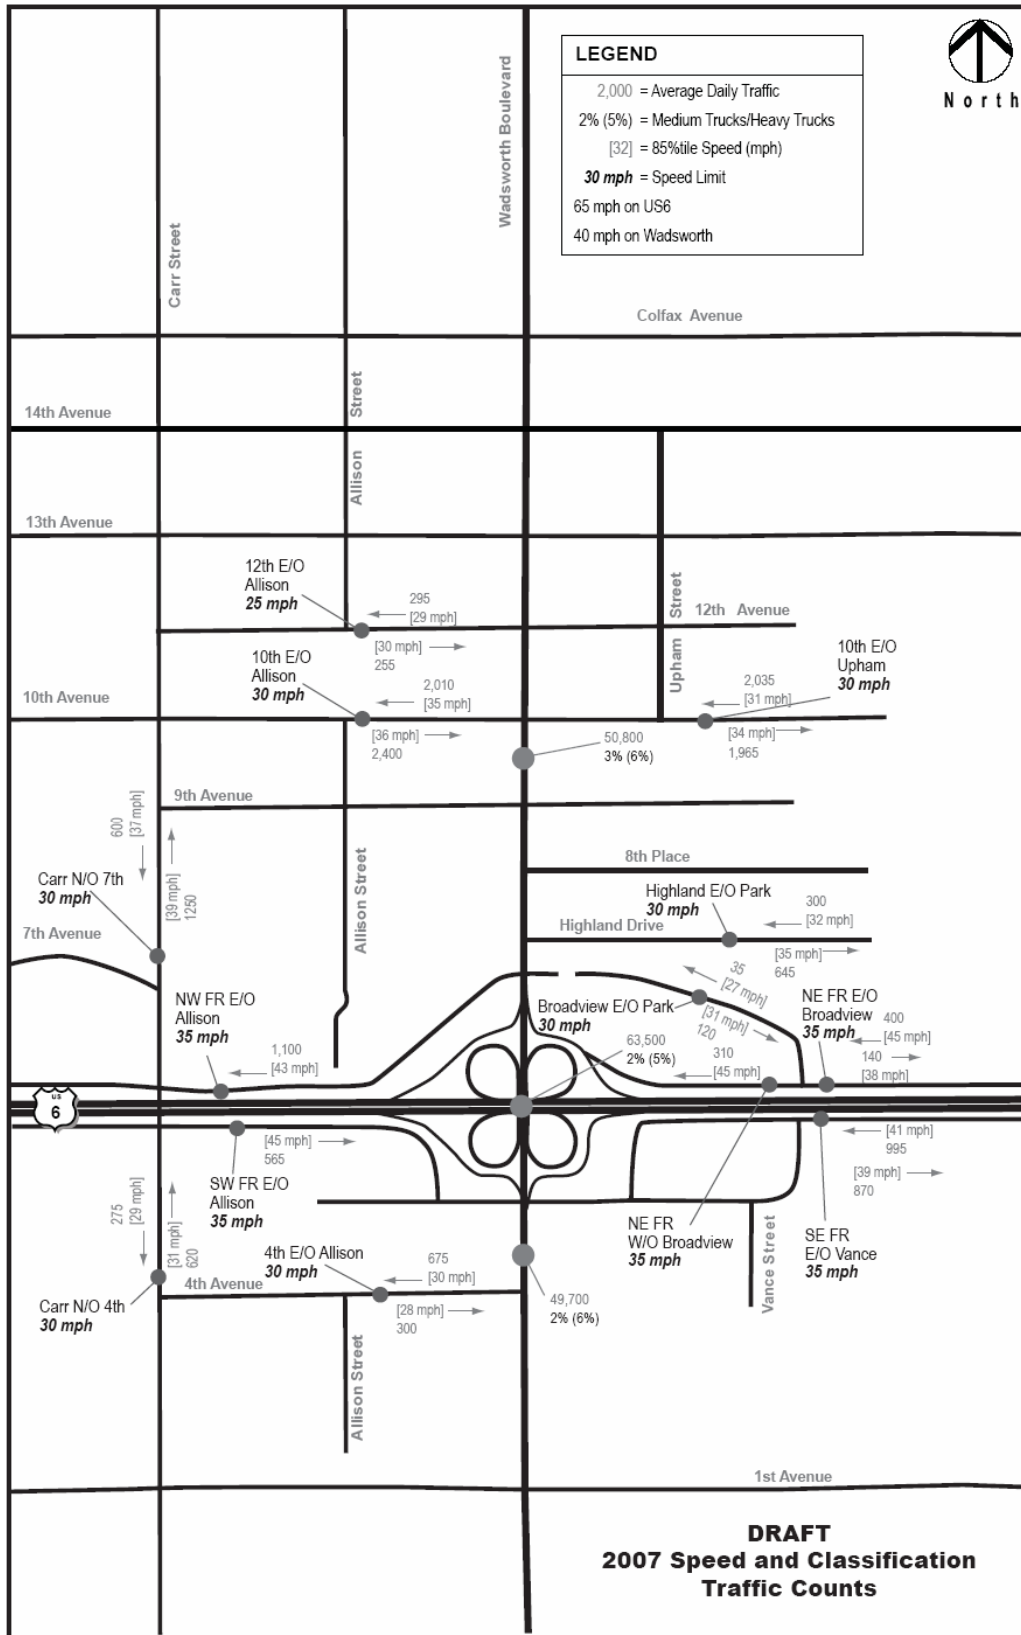
Figure 1: Traffic Volume and Speed Data

2. The data indicates a slight speeding problem along Highland Drive (34 mph 85<sup>th</sup> percentile speed vs. 30 mph speed limit), but the speeds are not high enough to be considered a traffic hazard to the neighborhood. It is also important to note that traffic patterns in this neighborhood could change if the existing frontage road connection to the eastbound US 6 off-ramp is removed. This frontage road does not carry a high volume of traffic (310 vpd); however, there is a history of neighborhood concern about traffic flow and local residents will likely voice concern about any additional traffic that is routed on their streets from the frontage road.
