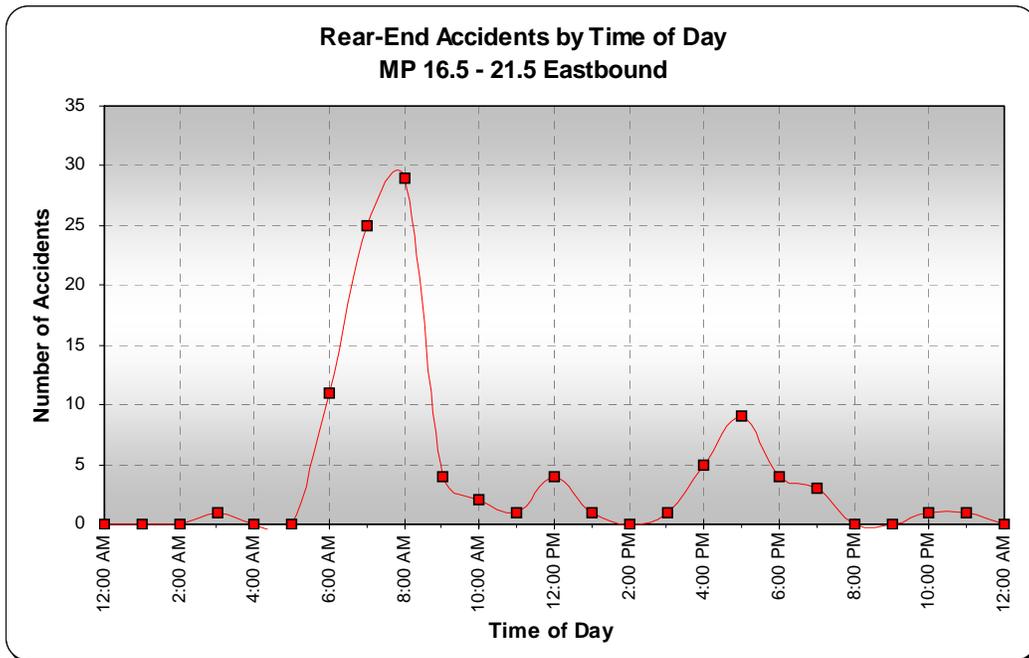
Figure 13

Examining the rear end accidents in the pattern area by direction, minor clusters predictably develop in the area of interchange ramp merge-diverge zones. In the *eastbound* direction, minor rear-end accident concentration is noted at the following locations among others:

- Wadsworth on-ramp to eastbound C-470, am peak
- Santa Fe on-ramp to eastbound C-470, am peak
- Lucent Blvd. on-ramp to eastbound C-470, am peak
- Broadway on-ramp to eastbound C-470, various times
- University Blvd. on-ramp to eastbound C-470, am peak

An increase in rear-end accident frequency is typical during high ADT periods. Added traffic capacity will be the most effective improvement in reducing these congestion-related accidents. Additionally, providing on-ramp acceleration lanes as long as practical at interchanges may help minimize speed reduction and disruption to through traffic lanes. In some instances, the parallel type acceleration lane may create less disturbance in the mainline traffic flow as well. At several of the above locations (westbound in the Santa Fe interchange area, westbound from 22.95-23.1 and near the University Blvd. Interchange) downhill grades make slowing or stopping for unexpected traffic congestion even more difficult. Again, providing extended ramp lanes in these areas to segregate slowing traffic may marginally help reduce the incidence of rear-end collisions.

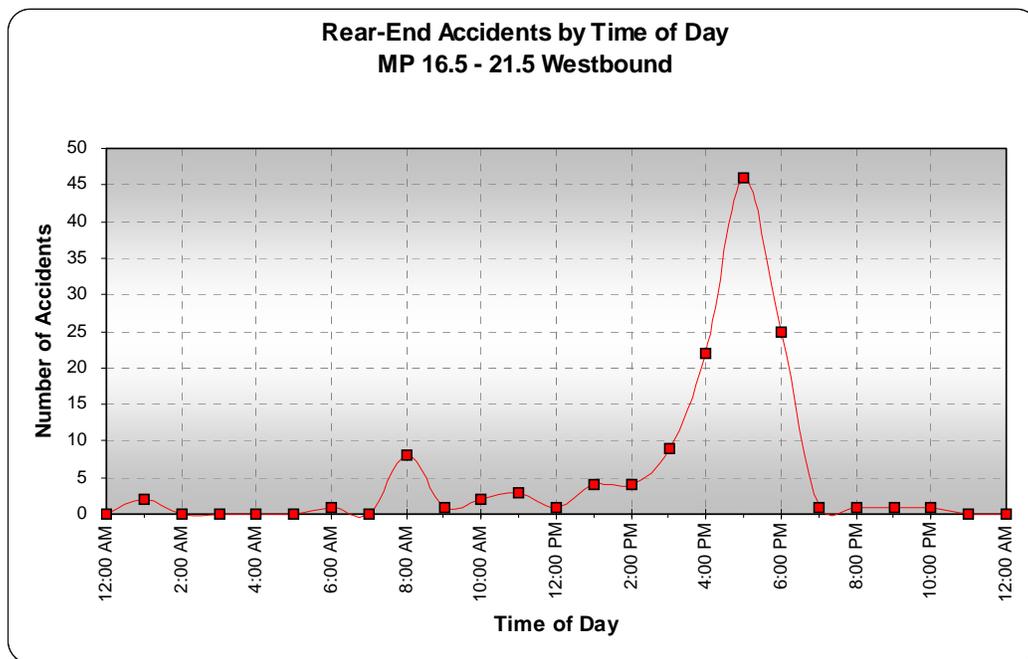
Figure 14

Rear-end accident concentration in the *westbound* lanes are noted at the following:

- A broad area in the vicinity of Santa Fe interchange (MP 16.6-17.5), pm peak
- University Blvd. interchange area (MP 20.9-21.3), mid-day to pm peak
- MP 22.95-23.1, downgrade near bridge, pm peak
- Quebec interchange off ramp & on ramp merge areas to westbound C-470, pm peak
