# C-470 & Platte Canyon Rd. Interchange

### *C-470 and Santa Fe Drive Interchange*

# C-470 & Santa Fe Interchange

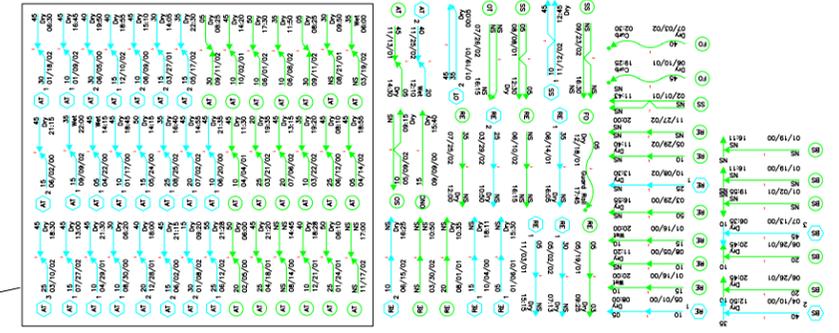
Collisions occurring at north ramp intersection

Significant approach turn collision problem for NB Hwy 85 to WB C-470 movement
