Twin Tunnels Environmental Assessment

Engineering Existing Conditions Summary

December 22, 2011

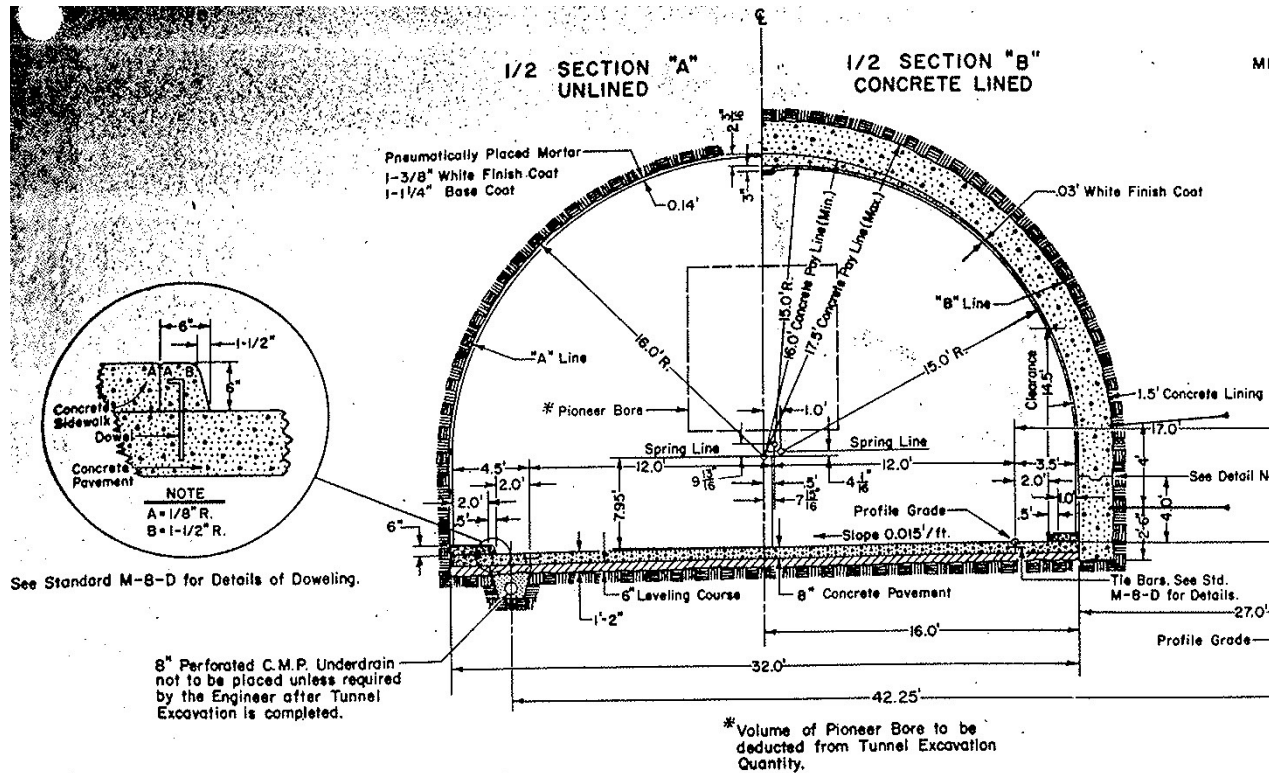
Figure 3. Tunnel typical section from original design plans

The existing roadway width at the I-70 Twin Tunnels (milepost [MP] 242.2) is approximately 29 feet with a tunnel span of 32 feet, including the shoulder barriers. Refer to Figure 3 for a typical section from the original tunnel construction plans. The following critical issues are present at the tunnel:

- The tunnel portals are boxy and imposing to drivers and tend to cause drivers to perceive them as potential obstacles and thus slow down to improve perceived safety. In addition, the tunnel bores themselves appear dark and produce a “black hole effect,” adding to the perceived safety concern, compounding the drivers’ tendency to slow down, causing reduced traffic flow and queuing.

- Lighting at the tunnel has been upgraded and more improvements are not likely to help the constraints of the tunnel width.
- The tunnel is a two-lane facility and will need to be widened to three lanes.
- The existing effective pillar between the tunnels is approximately 25 to 26 feet wide, and requires more geologic investigation to determine stability needs for larger or additional tunnel bores.
- The tunnels will have to be widened to the south side so as to not reduce the pillar width.
- The tunnel does not provide for hazardous materials spill containment.
- The tunnel does supply a means for emergency egress.
- The west portal has a rock fall hazard potential that needs to be addressed in any new design.

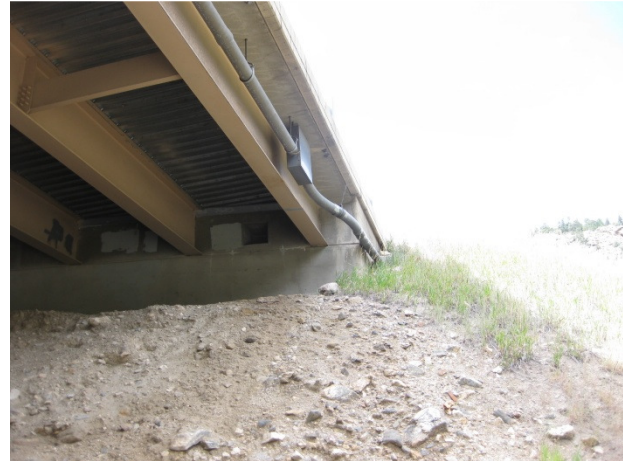
Figure 6. Girders and cross bracing

Overall, this bridge is in very good condition with efflorescence seen in very few places. The concrete finish is smooth and the galvanized type 10M barriers are in good condition.

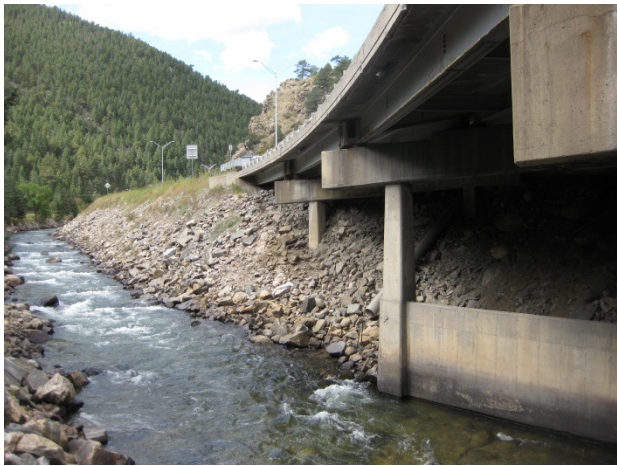
Figure 7. Bridge looking west

This bridge was built in 1961 and is a four-span, steel plate girder bridge over Clear Creek supported over multi-column bents and seat type abutments on a horizontal curve, as shown in Figure 7. Two pier caps, one for each direction of traffic, are connected by a pier wall. The bridge is in a skew with short wing walls on all four corners. Type 3 galvanized steel barriers with a concrete median barrier in the middle accommodate two lanes of traffic in each direction. The bridge has a sufficiency rating of 93.1 according to the CDOT Structure Inspection and Inventory Report, dated December 14, 2009. Because the sufficiency rating is higher than 80.0, the bridge is not eligible for federal aid for rehabilitation.

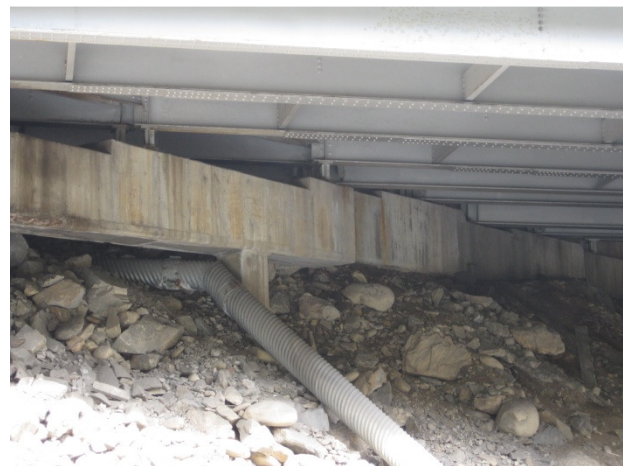
Figure 13. Drain pipe near west abutment

Rocker bearings are rusted and dirty and show significant rotation, as shown in Figure 12. The deck is drained by pipes installed at a 45-degree angle through an overhang, as shown in Figure 7. There is a corrugated metal pipe (CMP) drain pipe on the west abutment, as shown in Figure 13. There are steep slopes near both abutments. Overall, the bridge is in good condition.

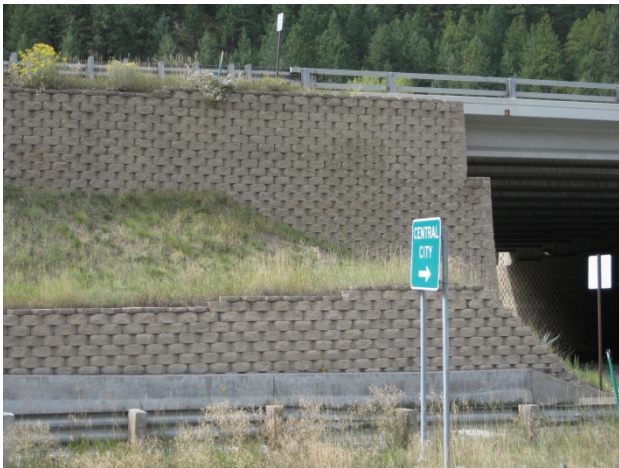
Figure 14. Tiered MSE wall on northeast corner

This bridge was built in 1999 and is a single-span, bulb-tee, pre-stressed girder bridge on I-70 over Central City Parkway near exit 243. This bridge is located only a few hundred feet west of structure F-15-BX. Bridge rails are type 10M galvanized and are in good condition. Both the abutments are wrapped by mechanically stabilized earth (MSE) walls with concrete block facing. The MSE walls are tiered on the north side, as shown in Figure 14. The west abutment MSE walls are more than 240 feet long on each side, as shown in Figure 15. This bridge has a sufficiency rating of 96.0 according to the CDOT Structure Inspection and Inventory Report, dated December 14, 2009. Because the sufficiency rating is higher than 80.0, the bridge is not eligible for federal aid for rehabilitation.

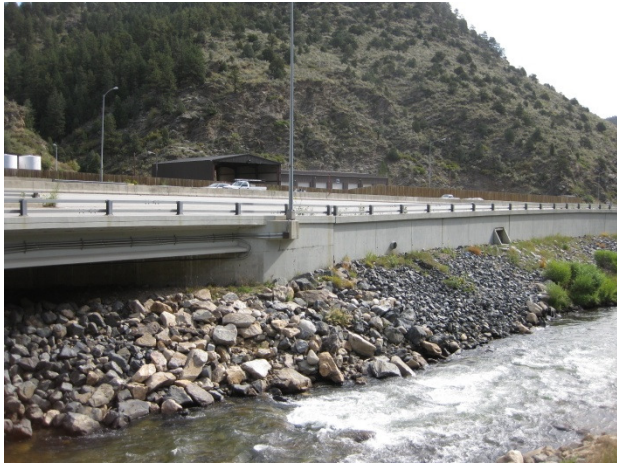
Figure 22. Retaining wall with box culvert

A cast-in-place (CIP) retaining wall runs for more than 400 feet along Clear Creek on the southeast corner of the eastbound ramp bridge, as shown in Figure 22. Light poles are attached and a small box culvert and a couple of reinforced concrete pipes (RCP) cross through this wall, as shown in Figure 23.

This bridge is in good condition and there is no reinforcement or concrete spalls exposure on this structure. The retaining wall is in good condition and was built with crack control and expansion joints. The stay-in-place forms and galvanized steel diaphragms are in good condition. There is some efflorescence below the pier caps, as shown in the Figure 24, as well as in the abutments, as shown in Figure 25.

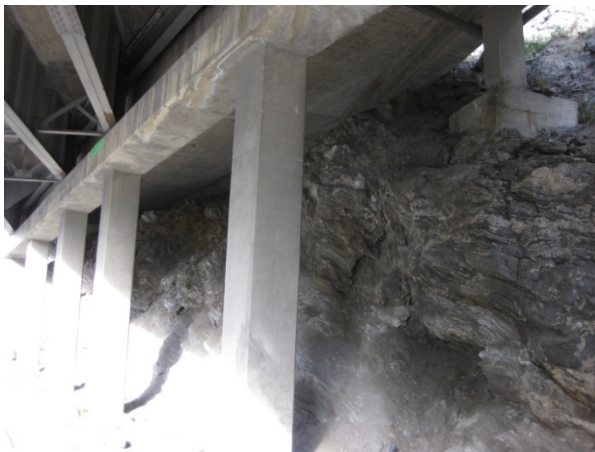
Figure 32. North abutment

This bridge was built in 1959 and is a six-span bridge with a steel plate girder superstructure over multi-column bents. The end span on the north side is a short span with no girders, as shown in Figure 32. The bridge is in a horizontal curve with superelevation and piers have large skews. A CIP retaining wall of approximately 30 feet in length retains I-70 westbound located a few hundred feet past the north abutment, as shown in Figure 33. This bridge has a sufficiency rating of 43.6 according to the CDOT Structure Inspection and Inventory Report, dated December 12, 2009. Because the sufficiency rating is less than 50.0, the bridge is eligible for federal aid for replacement.

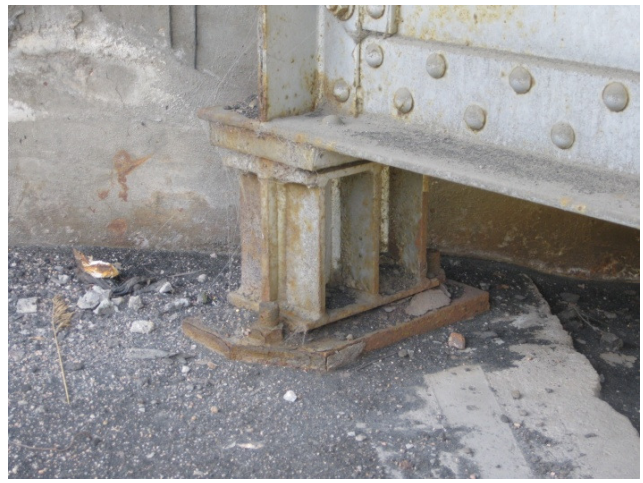
Figure 39. South abutment bearing

The original bridge rails and light posts are removed, and the bolts on the sides of the bridge deck show rust, as shown in Figure 38. The original bridge rail was replaced by CDOT with crash-tested concrete barrier. Steel plate girders and intermediate truss type diaphragms show rusting in many places. Abutment 1 has short wing walls and is surrounded by steep embankment with slopes closer to a 1:1 ratio. The bearings are dirty and show signs of corrosion, as shown in Figure 39. Large cracks are on the top portion of the abutment seat, as shown in Figure 40. Abutment 2 is a short seat abutment resting directly on hard bedrock.

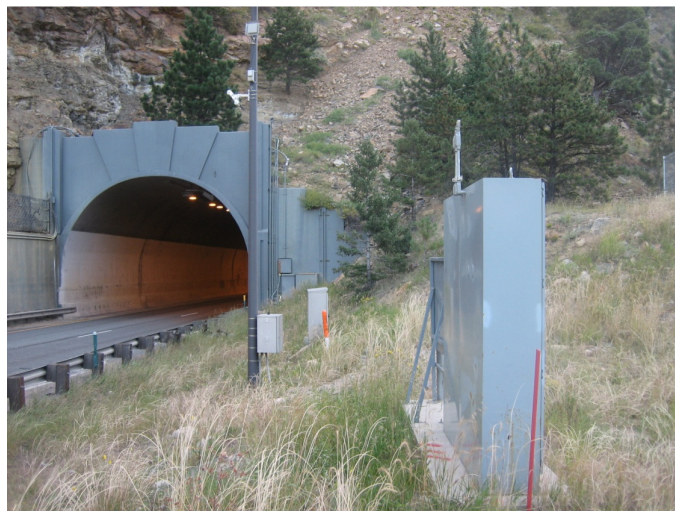
Figure 44. CDOT utility infrastructure at eastbound I-70 west tunnel portal

CDOT Electric. CDOT electrical infrastructure is located in the study area, as shown in Figure 44. CDOT infrastructure that requires electric service lines include chain station lights, roadway lights, variable message boards, and signing.

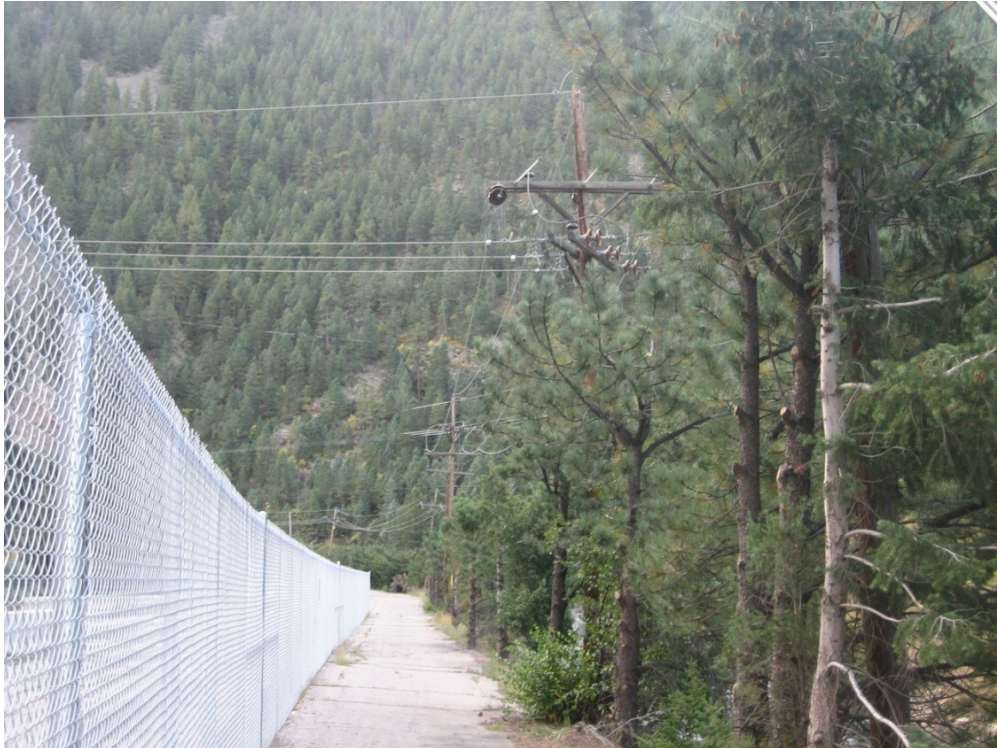
Figure 45. Overhead Xcel Energy electrical service lines with other utilities attached

Electrical Service Lines. Xcel Energy has several electrical service lines in the study area. The known service lines are above-ground facilities. The majority of the above-ground facilities are not located adjacent to I-70, rather runs along the south side of old Route US 40 and the south side of the Frontage Road. Several overhead and underground electric service drops form the main overhead service line, as shown in Figure 45.

Telephone Lines. CenturyLink has telephone lines in this area. Contacts to confirm the location have been unsuccessful to date. It is assumed that the telephone lines are located on the Xcel Energy overhead electrical service lines with associated drops at certain locations, as shown in Figure 45.

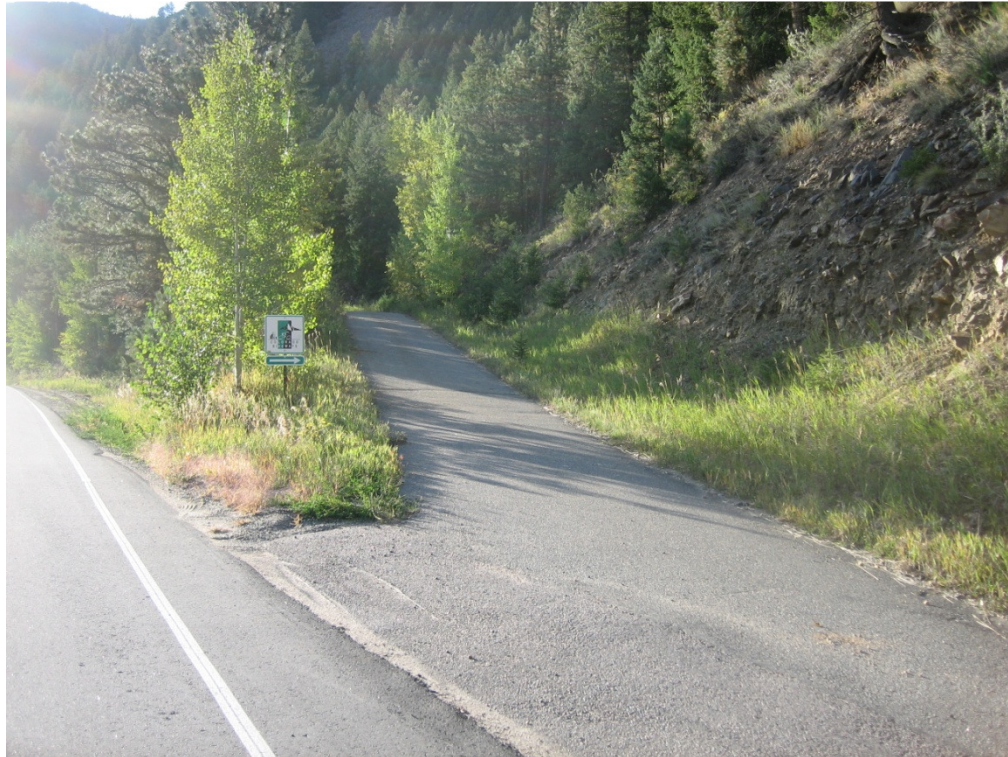
Figure 48. Bikeway signage

The bikeway has signage alerting riders to the direction of the trail (see Figure 48). There are also pavement markings indicating the location of the bike path in some areas (see Figure 49).
