**SH 83 Safety and Operations Analysis:
Bayou Gulch to El Paso County Line
MP 30.20 – MP 53.88
Project Code 23008**

Appendix A - Safety Assessment Report

March 2022

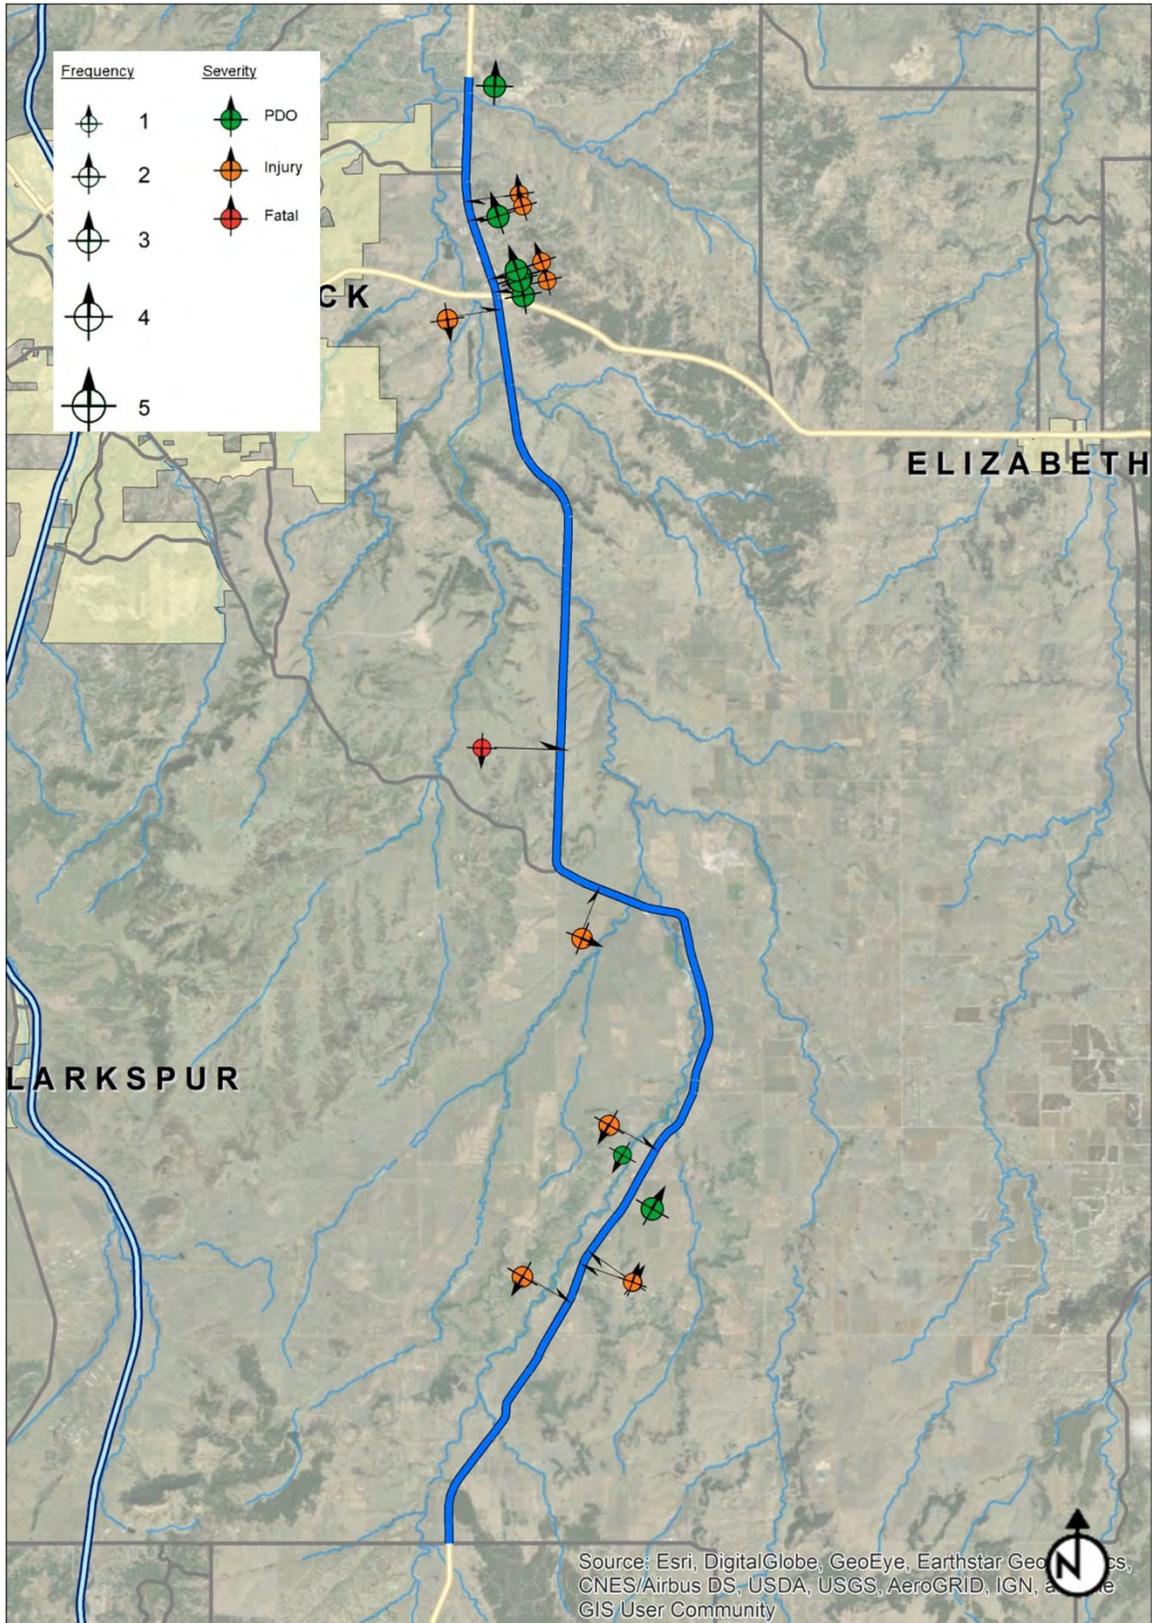
Figure A26: Driveway Crashes by Frequency and Severity

There was one (1) fatal *rear end* crash that occurred in September 2016 at MP 44.03. Details were limited, but it appears that a southbound passenger car and a southbound motorcycle were both stopped in traffic, presumably due to a vehicle waiting to turn left into the nearby driveway. A third vehicle failed to stop and collided with the stopped vehicle at a high rate of speed. The chain collision resulted in the death of the motorcycle rider.

As per the access control plan, combine or limit access to identified locations as development occurs to enhance the safety and operations of the SH 86 corridor. In particular in the Franktown area and to the north along SH 83 toward the end of the study segment at Bayou Gulch Road due to the higher frequency of driveway related crashes.
