Bridges Technical Memorandum

July 09, 2018

The Interstate 25 (I-25) Central Planning and Environmental Linkages (PEL) Study includes approximately four and one-half miles of highway and nine interchanges through one of the most congested segments of interstate in Colorado. Many factors contribute to this congestion, including traffic volumes, vehicle mix (high truck percentage), and deficient roadway geometrics. Roadway geometrics include design elements such as horizontal alignment, vertical alignment, stopping sight distance, ramp spacing, etc. Deficient elements within the corridor can cause traffic operation and safety issues. An evaluation of the existing I-25 mainline and ramp conditions within the project limits has been performed and is documented in this technical memorandum.

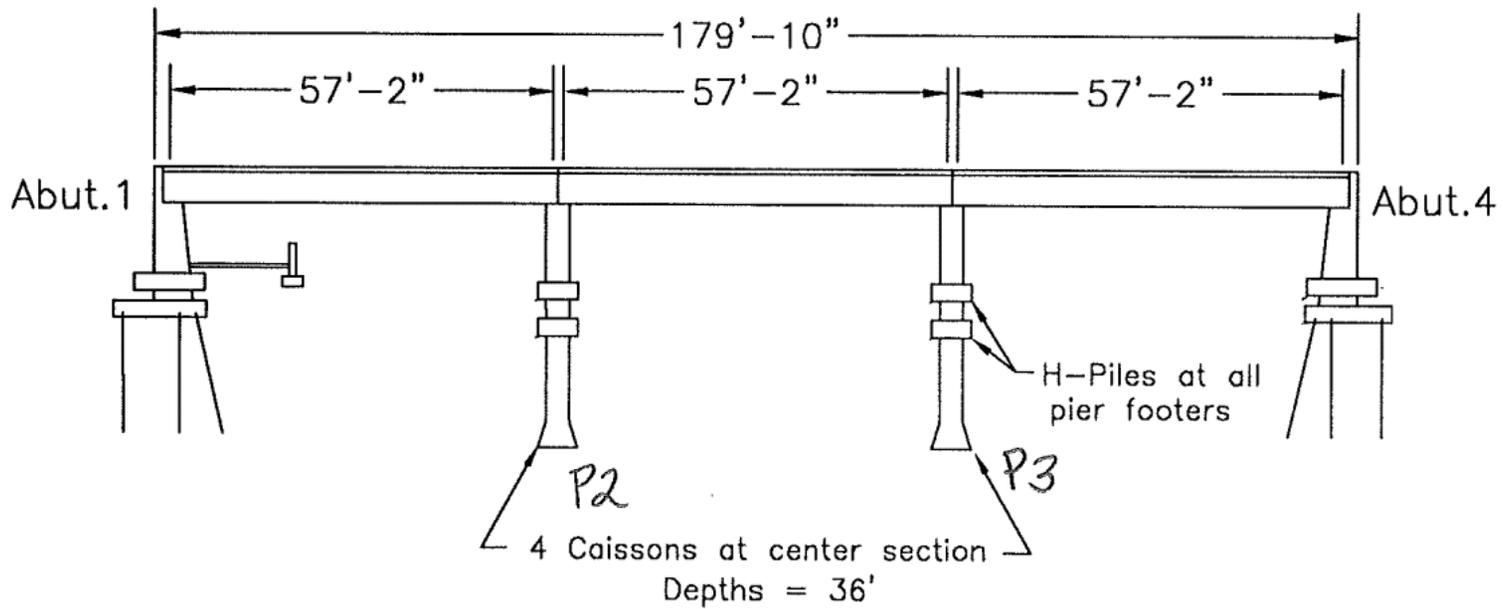
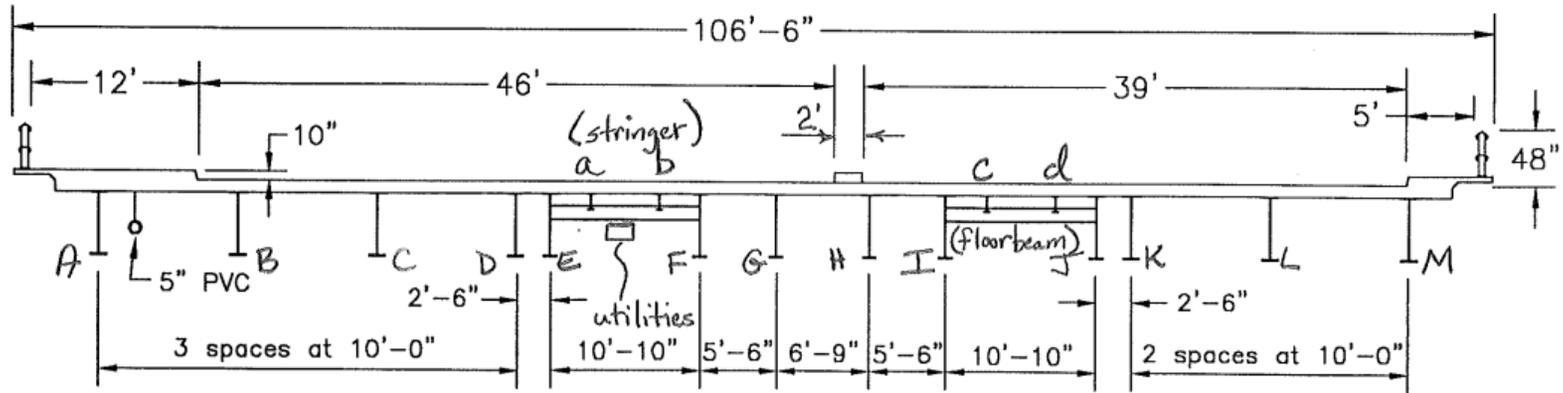
Numerous locations of heavy concrete cracking and spalling throughout substructure and deck overhang.

Widening to north and south was completed in 1959. Concrete repairs to deck overhang were completed in 2006. South bridge rail rehab completed in 2010.

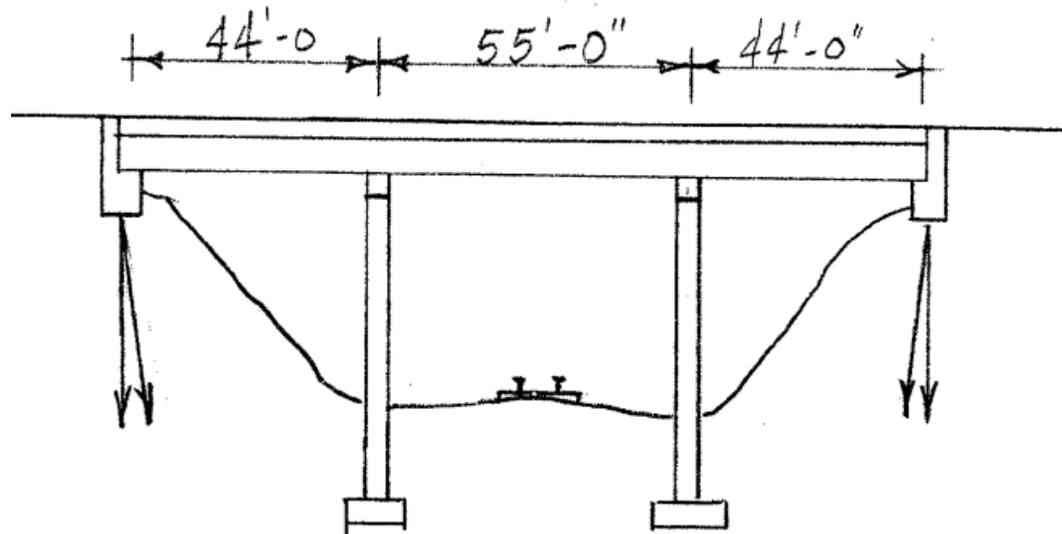
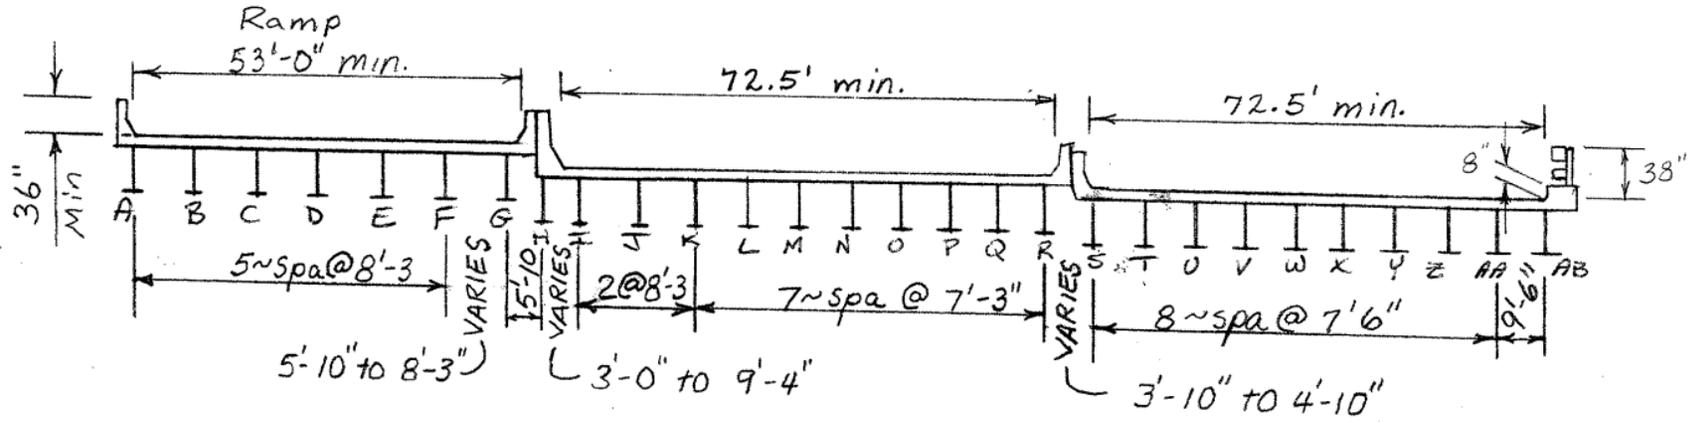
Actively leaking longitudinal construction joints in deck.

Concrete repair to deck and abutments completed and new expansion joint installed in 1998.

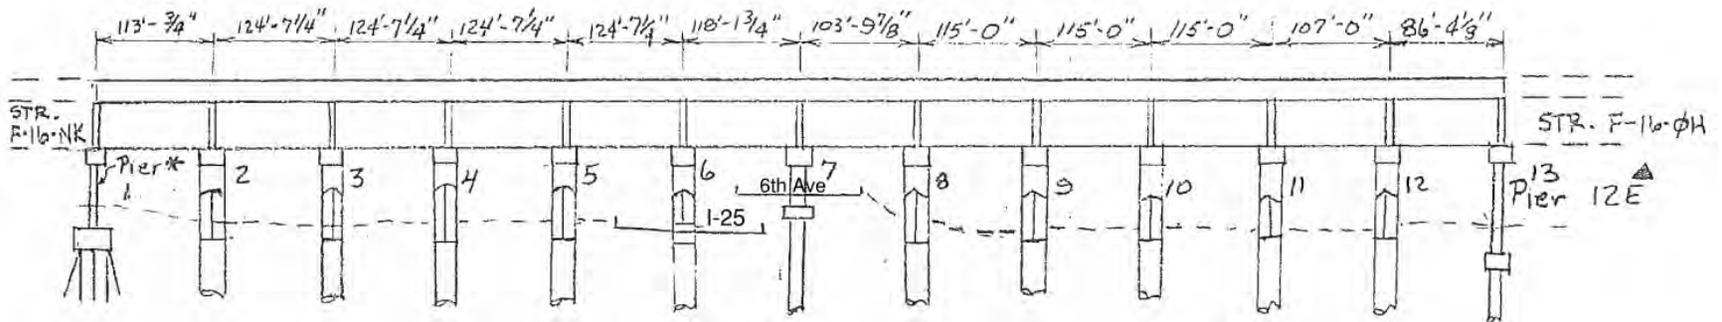
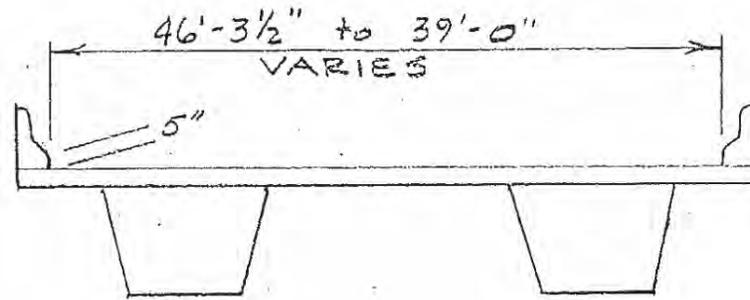
More than 20 cracks were discovered in a 4-year time period, thus bridge is on a 12-month inspection cycle. Many cracks have been arrested but some still exist as of 2017 inspection.

Sixteen feet of rail damaged/missing due to vehicular impact on August 2017.

Expansion joints are actively leaking at Piers 1 and 13.

Cracks from 2014 and 2016 inspections were arrested in May 2016.

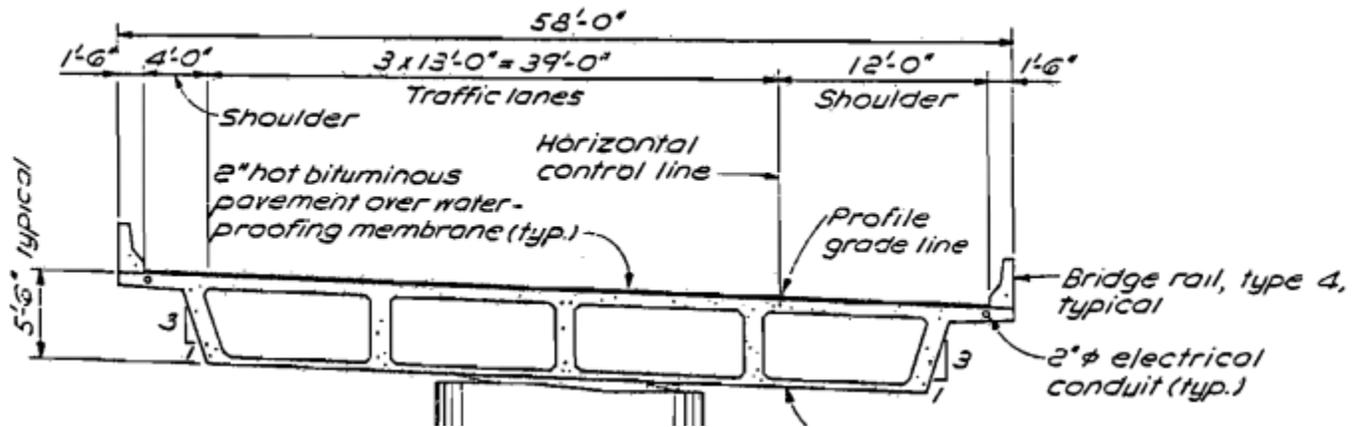
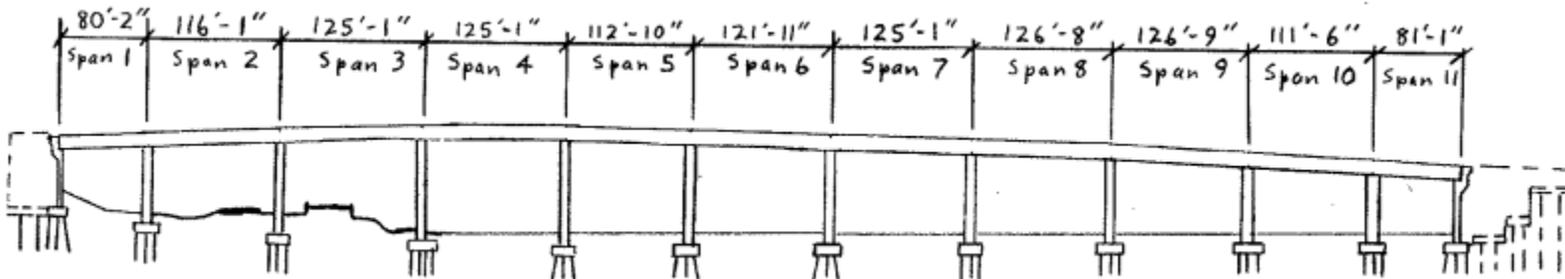
Section - F-16-NY

Concrete repair work has been completed in several cells.

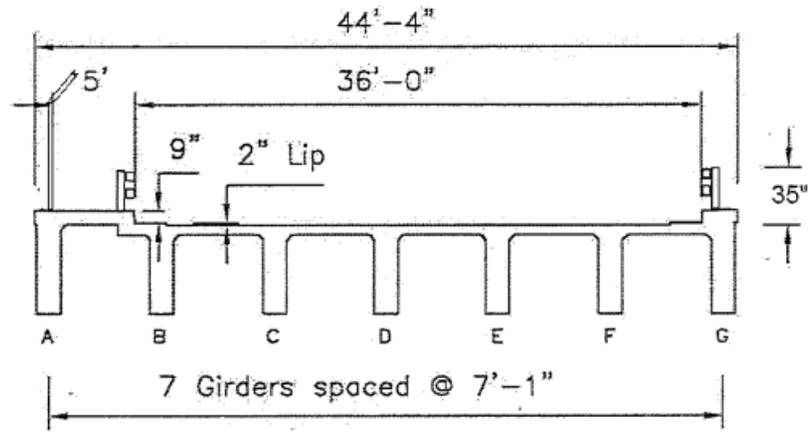
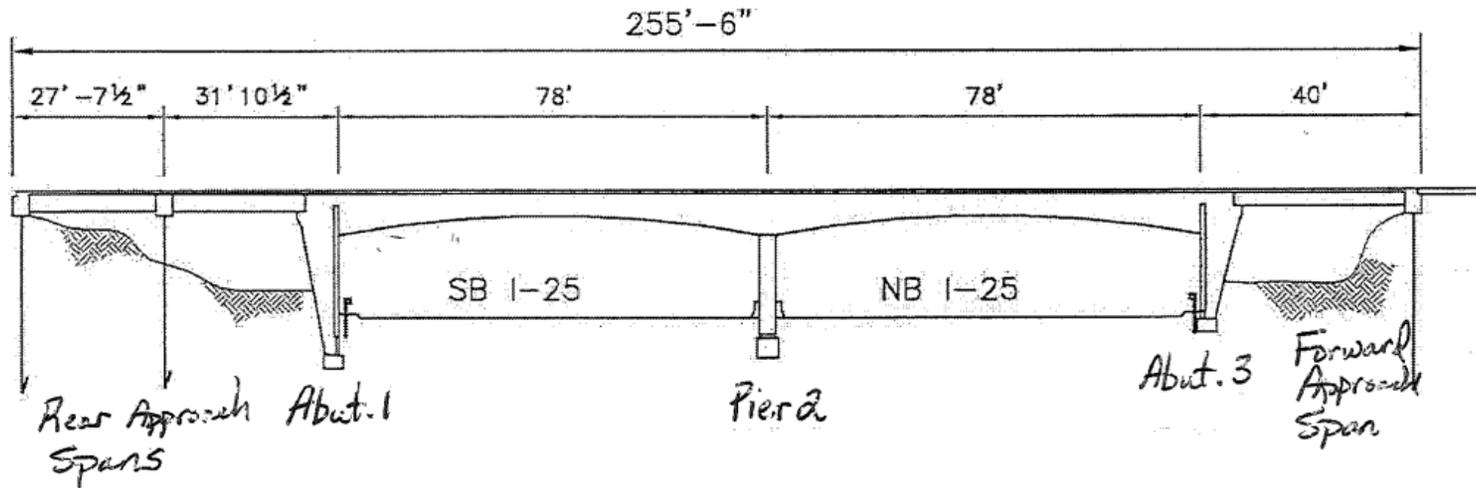
Section - F-16-DA

Structure has experienced multiple vehicular impacts resulting in damaged girders and exposed primary reinforcing. Cracking, heavy efflorescence, and spalled concrete with exposed rebar present throughout concrete deck.

Girder concrete was previously patched where impacted by vehicles but additional vehicular impacts to the patched areas have caused spalling of the patch concrete.

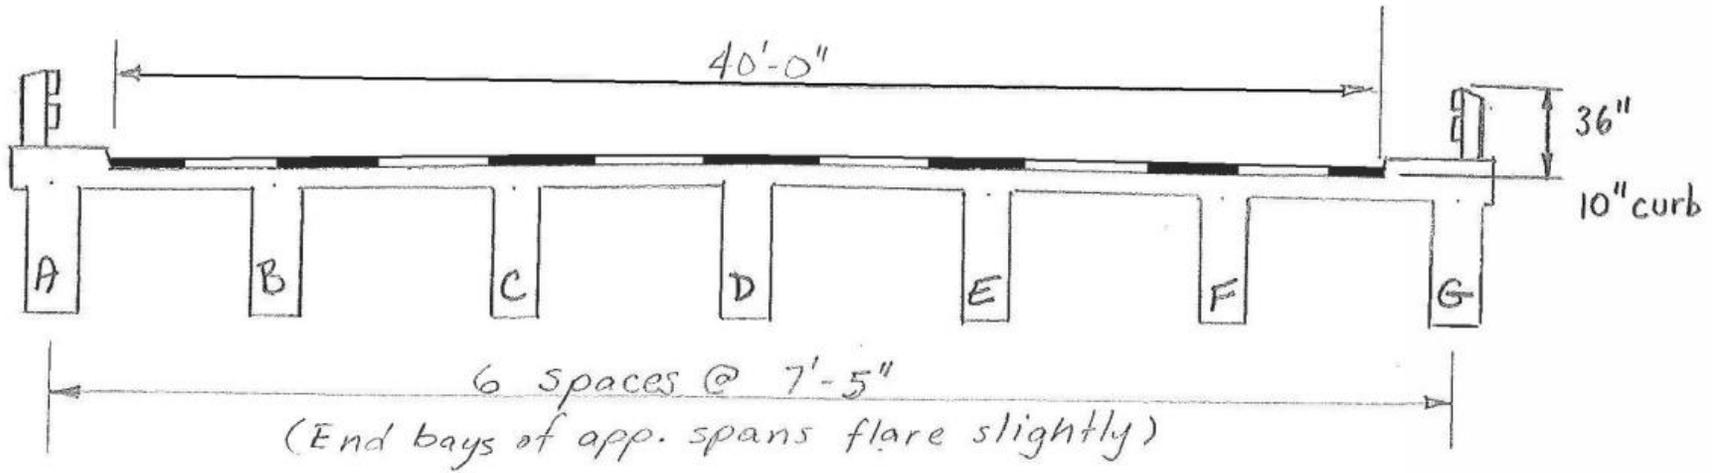
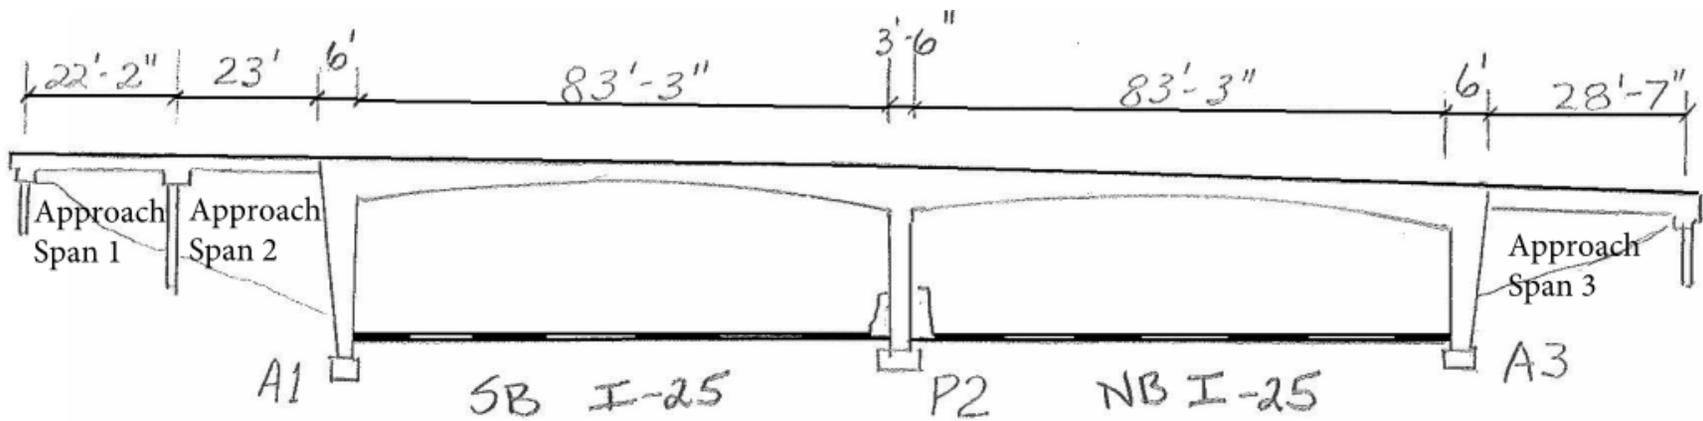
Section - E-16-E0

Structure has experienced multiple vehicular impacts resulting in damaged girders and exposed primary reinforcing. Cracking, efflorescence, and spalled concrete with exposed rebar present throughout concrete deck.

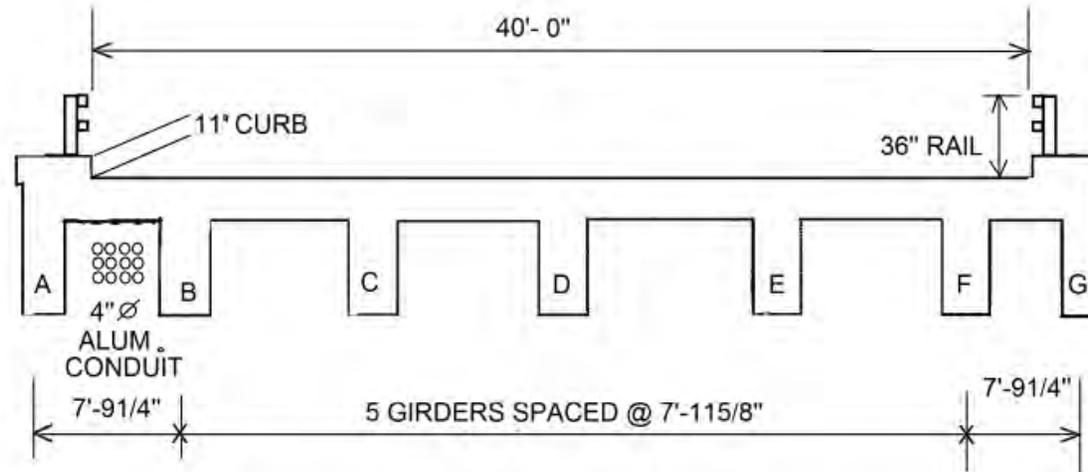
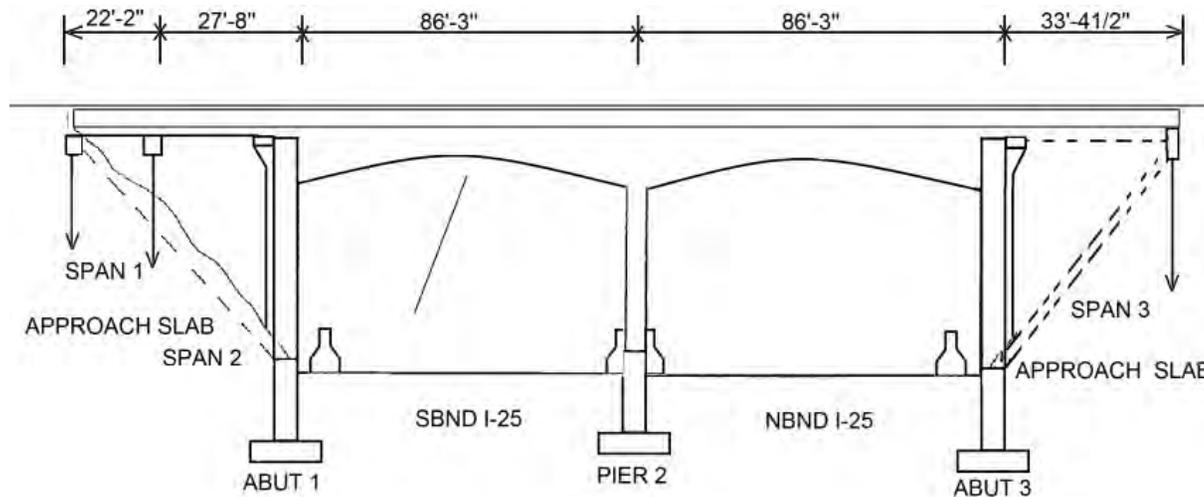
Section - E-16-EW

Structure has experienced multiple vehicular impacts resulting in damaged girders and exposed primary reinforcing. Cracking, efflorescence, and spalled concrete with exposed rebar present throughout concrete deck.

Bridge rail was replaced in 2008. Some concrete has been patched where vehicular impact damage occurred.
