COLORADO
Department of Transportation

CDOT R1 I-70 WB BAKERVILLE TO EJMT CLIMBING LANE EXISTING CONDITIONS REPORT

NHPP 0703-502 ▪ PCN 24808 ▪ Revision: May 19, 2023

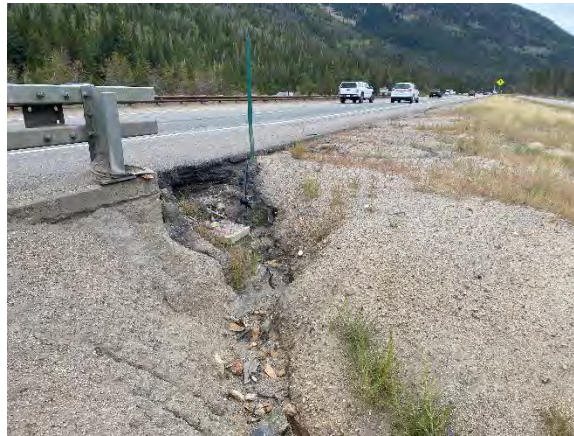
Figure 30. Erosion holes at ends of approach curbs

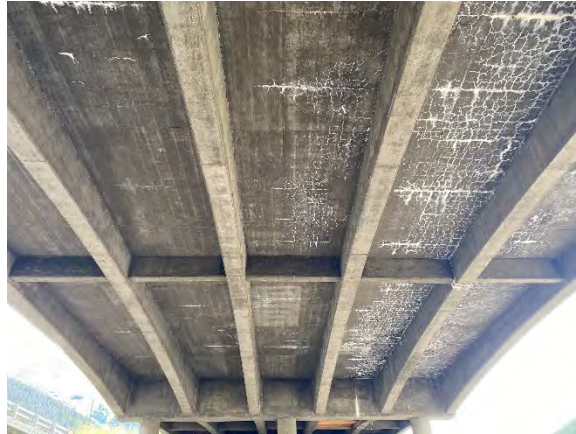
Figure 32. General view of the underside of the deck in Span 2

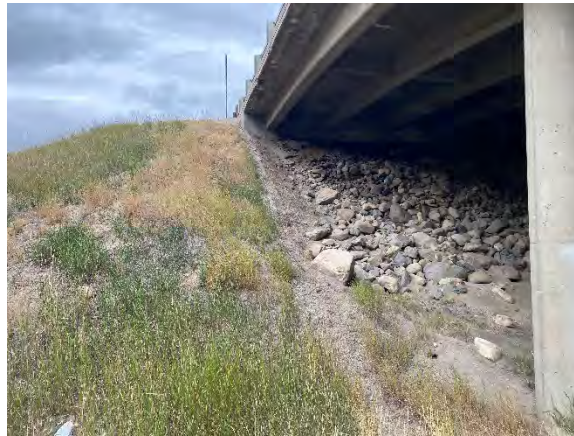
The berms in front of both abutments are steep and only locally protected with riprap. Areas of erosion and piles of debris are present at all 4 corners of the bridge.

Figure 37. Erosion of berm embankments

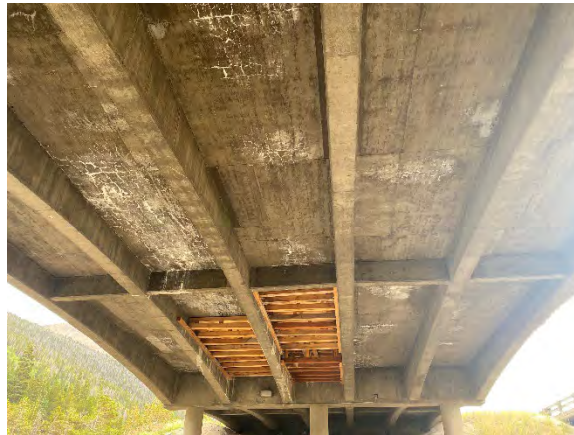
Figure 43. General view of the underside of the deck in Span 2

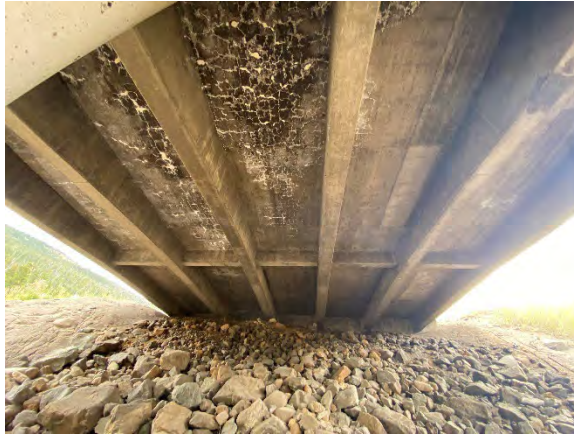
Figure 44. General view of the underside of the deck in Span 3

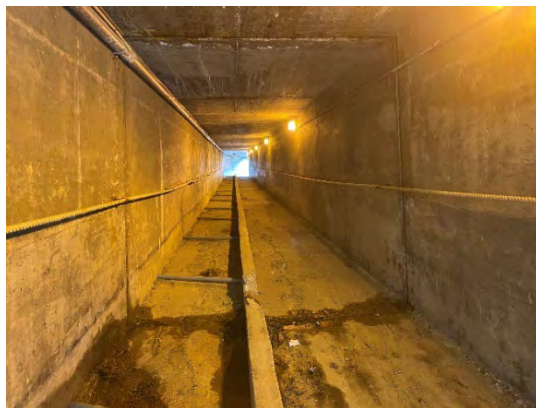
Figure 57. General view through culvert barrel

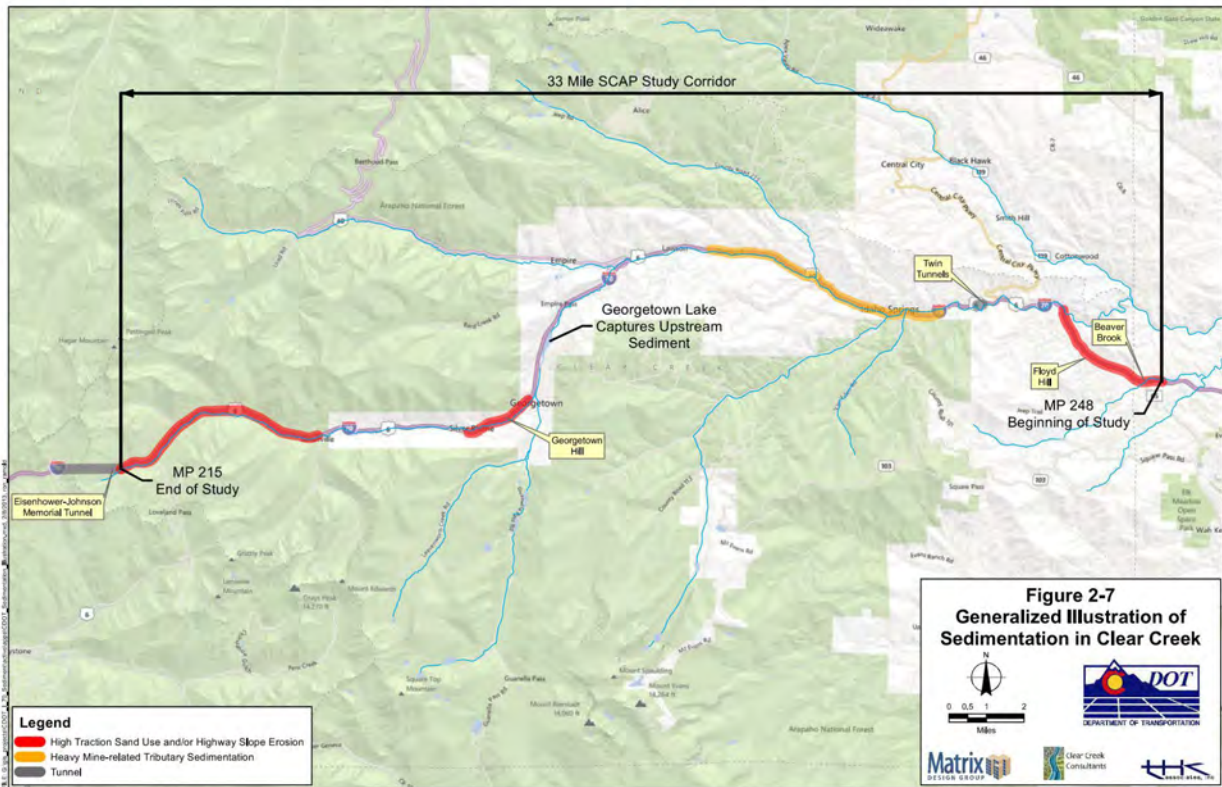
implementation approach plan. The SCAP provides a map of sedimentation along this corridor. High traction sand use and/or highway slope erosion were found in the Project area. See **Figure 67** (SCAP Figure 2-7).

Figure 67. Sedimentation along I-70

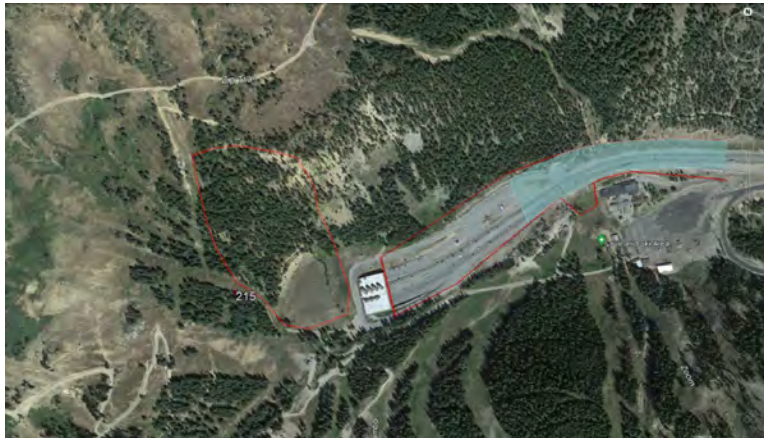
The main historic landslide in this section of corridor is at the east portal of the westbound EJMT tunnel complex at MP 215. A large buttress was constructed over the tunnel portal to stabilize the hillside at this location.

Figure 68. Historic EJMT landslide area and buttress located at MP 215

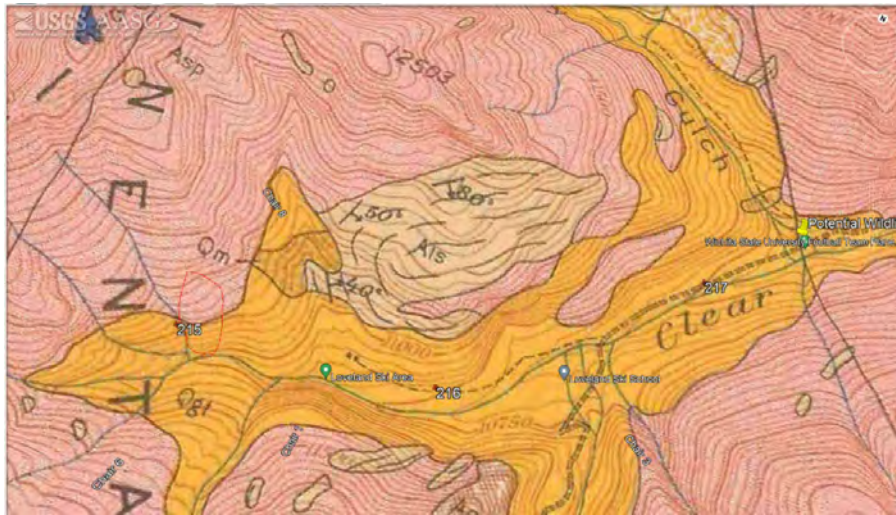
Figure 69. USGS Mapped landslide area above I-70 from MP 215.5 to 216.4

Other potential large scale landslide sections extend from MP 215.5 to 216.4. The area above is mapped as Idaho Springs Formation (Als) with glacial till (Qgt). The feature is not specifically mapped as a landslide but exhibits many of the geologic surficial conditions that are indicative of a landslide area. Potential cuts in the slope in this section may require an extensive geotechnical and geological investigation. Alignments that avoid cuts in this area would be preferable. If cuts are unavoidable, then extensive and creative slope stabilization mitigation may be required if there is the potential for a large-scale landslide.

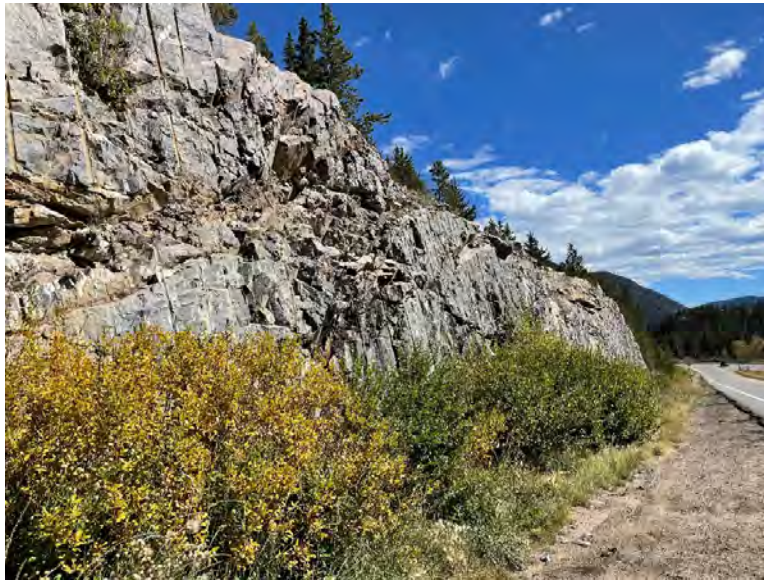
Figure 71. Bakerville exit presplit rockcut

The existing rockcuts at the Bakerville exit were excavated using presplitting blasting techniques. Presplitting is generally the most straightforward blasting method and provides for the most stable rockcuts. However, it does leave a half cast of the vertical drill hole. **Figure 71** shows the westbound exit ramp at Bakerville (MP 221.3). Much of the I-70 corridor from Silver Plume to west of the Bakerville exit consist of presplitting with half casts.

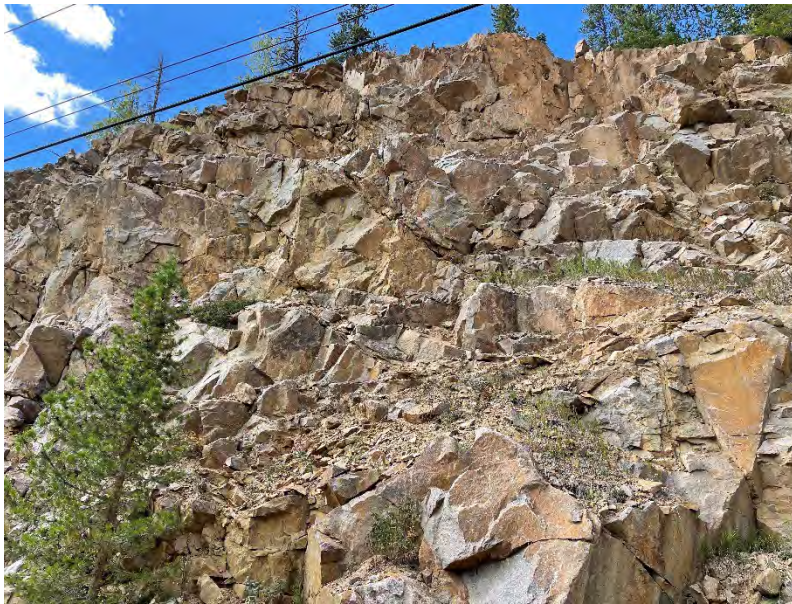
Figure 72. US 6 cushion blast type rockcut

Some CSS related projects discourage presplit blasting techniques in favor of cushion or other blasting techniques. Cushion types of blasts generally leave a relatively unstable rockcut face that is much more prone to rockfall and unstable rock slopes. **Figure 72** below depicts a cushion blast on US 6 just east of the Bakerville exit.

Cushion type rockcuts, while possibly more visually appealing than presplit, will require a much wider rockfall catchment ditch and/or other forms of rockfall netting and/or mesh to keep rockfall from impacting I-70. Depending on which rock blasting technique is permitted, the initial roadway design should consider the type of blasting cut proposed or accepted. Presplits are generally more stable and require less ditch vs cushion blasting that may require additional ditch width and/or mesh to ensure less rockfall on I-70.

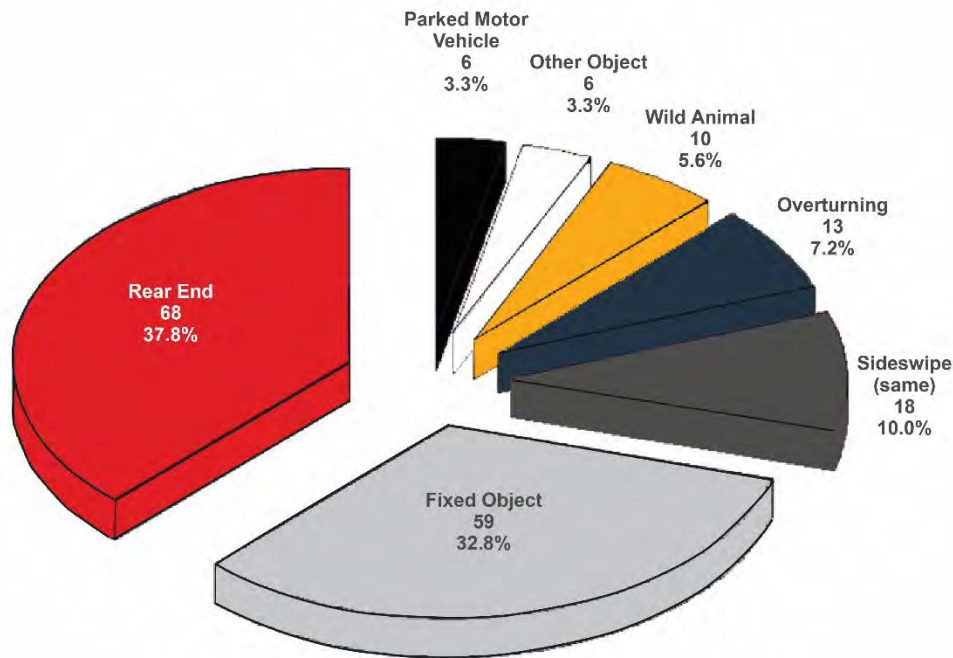
Figure 82. I-70 Mainline Crash Distribution by Type, MP 215.30 to MP 221.50 (WB Direction)

Figure 82 shows the distribution of WB crash types that occurred within the study area. The most predominant crash type was rear-ended collisions (38 percent), followed by fixed object collisions (33 percent) and sideswipe collisions (10 percent). Of the fixed object collisions, cable rail was the most common type of object struck, followed by embankment and guardrail.

Crash pattern recognition identified a pattern of cable rail and embankment collisions for the segment between the EJMT and the Herman Gulch interchange. Crashes occurring during adverse winter road and weather conditions are also an identified pattern in that segment. For the segment between the Herman Gulch interchange and the Bakerville interchange, the crash pattern recognition identified a pattern of injury, multi-vehicle, rear-end, and cable rail crashes, as well as crashes occurring under winter road conditions.
