## **Close Out Documents**

**AP-75: 4620 Clayton St.**

Structural Demolition

## **Structure Survey Assessment Report AP-75**

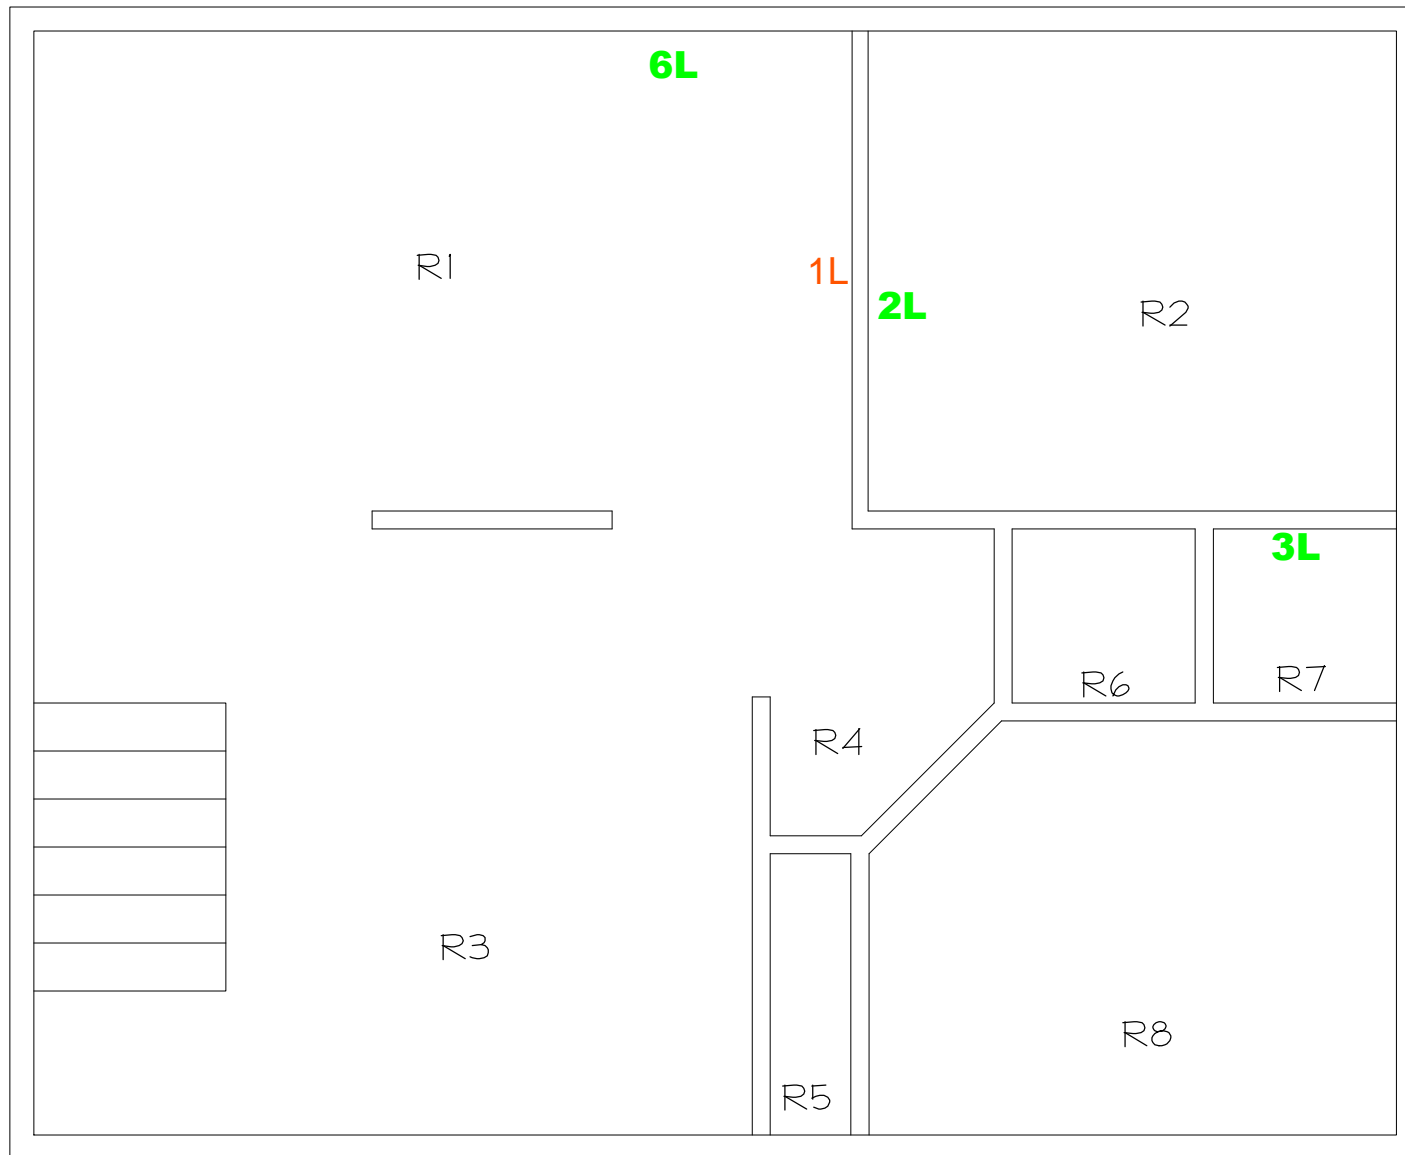
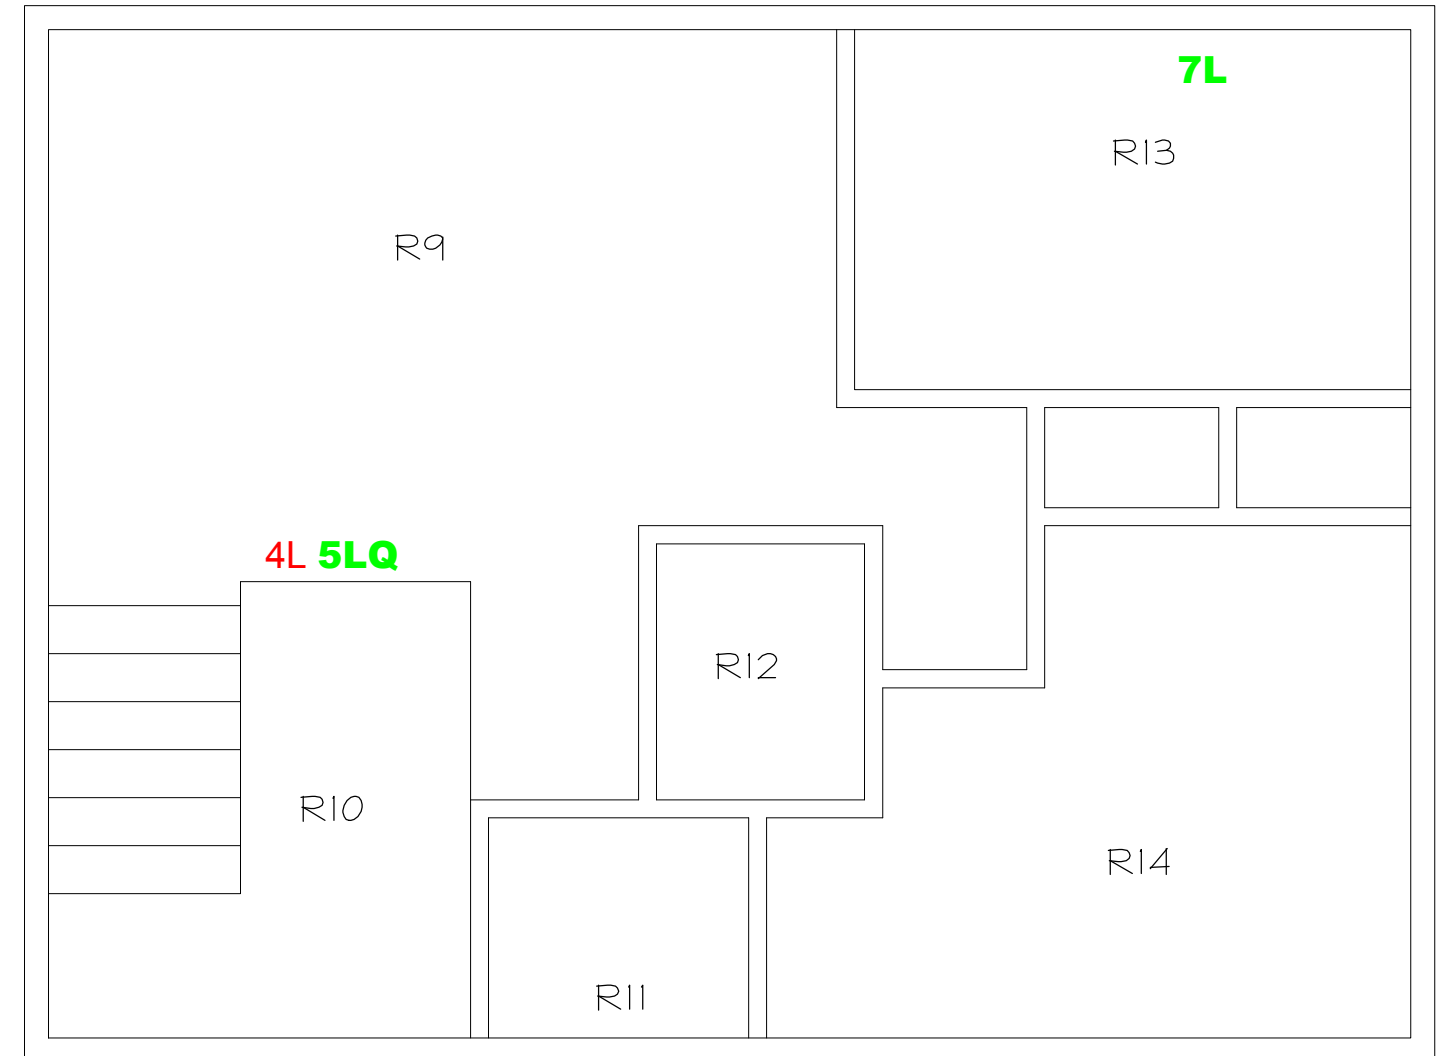
**FIGURE 3 - Lead-Based Paint Sample Locations**  
 CENTRAL 70 - Structure Survey Assessment Map  
 AP-75  
 4620 Clayton St., Denver, CO  
 April 27, 2018  
 APEC #: 18-3066

A total of 9 homogeneous paint color variations were analyzed for the presence of LBPs and LCPs (Table 3-2; Figure 3). Under EPA 40 CFR Part 745, LBP is defined as any paint or surface coating that contains lead equal to or exceeding 0.5% (by weight), while LCP is defined as any paint or surface coating containing lead greater than or equal to 0.06% up to 0.5% (by weight). Please note that the regulatory definition of LBP only applies to child-occupied facilities or targeted housing (pre-1978). For all other facilities. Caution should be taken during demolition to minimize cutting, abrading, or otherwise causing an air disturbance to this material and work must be completed in accordance with the OSHA Lead in Construction Standard (29 CFR 1926.62).

Two lead samples (4620CL-1L & 4620CL-4L) are found to be greater than 0.06% by weight and less than 0.5% by weight and is considered LCP (Table 3-2). Two samples (4620CL-8L & 4620CL-9L) had lead concentrations greater than 0.5% by weight and is considered LBP. The remaining 5 sample results were less than the LCP and LBP thresholds, and are considered non-lead containing paint (NLC). The laboratory analytical report is included in Appendix D.

While the TCLP results indicate that the waste stream is not characteristically hazardous with respect to lead content, LCP and LBP are still present in the building materials. Therefore, the contractor responsible for demolition of this structure is notified with receipt of this report of the presence or potential presence of LCP and/or LBP in the building materials that comprise the building. The contractor should also notify their employees of the presence of LCP or LBP prior to any disturbance, and make the US Department of Labor Occupational Safety and Health Administration publication number 3142-12R 2004 available to their workers. (“Lead in Construction”, <http://www.osha.gov/Publications/osha3142.pdf>). The standards address topics such as permissible exposure limits (PELs) for workers, exposure assessment, protection of employees during assessment of exposure, employee notification, PPE, medical surveillance, along with other topics related to working with LCP and LBP.
