# MT. GARFIELD CULVERT STUDY

Colorado Department of Transportation

February 2021

# Executive Summary

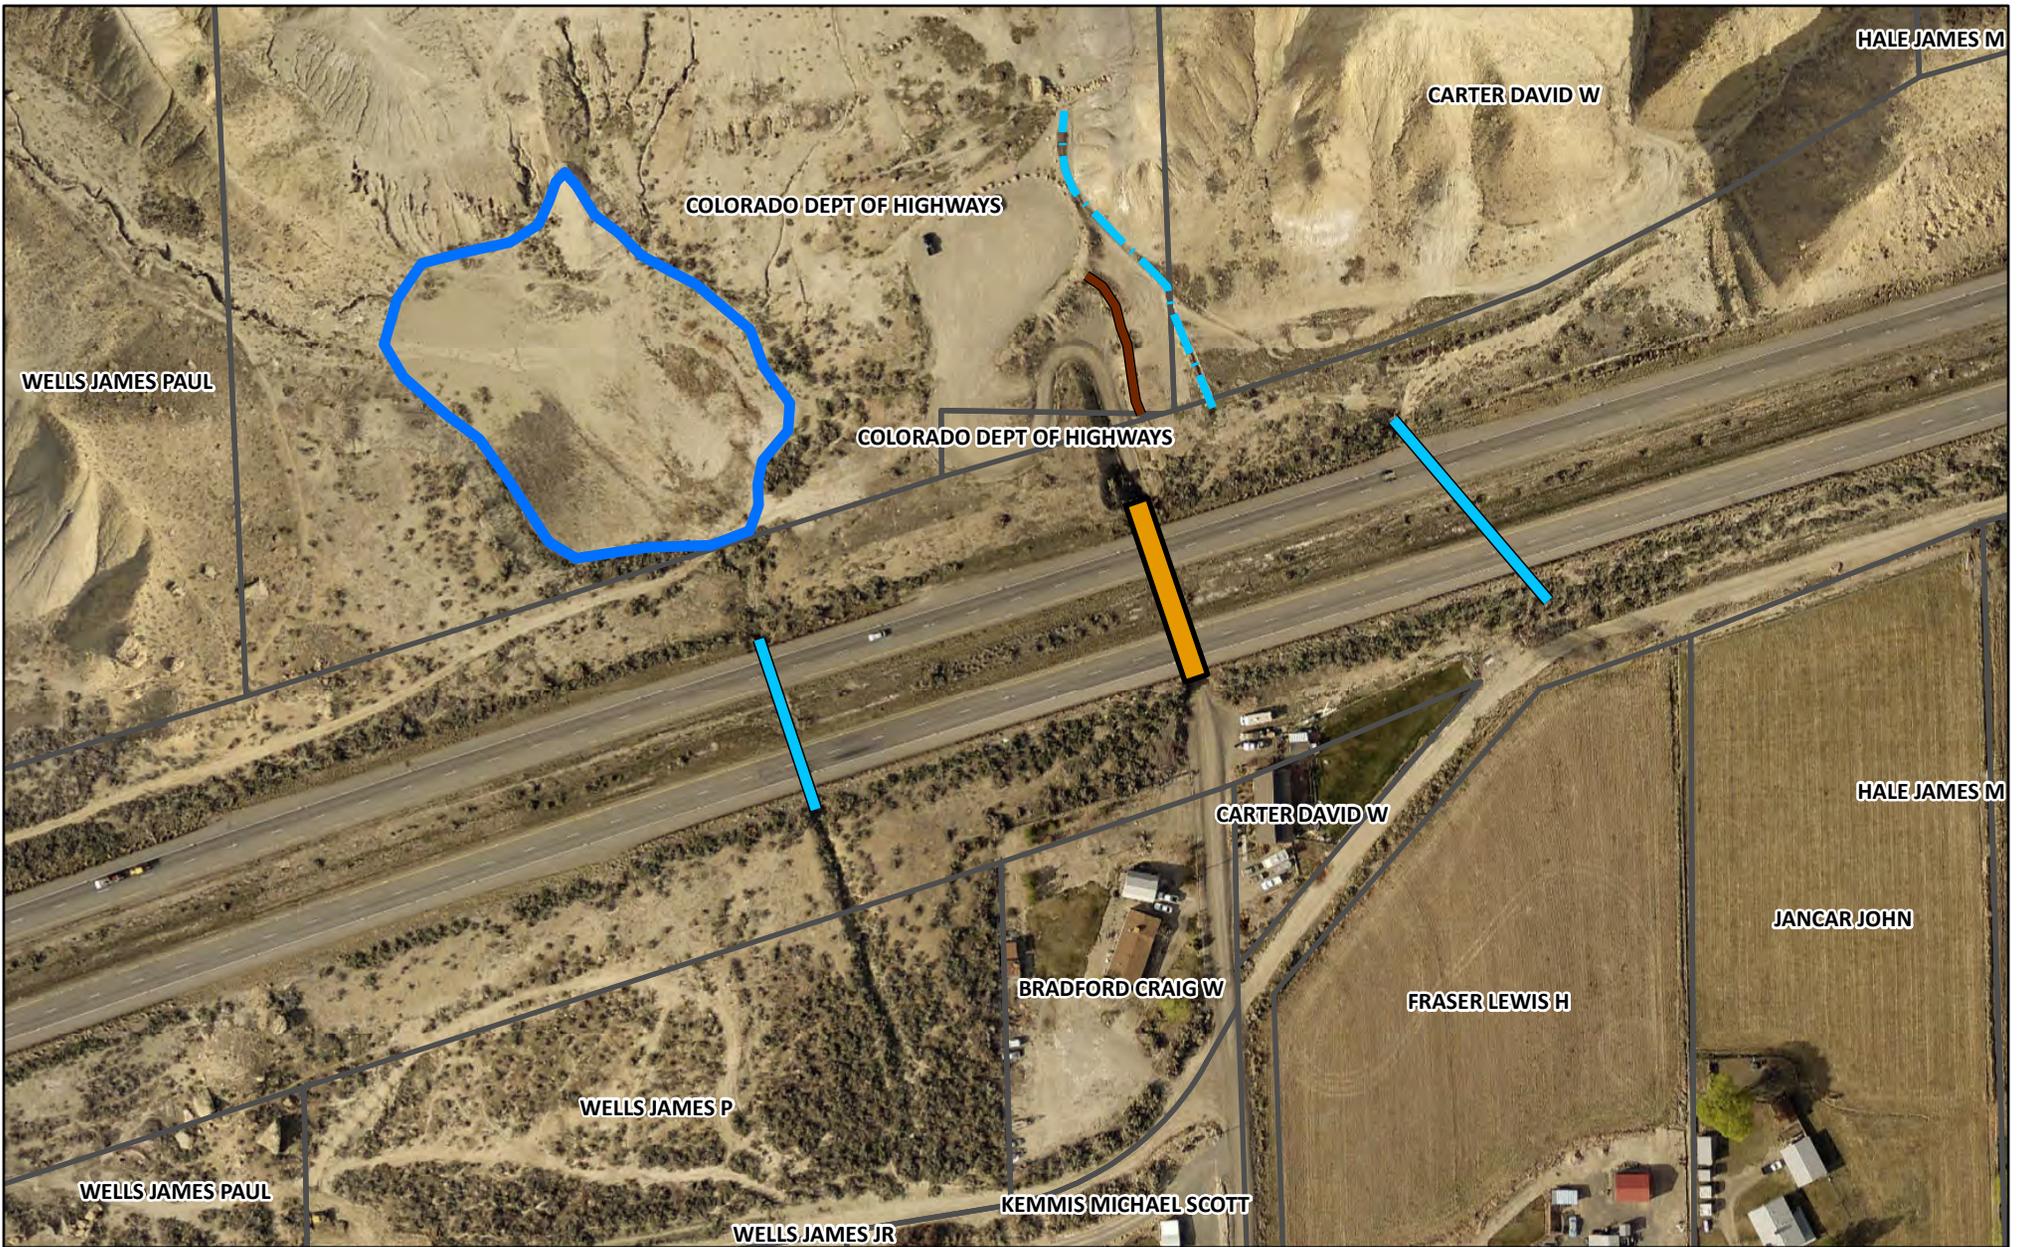
**Figure 1: Existing Stormwater Control Features  
Mt. Garfield Trailhead Alternatives Feasibility Study**

The existing features/structures identified during the field visit are shown in Figure 1. The trailhead access tunnel provides vehicular access to the trailhead. The floor elevation in the tunnel is lower at the north end of the tunnel and higher on the south end. As a result, stormwater entering the tunnel from the north pools within the northern portion of tunnel and does not discharge until the pooled water elevation increases to above the floor elevation at the south end of the tunnel. Any runoff discharging from the tunnel flows south along the access road, potentially impacting private property adjacent to the road. There was no evidence of diversion or control structures designed to capture or divert runoff flows discharging from the access tunnel for beneficial use.

Runoff originating from upgradient areas north-northwest of the trailhead flows toward a large detention basin that discharges to a large culvert that conveys flows to a drainage channel south of the interstate highway (Figure 1). The detention basin was dry at the time of the field visit. The basin appears to be nearly filled with sediment, resulting in limited capacity to detain storm flows. The basin had historically detained runoff, as is evident in the Mesa County 2016 aerial photograph, where ponded water covers approximately 50 percent of the basin. Evidence of former high-energy flows was evident along the drainage channel south of the interstate highway. No features or structures were observed along the channel to indicate that the period flows were captured or otherwise controlled for any beneficial use. Grading and placement of manmade barriers suggested that actions had been taken to prevent flooding of the adjacent lands.

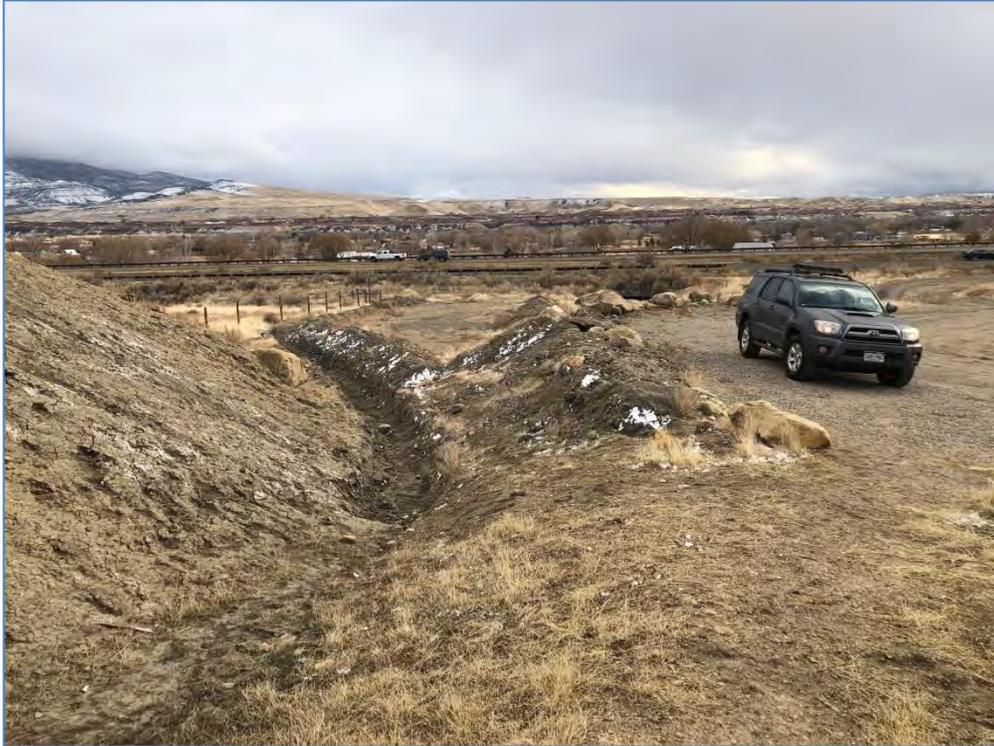
Photo 1: Upstream end of constructed channel.

A drainage channel and earthen berm have been constructed north of the tunnel to direct runoff originating north-northeast of the trailhead away from the parking area and access tunnel (Figure 1). Photographs of the channel and berm are provided in Attachment A. The drainage channel, which is approximately two feet wide and one foot deep, was presumably constructed to reduce the potential for runoff to flow onto the parking area and ultimately toward the trailhead access tunnel. The channel extends from near the northeast corner of the parking area, continues along the west side of a fence delineating the eastern CDOT property boundary, and terminates at the southern CDOT property boundary; it is suspected that CDOT's eastern property boundary coincides with the fence line and the boundary shown on the Mesa County parcel map and depicted in Figure 1 is not accurate. The channel directs runoff flows toward a low-lying area near the north end of a culvert extending beneath the interstate highway. The south end of the culvert appeared to be plugged; therefore, limited flow is currently expected through the culvert. There was no evidence of diversion or control structures designed to capture or divert runoff flows discharging from the culvert for beneficial use. The earthen berm was constructed east of the access road, extending from the parking area to the parcel boundary. The berm, which is approximately three feet wide and two feet high, directs flood flows in the constructed channel away from the access road and tunnel.
