**SH 83 Safety and Operations Analysis:
Bayou Gulch to El Paso County Line
MP 30.20 – MP 53.88
Project Code 23008**

Appendix A - Safety Assessment Report

March 2022

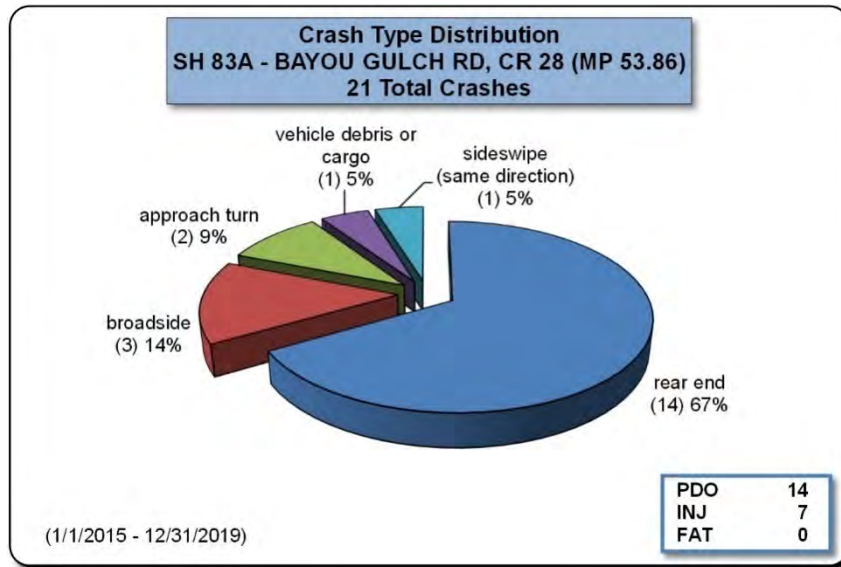
Figure A24: Bayou Gulch Road Crash Type Distribution

There were 21 crashes at this 2-lane divided signalized 4-leg intersection. The SPF analysis indicated LOSS III for both severe and total crashes. The crash type distribution is shown in **Figure A24**.

Relationship to Previous Study: There were 18 crashes reported in the 2019 Safety Assessment. There were no recommendations for improvement based on the 2012 to 2016 crash data.

The proportion of *rear end* crashes was somewhat higher than expected but not significant when compared to similar facilities. There was a minor concentration of crashes between 2 p.m. and 4 p.m. which could coincide with school egress. While no geometric improvements are recommended at this time, a review of the signal timing during this afternoon peak should be considered.

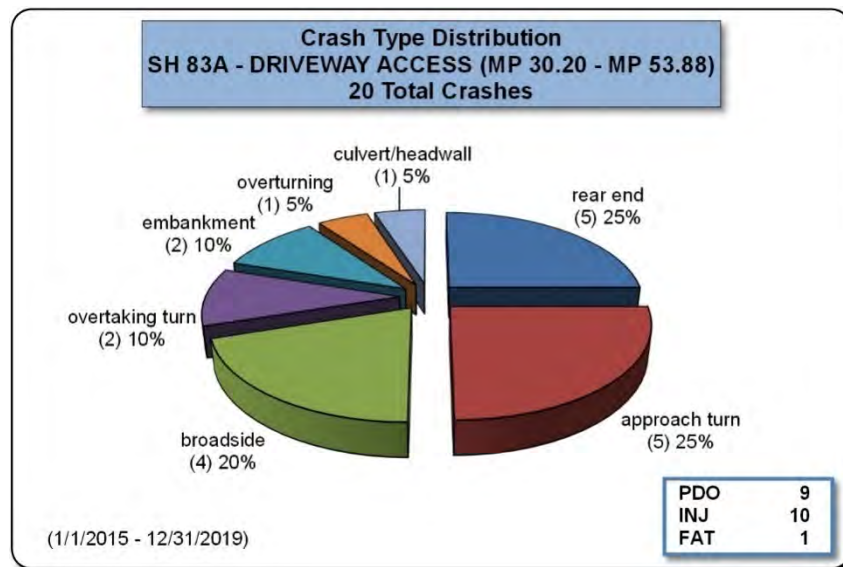
Figure A25: Driveway Access Crash Type Distribution

Crashes that occurred at driveway access locations accounted for 5% of the total crashes (20 of 425). There are no SPF analysis methodologies that apply directly to driveway access crashes. **Figure A25** shows the crash type distribution for the driveway access crashes during the study period. A graphic displaying the approximate location and severity of driveway crashes, by direction, is shown in **Figure A26**.

Relationship to Previous Study: There were 15 crashes reported in the 2019 Safety Assessment, one (1) resulted in a fatality. There were no recommendations for improvement specific to driveway access crashes based on the 2012 to 2016 data.

There was one (1) fatal *rear end* crash that occurred in September 2016 at MP 44.03. Details were limited, but it appears that a southbound passenger car and a southbound motorcycle were both stopped in traffic, presumably due to a vehicle waiting to turn left into the nearby driveway. A third vehicle failed to stop and collided with the stopped vehicle at a high rate of speed. The chain collision resulted in the death of the motorcycle rider.

As per the access control plan, combine or limit access to identified locations as development occurs to enhance the safety and operations of the SH 86 corridor. In particular in the Franktown area and to the north along SH 83 toward the end of the study segment at Bayou Gulch Road due to the higher frequency of driveway related crashes.
