I-270 Existing Safety Conditions Report

I-270 Corridor Improvements

July 2021

CDOT Project No.
STU 2706-043

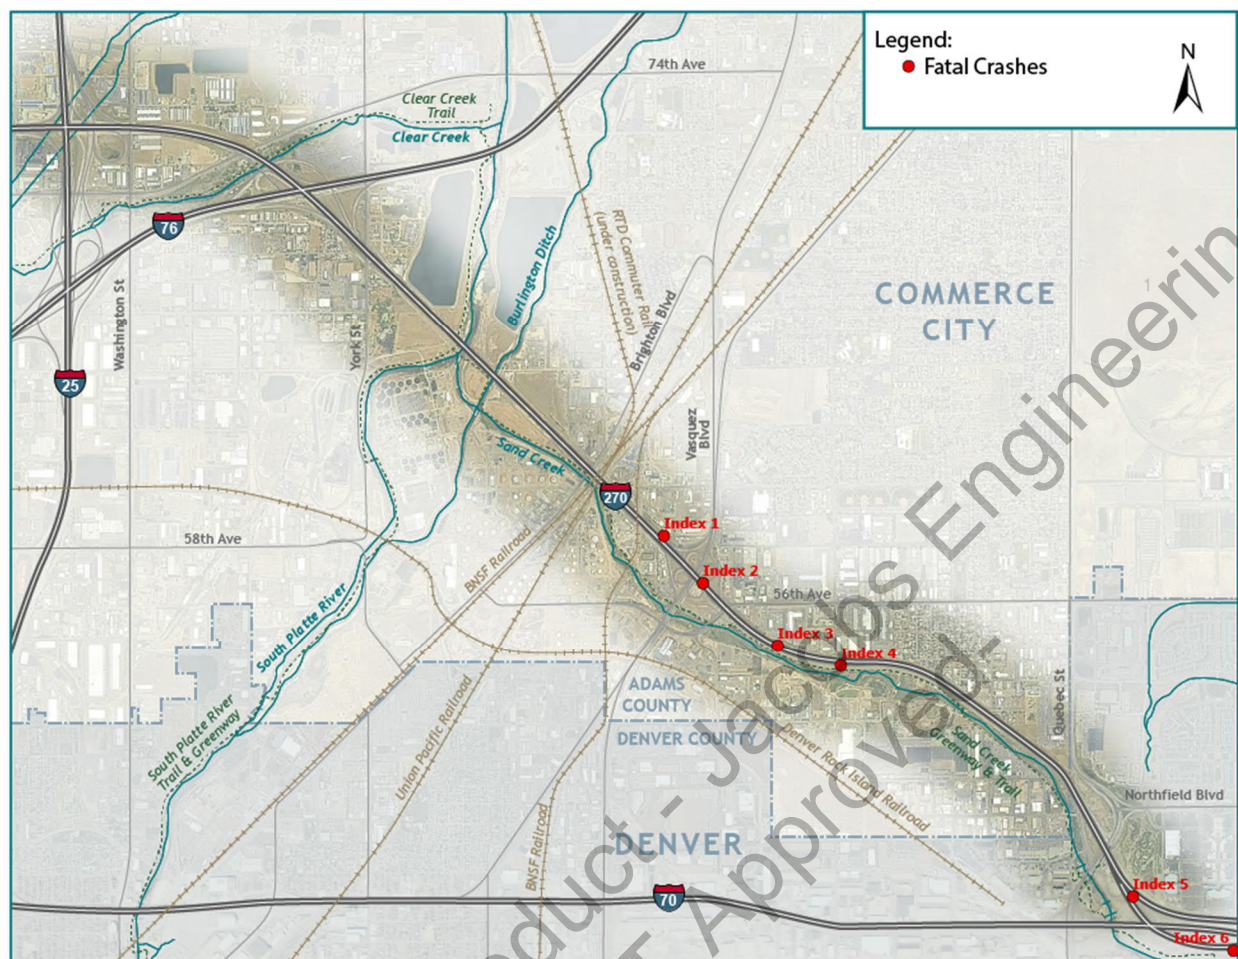
Figure 6. Location of the I-270 Mainline Fatal Crashes

Six fatal crashes occurred from 2014 to 2019 on the I-270 mainline but none on the I-270 ramps. These fatal crashes are explained in more detail in Table 2 and are shown on the map on Figure 6. The index number is used to link Table 2 and Figure 6. For each fatal crash, the location, date, roadway, light, and weather condition information are provided in addition to crash type. Information about the driver (or pedestrian) and possible contributing factors (if any were recorded) are provided.

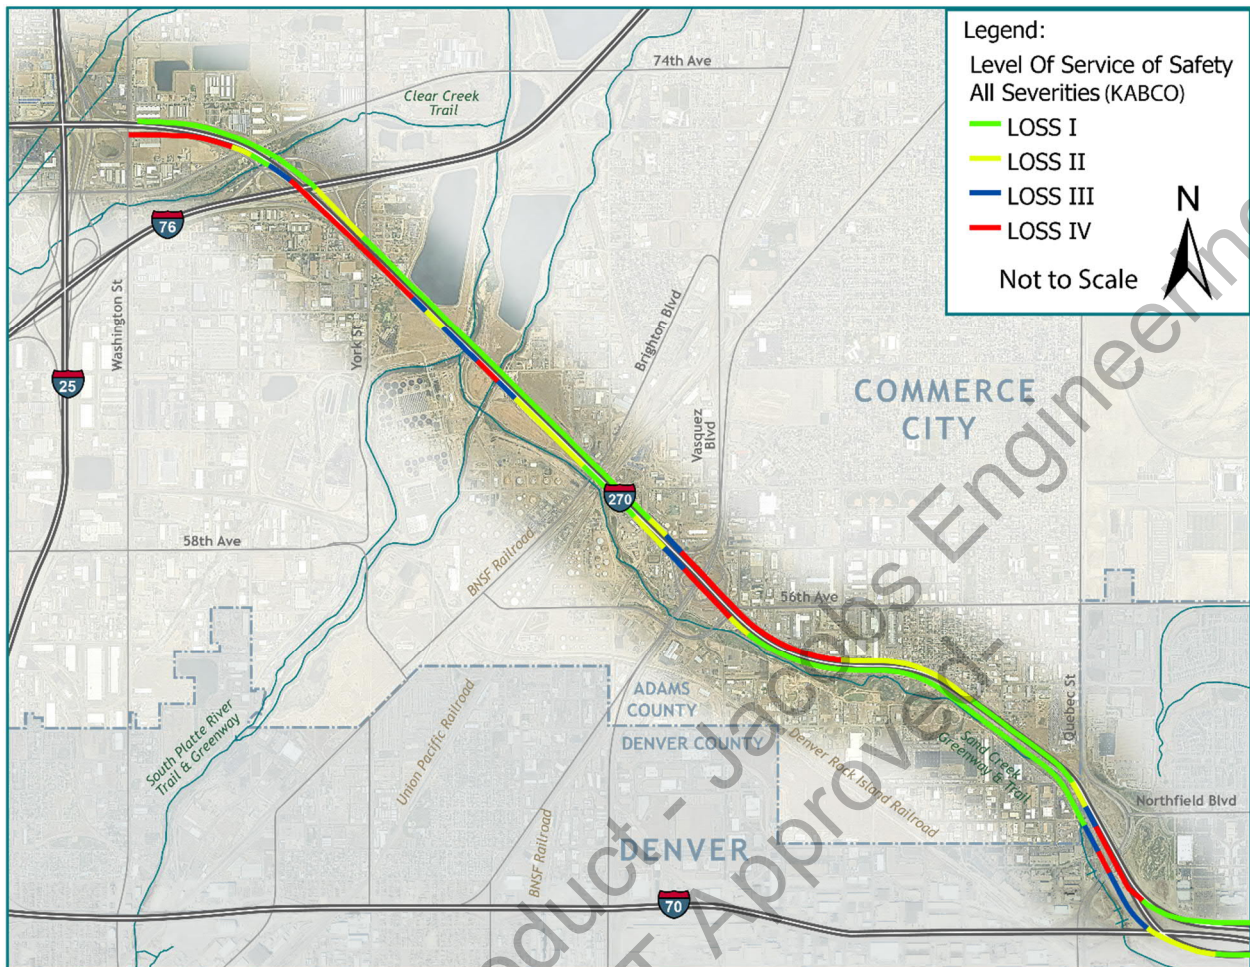
Figure 11. Level of Service of Safety Based on Total Crashes

As shown on Figure 11, there are seven hotspots (LOSS III or IV) along the I-270 mainline. Analysis of each of these locations is presented in this section. In addition to the LOSS based on all crashes, the LOSS is also calculated based on fatal/injury crashes shown on Figure 12. Even though the hotspots are identified based on total crashes (Figure 11), the LOSS based on fatal/injury crashes can provide an overview of the severity of the crashes for each hotspot. Also, consideration of the severity of crashes and the sites that have a higher magnitude of severe crashes, for example fatal/injury related, is important because this addresses the objective of the *Colorado Strategic Highway Safety Plan (2014)*, which is to reduce severe crashes.

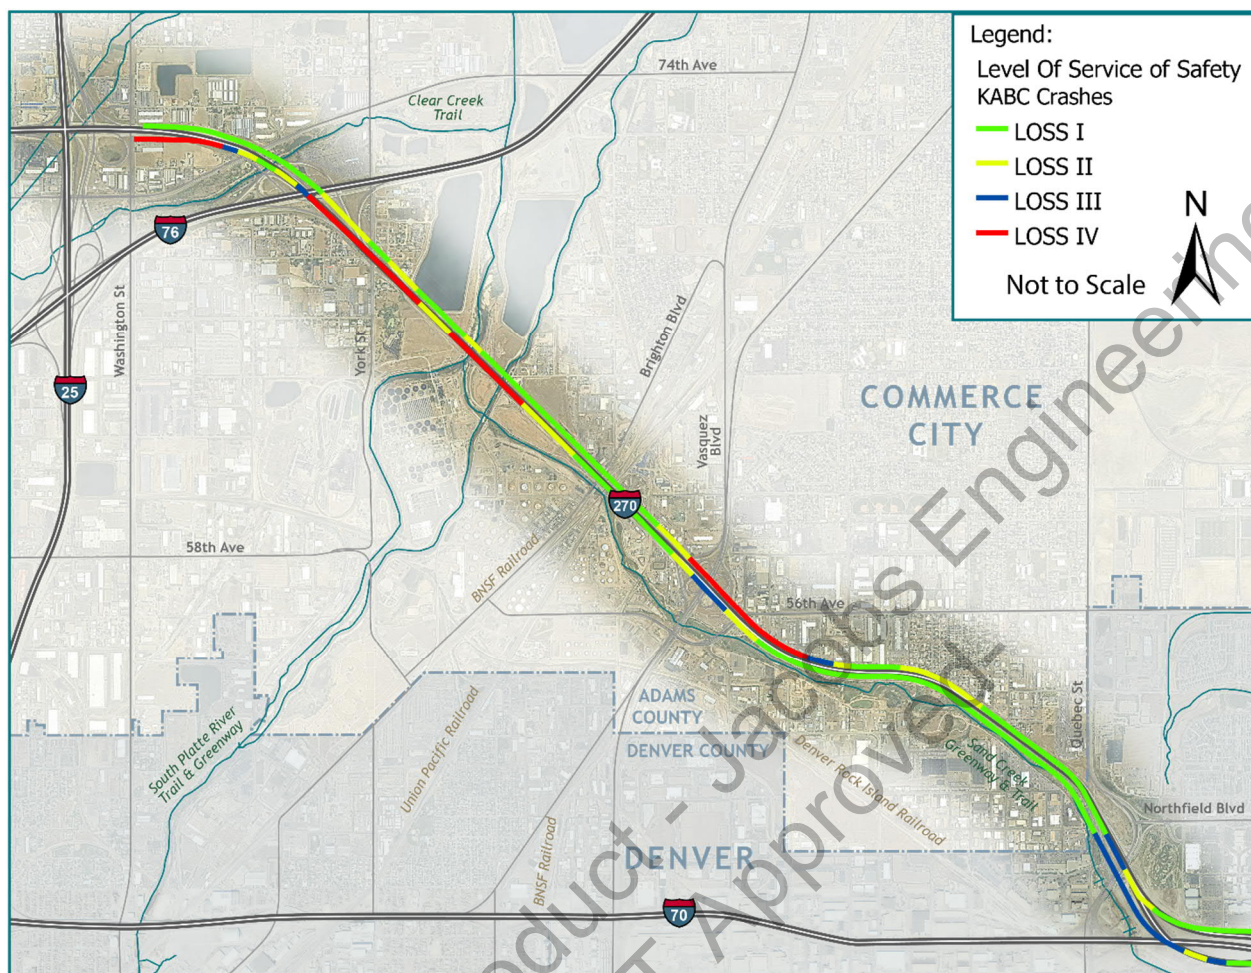
Figure 12. Level of Service of Safety Based on Fatal and Injury Crashes (KABC)

Comparing Figure 12 and Figure 11 provides an overview of the severity extent of each hotspot. Whereas some hotspots may have similar LOSS in both figures, there might be locations that have a higher LOSS based on fatal/injury LOSS or vice versa. For example, hotspots at Quebec Street interchange (both directions) are identified as LOSS IV for all crashes but are identified as LOSS III for fatal/injury crashes, which means crashes are less severe at this location. However, the eastbound hotspot over the South Platte River and the Burlington Ditch is mostly LOSS III for all crashes but is identified as LOSS IV for fatal/injury crashes, which means crashes at this location are more severe.

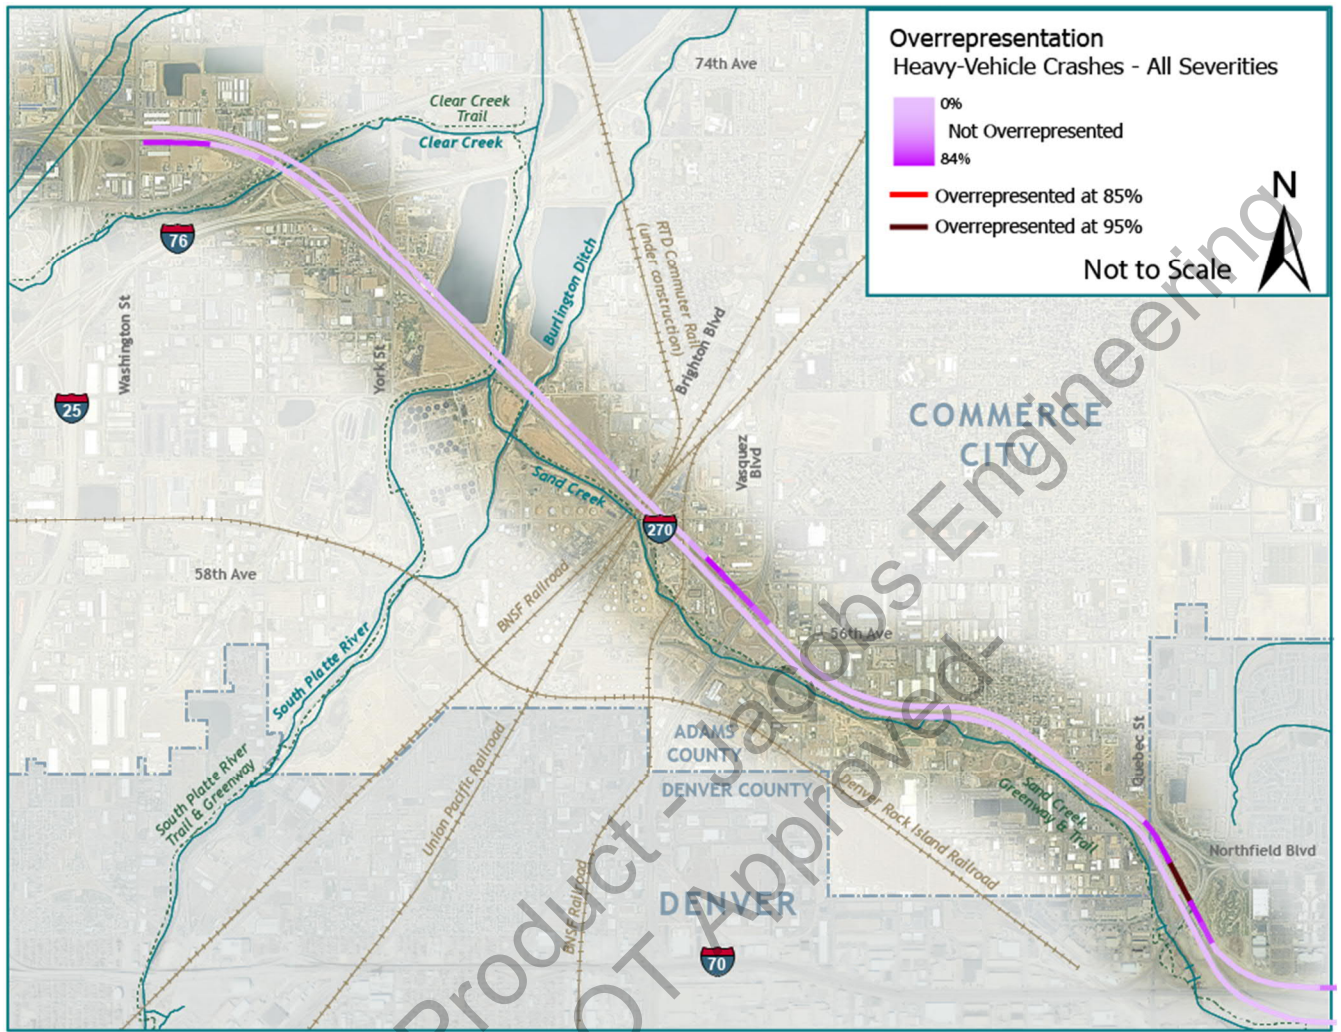
Figure 19. Overrepresentation of Heavy-Vehicle Crashes – All Severities

Figure 19 shows that for the mainline of I-270, the primary segment with a 95 percent overrepresented heavy-vehicle crash pattern is on the westbound direction of the Quebec interchange, which also has a slight overrepresentation of heavy-vehicle crashes (below but close to 85 percent) on the westbound Vasquez interchange and eastbound between I-25 and I-76. Part of the overrepresentation of truck crashes in the Quebec interchange area may be due to the presence of two major truck service facilities that are located on each side of I-270 near the interchange, which add heavy-vehicle traffic. In addition, the ramps of Vasquez interchange have an overrepresentation of heavy-vehicle crashes, which is discussed in Section 5.0.

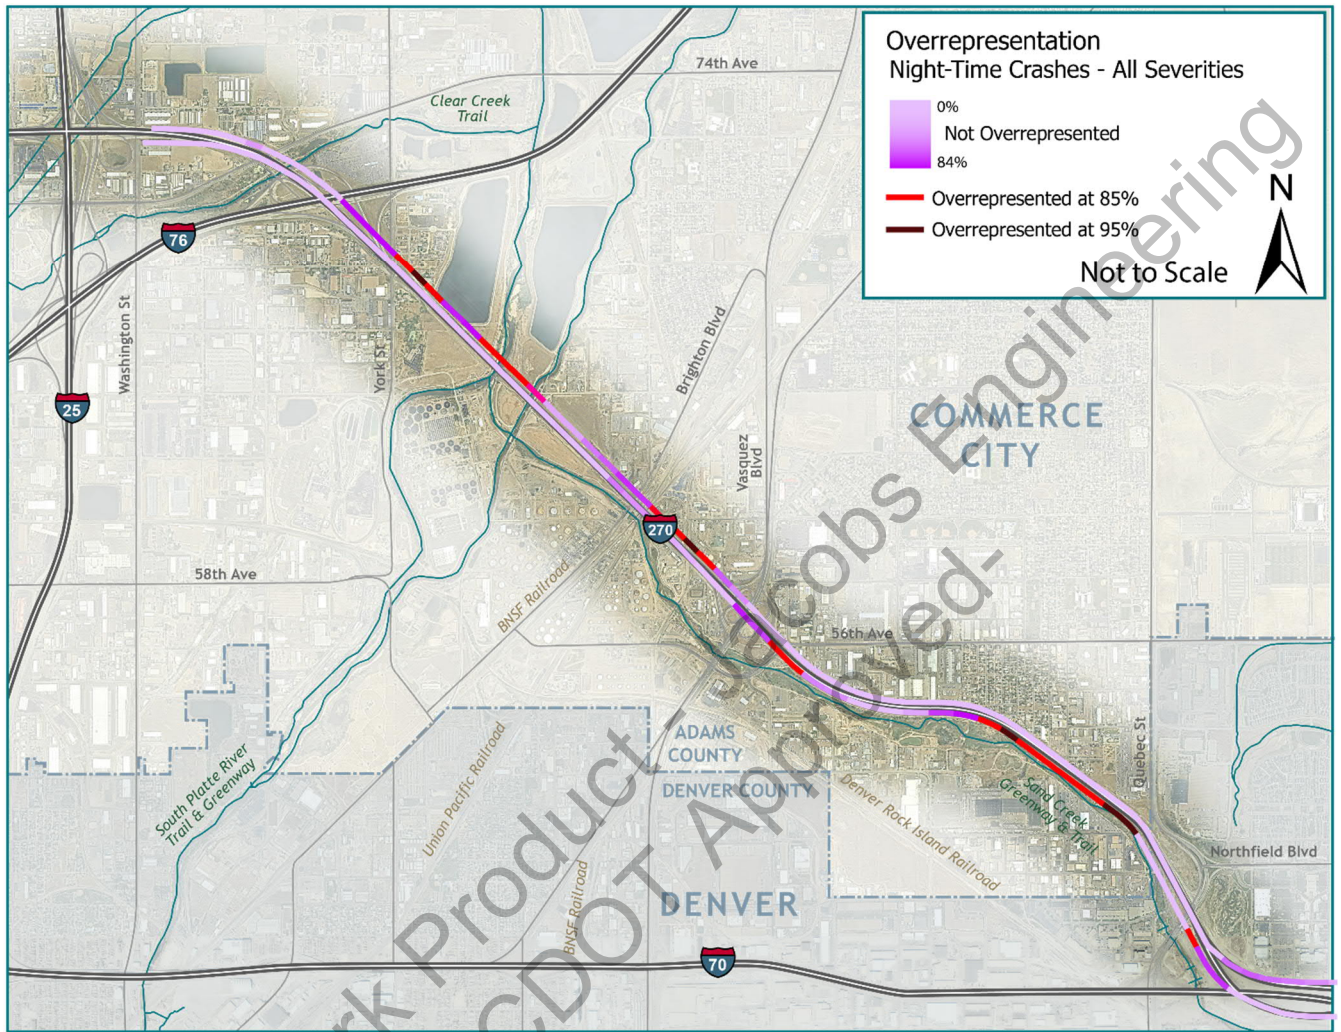
Figure 21. Overrepresentation of Night-Time Crashes – All Severities
 Source: Jacobs

Figure 21 shows the overrepresentation of night-time crashes for I-270 and locations with high overrepresentation that would be candidates for improving the lighting. Night-time crashes are defined as crashes coded by the reporting police officer as dark-lighted, dark-unlighted, and dawn or dusk. Specifically, the eastbound direction from milepost 3.3 to 4.1 (between Vasquez Boulevard and Quebec Street) has a long continuous segment with night-time crashes overrepresented at either 85 or 95 percent.

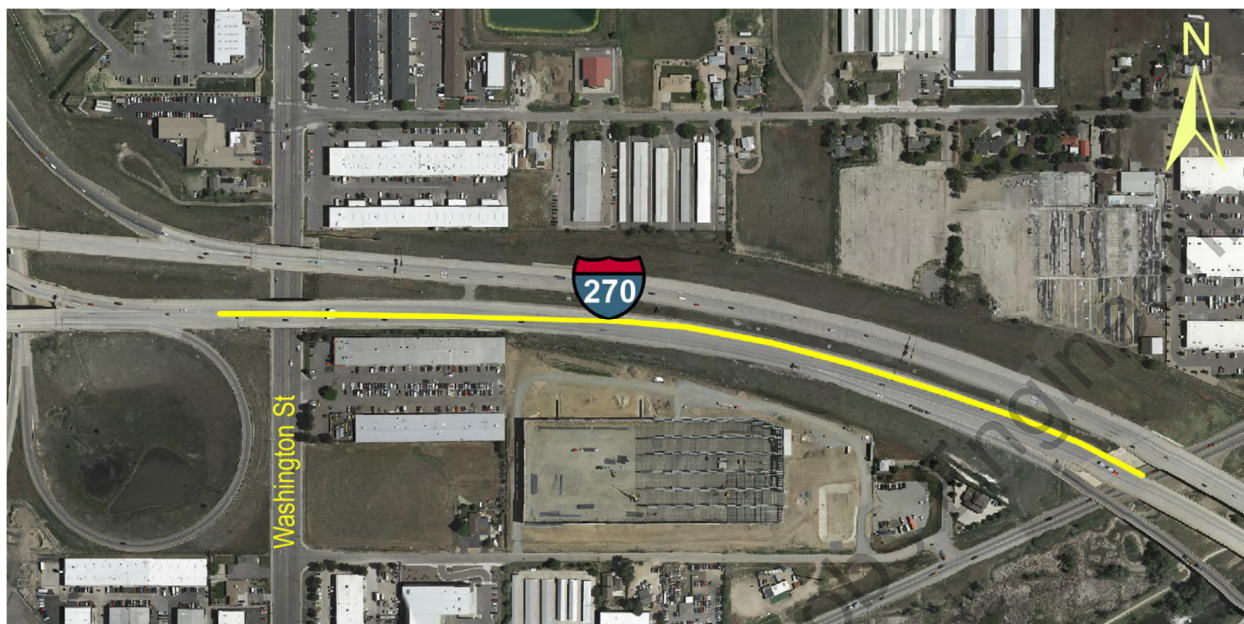
Figure 22. Summary Section - Eastbound from I-25 to I-76 (270B 0.17-0.67)

This location is a safety hotspot (ranked third) with a high potential for safety improvement and an overrepresented sideswipe-same-direction crash pattern (Figure 23). Responding officers coded the top two contributing factors as careless driving and unsafe lane change (Figure 23b).

Given the congested conditions during the a.m. and p.m. peak periods and the shorter weaving distance provided, there can be limited gaps in traffic for motorists to weave across the three I-270 mainline lanes to reach the downstream right-side exit. This maneuver may be particularly challenging for heavy-vehicle drivers that would need to make lane changes. A study conducted by CDOT indicated that this weaving maneuver volume from I-25 to I-76 may be relatively light; the average frequency of weaving vehicles was 66 vehicles in the a.m. peak (6 to 8 a.m.) and 36 vehicles in the p.m. peak (3 to 6 p.m.).

Overall, under current conditions, a statistically high overrepresentation of sideswipe crashes occurs (Figure 17). There is a 25 percent proportion of truck crashes, which translates to an 81 percent probability of overrepresentation at this section (Figure 19).

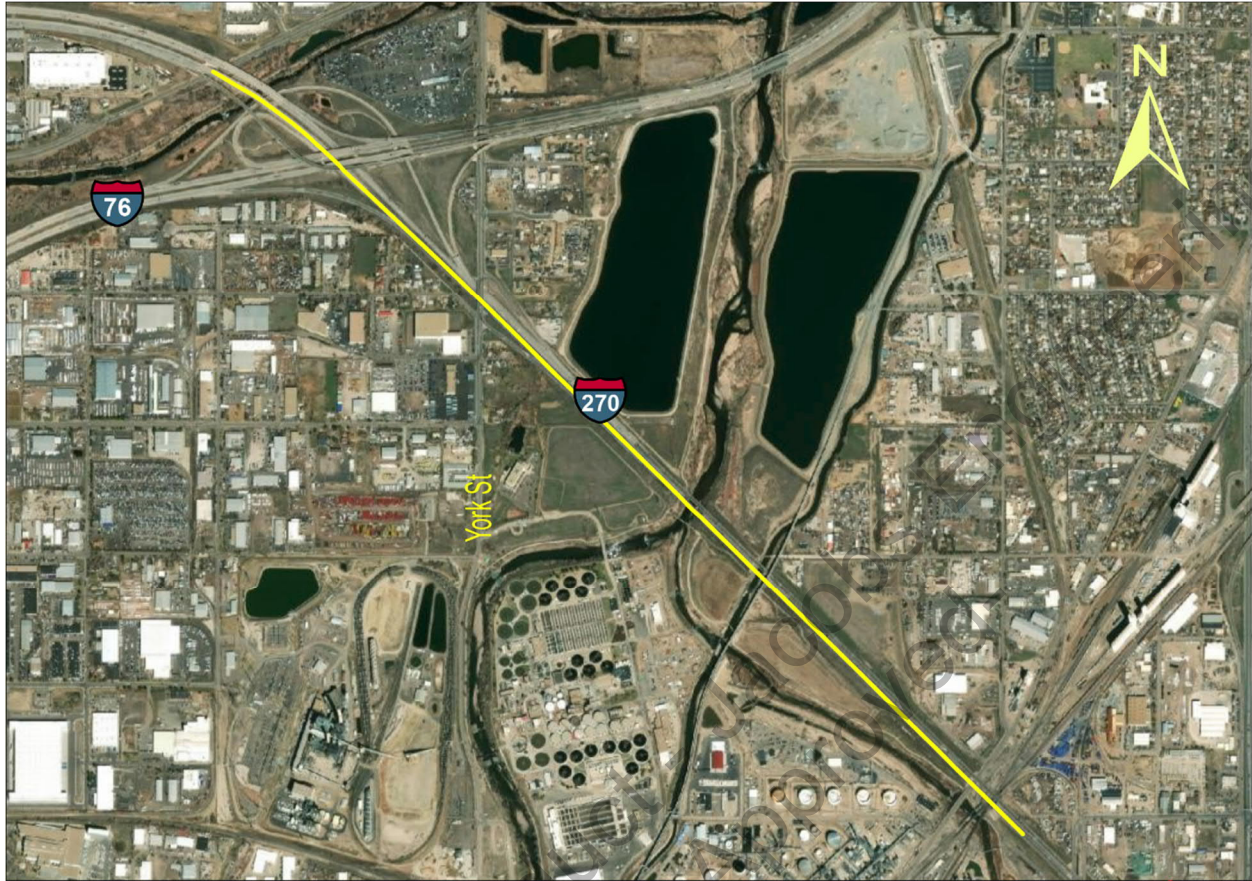
Figure 24. Summary Section - Eastbound from I-76 to Vasquez Boulevard (270B 0.877 to 270A 1.6)

The elevated rear-end crash frequency is likely caused, at least in part, by the close proximity of the I-76 and York Street successive on-ramps in the eastbound direction, which is a site of regular traffic congestion. The largest proportion of crashes happen during the a.m. peak (Figure 25c). It is important to note this section also has a higher frequency of heavy-vehicle crashes (Figure 8) but is not considered to be overrepresented at the 85 or 95 percent levels (Figure 19).

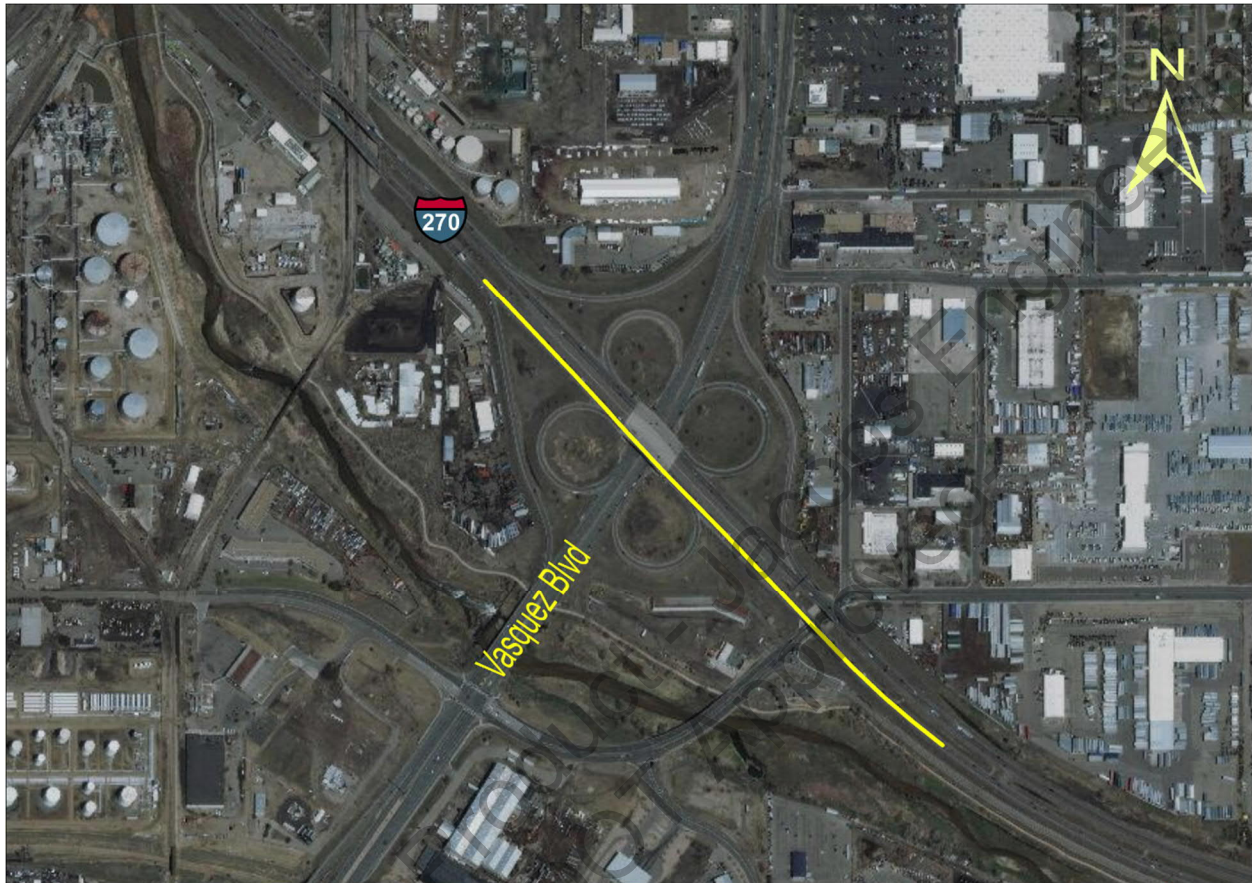
Figure 26. Summary Section - Eastbound Vasquez Interchange (270A 2.1-2.5)

I-270 eastbound near Vasquez Boulevard is a safety hotspot (rank 5) with potential for safety improvement. Both rear-end and sideswipe-same-direction identified crash patterns are likely resulting from slower traffic merging with high-speed mainline traffic and diverging traffic associated with the cloverleaf interchange design. No specific pattern regarding time of day was observed at this location.

When the interchange was constructed decades ago, lower volume and congestion levels were likely present to enable appropriate accelerating and decelerating to occur in the auxiliary lane between the ramps. The approximately 450-foot weaving distance between the successive eastbound on- and off-ramps is likely not sufficient based on current needs for merging and diverging maneuvers given the current through and weaving volumes. The rear-end crashes may be happening because heavy volumes of accelerating/decelerating vehicles, particularly heavy vehicles, are occurring to and from the mainline lanes, resulting in a speed differential with through traffic.

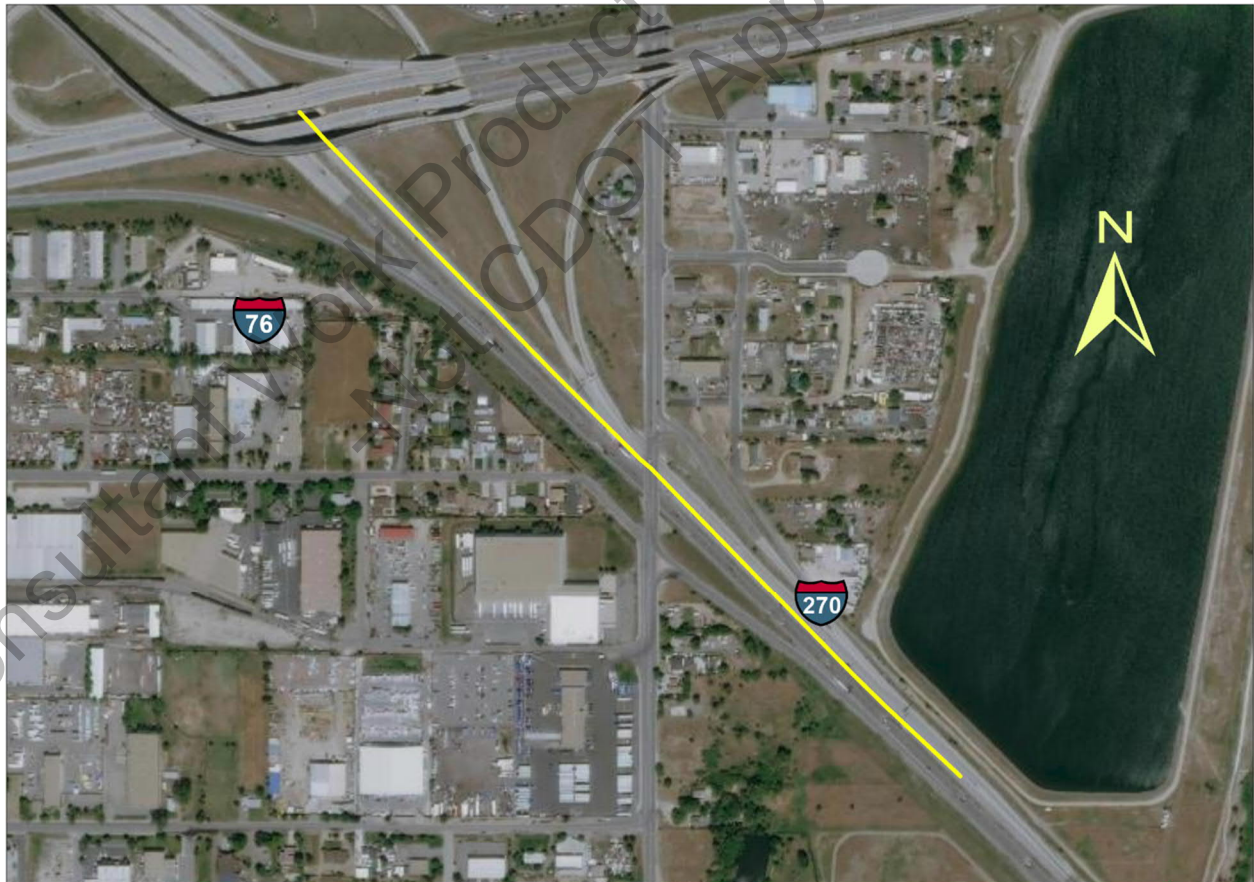
Figure 33. Summary Section - Westbound York Street to I-76 (270A 0-0.7)
Source: Jacobs

This location is not a safety hotspot but shows a strong pattern of ROR (Figure 16) and wet-pavement crashes (Figure 18) happening in off-peak hours (Figure 34d). Concrete barrier crashes (Figure 34c) during snow or rain (Figure 34a) and driving too fast for conditions (Figure 34b) are identified at this location. Installing a high-friction surface and/or check for possible drainage issues could help to address safety issues at this location.

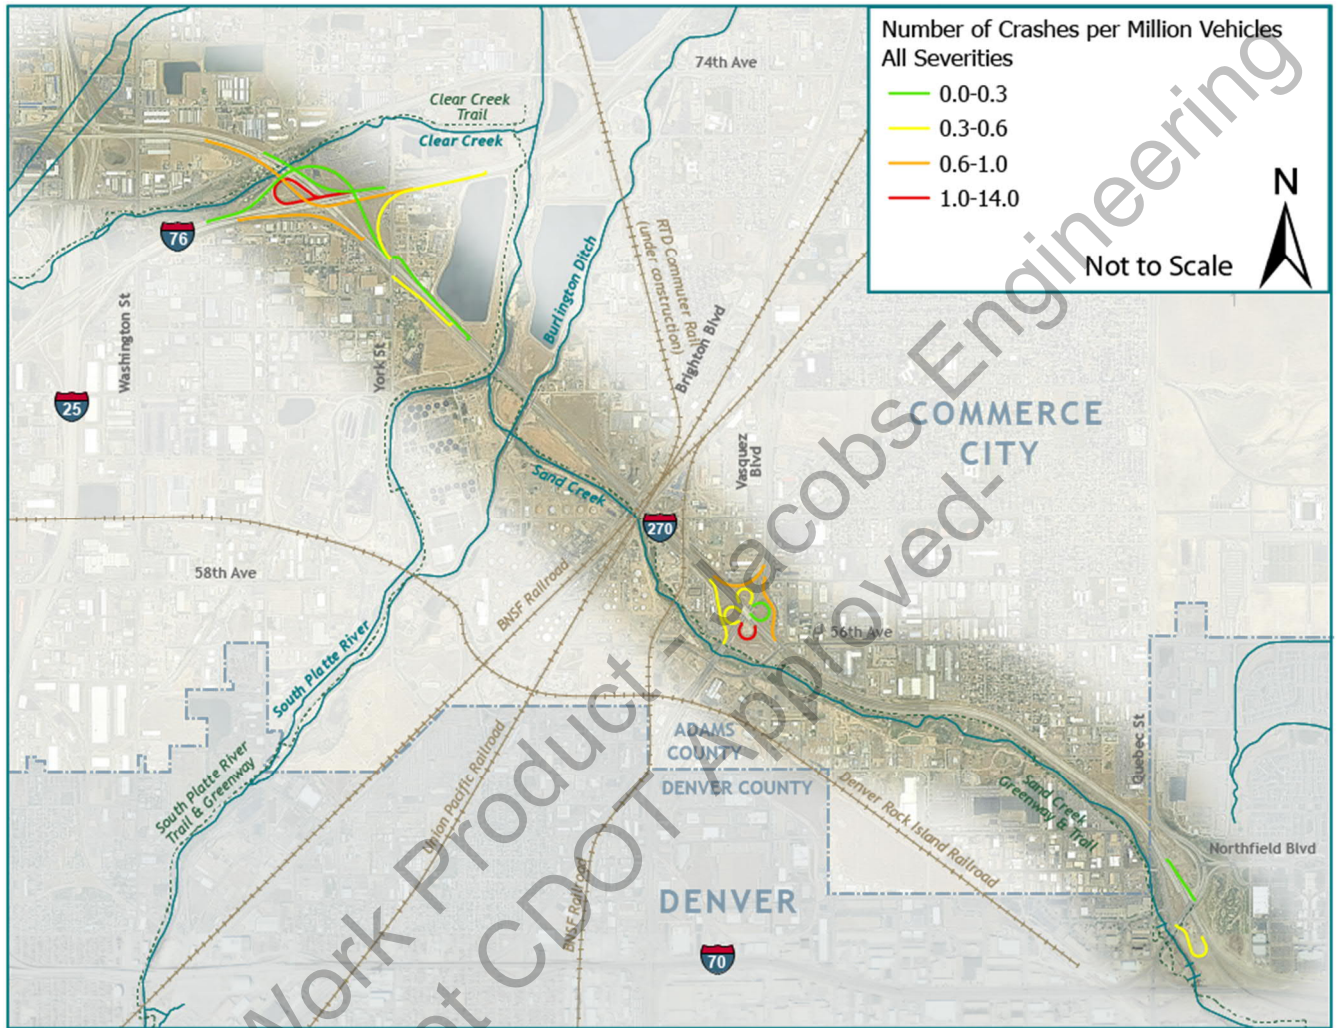
Figure 36. Results of Ramp Screening

Street, Vasquez Boulevard, and Quebec Street are analyzed. For each ramp, the calculated number of crashes per million vehicles per year ranges from 0.04 to 13.8 per million vehicles of travel and is shown on Figure 36. Results are visualized in four different colors, and the legend shows the range for each color.

The highest crash rate on ramps is related to the I-76 westbound to I-270 eastbound interchange, with a value of 13.8 crashes per million vehicles. The second highest rate is related to the loop ramp on I-270 eastbound to Vasquez Boulevard northbound, with the value of 1.09 crashes per million vehicles. These two ramps are shown in red on Figure 36.

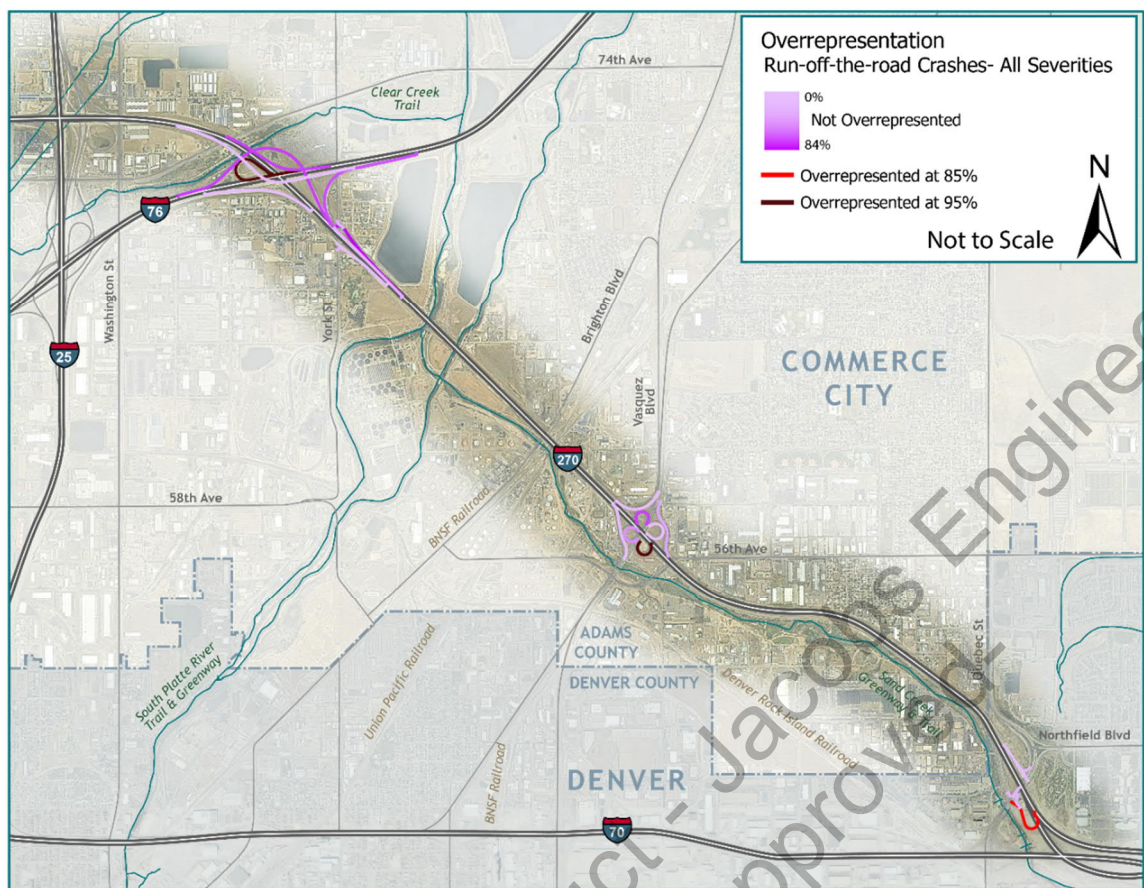
Figure 37. Overrepresentation of Run-off-the-road Crashes for Ramps – All Severities

Figure 37 shows ramps that have overrepresentations of ROR crashes. As indicated, the I-76 westbound to I-270 eastbound and I-270 eastbound to Vasquez Boulevard northbound are identified with an overrepresentation of ROR crashes with more than 95 percent confidence, and the I-270 eastbound to Quebec ramps are identified with an overrepresentation of more than 85 percent confidence. (Figure 38 shows photos of three of these situations having crash overrepresentations of ROR crashes.) It is shown later on Figure 48 that the I-76 westbound to I-270 eastbound and the I-270 eastbound to Quebec ramps are also overrepresented for night-time crashes and likely for ROR crashes.

Recommended countermeasures include providing increased deceleration length, improving visibility of curves, and adding signage could help improve the safety performance of these ramps. Note that I-270 eastbound to Vasquez Boulevard northbound has improved signage that may contribute to a reduced crash experience for night-time crashes (Figure 38b).

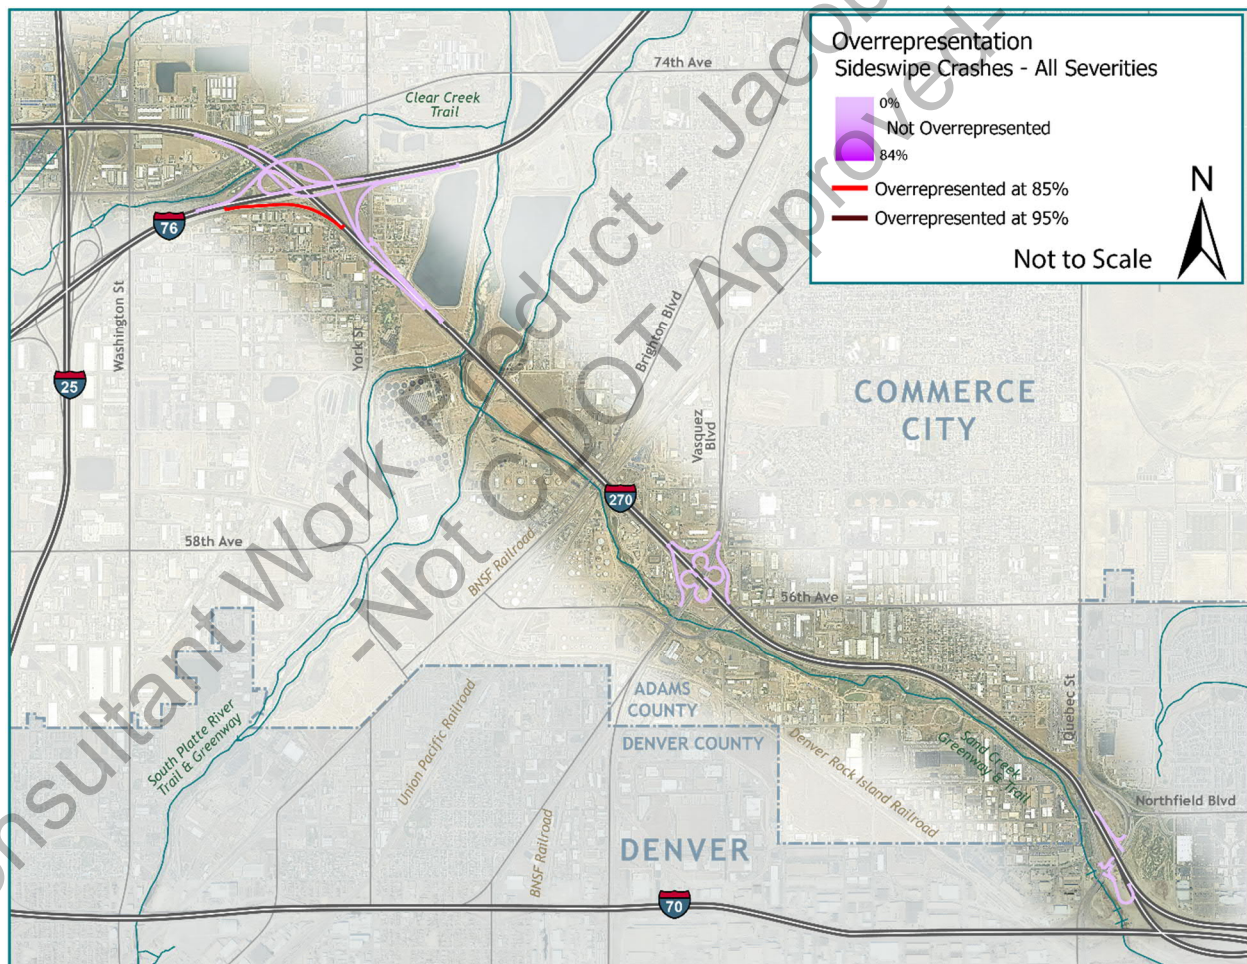
Figure 41. Overrepresentation of Sideswipe Crashes for Ramps – All Severities

As shown on Figure 41, the only ramp with an overrepresentation of sideswipe crashes is the I-76 northbound to I-270 eastbound, which is a two-lane ramp dropping to a one-lane ramp prior to merging with I-270, as shown on Figure 42. It is shown on Figure 47 that there is an overrepresentation of speed-related crashes and a slight (65 percent) overrepresentation of heavy-vehicle crashes on this ramp.

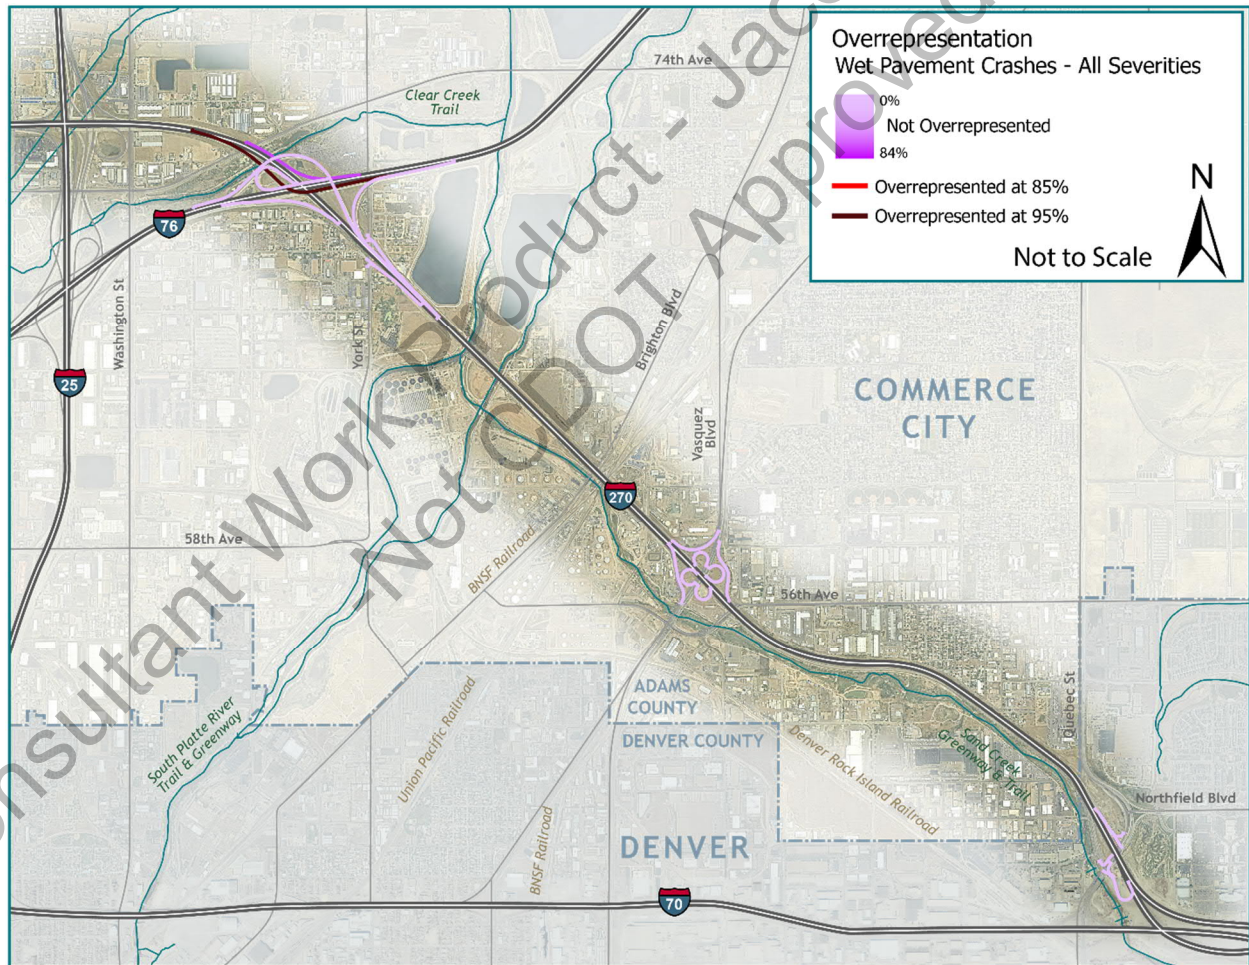
Figure 43. Overrepresentation of Wet-pavement Crashes for Ramps – All Severities
Source: Jacobs

As shown on Figure 43, wet-pavement crashes are overrepresented at the flyover ramp of I-270 eastbound to I-76 northbound (Figure 44). High-friction surface treatment could help to enhance the safety of this ramp. In addition, other potential countermeasures may include a review of the superelevation characteristics and drainage and the installation of active advisory speed warning devices.

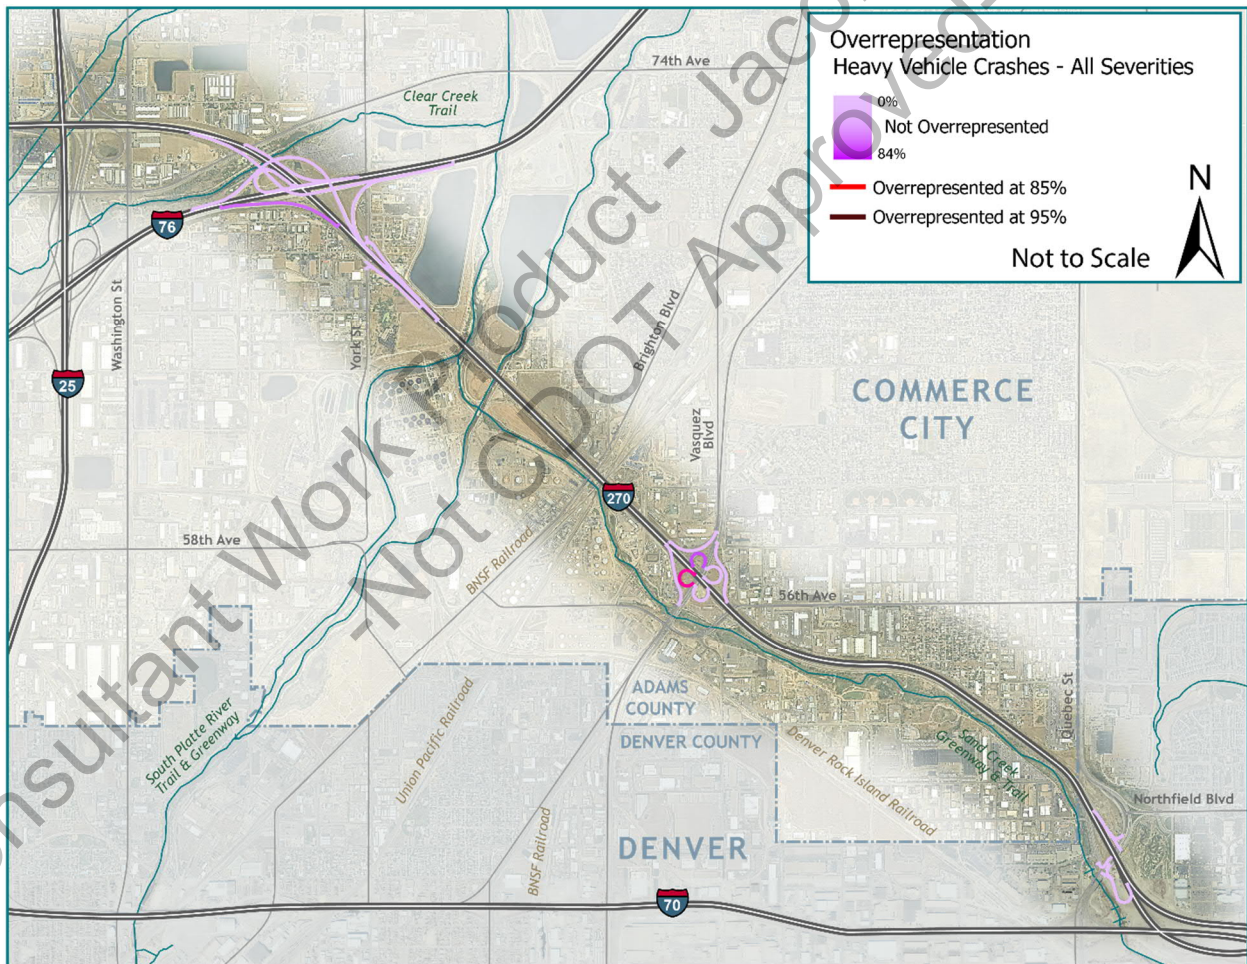
Figure 45. Overrepresentation of Heavy-vehicle Crashes for Ramps – All Severities
 Source: Jacobs

As shown on Figure 45, there is an overrepresentation of heavy-vehicle crashes on the loop ramp of Vasquez Boulevard southbound to I-270 eastbound, with a confidence level of 85 percent. Additionally,

the loop ramp of I-270 westbound to Vasquez Boulevard southbound also has an overrepresentation of heavy-vehicle crashes at a 71 percent confidence level. The smaller radii of the loop ramps might be more challenging for heavy vehicles to navigate and may contribute to more crashes. Crash issues may also be related to a higher volume of trucks on these ramps.

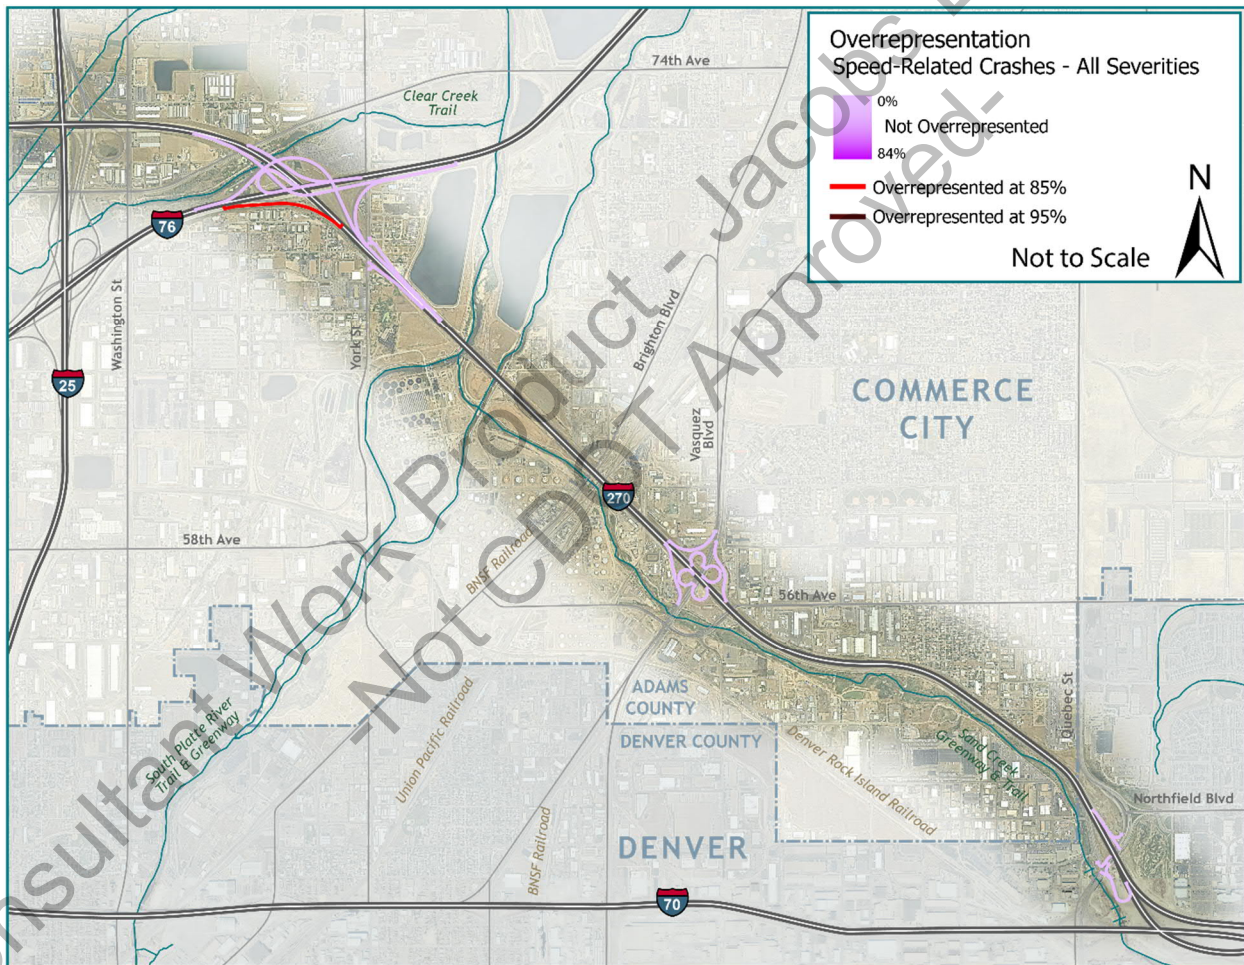
Figure 47. Overrepresentation of Speed-related Crashes for Ramps – All Severities

As shown on Figure 47, the only ramp with an overrepresentation of speed-related crashes is the I-76 northbound to I-270 eastbound ramp. This ramp also has overrepresentation of sideswipe crashes and slight overrepresentation of heavy-vehicle crashes. This ramp is discussed related to sideswipe crashes and is shown on Figure 41.

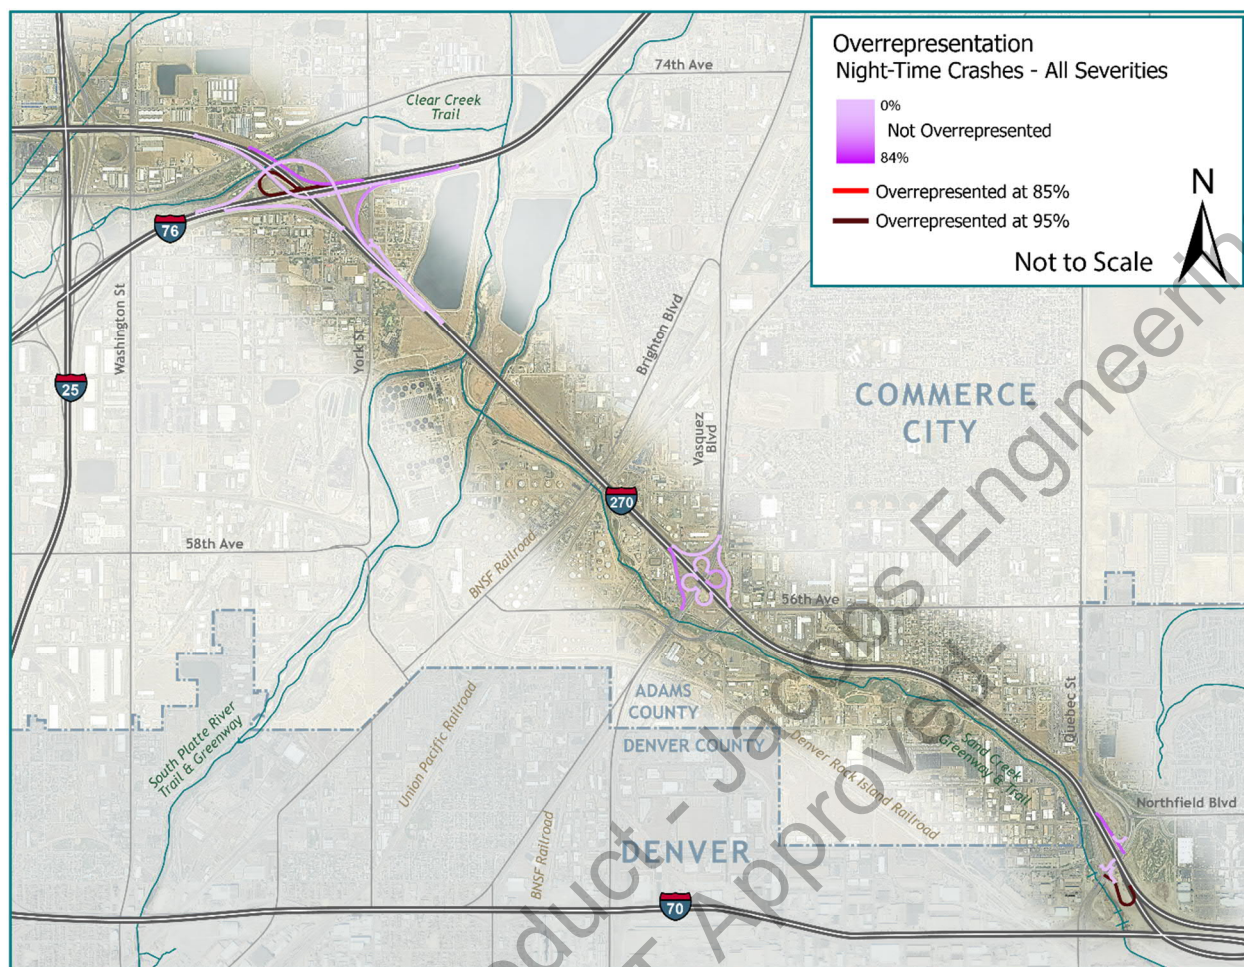
Figure 48. Overrepresentation of Night-Time Crashes for Ramps – All Severities

As shown on Figure 48, the I-76 westbound to I-270 eastbound and I-270 eastbound to Quebec ramps are identified with overrepresentation of night-time crashes. These ramps also are identified with overrepresentation of ROR crashes and are discussed after Figure 37.
