**HAZARDOUS MATERIALS  
TECHNICAL MEMORANDUM**

**Federal Boulevard Improvements between  
West 7<sup>th</sup> Avenue and West Howard Place  
Environmental Assessment**

PINYON ENVIRONMENTAL, INC.

**October 2014**

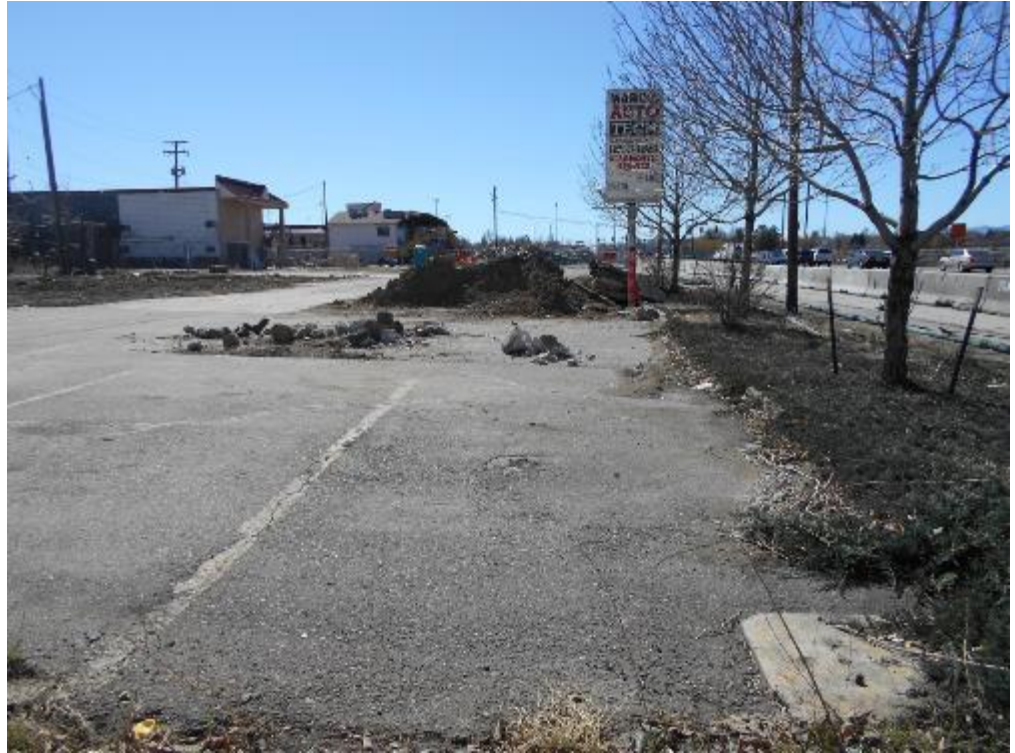
1. View of 690 Federal Boulevard (formerly Marc's Auto Tech) facing south from the southeastern corner of the West 7<sup>th</sup> Avenue and Federal Boulevard intersection.

Parcel (Facility) Address and Current Use (Figures 6 and 7)	Parcel Location and Hydrogeologic Relationship Relative to Study Area	Potential for Impacts to Study Area and Site-Specific Recommendations <sup>1</sup>
<b>Properties Adjacent to the East of Federal Boulevard</b>		
690 Federal Boulevard: Vacant Parcel (Formerly Marc’s Auto Tech)	Adjacent to the Study Area on the southeast corner of the West 7 <sup>th</sup> Avenue and Federal Boulevard intersection. This parcel is up- and cross-gradient to the Study Area.	<p><b>Low.</b> This property was a vacant parcel at the time of the site reconnaissance; however, a sign indicating previous use as “Marc’s Auto Tech” was observed. The parcel reportedly operated as an automotive-repair and vehicle-maintenance facility from 1961 until 2009; however, a review of City directories indicated that the parcel may have also operated as a gasoline station in the 1960s.</p> <p>This property was acquired by CDOT in 2013 and is being developed as part of the Federal Boulevard Alameda Avenue to West 5<sup>th</sup> Avenue project. There is a low potential that any residual contamination from previous uses would migrate to the Study Area due to its location. No further assessment is recommended for this property.</p>

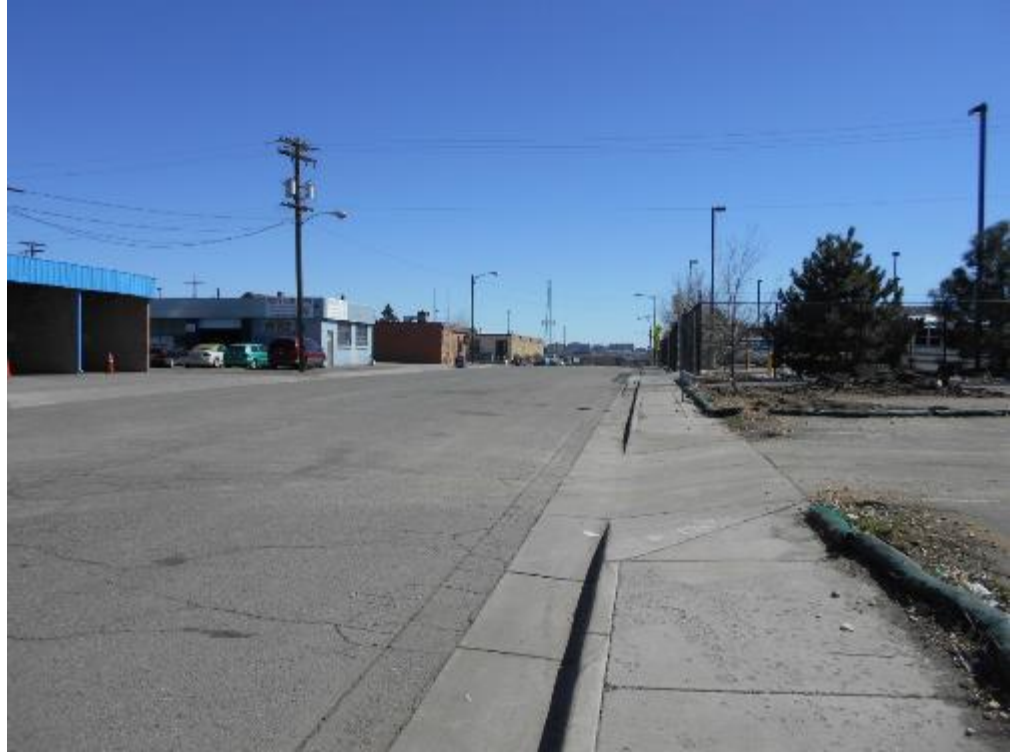
3. View of 2943 West 7<sup>th</sup> Avenue (Troy's Auto Repair) facing east from the south-eastern corner of the West 7<sup>th</sup> Avenue and Federal Boulevard intersection.

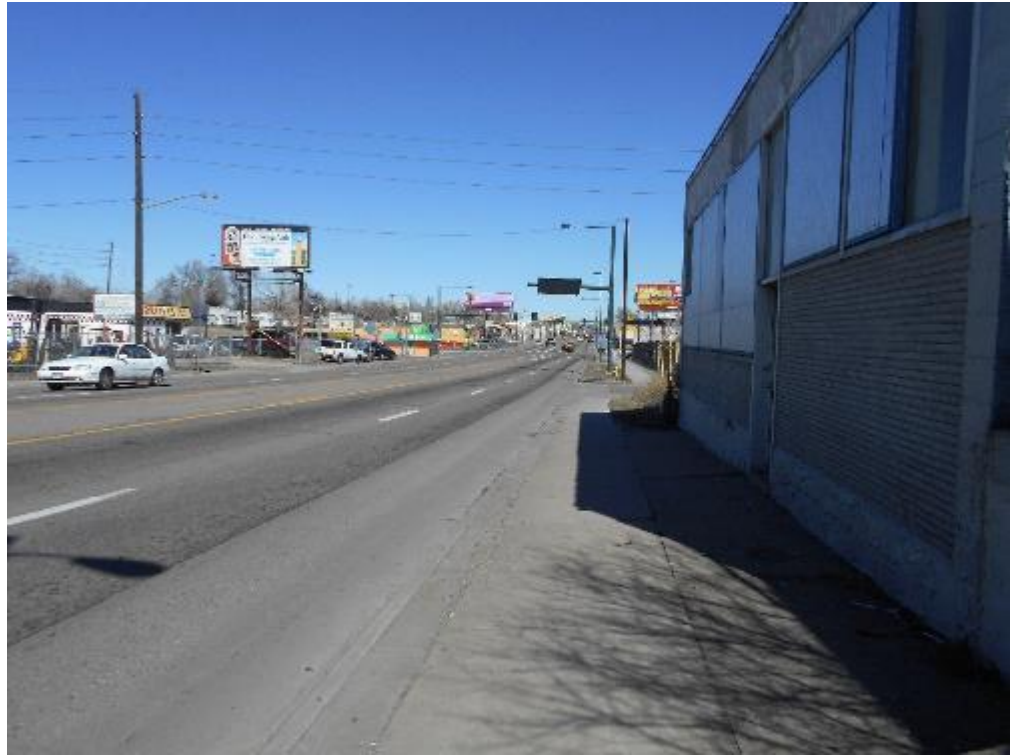
5. View of 730 Federal Boulevard (vacant commercial building) facing north from the eastern side of Federal Boulevard.

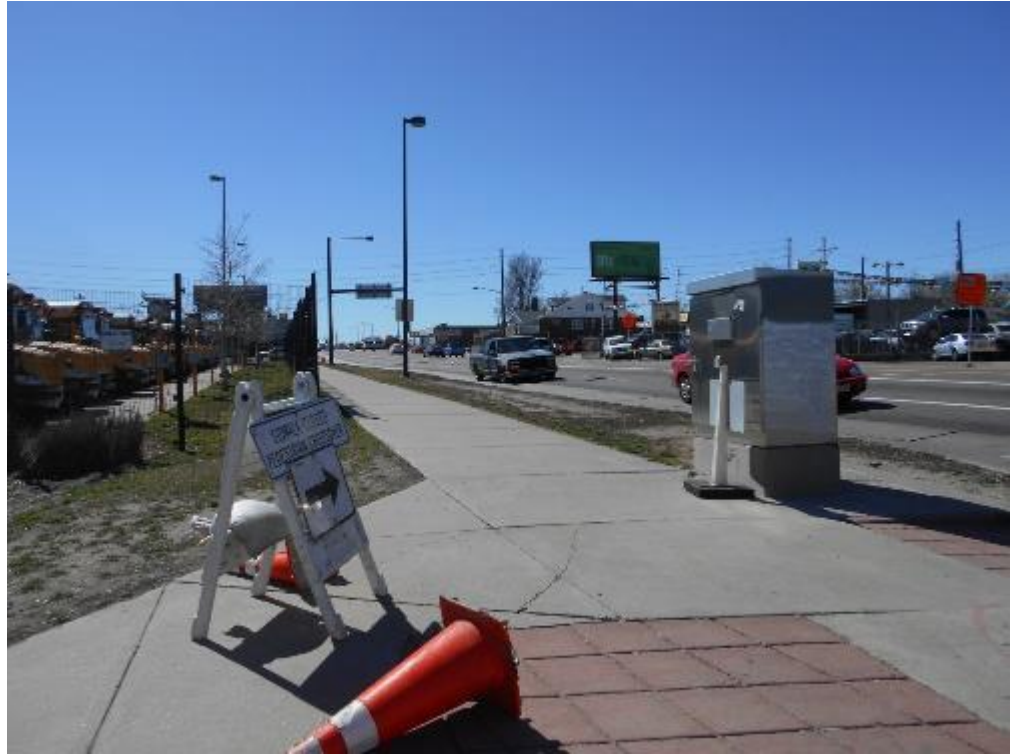
7. View of 750 Federal Boulevard/2880 West 8<sup>th</sup> Avenue (Denver Public Schools Hilltop Bus Terminal, formerly Federal Auto and Wrecking) facing south from the southeast corner of the West 8<sup>th</sup> Avenue and Federal Boulevard Intersection.

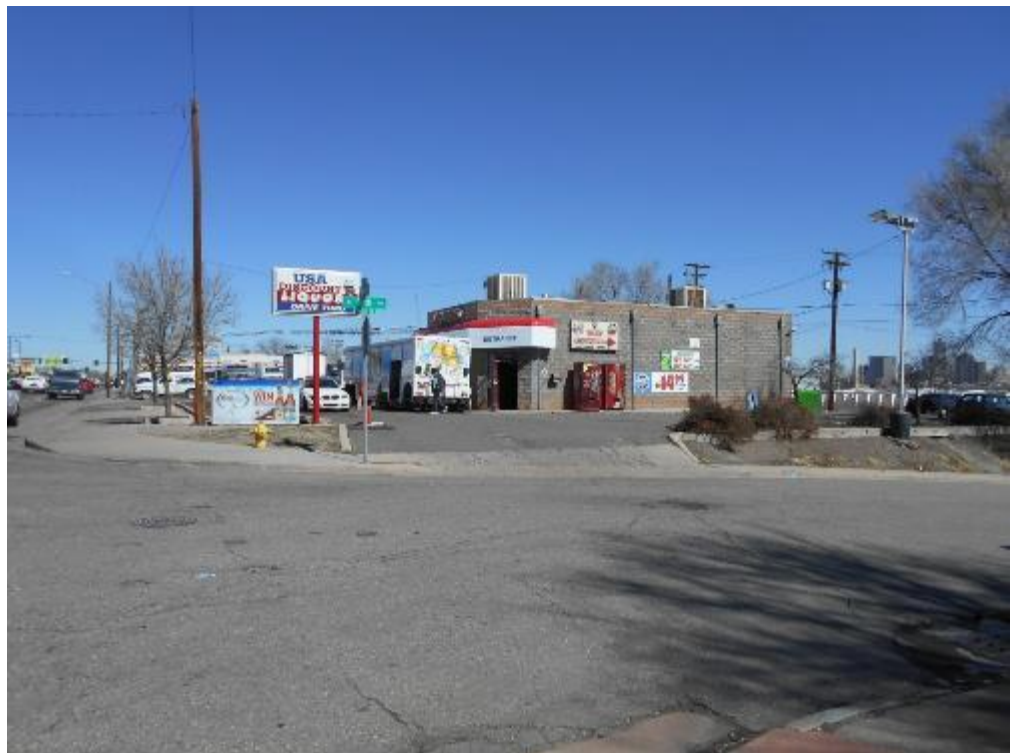
12. View of 900/902 Federal Boulevard (USA Discount Liquor, formerly a gasoline station) facing north from the southeastern corner of the West 9<sup>th</sup> Avenue and Federal Boulevard intersection.

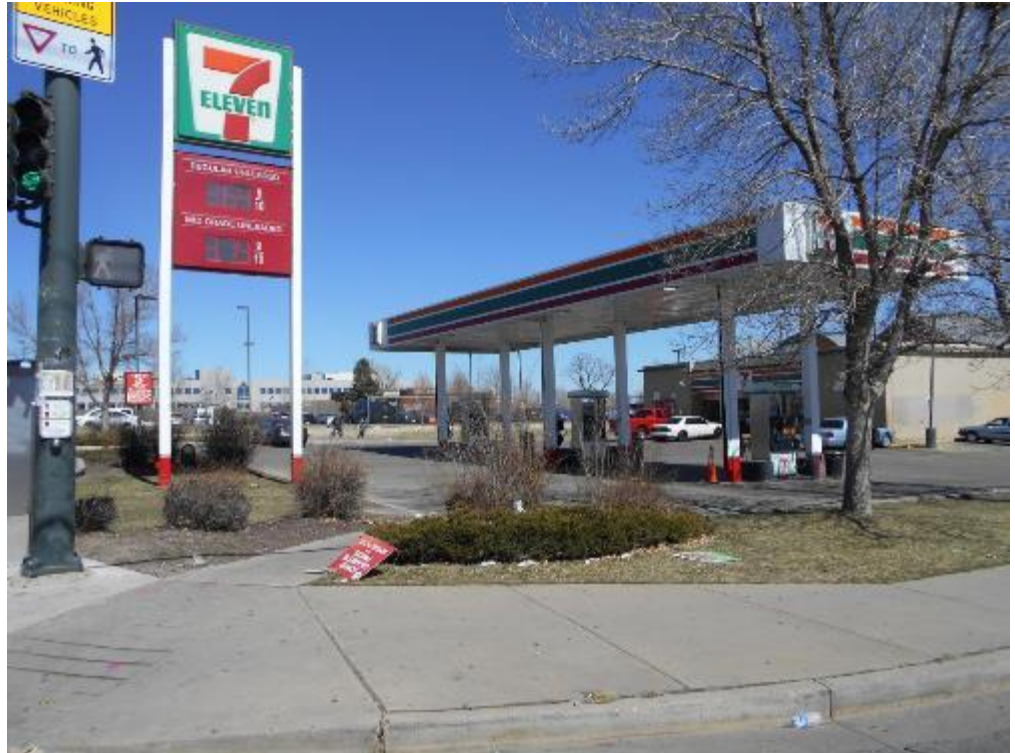
15. View of 1000 Federal Boulevard (7-Eleven convenience store and gasoline station) facing northeast from the West 10<sup>th</sup> Avenue and Federal Boulevard intersection.

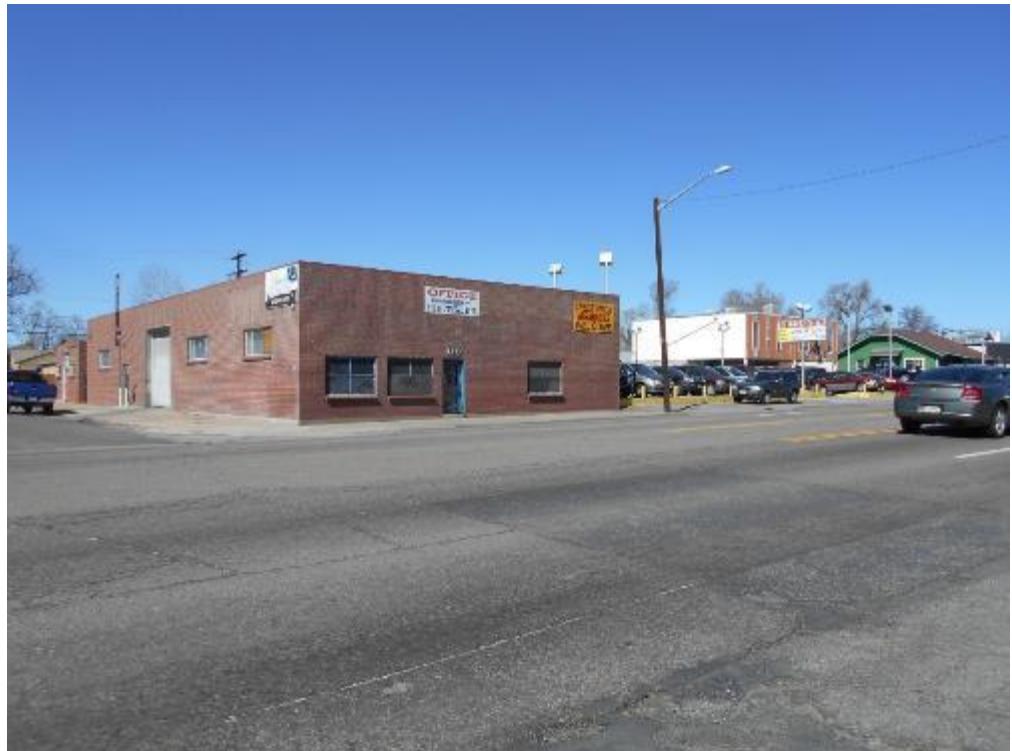
28. View of 903 Federal Boulevard (vacant commercial building, formerly Spitfire Engine & Machine and a gasoline station) facing northwest from the eastern side of Federal Boulevard.

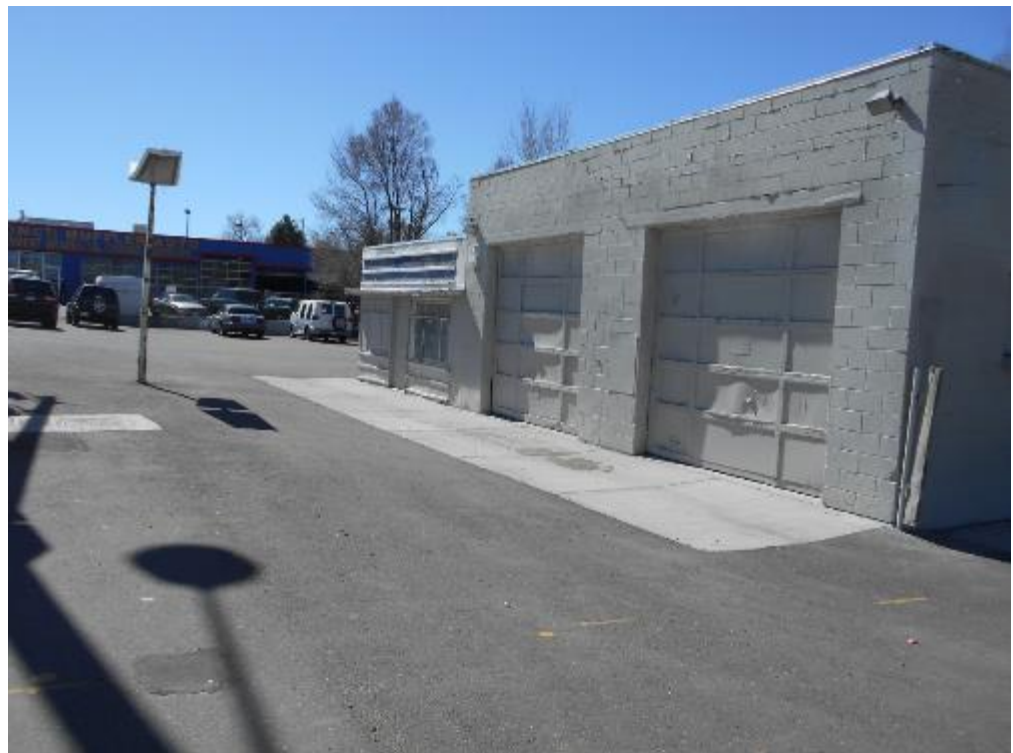
38. View of  
1251 Federal  
Boulevard  
(vacant  
service  
station;  
formerly a  
gasoline  
station)
