Appendix A

Project Leadership Team and Technical Team Meeting Minutes

I-70 East Vail Pass Wildlife Crossing Feasibility Study
Project Leadership Team Meeting
January 6, 2020
Meeting Minutes

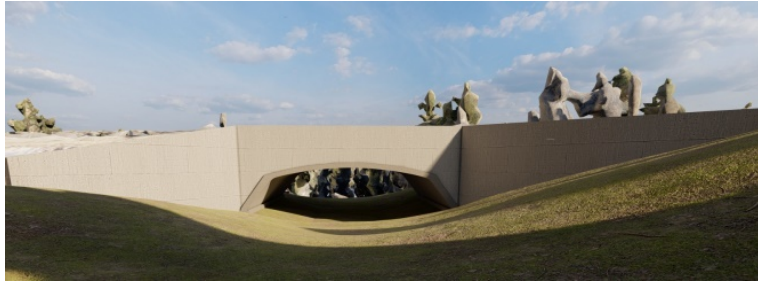
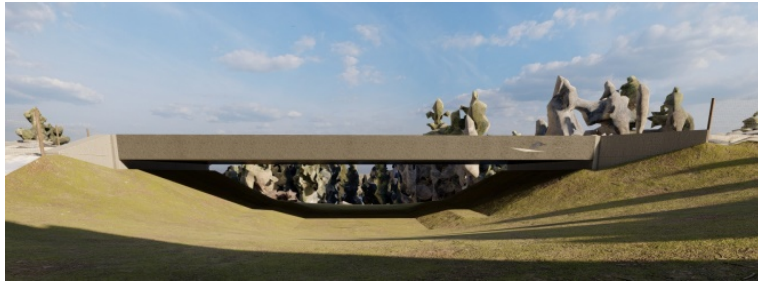
Area 1: MP 193.5

Wildlife Crossing Dimensions and Evaluation Matrices

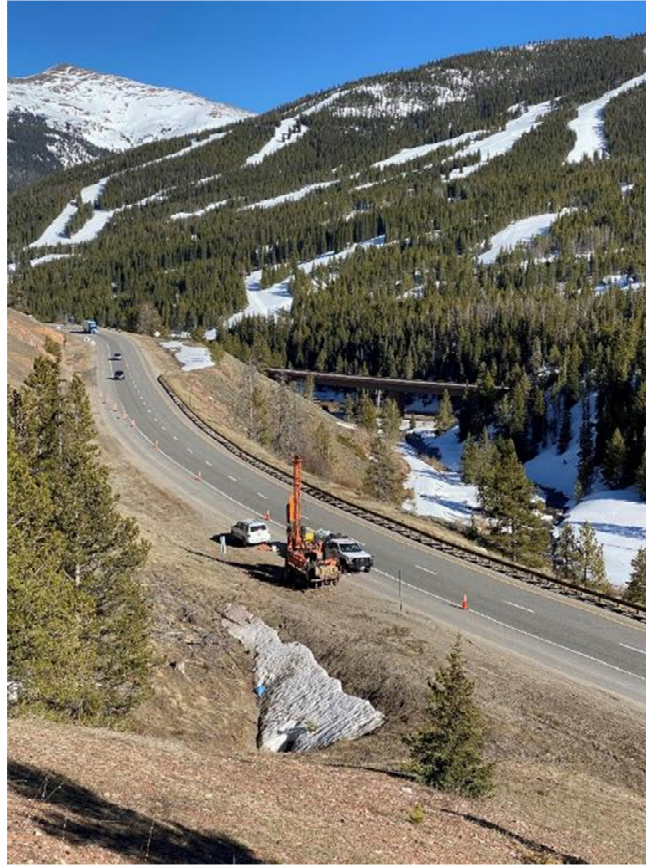
Figure 2. Area 1, Boring B-1 location near existing drainage. Eastbound I-70 bridge near Copper Mountain Ski Area shown in the background, looking southeast.

| FIGURE 2. AREA 1, BORING B-1 LOCATION NEAR EXISTING DRAINAGE. | 4 |

We understand the preferred design alternative at Area 1 consists of a buried bridge designed with an integral abutment supported on H-pile foundations. A sloped embankment in front of the abutment will be incorporated in the design. We understand the preferred design alternative at Area 2 consists of a buried arch structure supported on drilled shaft foundations. Reinforced concrete box culverts supported on shallow foundations may also be considered for wildlife underpass crossings at Areas 1 and 2.

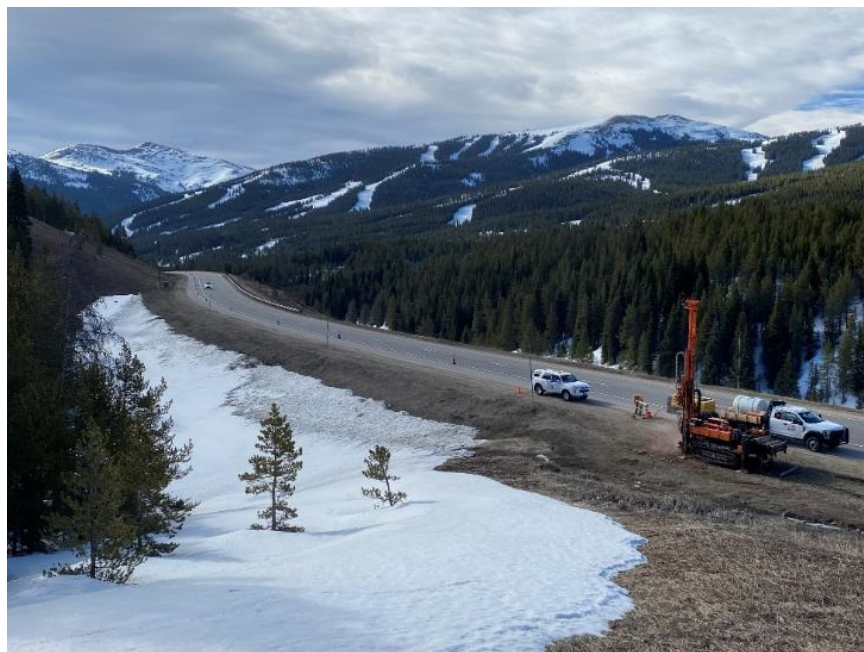
Figure 3. Area 2, Boring B-2 near existing drainage, looking southeast.

| FIGURE 3. AREA 2, BORING B-2 NEAR EXISTING DRAINAGE, LOOKING SOUTHEAST. | 4 |

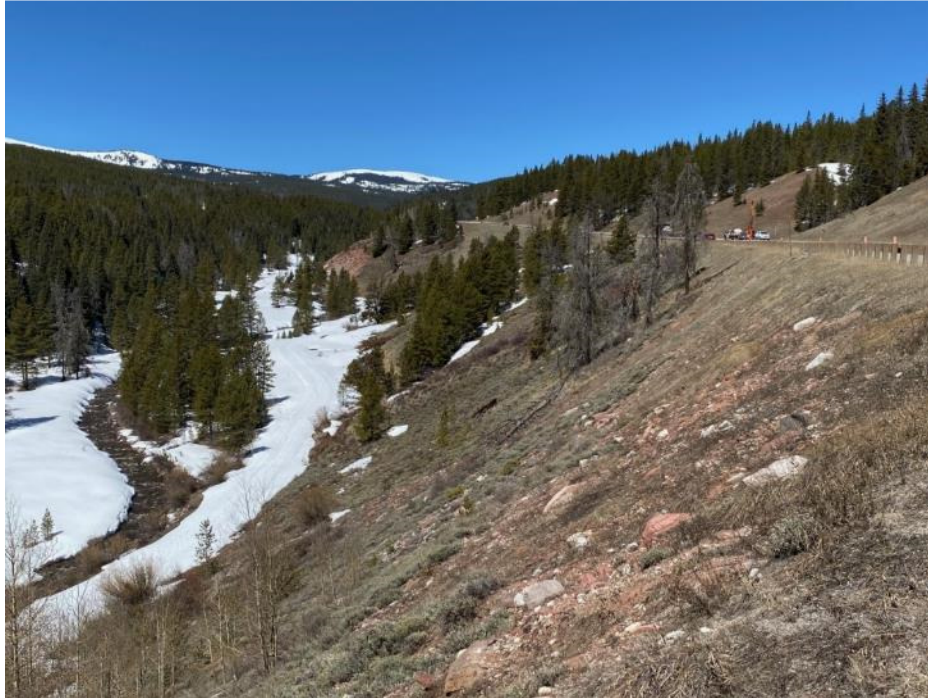
Figure 4. Area 1, Steep hillside and terrace south of boring B-1 looking west.

| FIGURE 4. AREA 1, STEEP HILLSIDE AND TERRACE SOUTH OF BORING B-1..... | 5 |

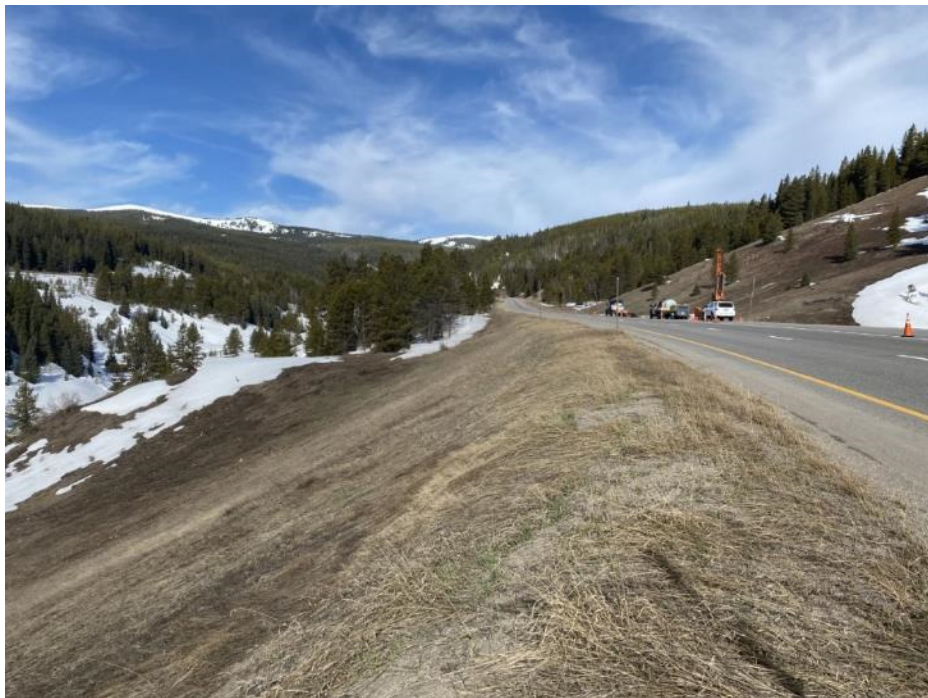
Figure 5. Area 2, Steep hillside and terrace area south of boring B-2 looking west.

| FIGURE 5. AREA 2, STEEP HILLSIDE AND TERRACE AREA SOUTH OF BORING B-2..... | 5 |

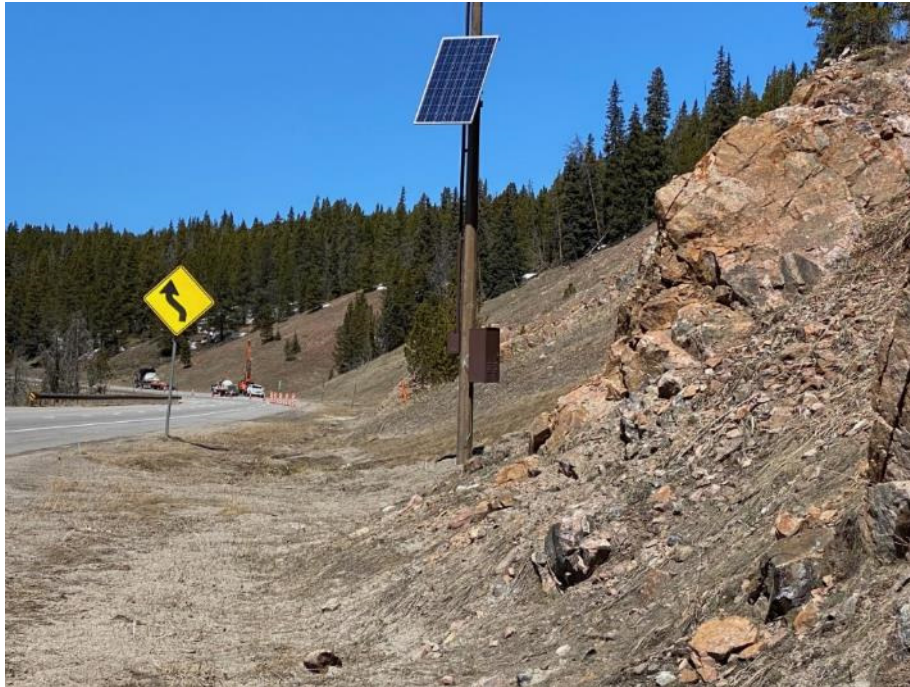
**Figure 6. Bedrock outcroppings east of the project site.
Drilling boring B-1 in background, looking west.**

| FIGURE 6. BEDROCK OUTCROPPINGS EAST OF THE PROJECT SITE..... | 6 |

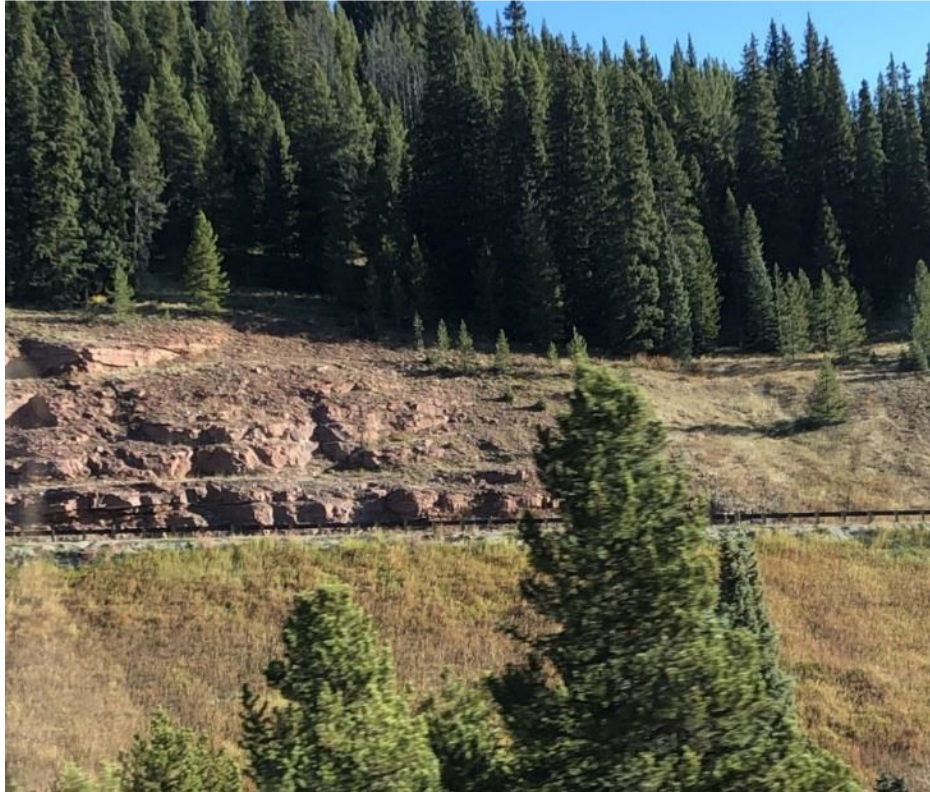
Figure 7. Bedrock outcropping located west of boring B-3 location.

| FIGURE 7. BEDROCK OUTCROPPING LOCATED WEST OF BORING B-3 LOCATION. | 7 |

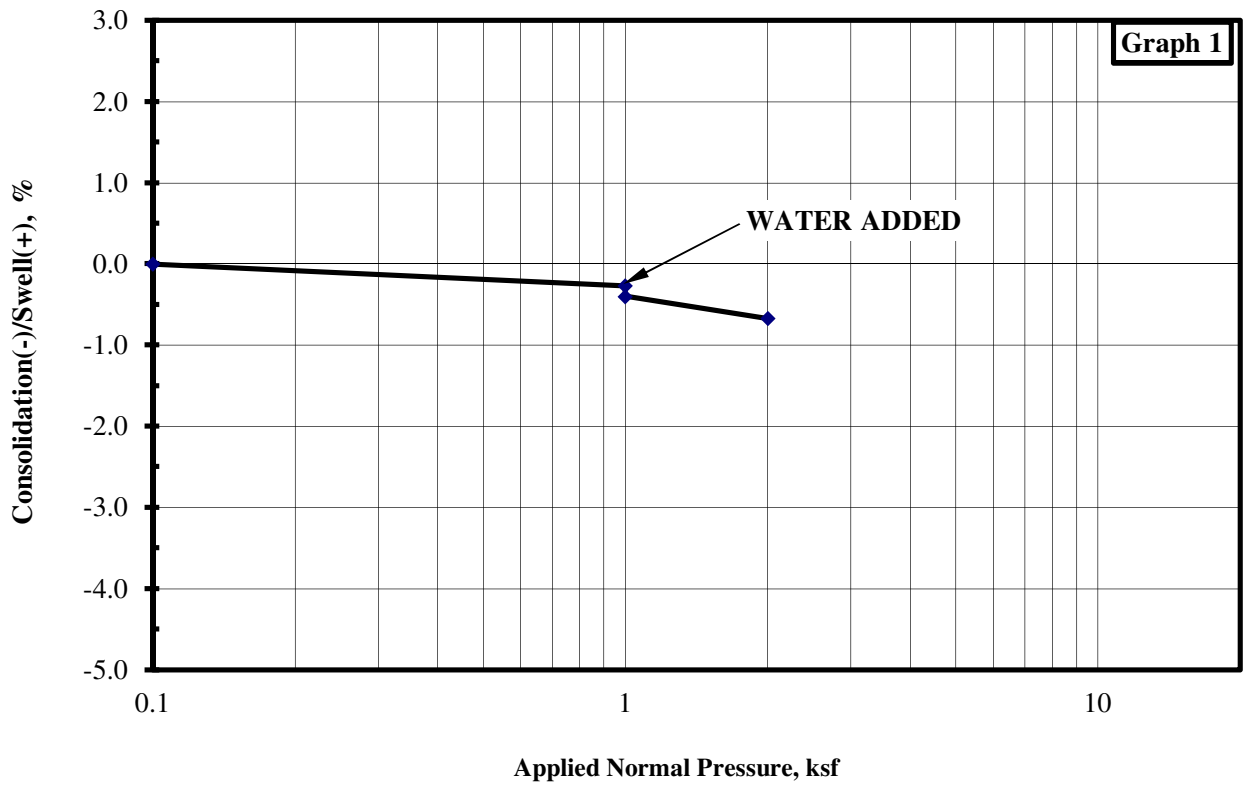
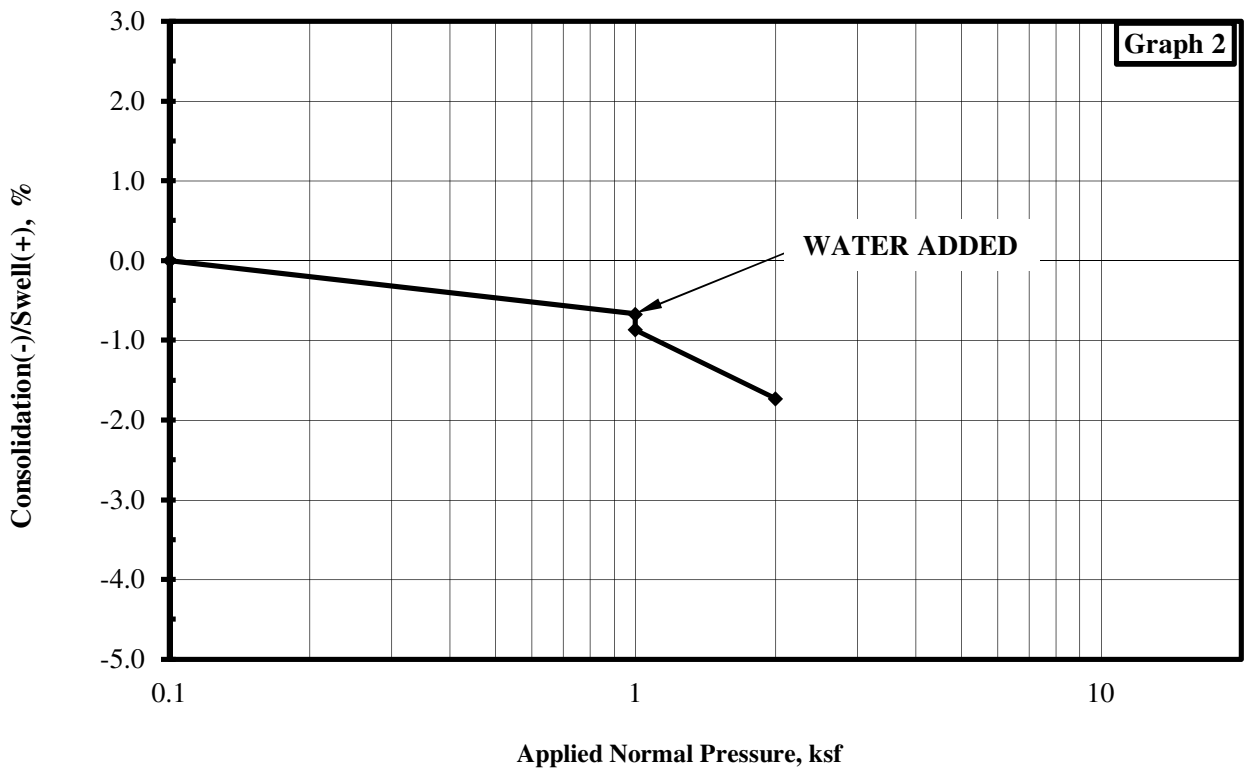
| Graph Number | Boring Number | Depth (ft) | Natural Dry Density (pcf) | Moisture Content (%) | Swell(+) / Consolidation(-) (%) | Soil Description | SWELL / CONSOLIDATION GRAPH |
|---|---|---|---|---|---|---|---|
| Job No: | 219-176 | Project Name: | | East Vail Pass Wildlife Crossings | | | Figure No. D-1 |

| Graph Number | Boring Number | Depth (ft) | Natural Dry Density (pcf) | Moisture Content (%) | Swell(+) / Consolidation(-) (%) | Soil Description | SWELL / CONSOLIDATION GRAPH |
| 1 | B-1 | 15 | 112 | 14.2 | -0.1 | SAND, silty, clayey with gravel | Drawn By: SAW |

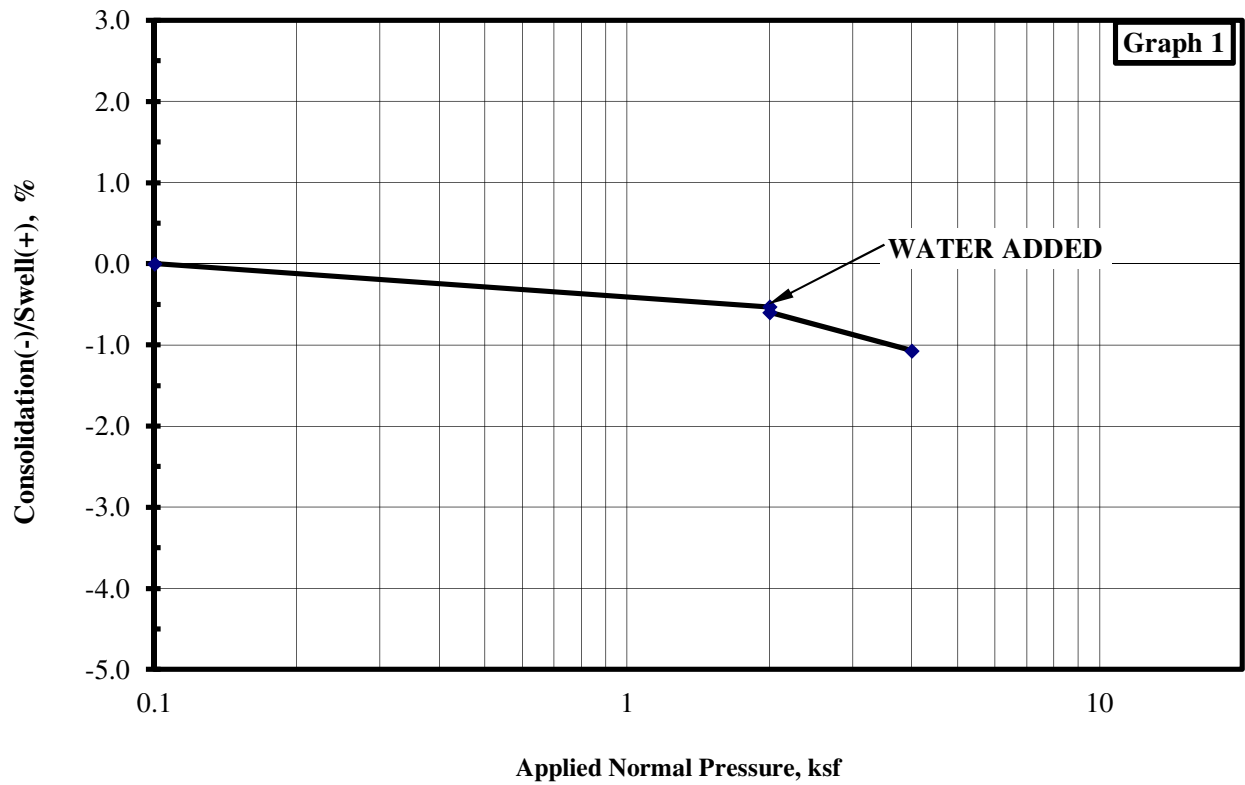
| Graph Number | Boring Number | Depth (ft) | Natural Dry Density (pcf) | Moisture Content (%) | Swell(+) / Consolidation(-) (%) | Soil Description | SWELL / CONSOLIDATION GRAPH |
| 1 | B-2 | 36 | 133 | 6.1 | -0.1 | GRAVEL, silty, clayey with sand (GC-GM) | Drawn By: SAW |

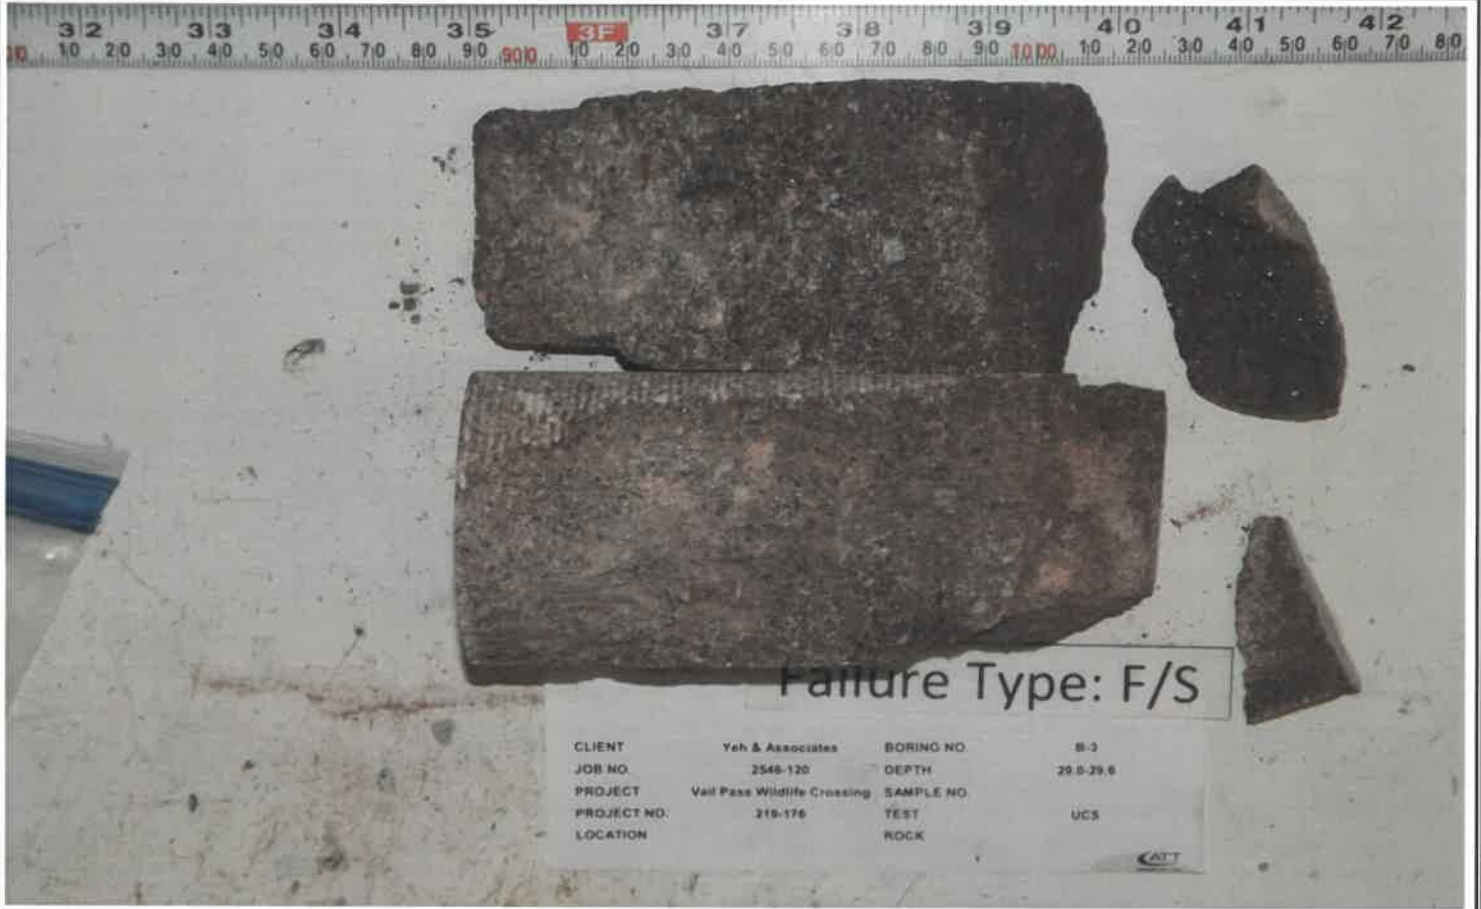
BORING NO. B-3
 DEPTH 29.0-29.6
 SAMPLE NO.
 TEST TYPE UCS
 ROCK TYPE

CLIENT Yeh & Associates BORING NO. B-3
 JOB NO. 2546-120 DEPTH 29.0-29.6
 PROJECT Vail Pass Wildlife Crossing SAMPLE NO.
 PROJECT NO. 219-176 TEST UCS
 LOCATION ROCK

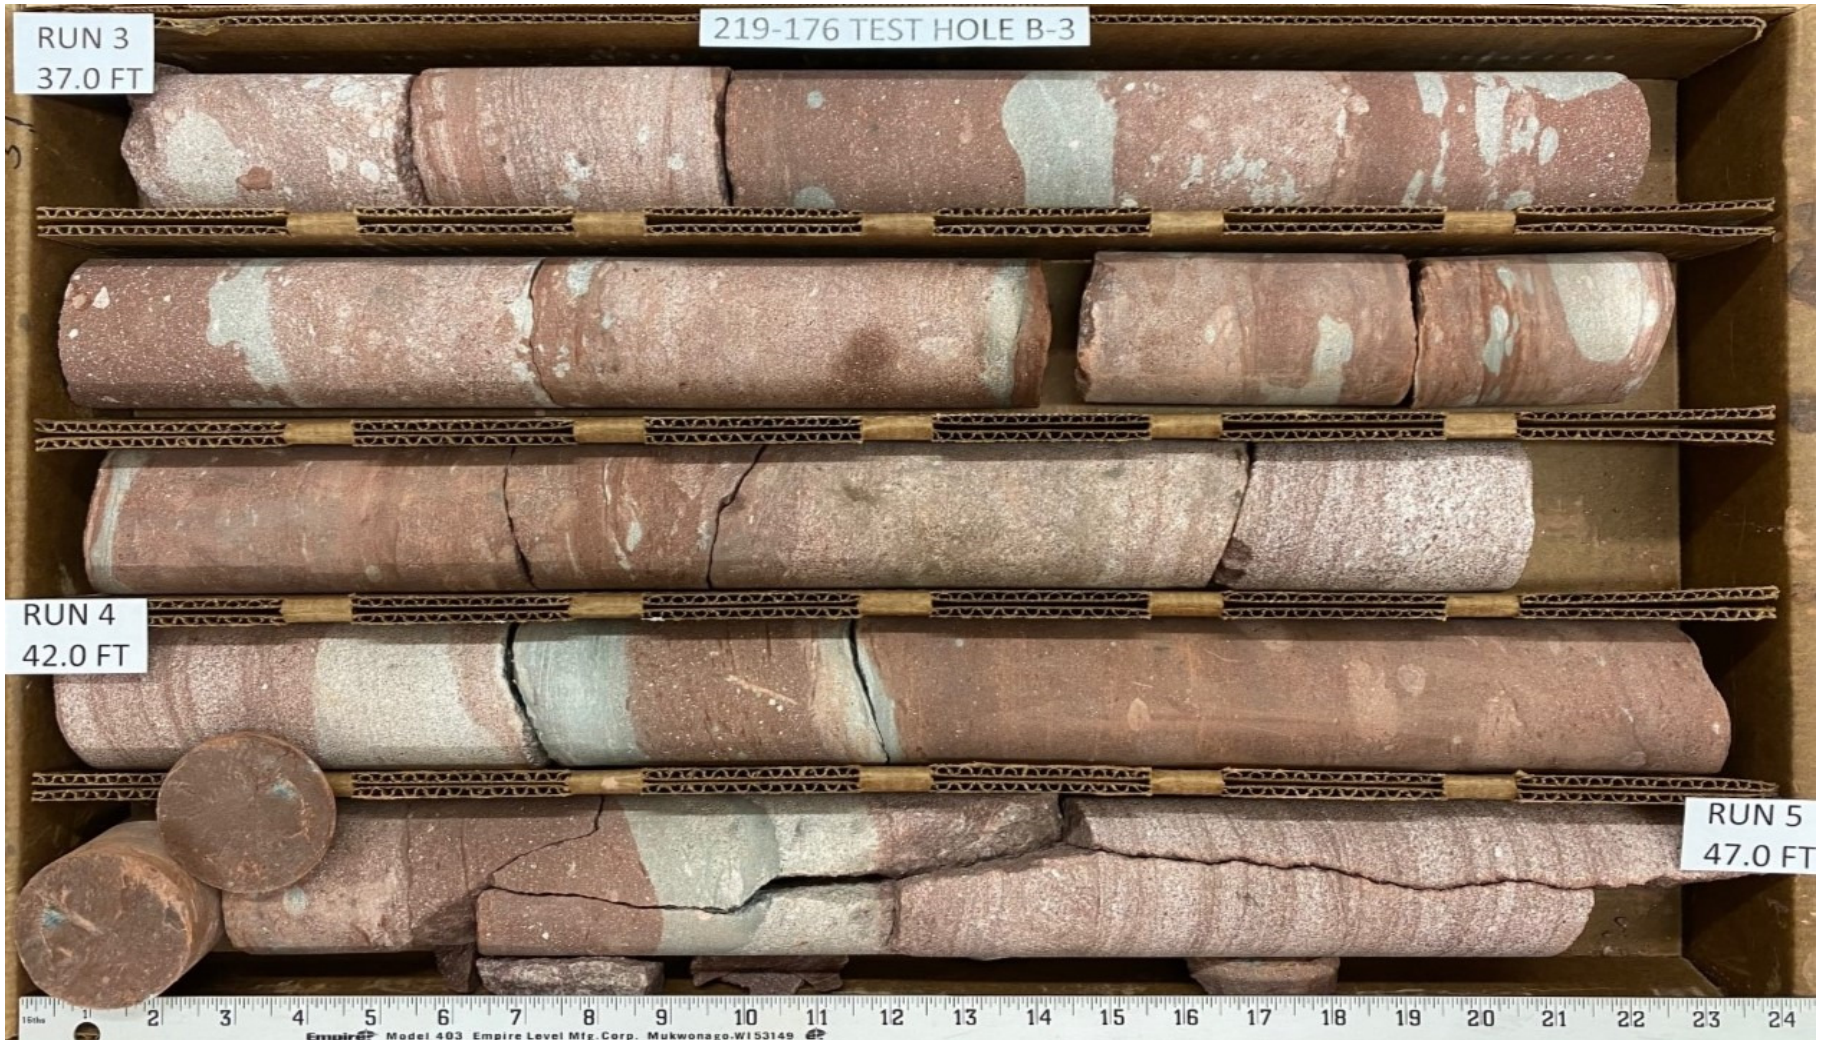
Rock Core Photos
Boring B-3
Depth: 37.0 to 47.0 feet

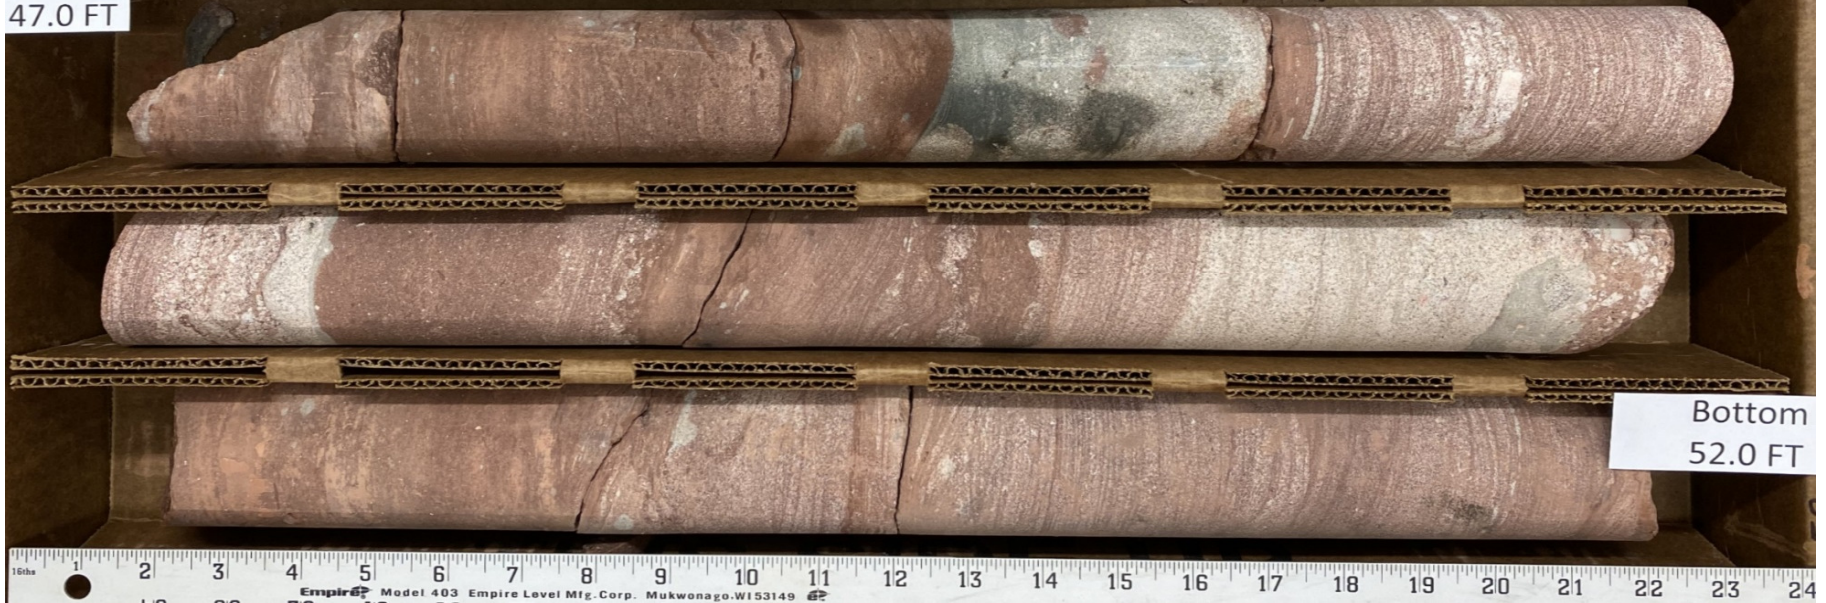
219-176 TEST HOLE B-3

Bottom
52.0 FT

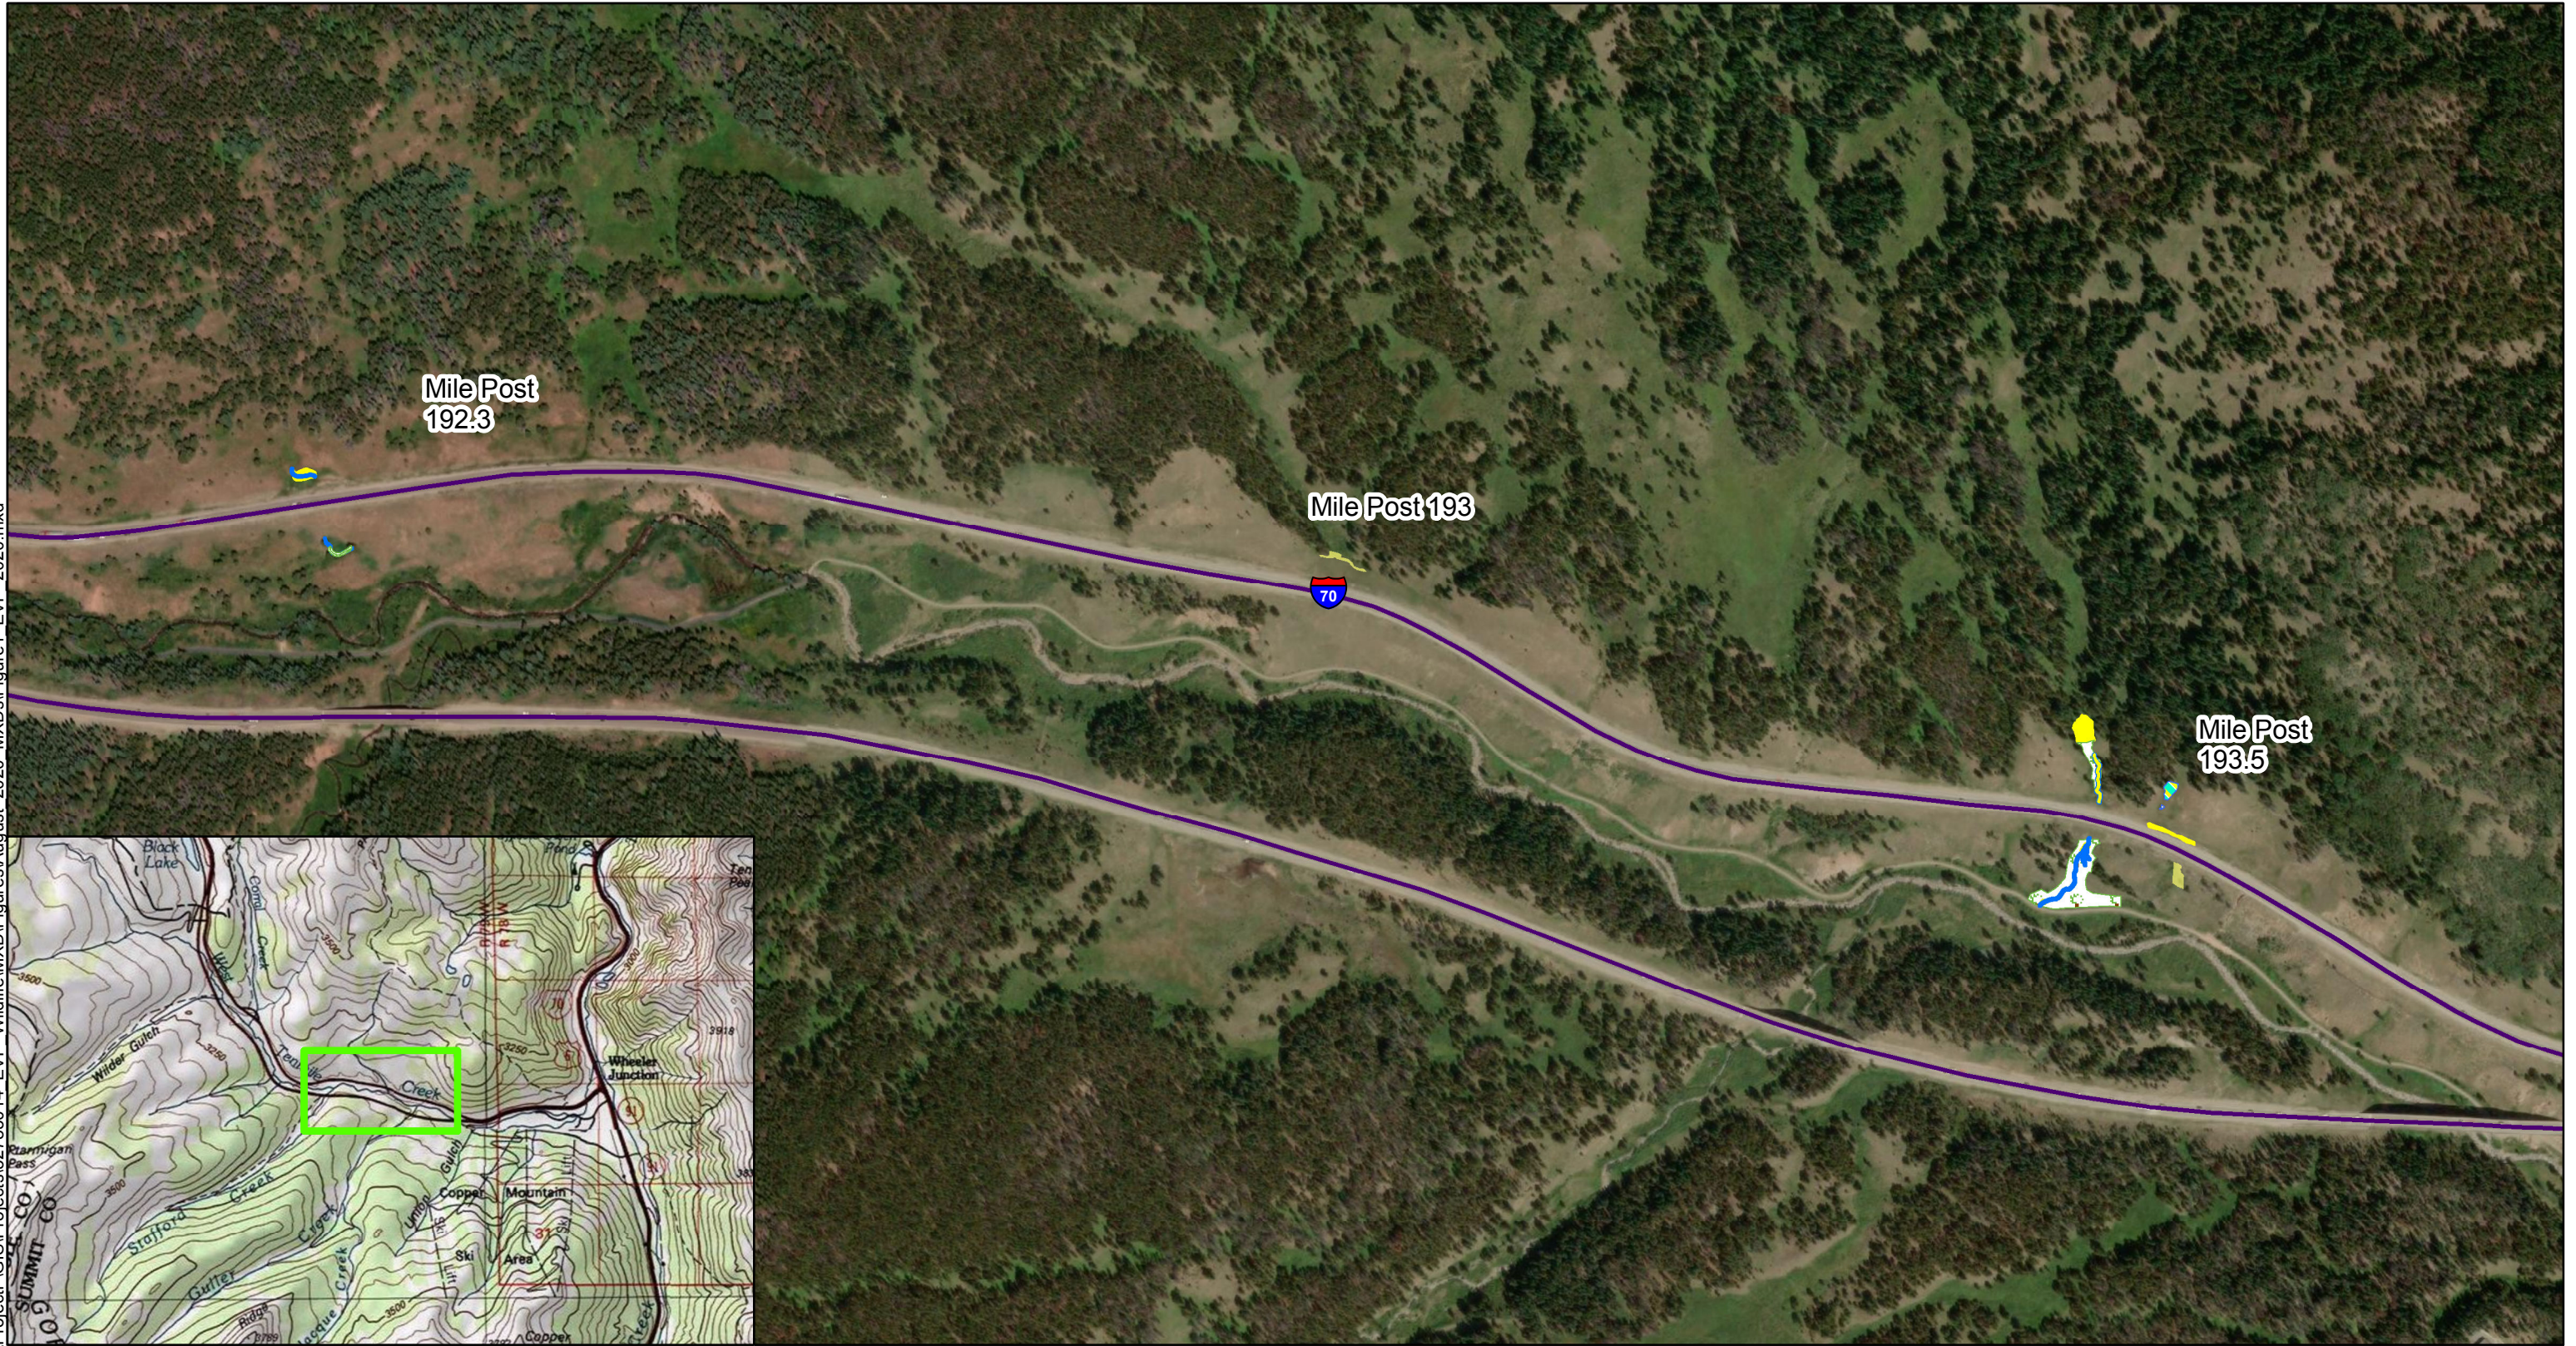
Figure 1

- Stream Channel
- Potential Fen
- Riparian
- Potential Wetland
- Interstate 70

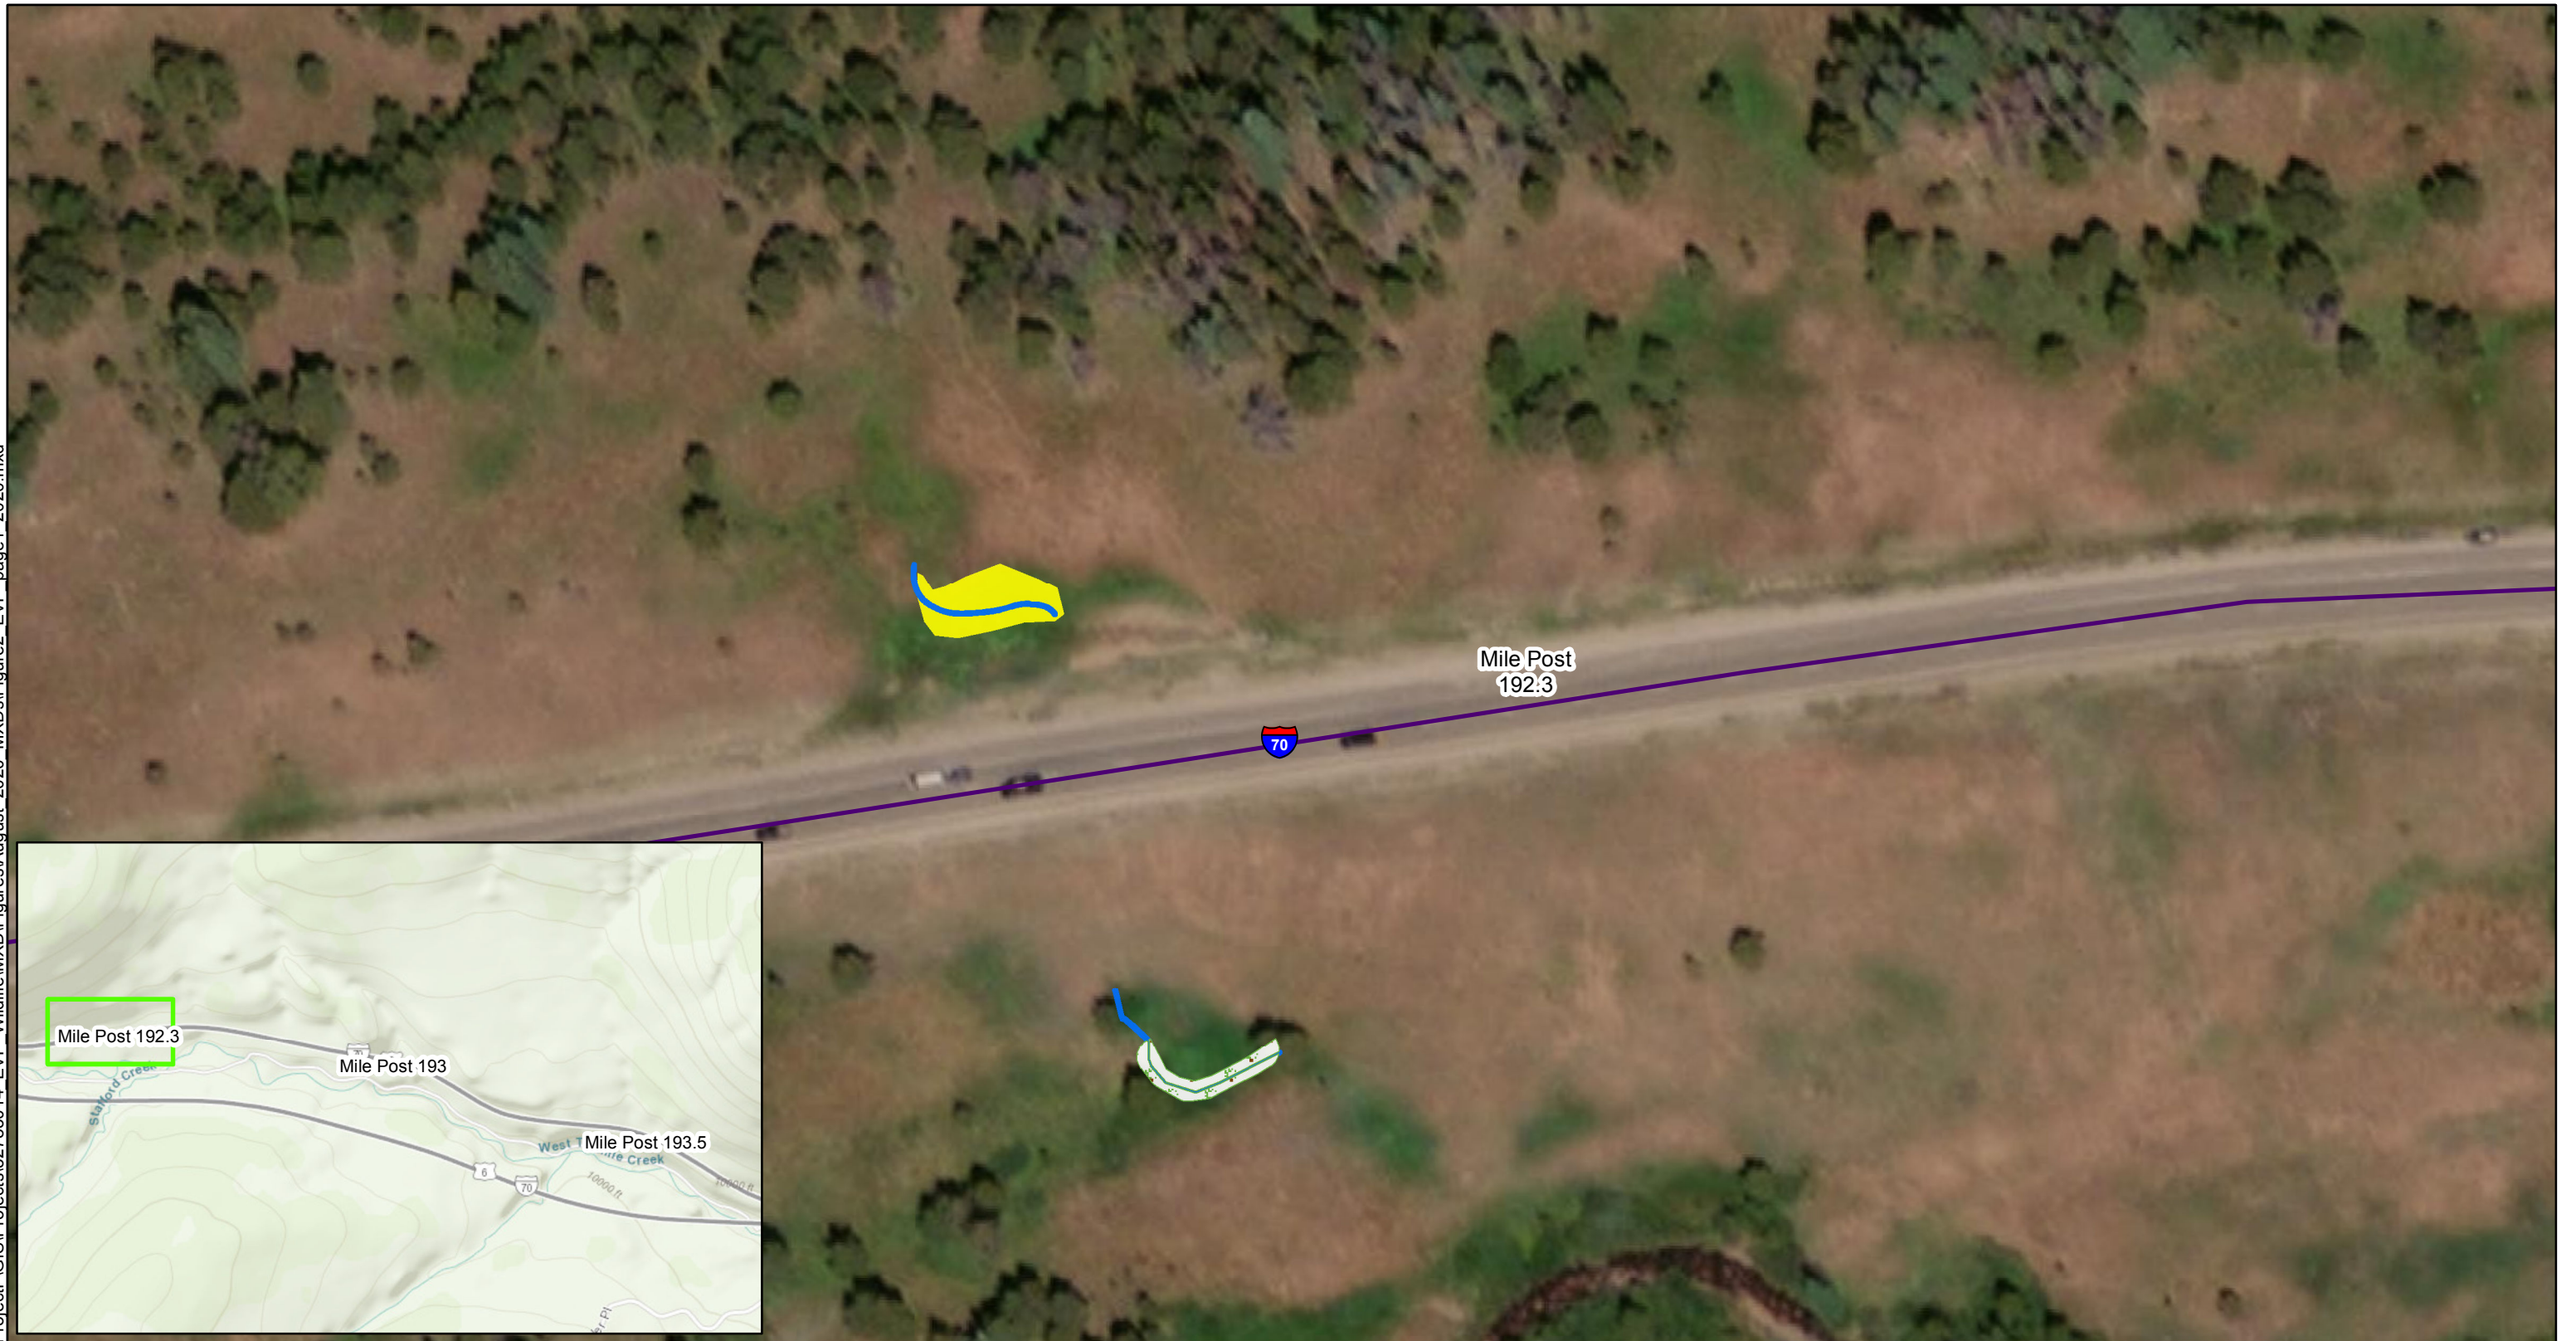
Figure 2: Page 1

-   Stream Channel
-   Interstate 70
-   Riparian
-   Potential Wetland
