## Colorado Procedure 79-19

### *Standard Practice for*

### **Evaluating MIT Scan Images for Uncut Dowel Baskets**

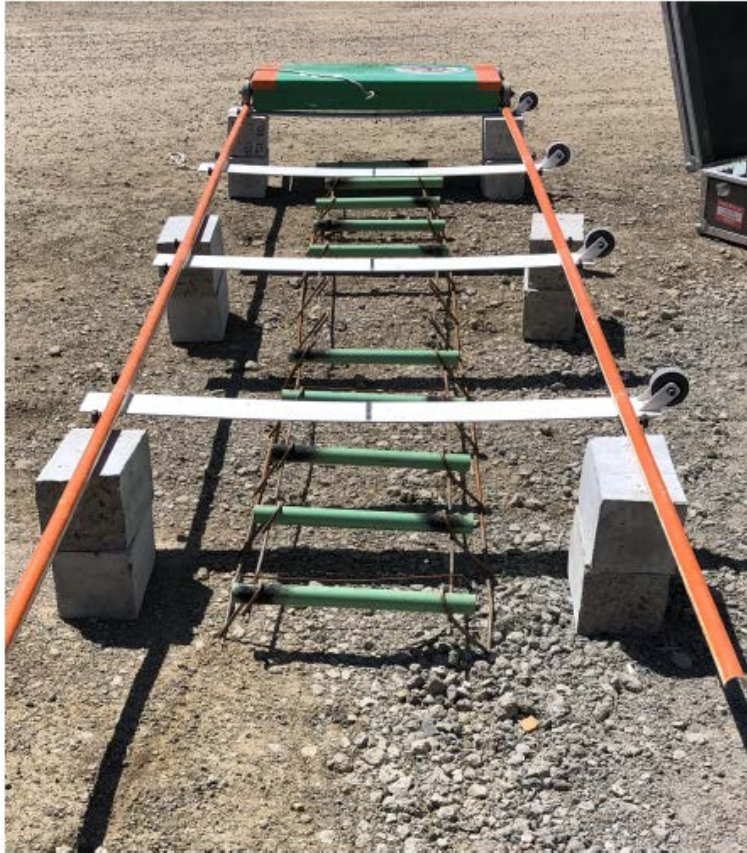
2.1 Figure 79-1 shows a properly aligned dowel basket under the MIT Scan-2 tracks. Figure 79-2 shows the corresponding MIT Scan-2 image map. This joint would be accepted without requiring corrective work.

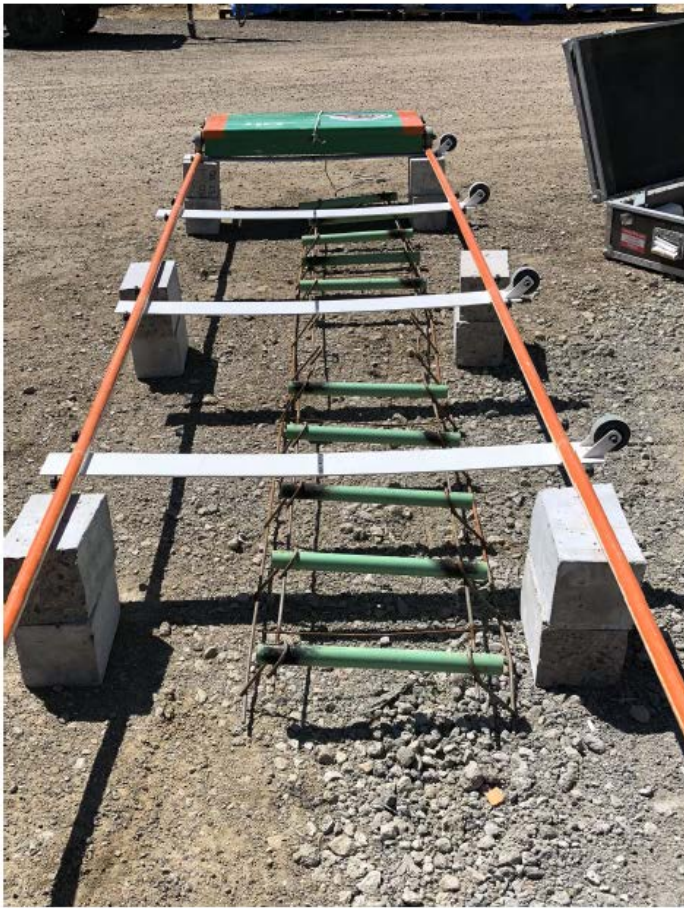
2.2 Figure 79-3 shows a basket that is not centered on the saw cut joint, but otherwise aligned. The saw cut is indicated by the black line on the MIT Scan-2 tracks. Figure 79-4 shows the corresponding MIT Scan-2 image map. Further investigation of this joint with cores or a pachometer should be conducted to determine if the minimum 6 inches of embedment on each side of the joint is achieved. If 6 inches of embedment on each side of the joint is not achieved, the joint is rejected and requires corrective work.

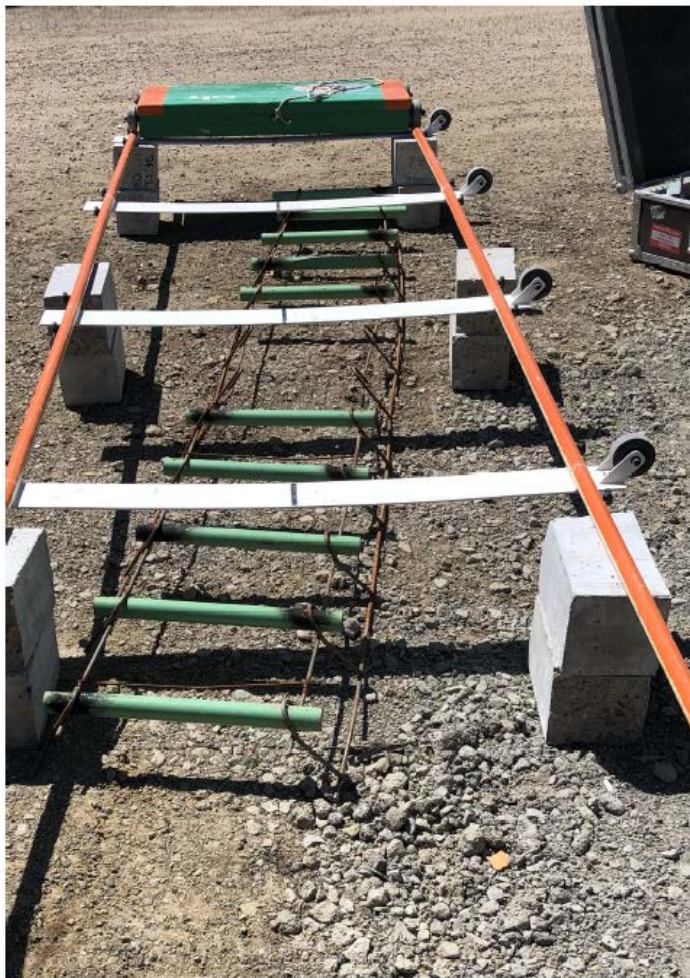
2.3 Figure 79-5 shows a skewed basket to the saw cut joint. The saw cut is indicated by the black line on the MIT Scan-2 tracks. Figure 79-6 shows the corresponding MIT Scan-2 image map. This joint should be further evaluated to determine if the saw cut is skewed and the basket is properly aligned or if the saw cut is skewed and the basket is properly aligned and each bar has the minimum embedment on each side of the saw cut, the joint can be accepted, otherwise it is rejected and corrective work must be performed. If the saw cut is skewed and the bars are properly aligned and each bar has the minimum embedment on each side of the saw cut, the joint can be accepted, otherwise it is rejected and corrective work must be performed. If the saw cut is correct, this would be a locked joint and would require corrective work if adjacent joints are also locked.

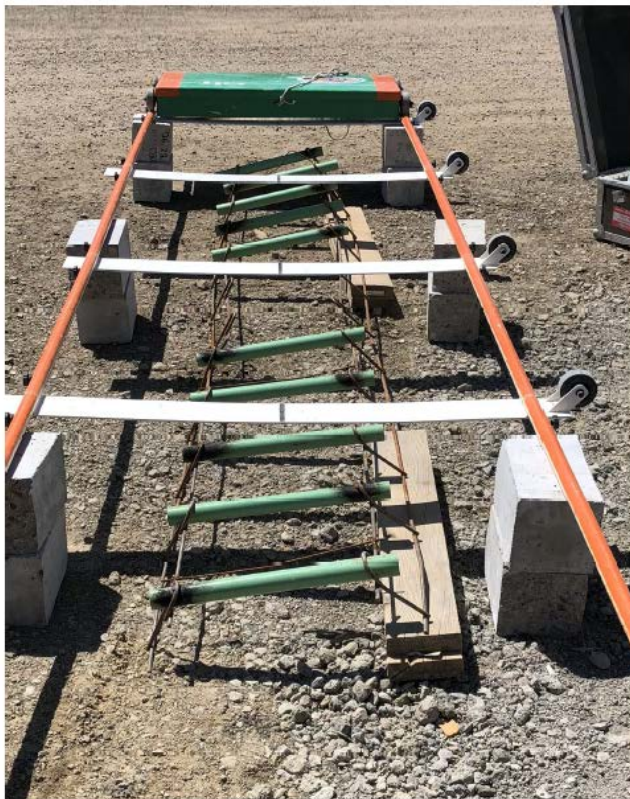
2.4 Figure 79-7 shows a basket that has been tilted. Figure 79-8 shows the corresponding MIT Scan-2 image map. This joint should be further evaluated by coring or a pachometer to determine the overall rotational misalignment of each bar. A joint score can be used to determine the acceptability of the joint using the criteria in subsection 412.13 and if corrective work is required. A single joint like this can be left in place without corrective work if the adjacent joints are correct and there is the required minimum cover above and below the dowel bars. Otherwise the joint requires corrective work.

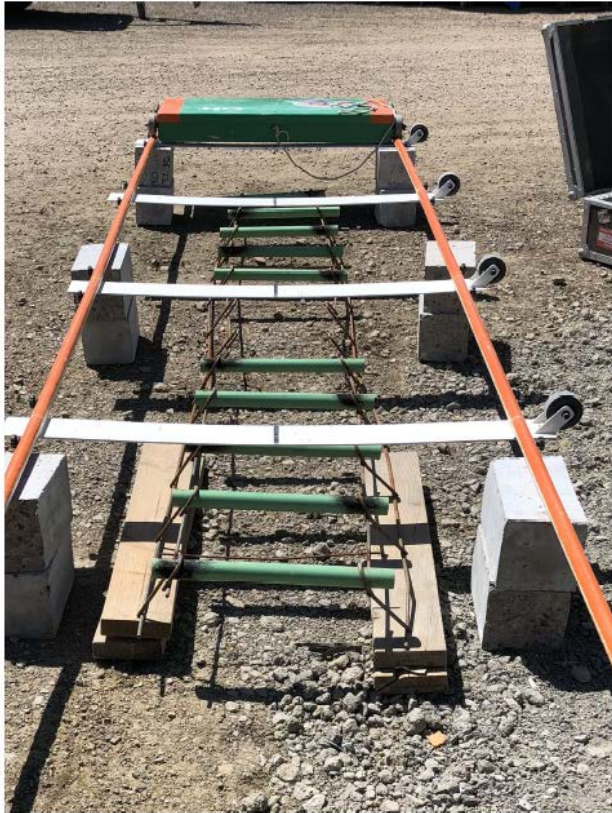
2.5 Figure 79-9 shows a basket that is deeper on one end than the other, but is otherwise aligned. Figure 79-10 shows the corresponding MIT Scan-2 image map. This joint should be further evaluated by coring or a pachometer to determine if there is the required minimum cover above and below the dowel bars. If there is proper cover above and below the dowel bars, the joint can be accepted, otherwise corrective work would be required.

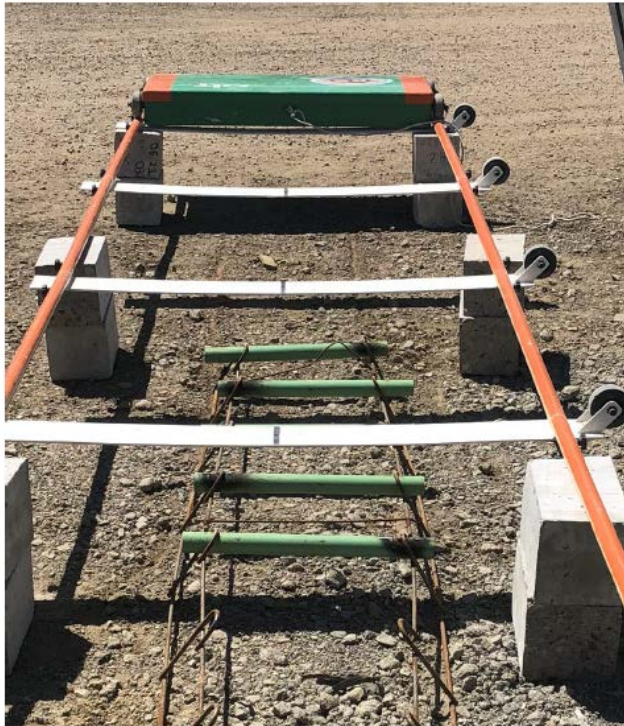
2.6 Figure 79-11 shows a basket that is only in one wheel path. Figure 79-12 shows the corresponding MIT Scan-2 image map. The top half of the MIT Scan-2 image map shows what a joint with no bars would look like. This joint requires corrective work to install the missing bars
