Colorado Procedure 79-20

Standard Practice for

Evaluating MIT Scan Images for Uncut Dowel Baskets

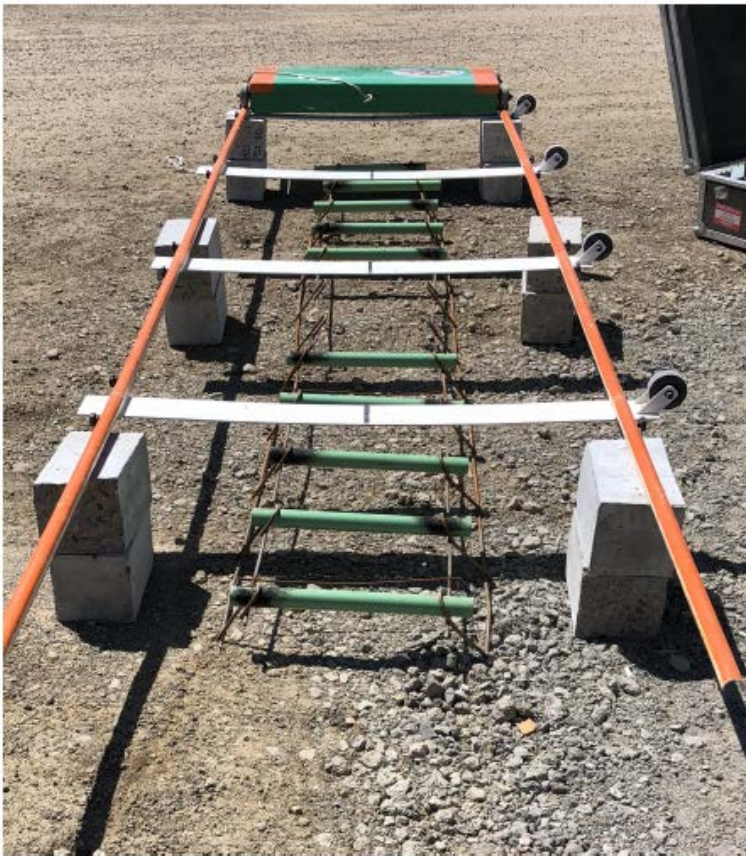
2.1 Figure 79-1 shows a properly aligned dowel basket under the MIT Scan-2 tracks. Figure 79-2 shows the corresponding MIT Scan-2 image map. This joint would be accepted without requiring corrective work.

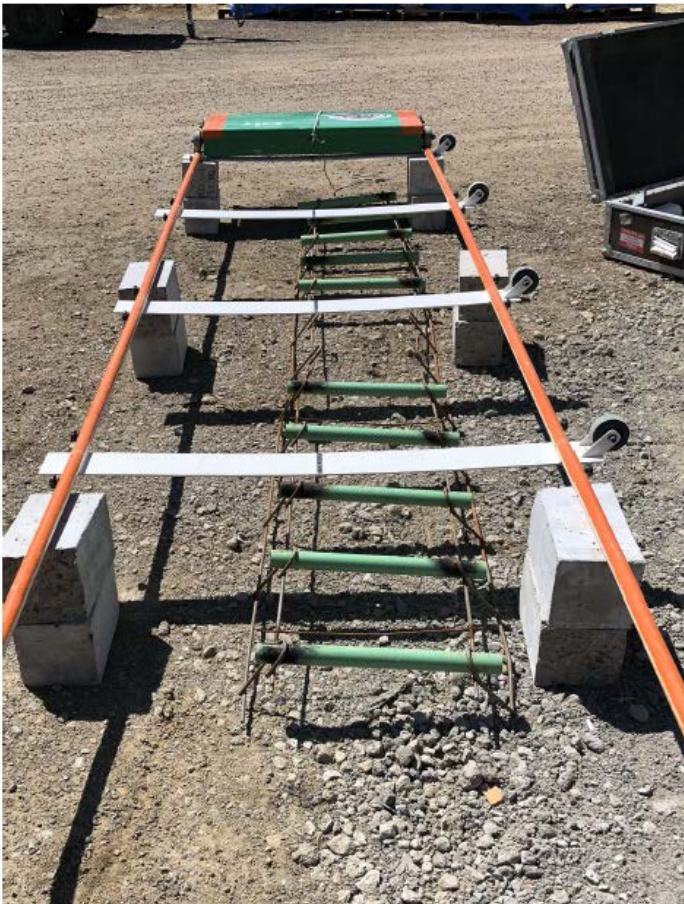
2.2 Figure 79-3 shows a basket that is not centered on the saw cut joint but otherwise aligned. The saw cut is indicated by the black line on the MIT Scan-2 tracks. Figure 79-4 shows the corresponding MIT Scan-2 image map. Further investigation of this joint with cores or a pachometer should be conducted to determine if the minimum 6 inches of embedment on each side of the joint is achieved. If 6 inches of embedment on each side of the joint is not achieved, the joint is rejected and requires corrective work.

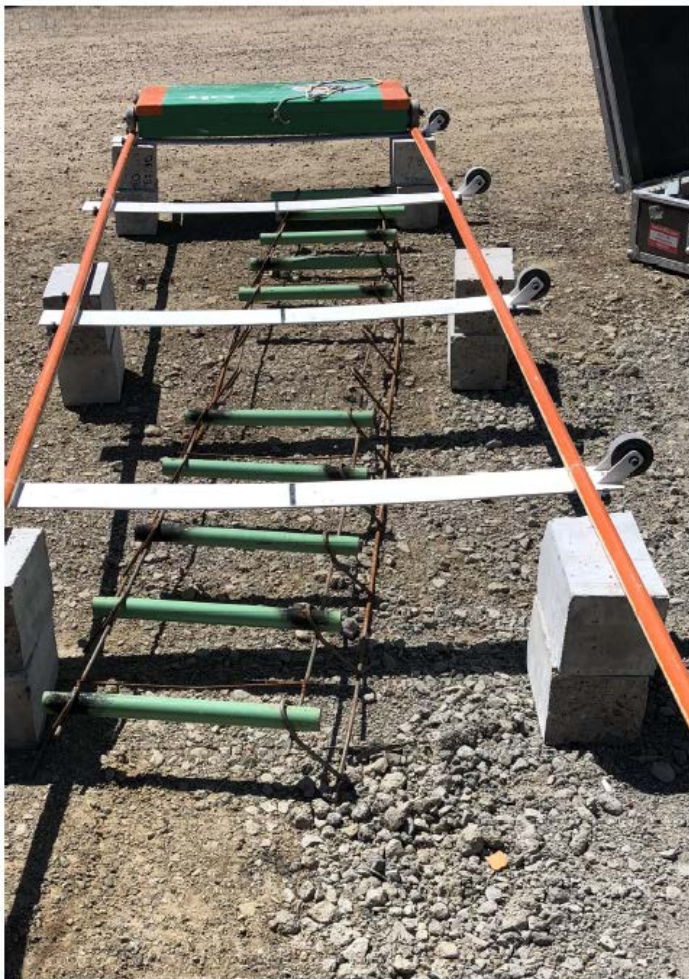
2.3 Figure 79-5 shows a skewed basket to the saw cut joints. The saw cut is indicated by the black line on the MIT Scan-2 tracks. Figure 79-6 shows the corresponding MIT Scan-2 image map. This joint should be further evaluated to determine if the saw cut is skewed and the basket is properly aligned or if the saw cut is correct and the basket is skewed. If the saw cut is skewed and the bars are properly aligned and each bar has the minimum embedment on each side of the saw cut, the joint can be accepted, otherwise, it is rejected and corrective work must be performed. If the saw cut is correct, this would be a locked joint and would require corrective work if adjacent joints are also locked.

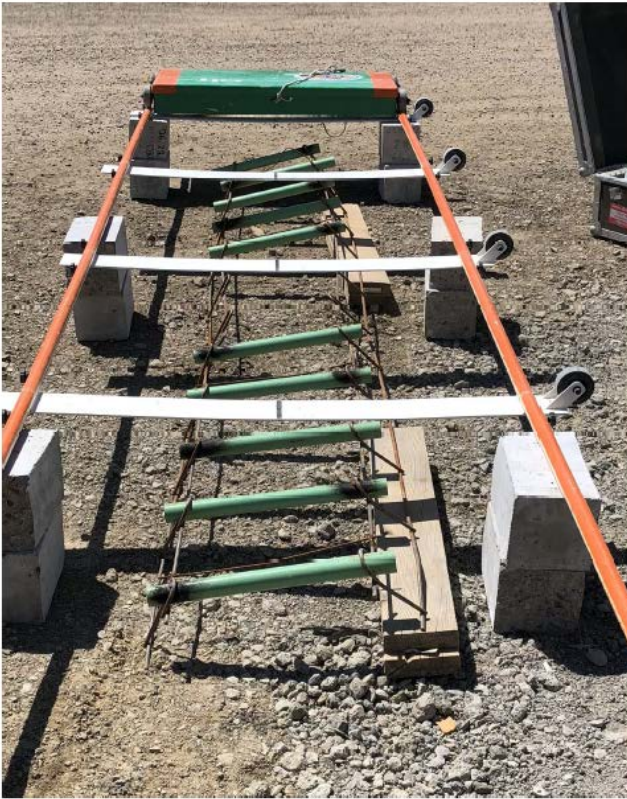
2.4 Figure 79-7 shows a basket that has been tilted. Figure 79-8 shows the corresponding MIT Scan-2 image map. This joint should be further evaluated by coring or a pachometer to determine the overall rotational misalignment of each bar. A joint score can be used to determine the acceptability of the joint using the criteria in subsection 412.13 and if corrective work is required. A single joint like this can be left in place without corrective work if the adjacent joints are correct and there is the required minimum cover above and below the dowel bars. Otherwise the joint requires corrective work.

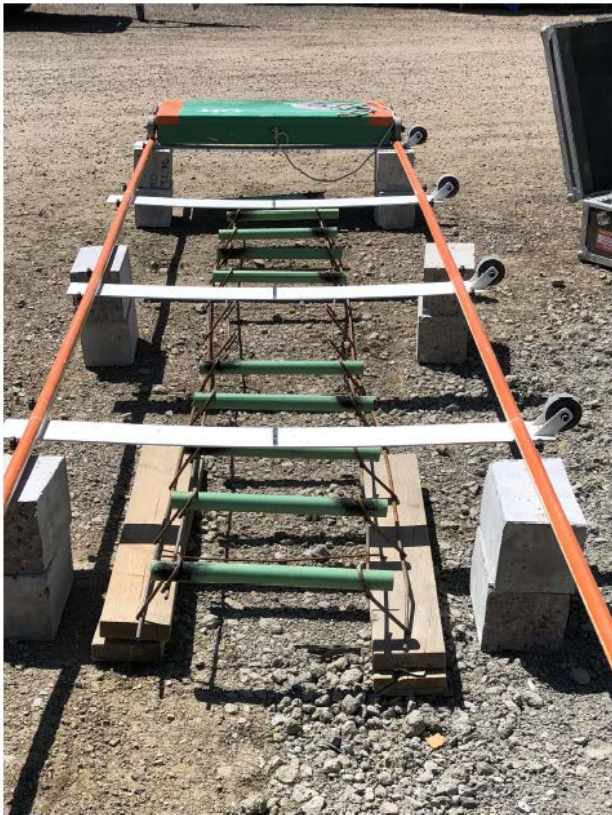
2.5 Figure 79-9 shows a basket that is deeper on one end than the other, but is otherwise aligned. Figure 79-10 shows the corresponding MIT Scan-2 image map. This joint should be further evaluated by coring or a pachometer to determine if there is the required minimum cover above and below the dowel bars. If there is the proper cover above and below the dowel bars, the joint can be accepted, otherwise, corrective work would be required.

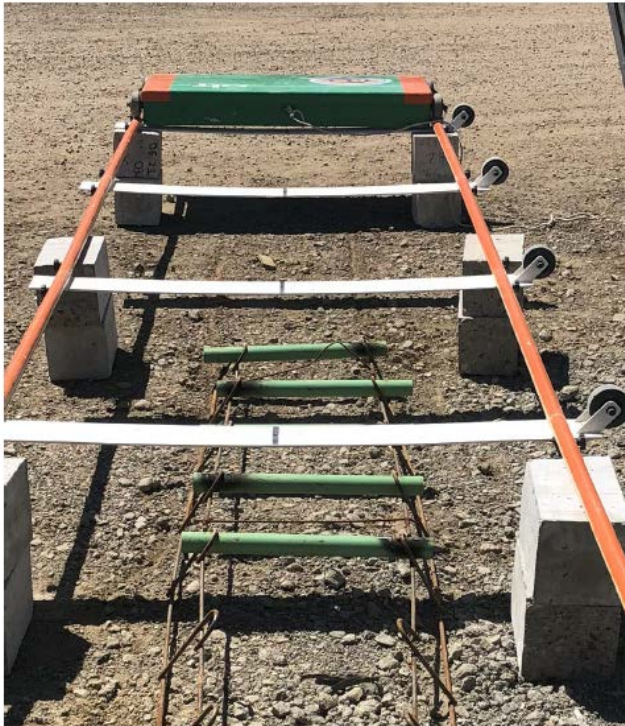
2.6 Figure 79-11 shows a basket that is only on one wheel path. Figure 79-12 shows the corresponding MIT Scan-2 image map. The top half of the MIT Scan-2 image map shows what a joint with no bars would look like. This joint requires corrective work to install the missing bars
