Colorado Procedure 79-22

Standard Practice for

Evaluating MIT Scan Images for Dowel Bars |

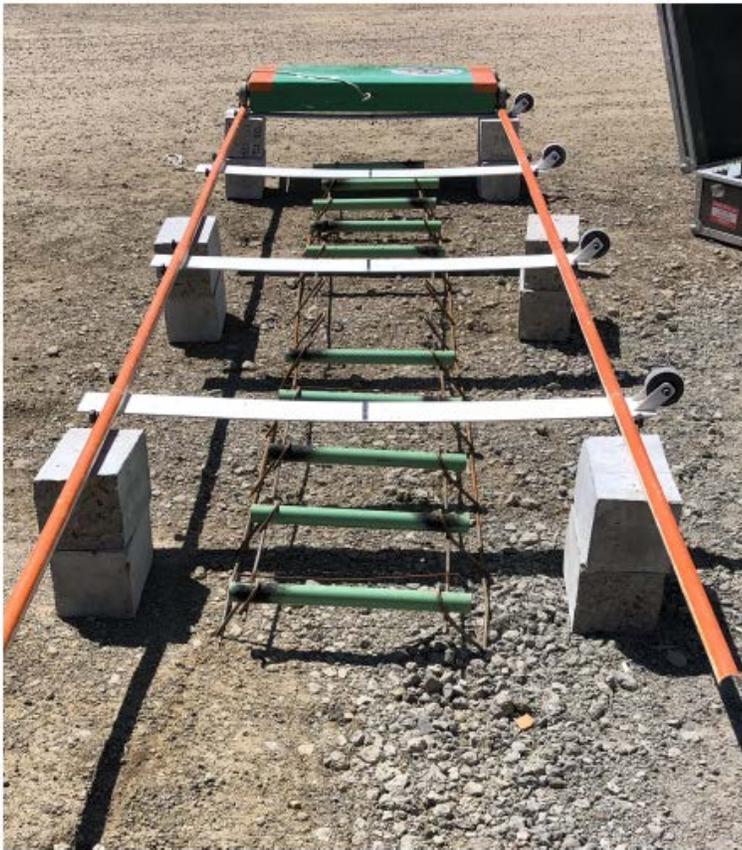
2.1 Figure 79-1 shows a properly aligned dowel basket under the MIT Scan-2 tracks. Figure 79-2 shows the corresponding MIT Scan-2 image map. This joint would be accepted without requiring corrective work.

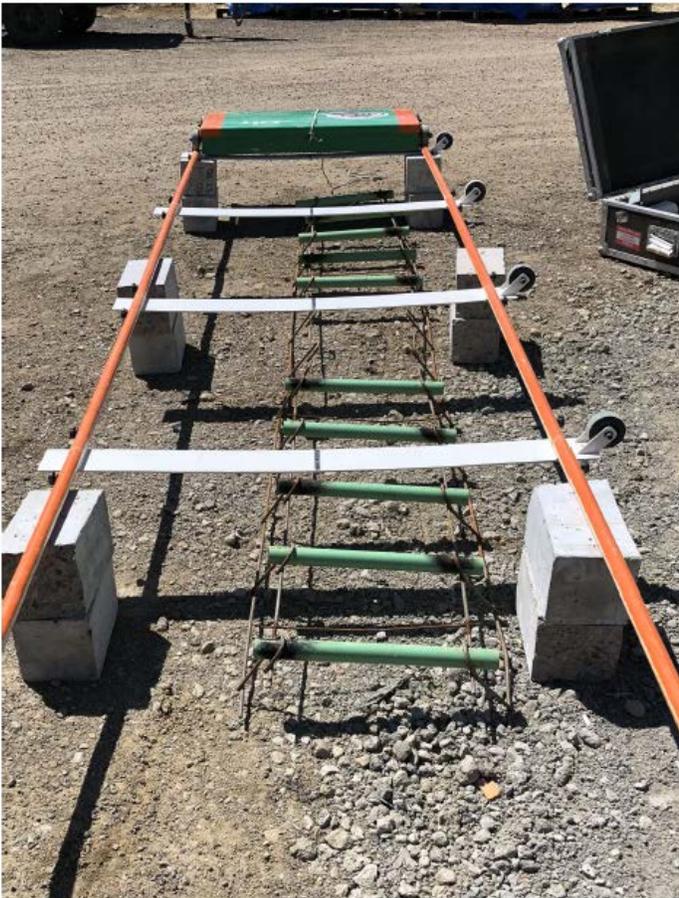
2.2 Figure 79-3 shows a basket that is not centered on the saw cut joint but otherwise aligned. The saw cut is indicated by the black line on the MIT Scan-2 tracks. Figure 79-4 shows the corresponding MIT Scan-2 image map. Further investigation of this joint with cores or a pachometer should be conducted to determine if the minimum 6 inches of embedment on each side of the joint is achieved. If 6 inches of embedment on each side of the joint is not achieved, the joint is rejected and requires corrective work.

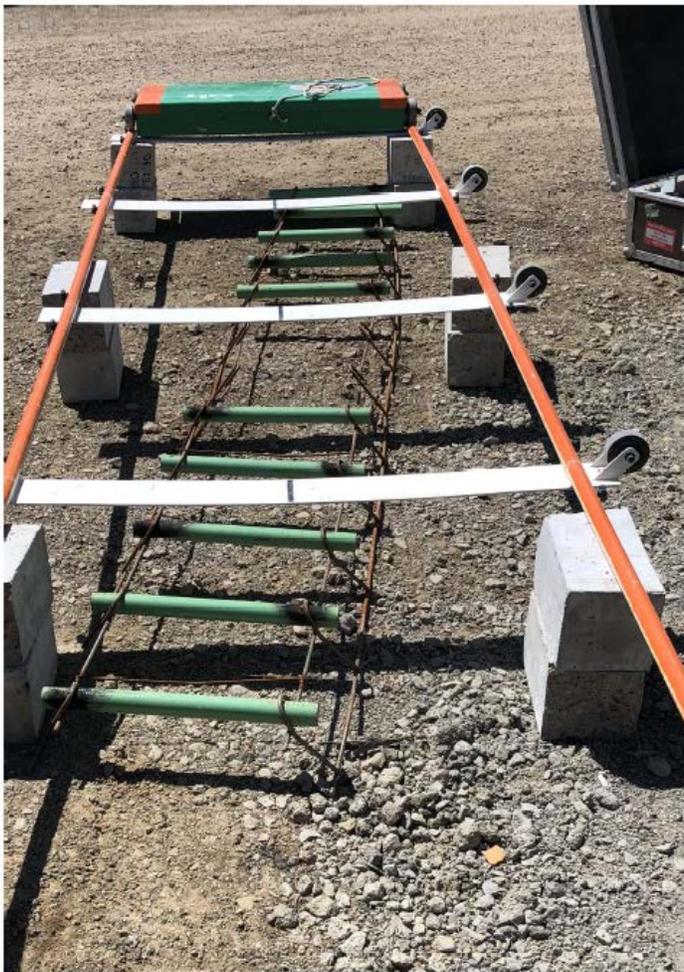
2.3 Figure 79-5 shows a skewed basket to the saw cut joints. The saw cut is indicated by the black line on the MIT Scan-2 tracks. Figure 79-6 shows the corresponding MIT Scan-2 image map. This joint should be further evaluated to determine if the saw cut is skewed and the basket is properly aligned or if the saw cut is correct and the basket is skewed. If the saw cut is skewed and the bars are properly aligned and each bar has the minimum embedment on each side of the saw cut, the joint can be accepted, otherwise, it is rejected and corrective work must be performed. If the saw cut is correct, this would be a locked joint and would require corrective work if adjacent joints are also locked.

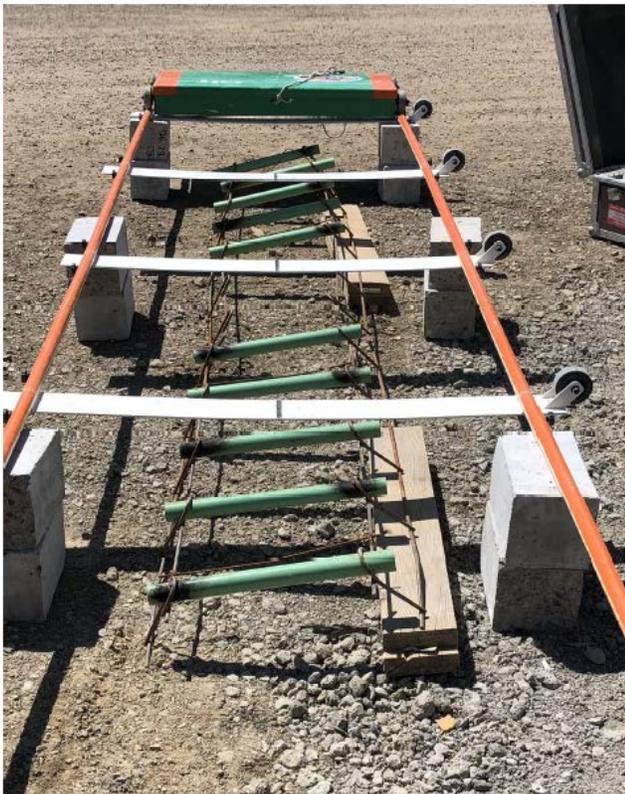
2.4 Figure 79-7 shows a basket that has been tilted. Figure 79-8 shows the corresponding MIT Scan-2 image map. This joint should be further evaluated by coring or a pachometer to determine the overall rotational misalignment of each bar. A joint score can be used to determine the acceptability of the joint using the criteria in subsection 412.13 and if corrective work is required. A single joint like this can be left in place without corrective work if the adjacent joints are correct and there is the required minimum cover above and below the dowel bars. Otherwise the joint requires corrective work.

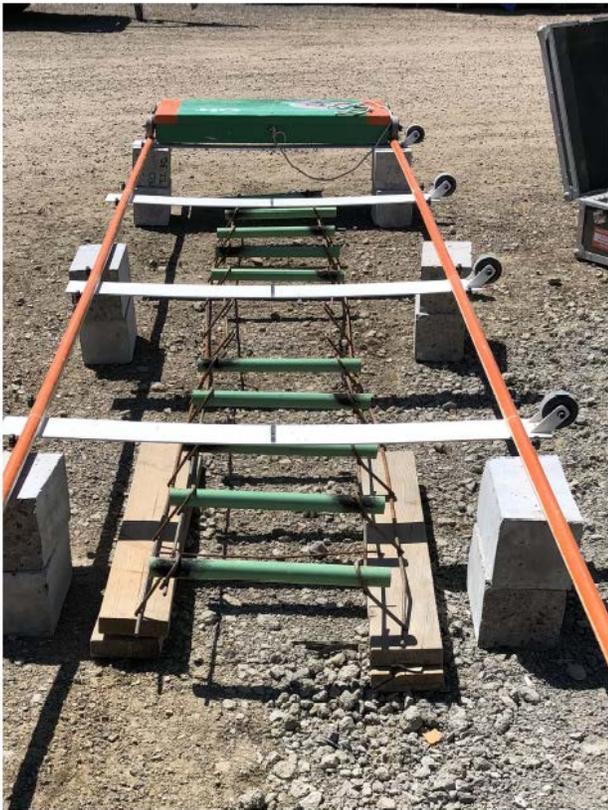
2.5 Figure 79-9 shows a basket that is deeper on one end than the other but is otherwise aligned. Figure 79-10 shows the corresponding MIT Scan-2 image map. This joint should be further evaluated by coring or a pachometer to determine if there is the required minimum cover above and below the dowel bars. If there is the proper cover above and below the dowel bars, the joint can be accepted, otherwise, corrective work would be required.

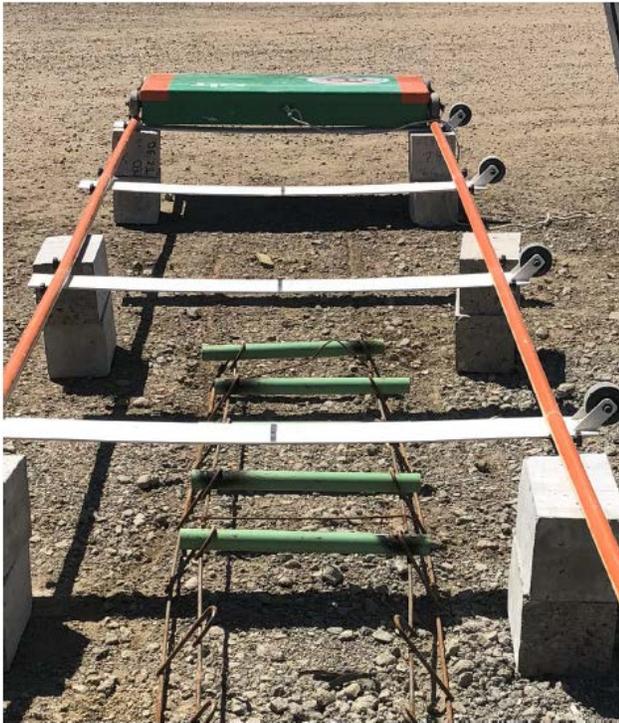
2.6 Figure 79-11 shows a basket that is only on one wheel path. Figure 79-12 shows the corresponding MIT Scan-2 image map. The top half of the MIT Scan-2 image map shows what a joint with no bars would look like. This joint requires corrective work to install the missing bars
