1.0 CHAPTER 1 PURPOSE AND NEED

Through this NEPA/planning process, which included input by City of Pueblo (City) engineering and planning staff, transportation conditions along I-25 through Pueblo were described, needs were identified, and transportation problems were defined. Consistent with NEPA and the regulation of the Council on Environmental Quality (CEQ) 40 CFR 1500-1508, and as set forth in 23 CFR, an active public participation program captured community values held by the citizens of Pueblo in a Vision Statement (provided at the end of this chapter) that asks FHWA and CDOT to respect the traditions and trends of the Pueblo community as they develop solutions to roadway problems. The culmination of this planning effort is called the New Pueblo Freeway project.

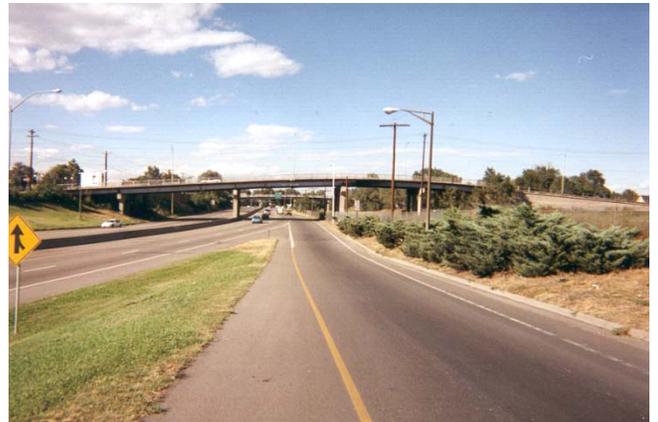
Mesa Avenue Bridge

A technical evaluation of the geometric and operational deficiencies for I-25 through Pueblo was conducted (CH2M HILL, 2002; 2011a). The evaluation resulted in a rating based on a combination of field measurements, field observations, review of original construction plans, and assessment of accident rates.

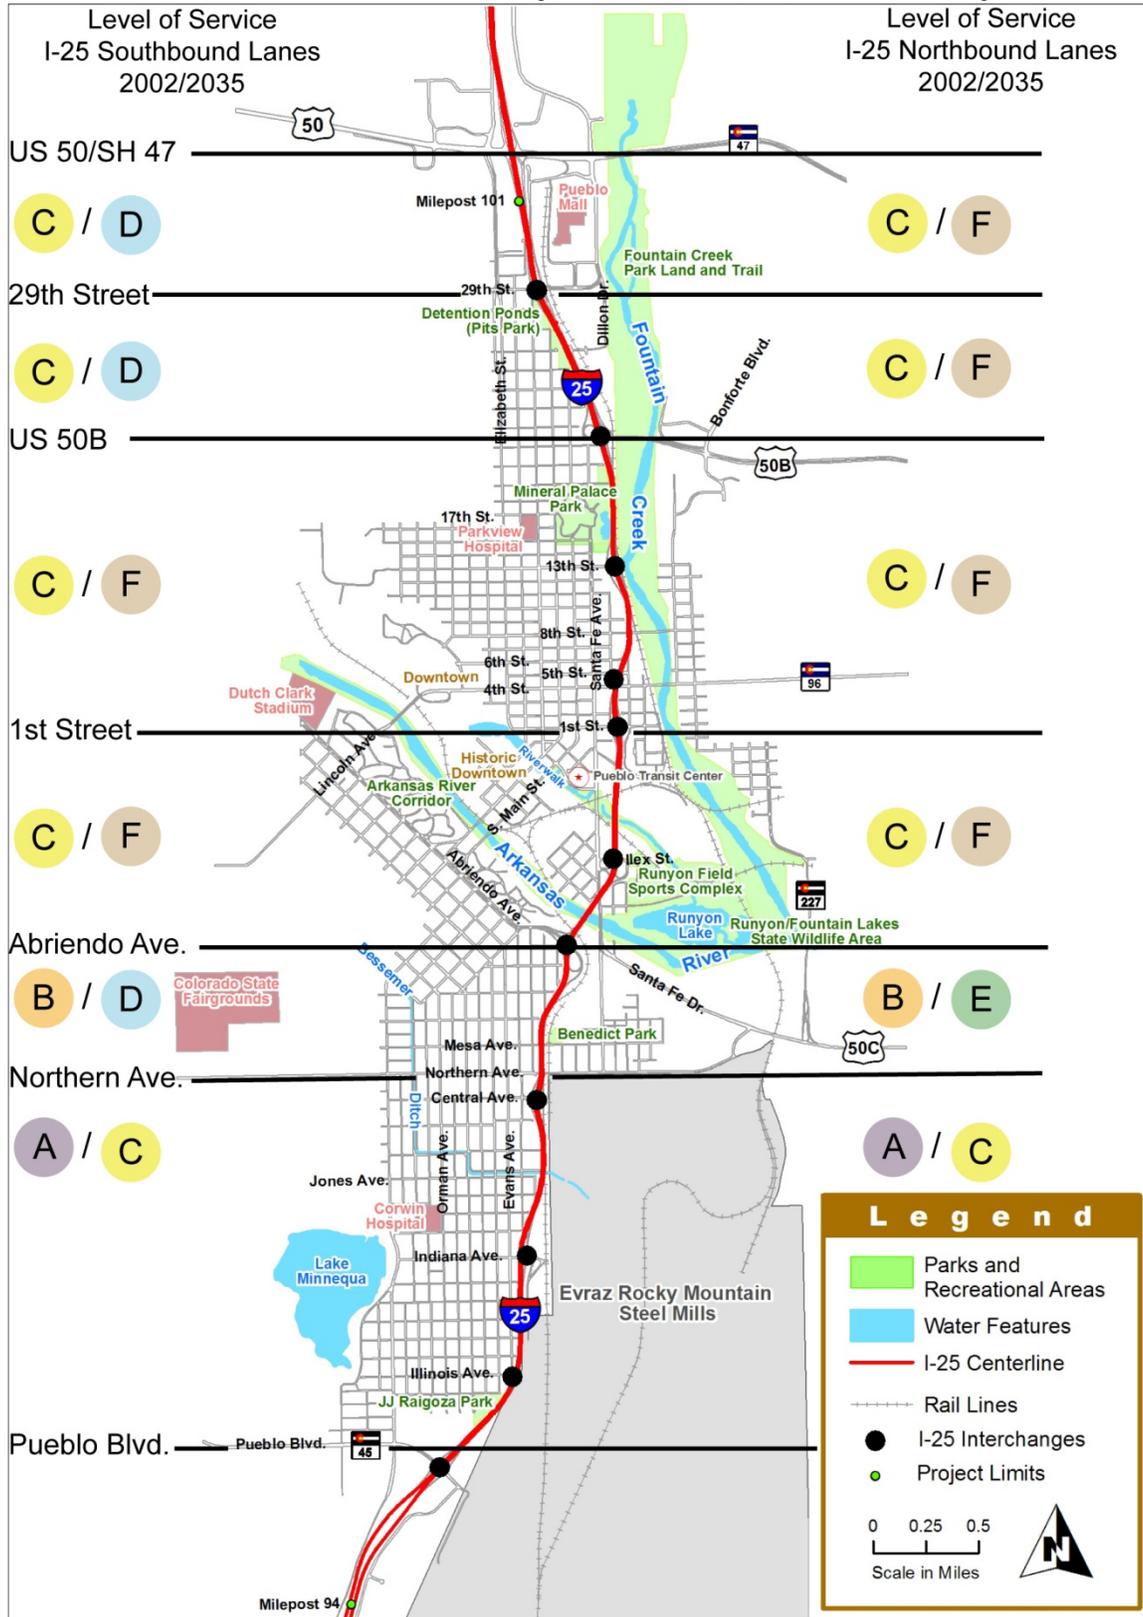
EXHIBIT 1-5

Illustration of PM Peak-Hour Level of Service for Existing (2002) and Future (2035) Traffic with Existing Conditions

As shown in these exhibits, the existing capacity of I-25 is sufficient for meeting the current traffic demand on the highway. However, many segments in the corridor exceed 8,000 vehicles per hour (4,000 in each direction) for the future No Action Alternative scenario, suggesting that six lanes would theoretically be required to handle this amount of traffic. While safety improvements alone would slightly improve the theoretical capacity, these improvements still would not provide sufficient capacity to meet future traffic demands on the system.

If additional highway capacity is not provided, traffic conditions will deteriorate corridor-wide, with many segments reaching stop-and-go to completely stopped (LOS F) traffic conditions by 2035. This increase in congestion will result in 2.29 minutes of delay per mile within the system (CH2M HILL, 2005a; 2010h).
