**EVALUATIVE TEST EXCAVATION OF ELEVEN  
HISTORIC SITES FOR THE COLORADO  
DEPARTMENT OF TRANSPORTATION  
INTERSTATE 25 NEW PUEBLO FREEWAY  
IMPROVEMENT PROJECT, PUEBLO COUNTY,  
COLORADO**

**Prepared for:**

**Colorado Department of Transportation  
Denver, Colorado**

**Centennial Archaeology, Inc.  
Fort Collins, Colorado**

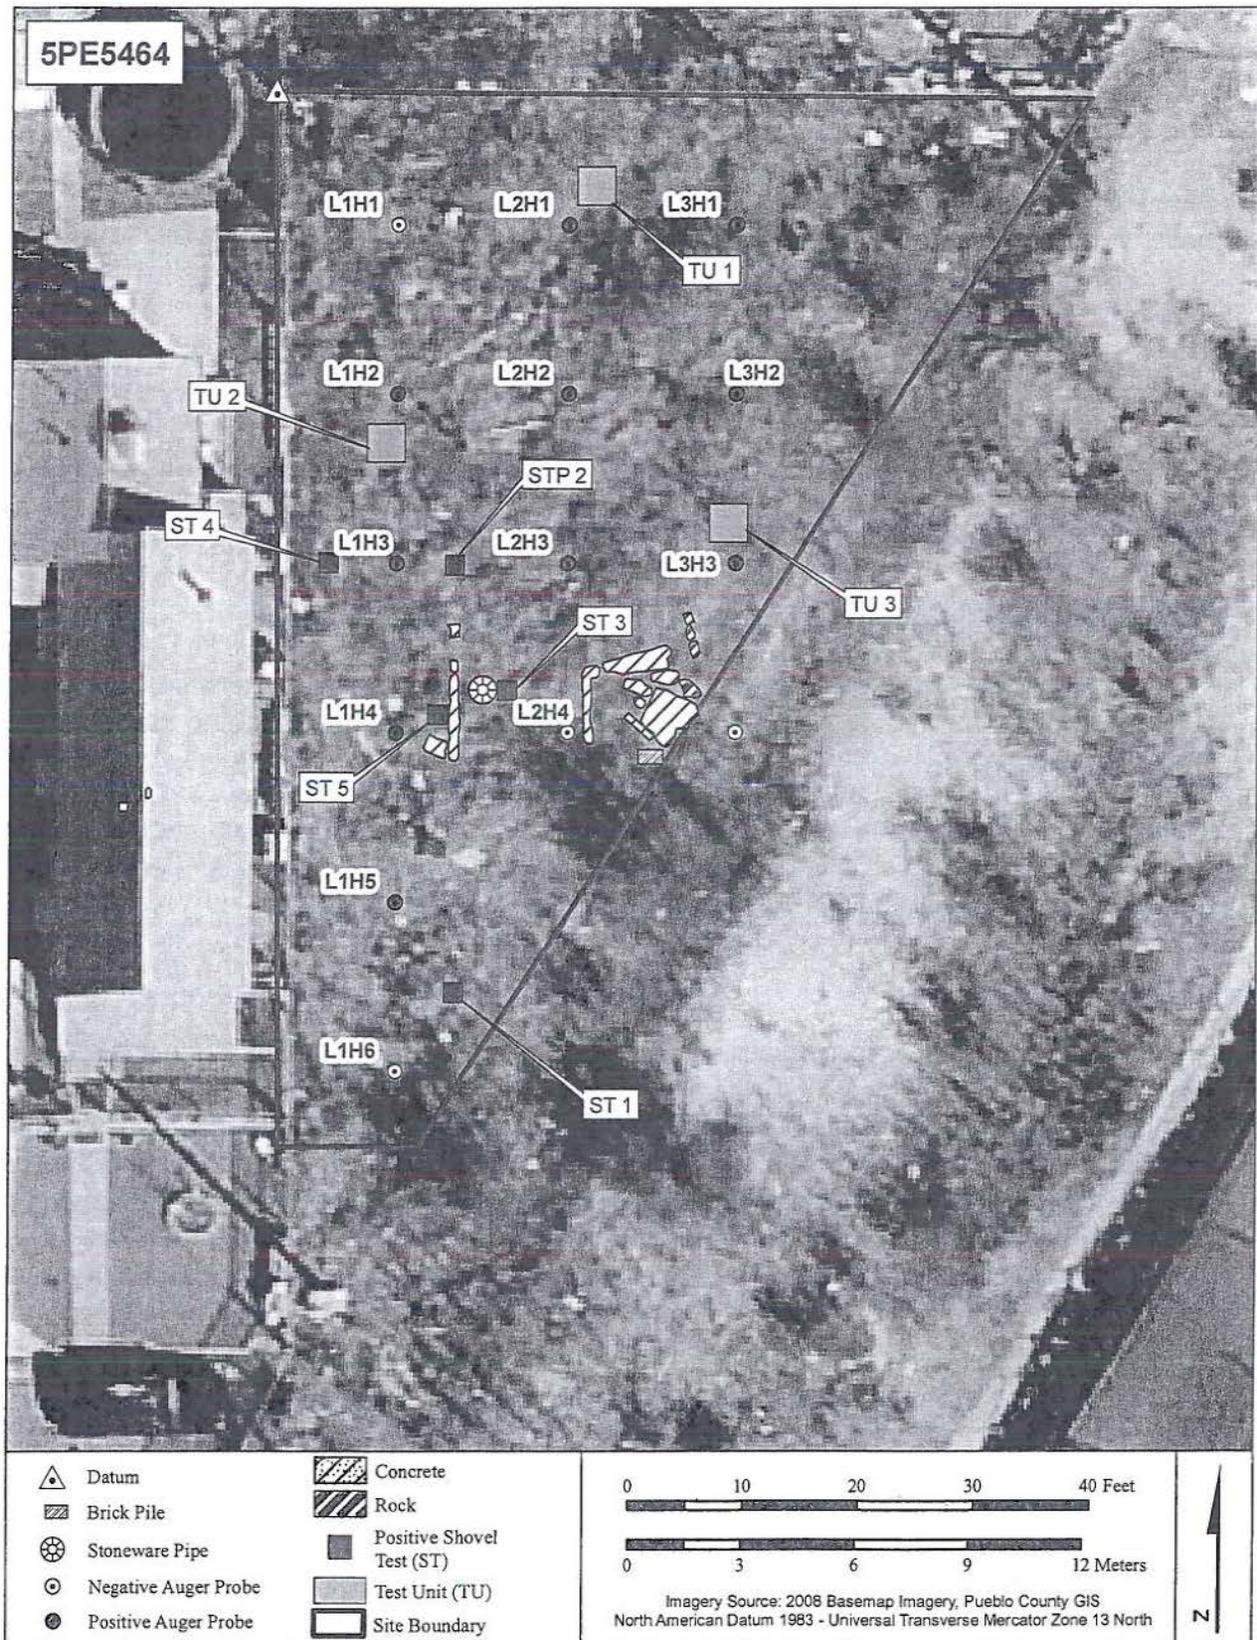
Figure 27. Site 5PE5464 plan map.

The site consists of portions of two residential lots (Figure 27). Based on the 1905 Sanborn Fire Insurance map, the lots originally would have measured 90 ft (N/S) x 32 ft (E/W) and encompassed 0.066 acre (Figure 28). Construction of I-25 resulted in the removal of a diagonal strip of land for the interstate right-of-way. The southeastern portion of the eastern lot was completely removed, and a small area in the southeastern corner of the western lot was also impacted.

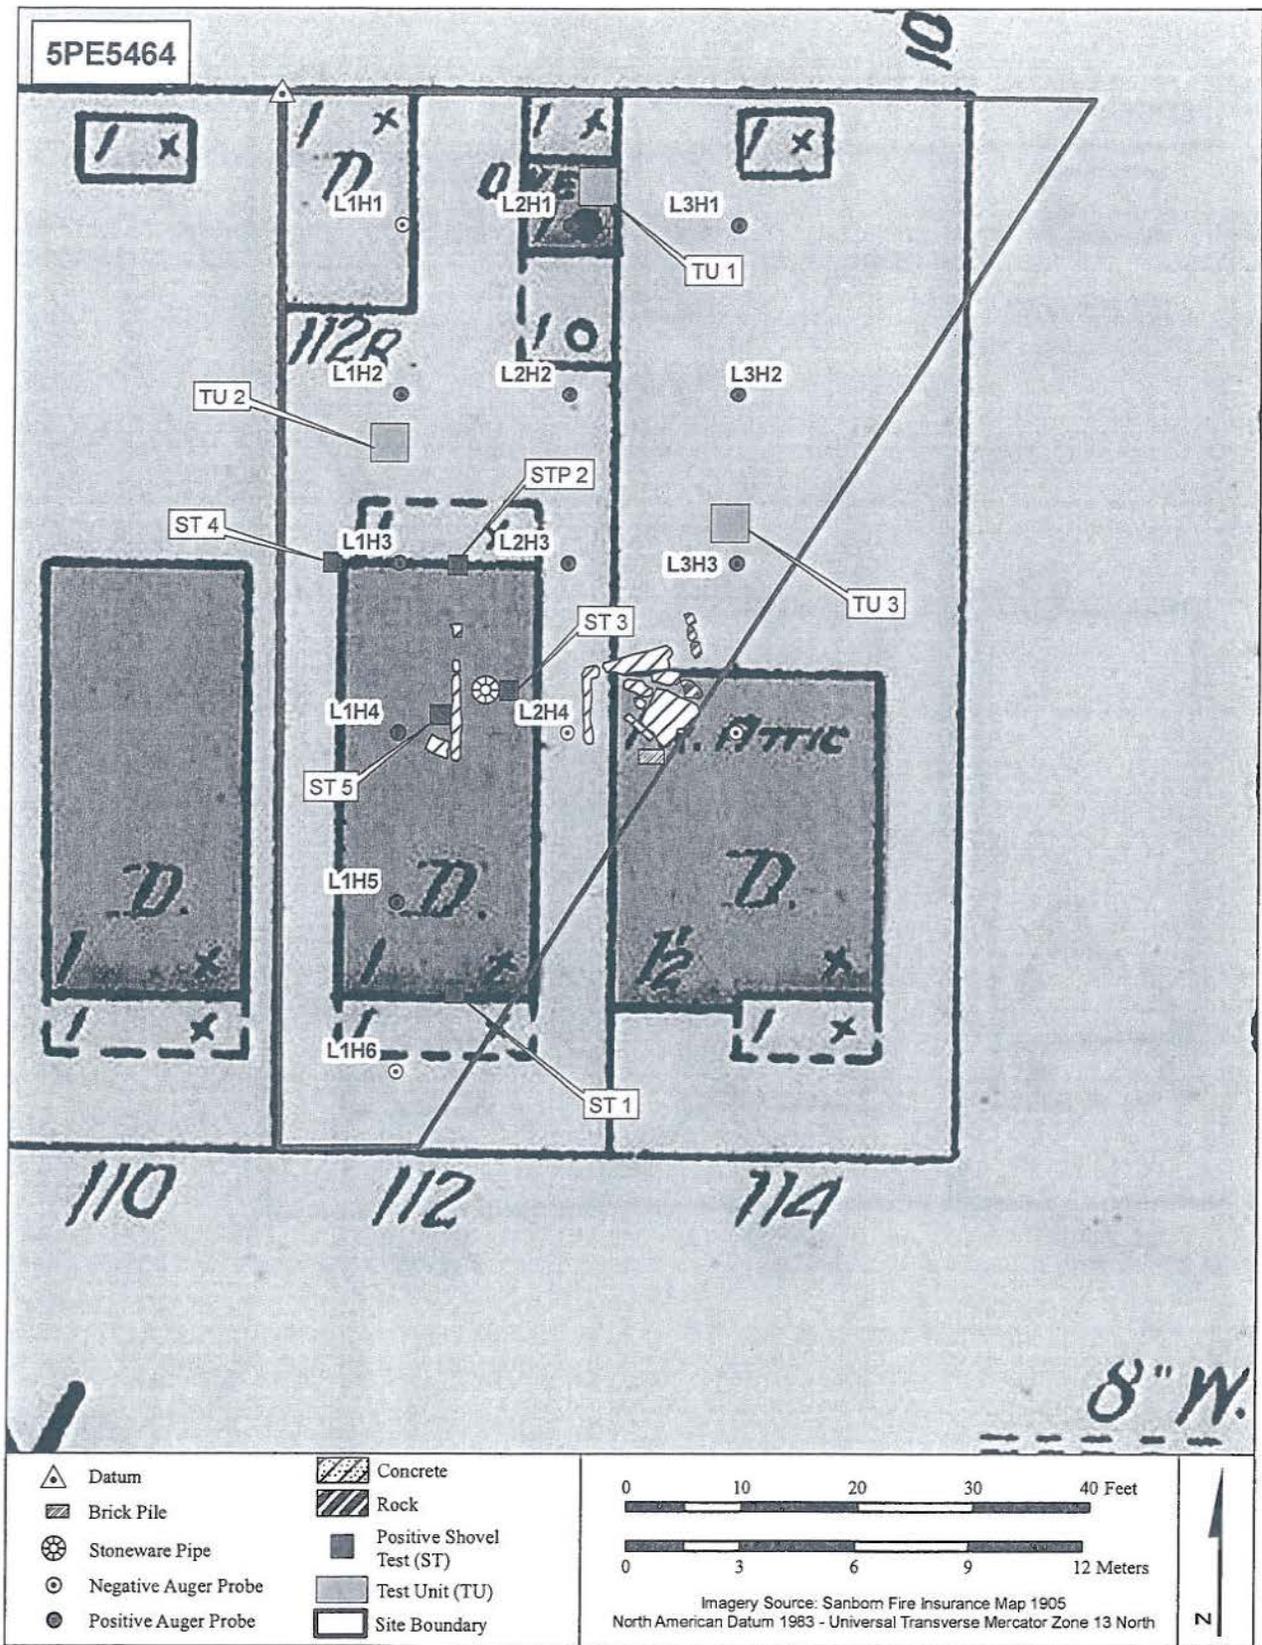
Figure 28. Site 5PE5464 plan map with 1905 Sanborn Fire Insurance map background.

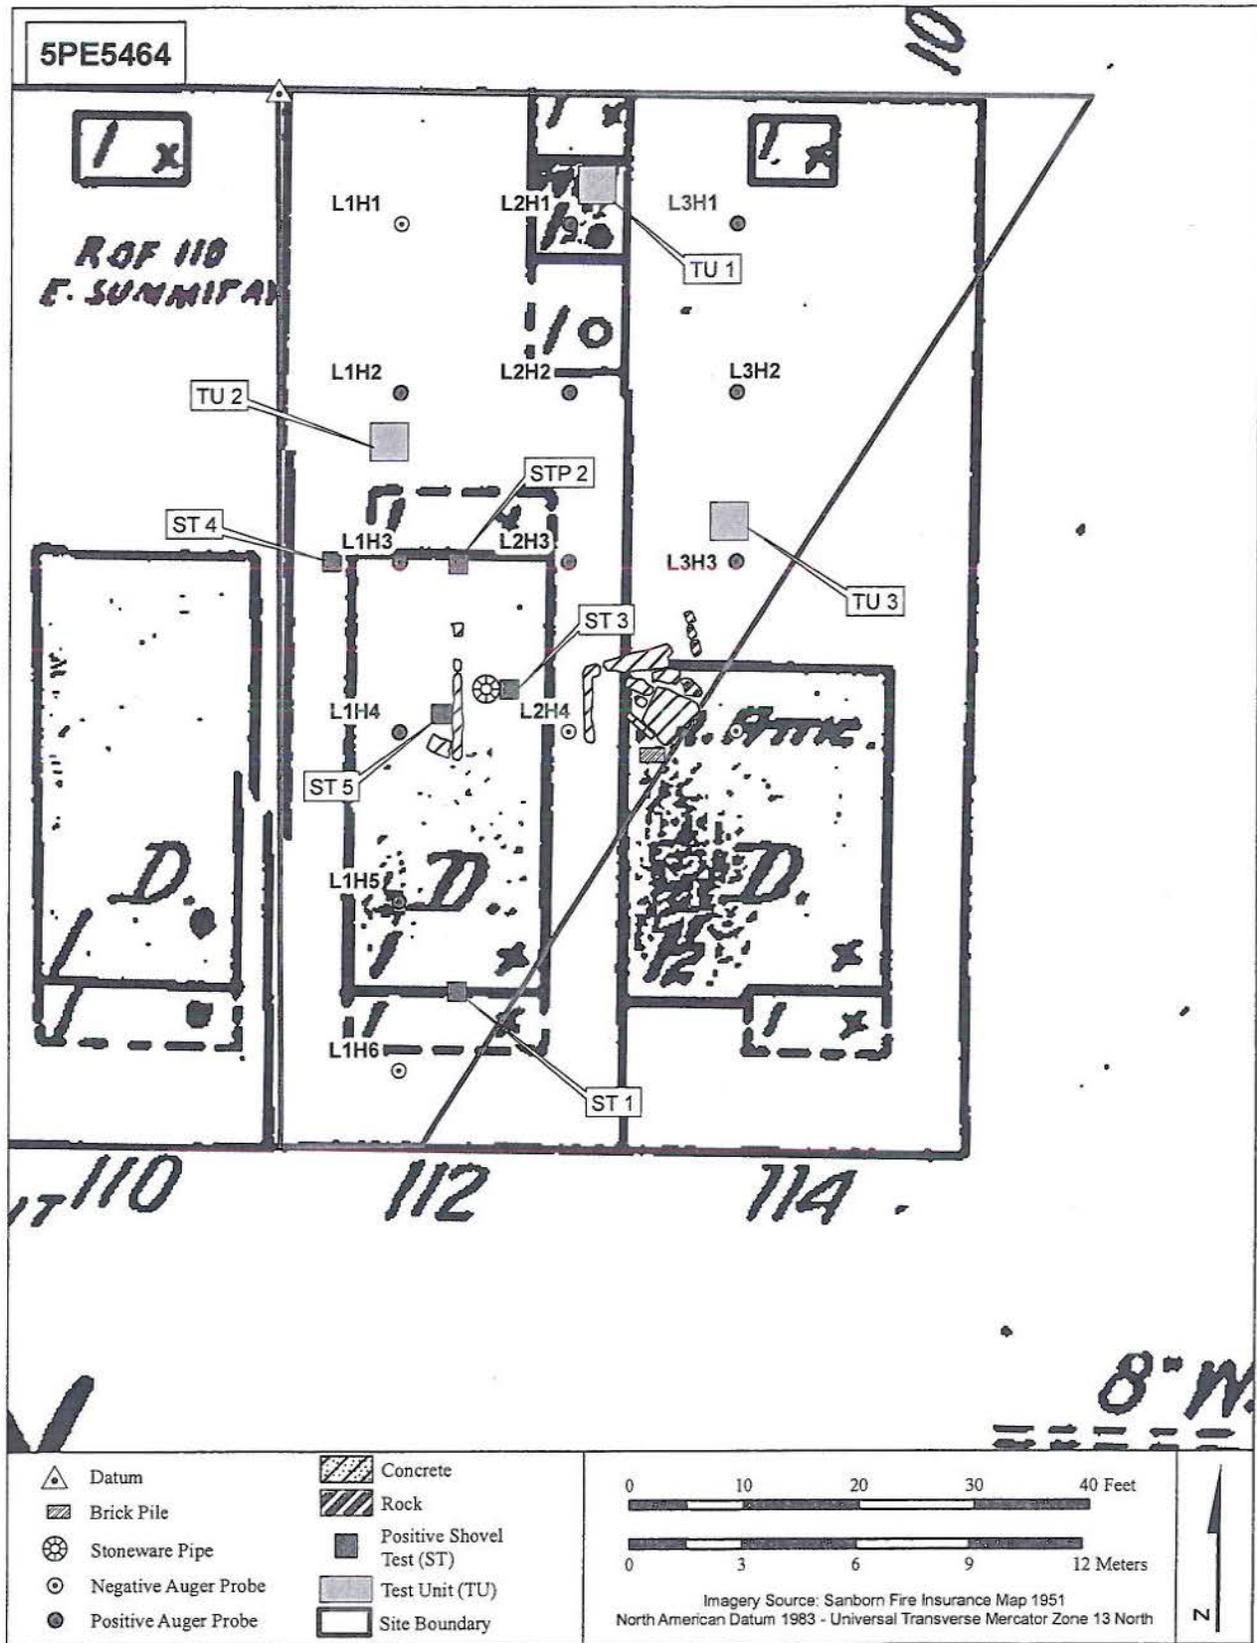
Figure 29. Site 5PE5464 plan map with 1951 Sanborn Fire Insurance map background.

In Figure 24, the location of site 5PE5464 is superimposed on an 1897 map of Pueblo. On the 1907 Pueblo City map (Figure 23) the site, which includes portions of two residential lots, is shown at the southern edge of the Elwell and Smiths Addition. The two lots, associated with the addresses 112 and 114 East Summit Avenue, are shown in detail on the 1905 Sanborn Fire Insurance map (Figure 28). Based on this map, there were at least two dwellings and one composite wood/brick structure at 112 East Summit Avenue, and one dwelling and an outbuilding located at the 114 East Summit Avenue location. The updated Sanborn Fire Insurance map indicates that the northernmost dwelling at 112 East Summit Avenue was no longer present in 1951 (Figure 29).

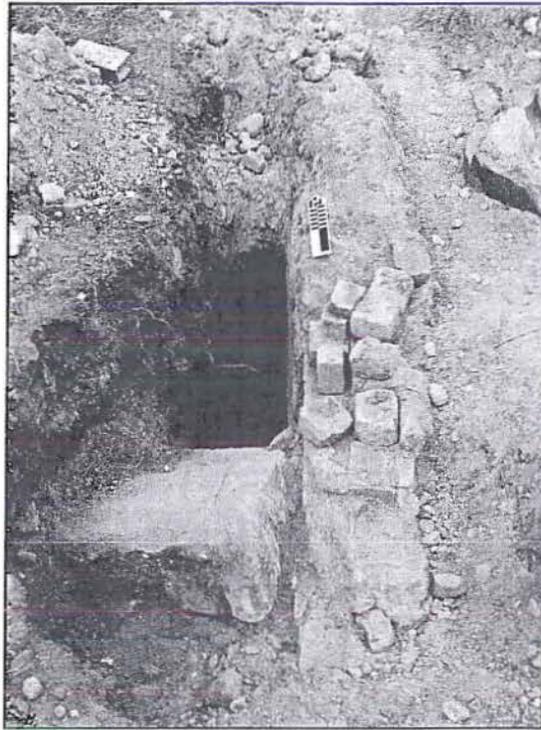
Figure 30. Site 5PE5464. Detailed view of Foundation 1.

This foundation is located near the center of the 112 Summit Avenue structural footprint as shown on the 1905 Sanborn Fire Insurance map. A 20-inch-long segment of this foundation, aligned north/south, was exposed at the surface. Scraping and trenching along the edges of the exposed portion uncovered a 6.5-ft-long section of foundation. The foundation comprised brick and mortar with a thin layer of cement along the upper surface. This section is 14 inches thick, and based on Shovel Test (ST) 5, it extends a minimum of 4 ft deep. Additional aligned foundation remnants were identified in ST 1 and 2 and may have been conjoined portions of Foundation 1. In addition to the foundation, a segment of vitrified clay pipe was excavated on the east side of the exposed edge of Foundation 1. This pipe segment, which measures 28 inches in diameter, is filled with concrete and exhibits a second segment of 6-inch pipe embedded in the top surface with bricks embedded along the edges (Figure 30). Based on ST 3, which was excavated on the eastern edge of the pipe, it extends 8-10 inches below ground. The function of this feature is unknown.

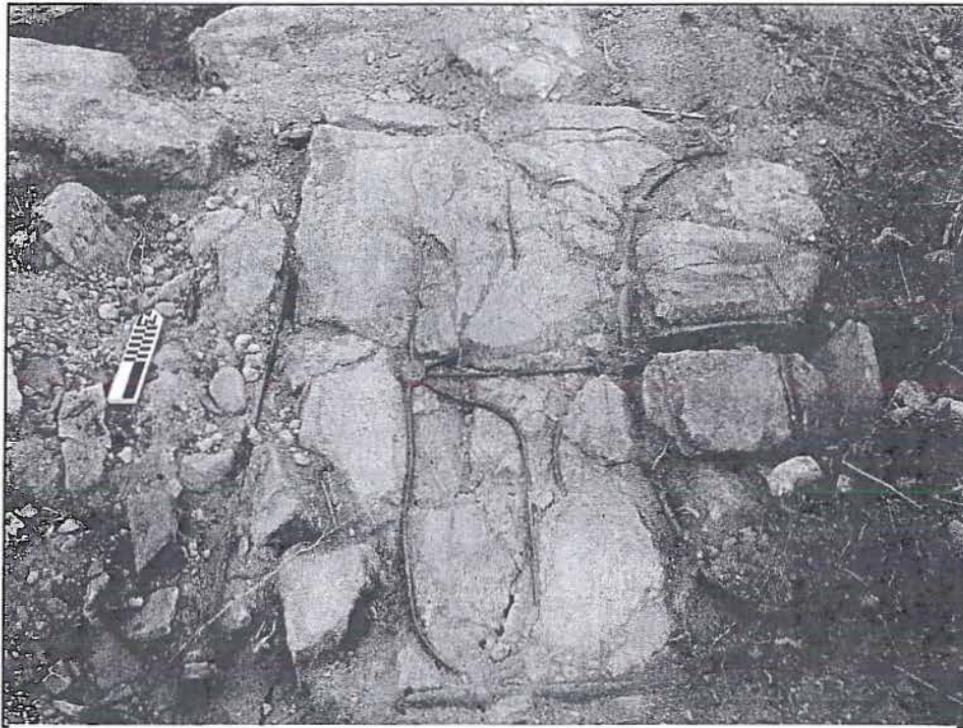
Figure 31. Site 5PE5464. Detailed view of Foundation 2.

Portions of a second foundation were exposed by trenching in the vicinity of the northwestern corner of the 114 Summit Avenue dwelling, as it is depicted on the 1905 Sanborn

Fire Insurance map. The structural remains consisted of a large broken concrete slab, large blocks of broken concrete, rock, and a discontinuous concrete foundation remnant. The large concrete slab measured approximately 4 ft long x 4.5 feet wide. An iron gate, which is embedded in the slab, appears to have been reused for purposes of reinforcing the concrete (Figure 31). Additional concrete blocks were exposed adjacent to the large slab, and many appear to have been broken as a result of demolition. The foundation is discontinuous, and consists of one segment aligned north/south with a portion of the corner and a disturbed segment that is aligned southwest/northeast. It seems likely that this portion of the foundation was pushed out of place during the demolition process.

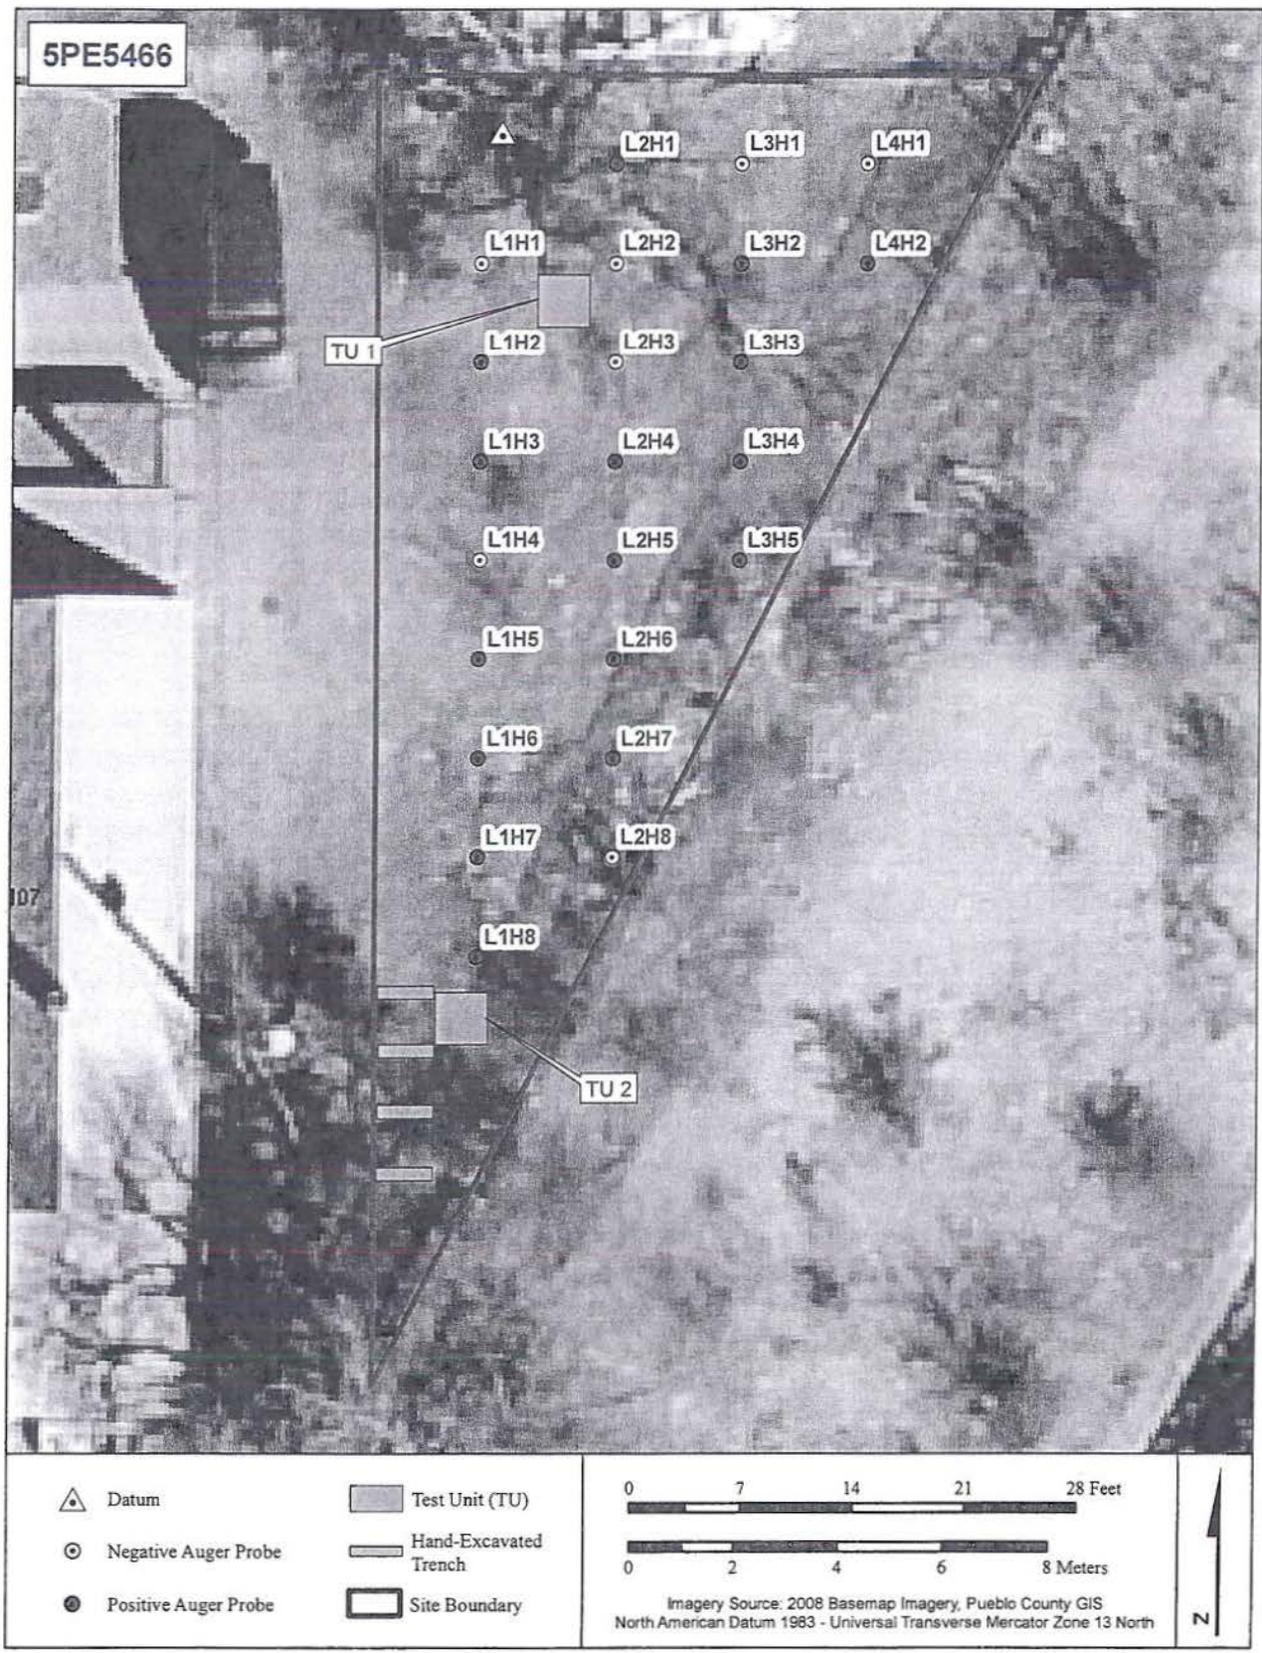
Figure 32. Site 5PE5466 plan map.

The area delineated as site 5PE5466 is a small triangular lot in a residential neighborhood (Figure 32). The site, which is located at an elevation of 4759 ft, is bounded to the north by Summit Avenue and to the southeast by the I-25 right-of-way, and lies adjacent to a residence to the west. The site is covered with modern trash as well as piles of tree branches. Surface soil is composed of dark brown sandy loam with organic materials, gravel, and small cobbles. Vegetation includes Asian elm, various weeds, and sparse grasses.

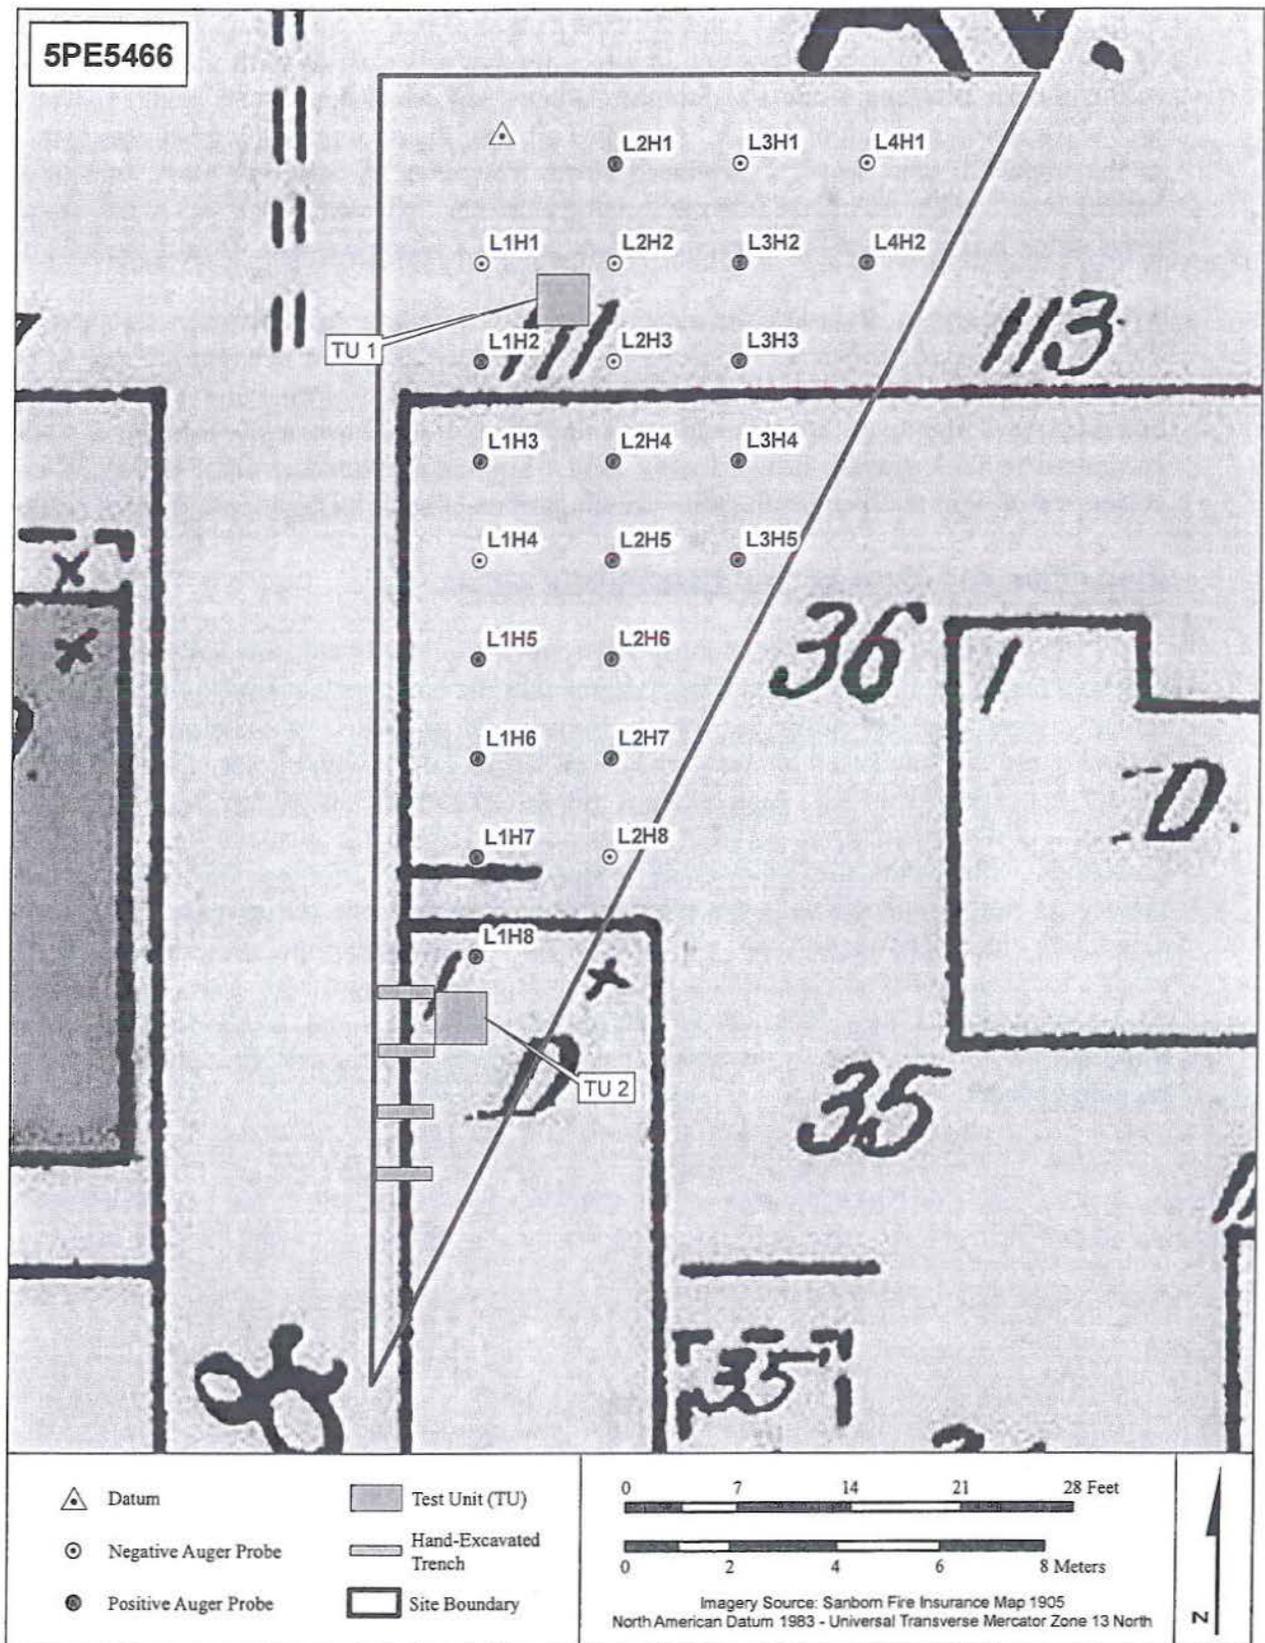
Figure 33. Site 5PE5466 plan map with 1905 Sanborn Fire Insurance map background.

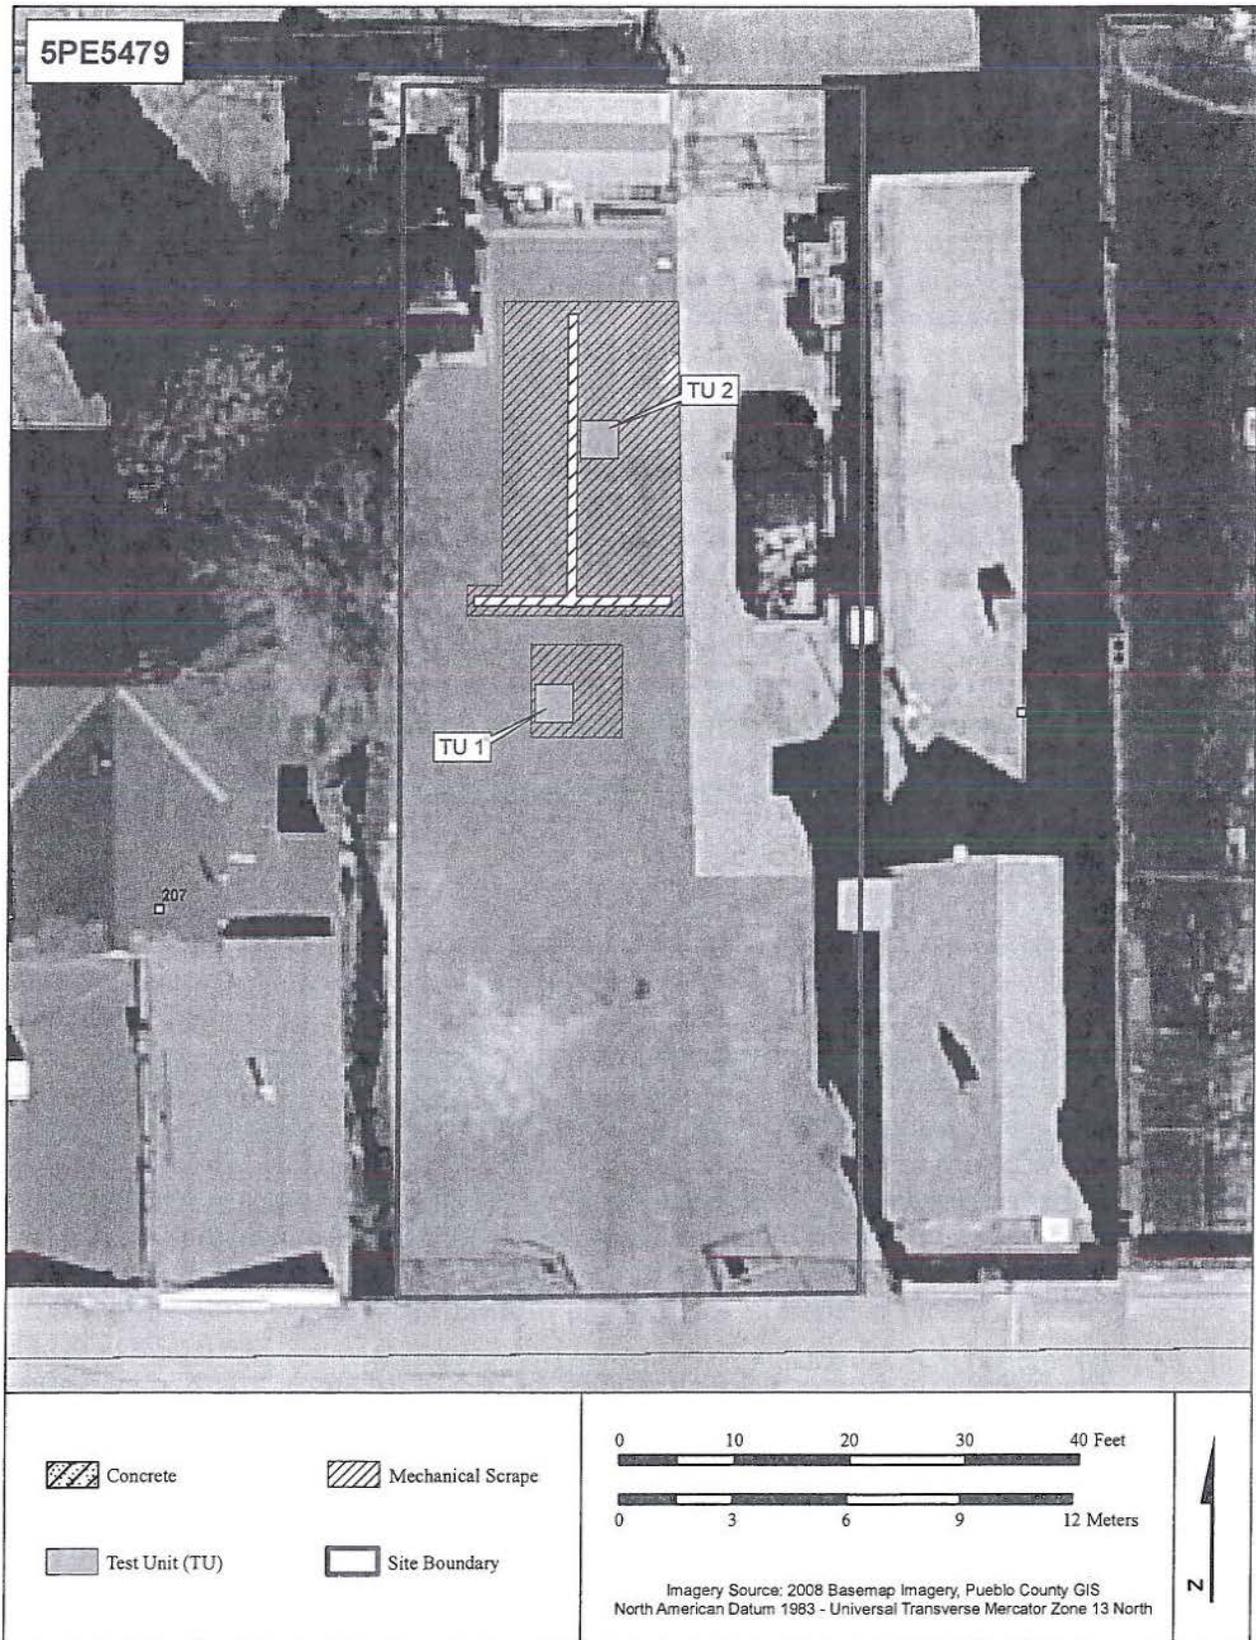
Figure 34. Plan map of site 5PE5479.

The site boundary encompasses the entire lot, which is bordered by roadways to the north and south, and commercial buildings to the east and west (Figure 34). Private residences are located across an alley to the north. Based on the 1905 Sanborn Fire Insurance map the historic dimensions of the lot are 110 ft (N/S) x 43 ft (E/W), enclosing an area of 0.11 acre. During the initial recording by WCRM the site was described as a vacant lot covered with gravel, and a concrete slab used as a storage area for cars and car repair. Cultural materials were reported as being visible from the perimeter of the site. Archival research by WCRM, based on the 1905 Sanborn Fire Insurance map, indicated that at least four commercial structures had been located on the lot; site dimensions were given as 105 ft (N/S) x 38 ft (E/W), encompassing 0.14 acre. Based on 2011 fieldwork, the site measures 105 ft (N/S) x 40 ft (E/W) and encompasses 0.1 acre.

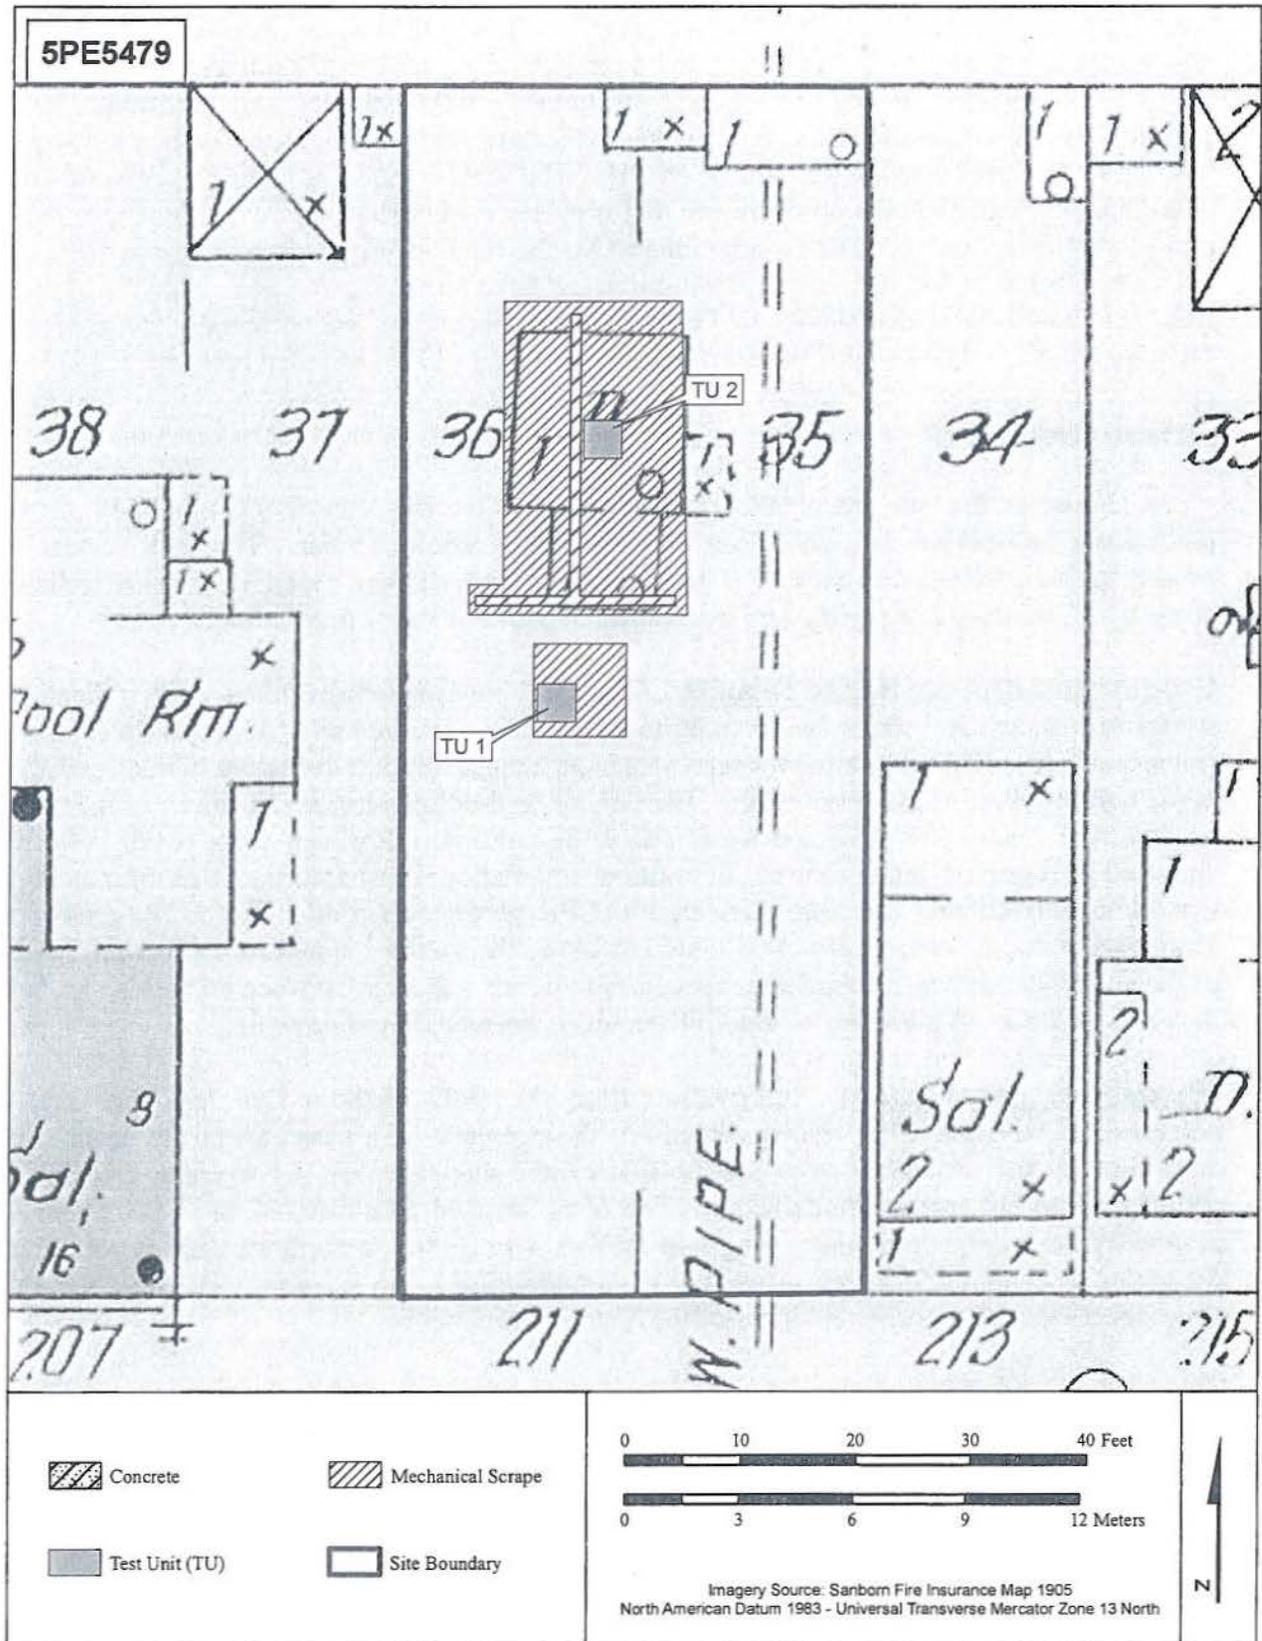
Figure 35. Site 5PE5479 plan map with 1905 Sanborn Fire Insurance map background

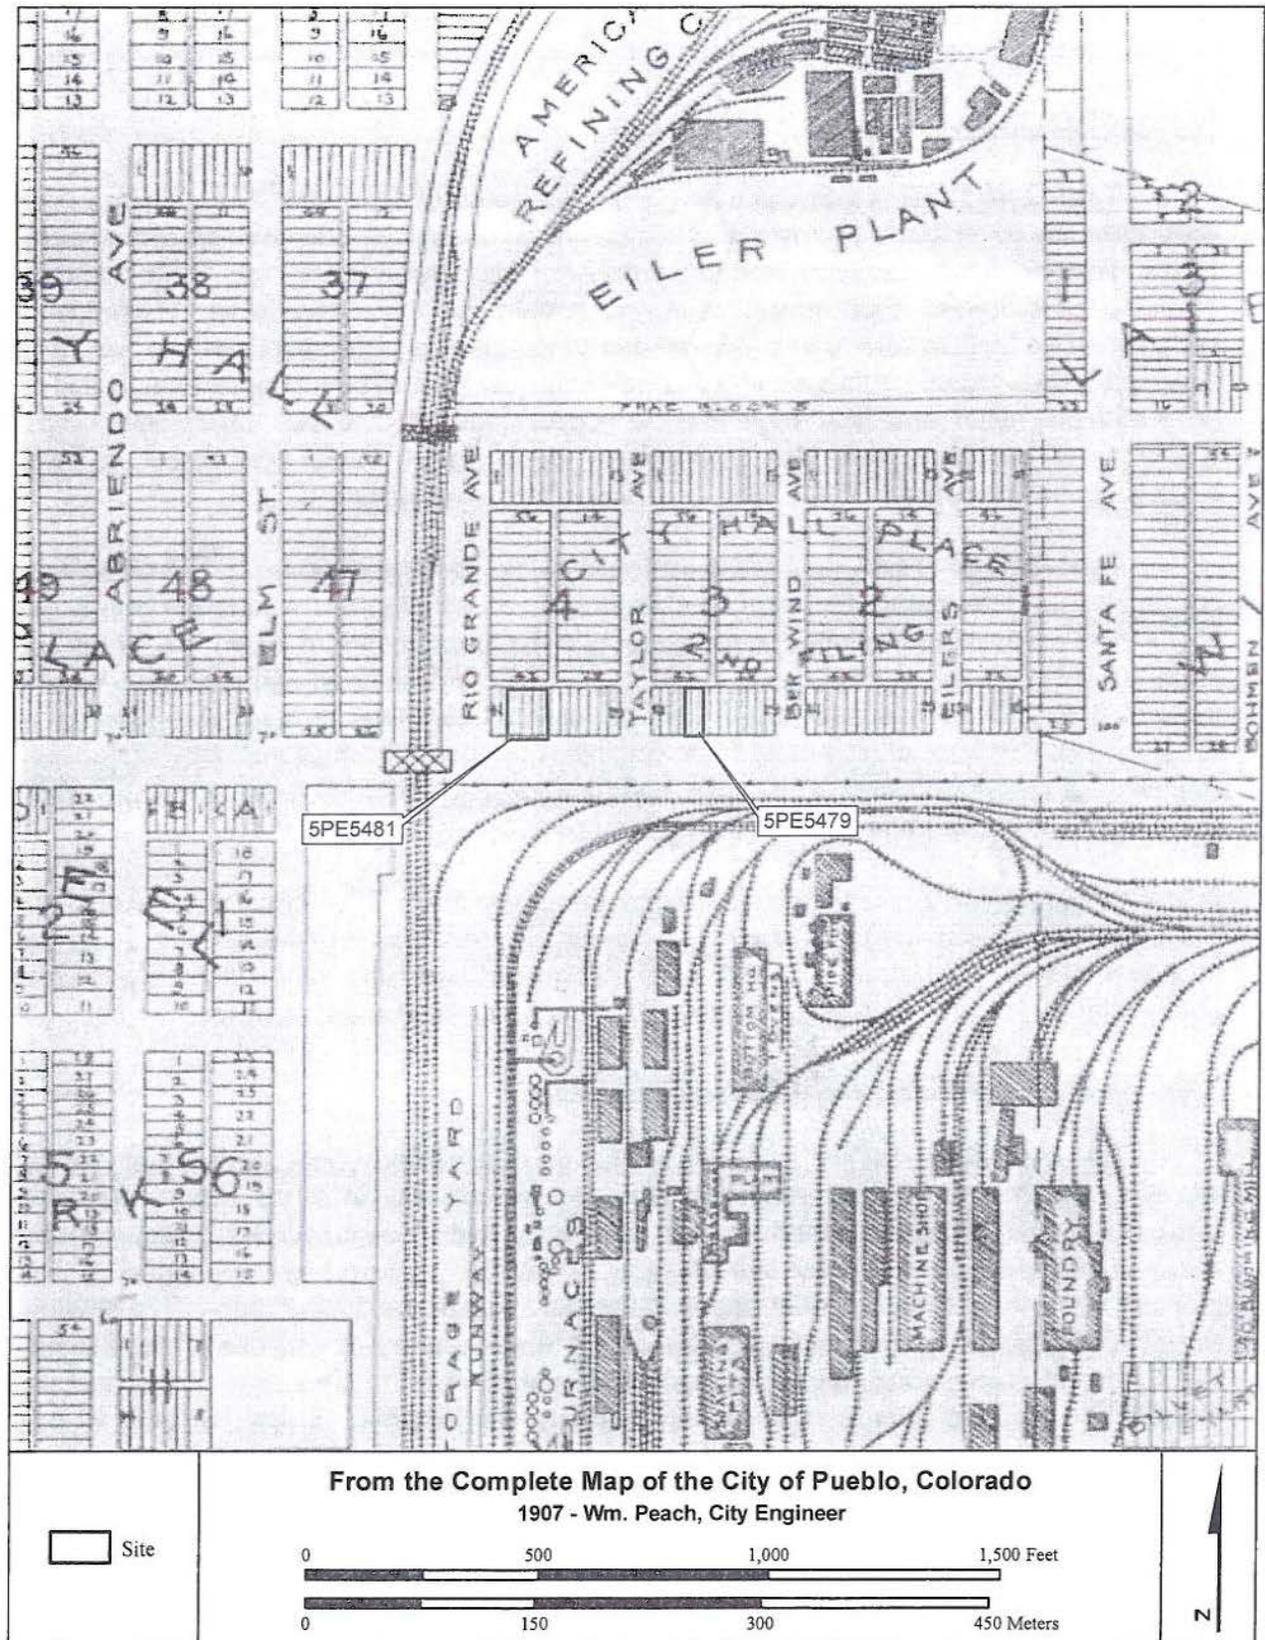
Figure 36. Sites 5PE5479 and 5PE5481 with 1907 Pueblo City map background.

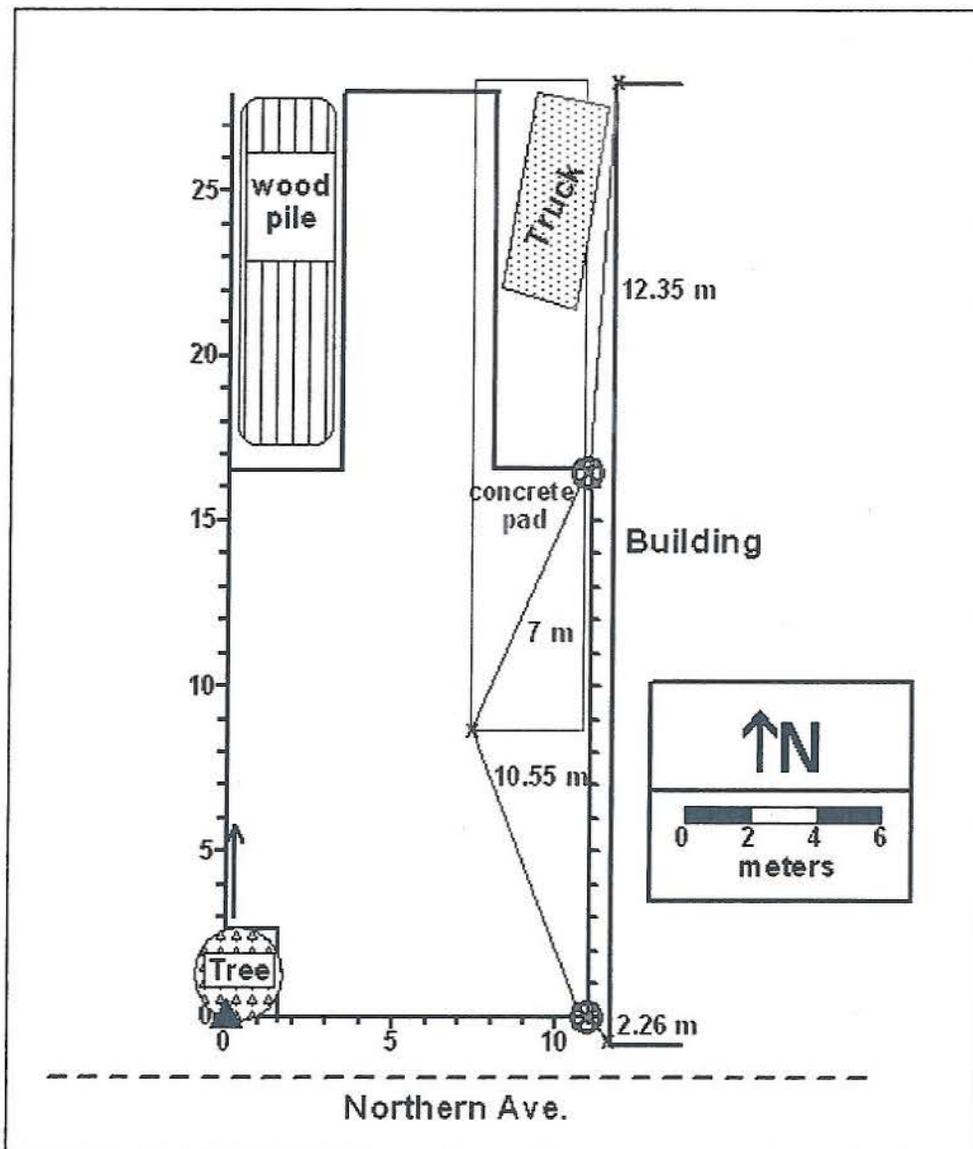
Figure 37. Sketch map of the GPR grid collected at site 5PE5479. A large wood pile and truck were present at the time of survey, so the grid was established to cover as much of the open area as possible. Also shown are measurements from the northeastern and southeastern corners of the grid to nearby features, including the corners of the adjacent building, and southwestern corner of the concrete pad.

**Ground-penetrating Radar Results:** The GPR investigation resulted in identification of subsurface anomalies which were interpreted as being the remains of a possible structure (Figures 37-40). This structure was represented as a concentration of high-amplitude reflections in the northern half of the survey area. The lack of well-defined linear reflections suggested that few parts of a structure remained intact due to demolition. However, some of the reflections appeared to represent intact sections of walls or foundation, illustrated in the profiles as strong, hyperbolic reflections. The area subjected to GPR survey was limited due to the presence of abandoned vehicles and construction materials along the western, northern and eastern margins of the site. The proposed foundation remains and debris appeared between 60 and 90 cm below the paved surface. A summary of the GPR results is presented in Figure 40.

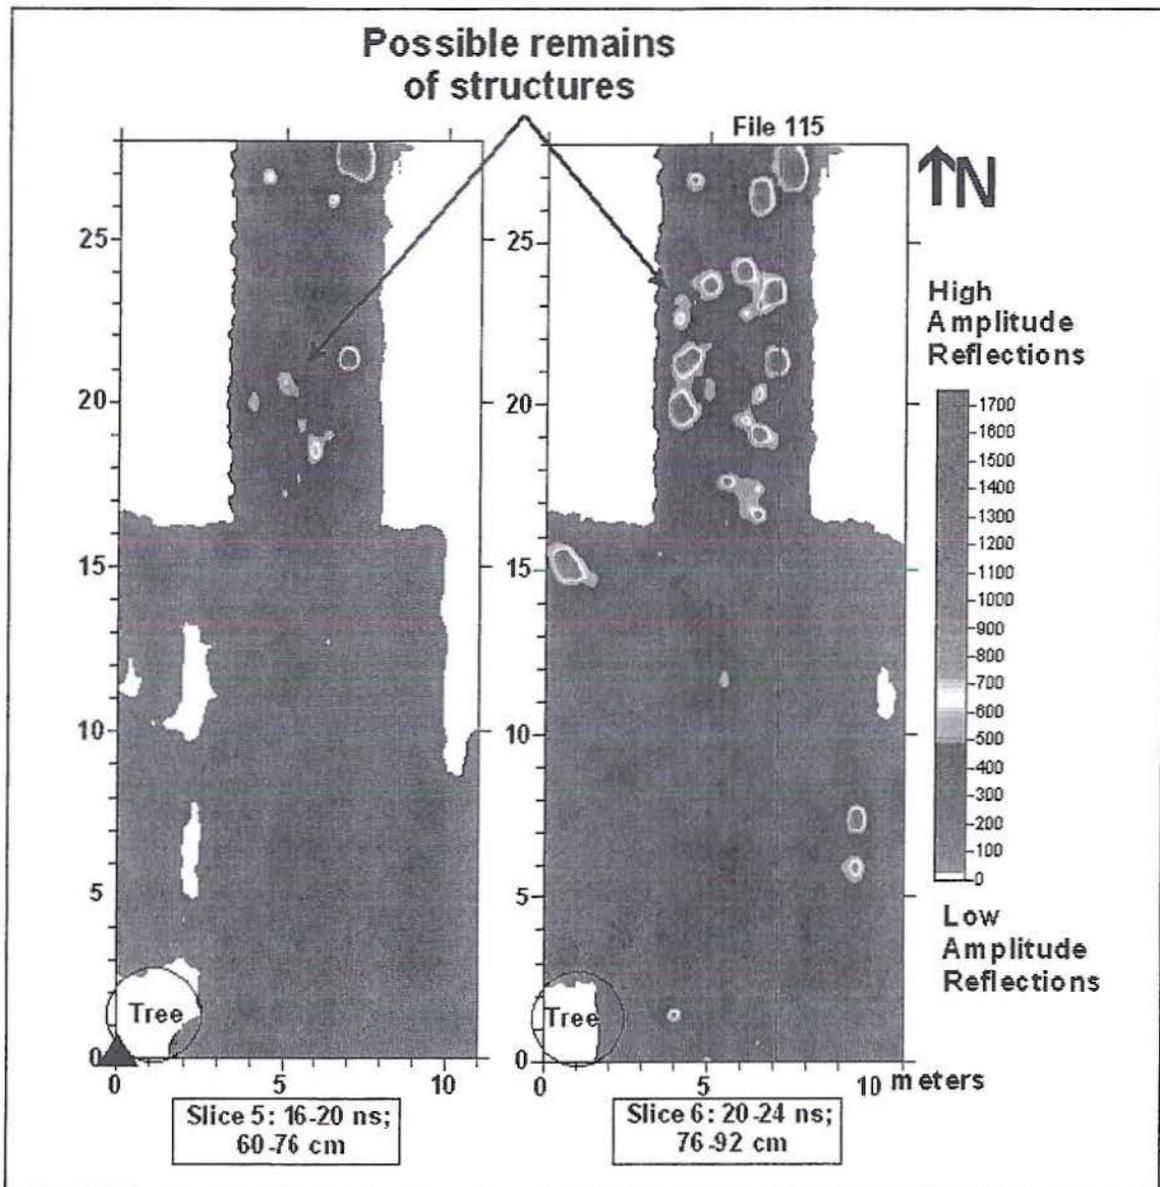
Figure 38. Amplitude slice-maps from site 5PE5479, showing the high amplitude reflections from possible remnants of walls/foundations or debris from a structure. The areas of blues, purples, and whites in the southern half of the survey area represent very low amplitude reflections, which commonly indicate a relatively homogenous subsurface. The location of reflection profile 115 (Figure 39, below) is also noted. These slice-maps represent a depth of approximately 16 - 24 ns, or 60 - 92 cm.
