**EVALUATIVE TEST EXCAVATION OF ELEVEN  
HISTORIC SITES FOR THE COLORADO  
DEPARTMENT OF TRANSPORTATION  
INTERSTATE 25 NEW PUEBLO FREEWAY  
IMPROVEMENT PROJECT, PUEBLO COUNTY,  
COLORADO**

**Prepared for:**

**Colorado Department of Transportation  
Denver, Colorado**

**Centennial Archaeology, Inc.  
Fort Collins, Colorado**

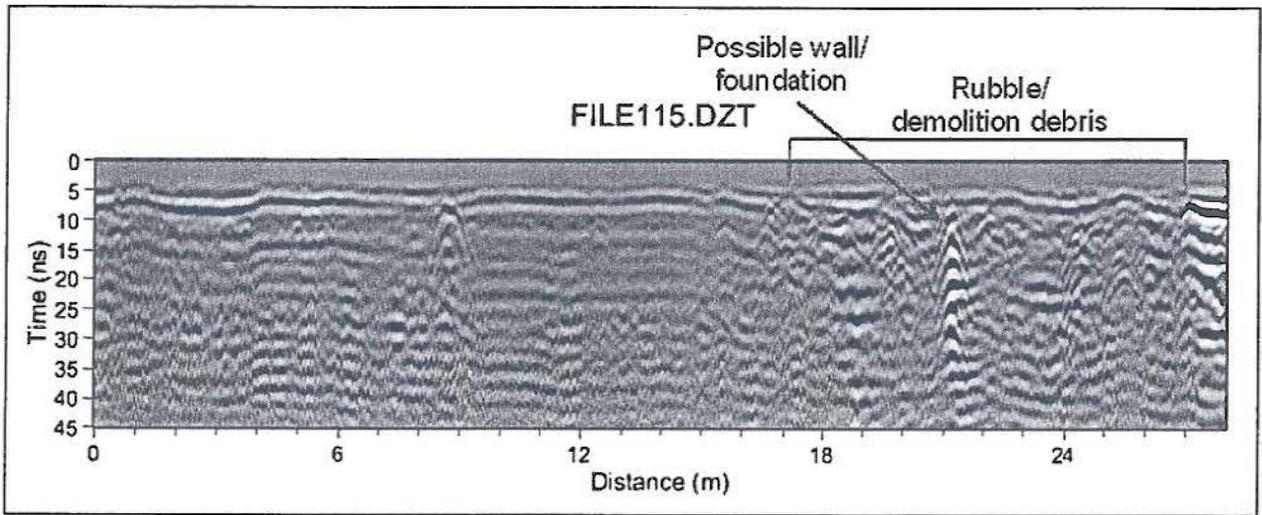
Figure 39. Reflection profile from site 5PE5479, showing the strong, hyperbolic reflection from what may be part of a wall/foundation or large piece of debris associated with a structure. Also shown are reflections from a possibly disturbed subsurface, which may indicate demolition of this structure.

**Ground-penetrating Radar Results:** The GPR investigation resulted in identification of subsurface anomalies which were interpreted as being the remains of a possible structure (Figures 37-40). This structure was represented as a concentration of high-amplitude reflections in the northern half of the survey area. The lack of well-defined linear reflections suggested that few parts of a structure remained intact due to demolition. However, some of the reflections appeared to represent intact sections of walls or foundation, illustrated in the profiles as strong, hyperbolic reflections. The area subjected to GPR survey was limited due to the presence of abandoned vehicles and construction materials along the western, northern and eastern margins of the site. The proposed foundation remains and debris appeared between 60 and 90 cm below the paved surface. A summary of the GPR results is presented in Figure 40.

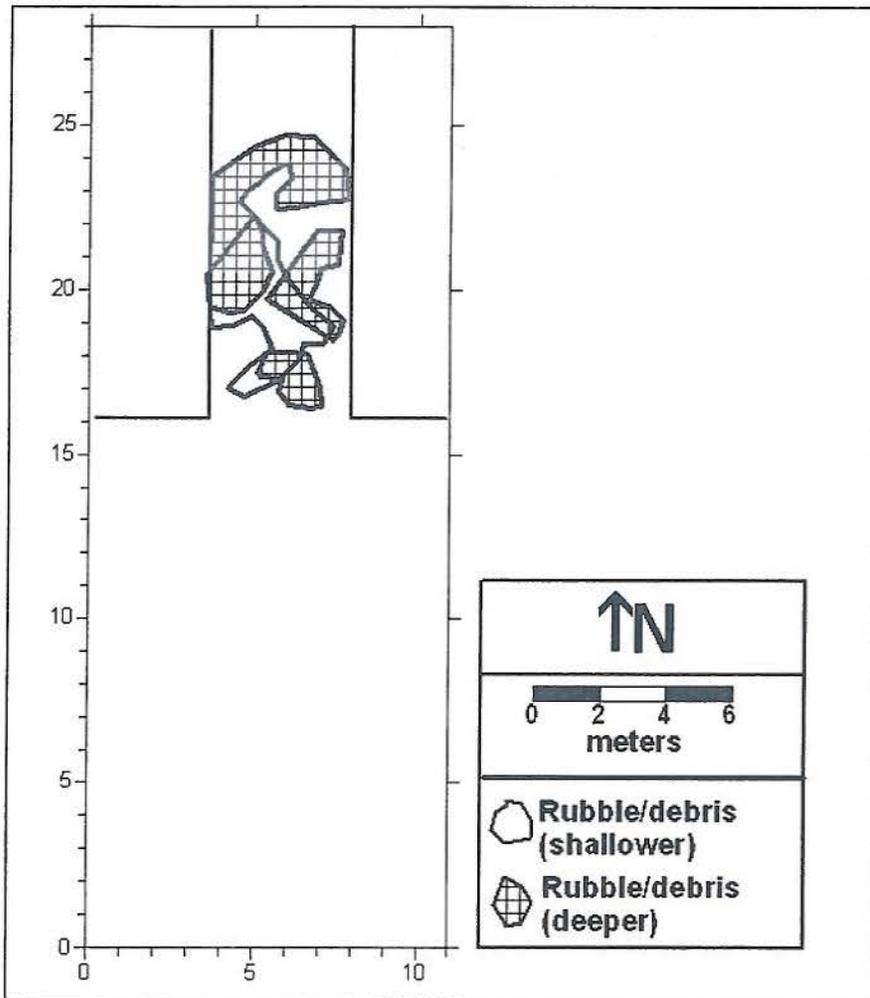
Figure 40. Interpretive map summarizing the results of the GPR survey at site 5PE5479. The rubble/debris from two depths is noted.

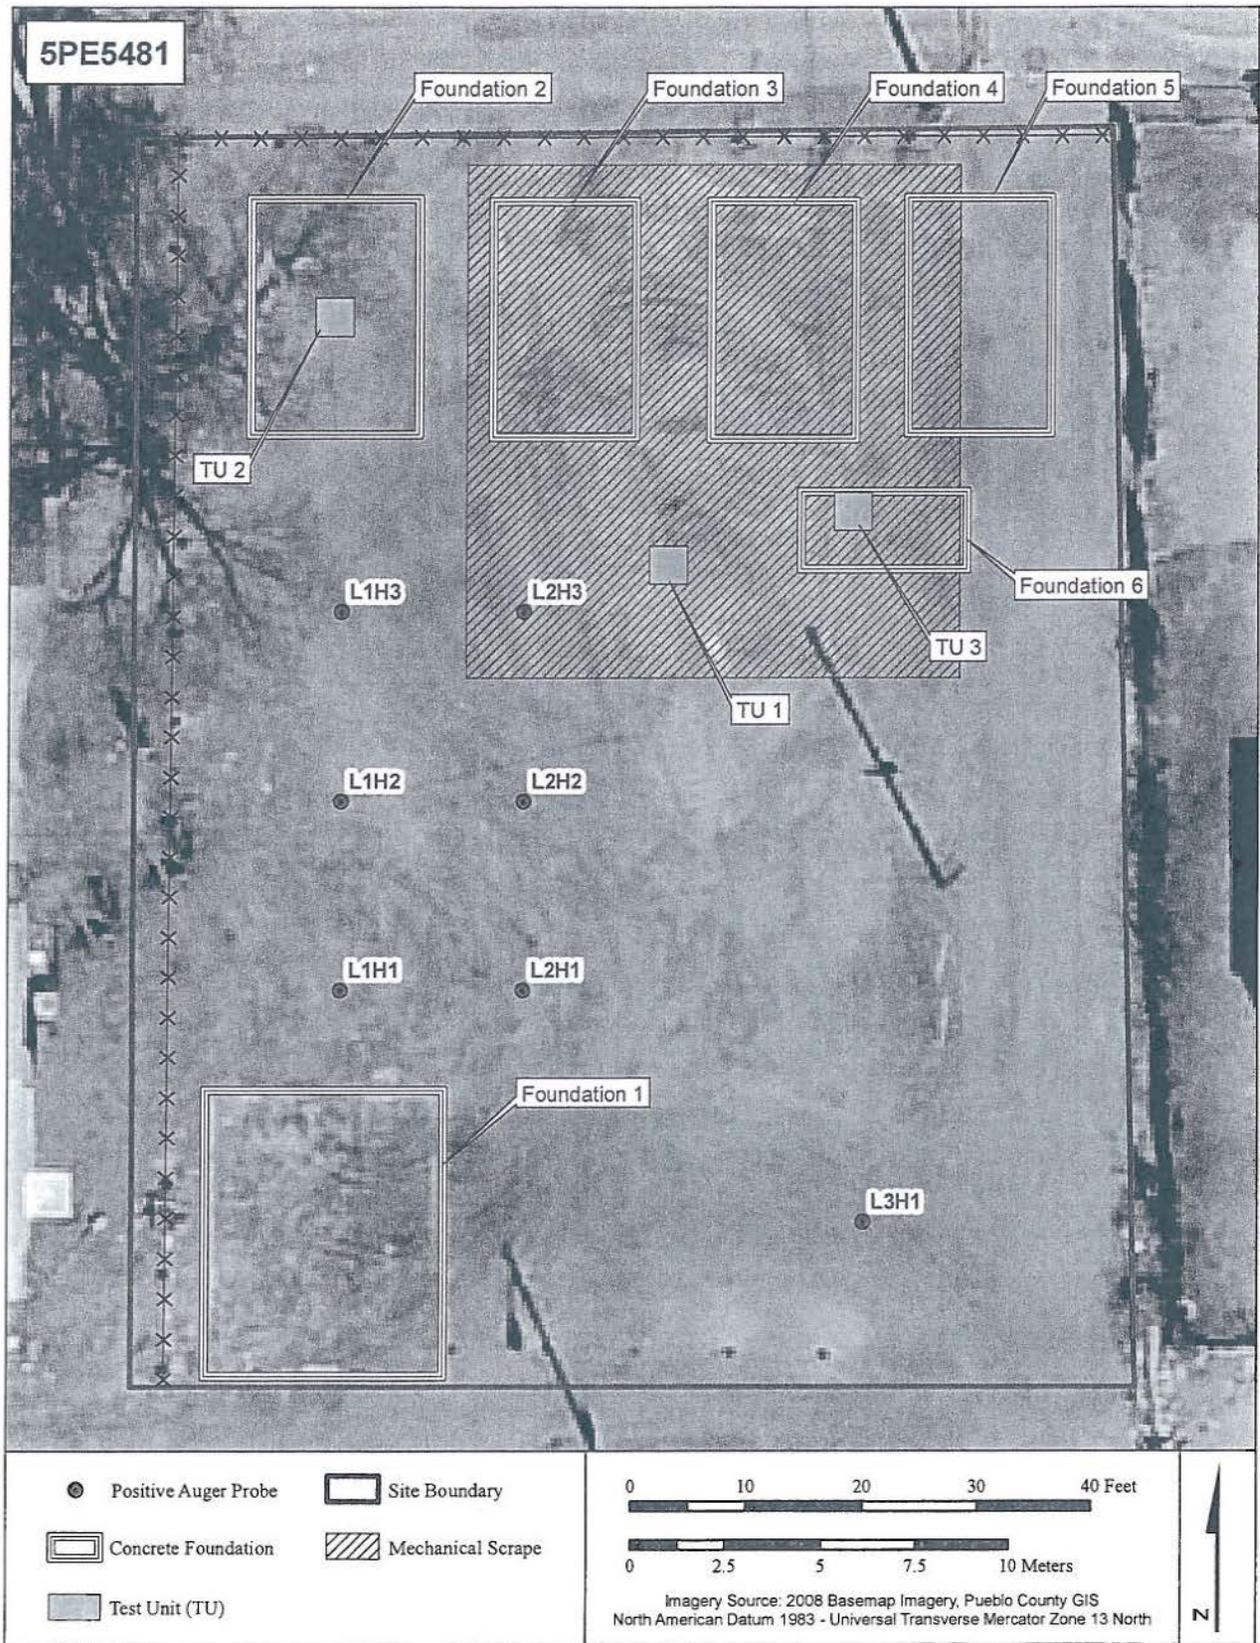
Figure 41. Site 5PE5481 plan map.

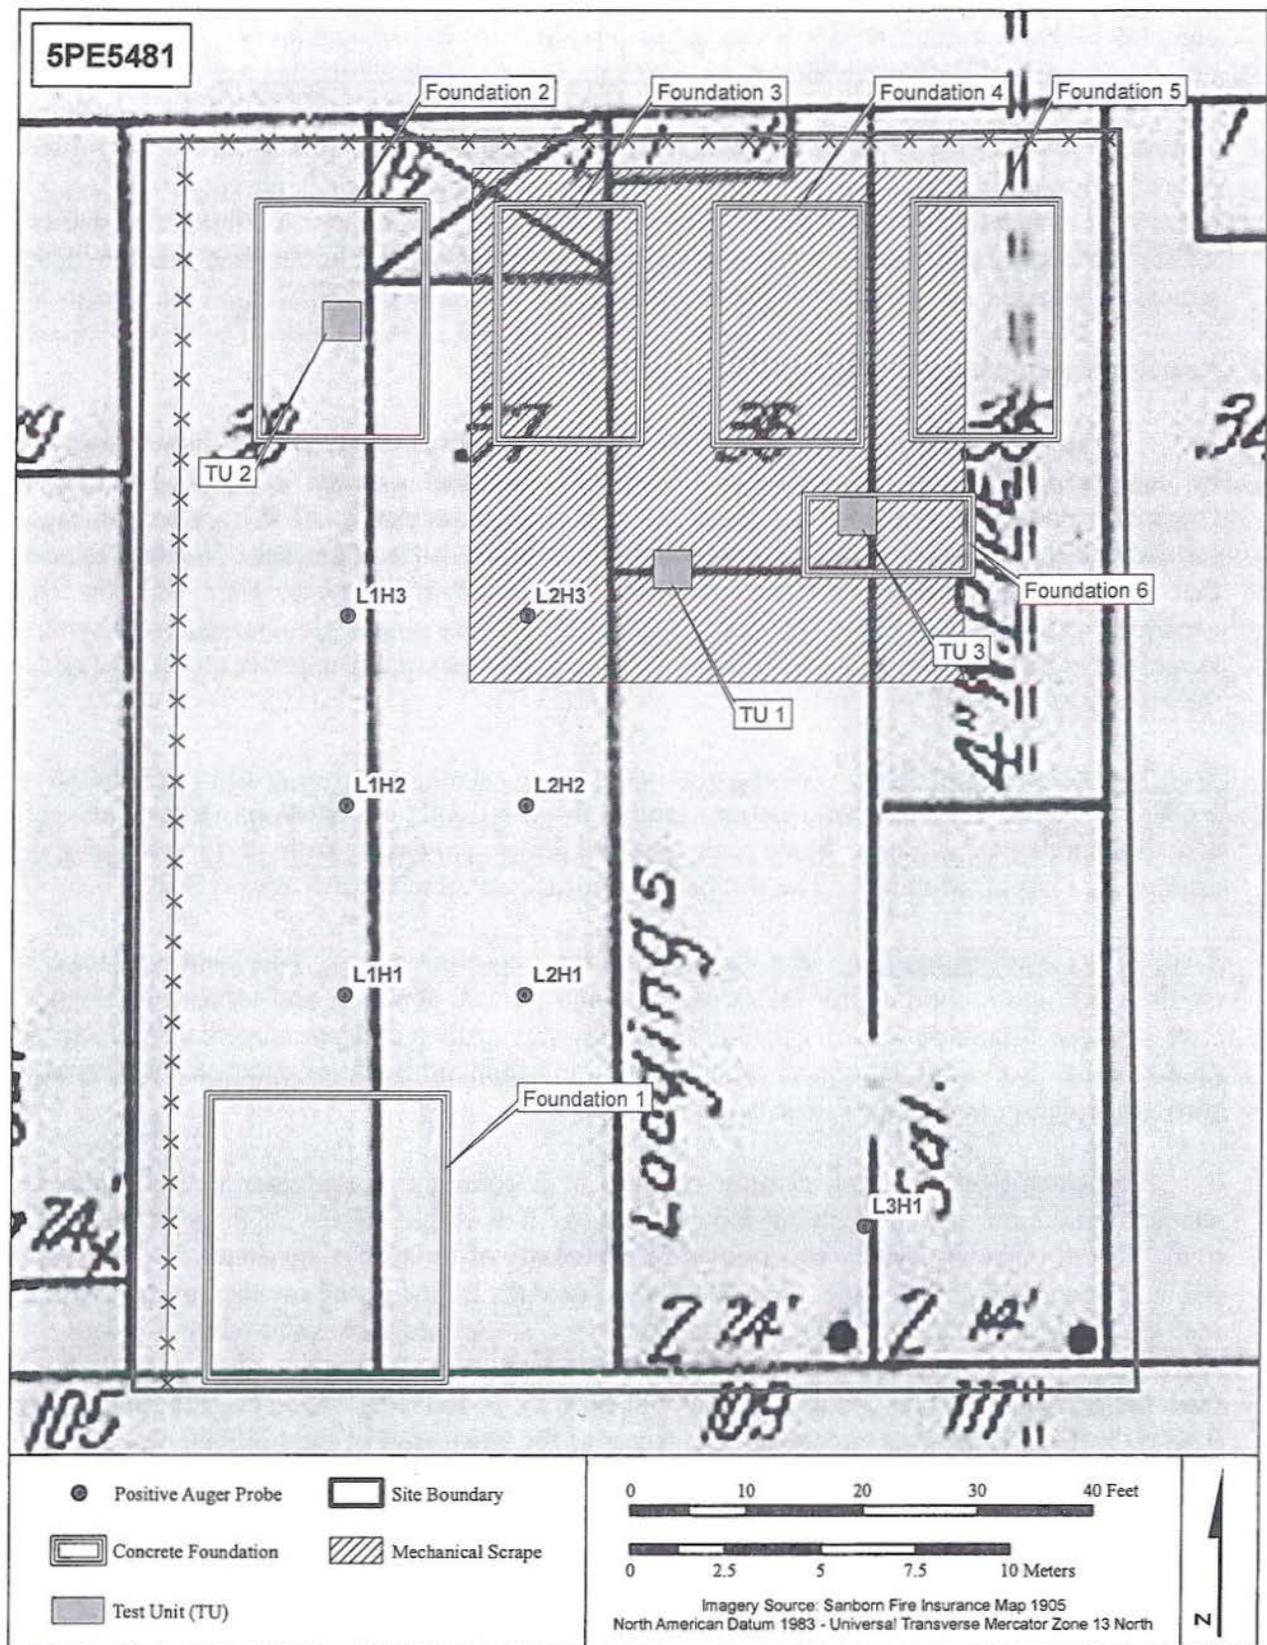
Figure 42. Site 5PE5481 plan map with 1905 Sanborn Fire Insurance map background.

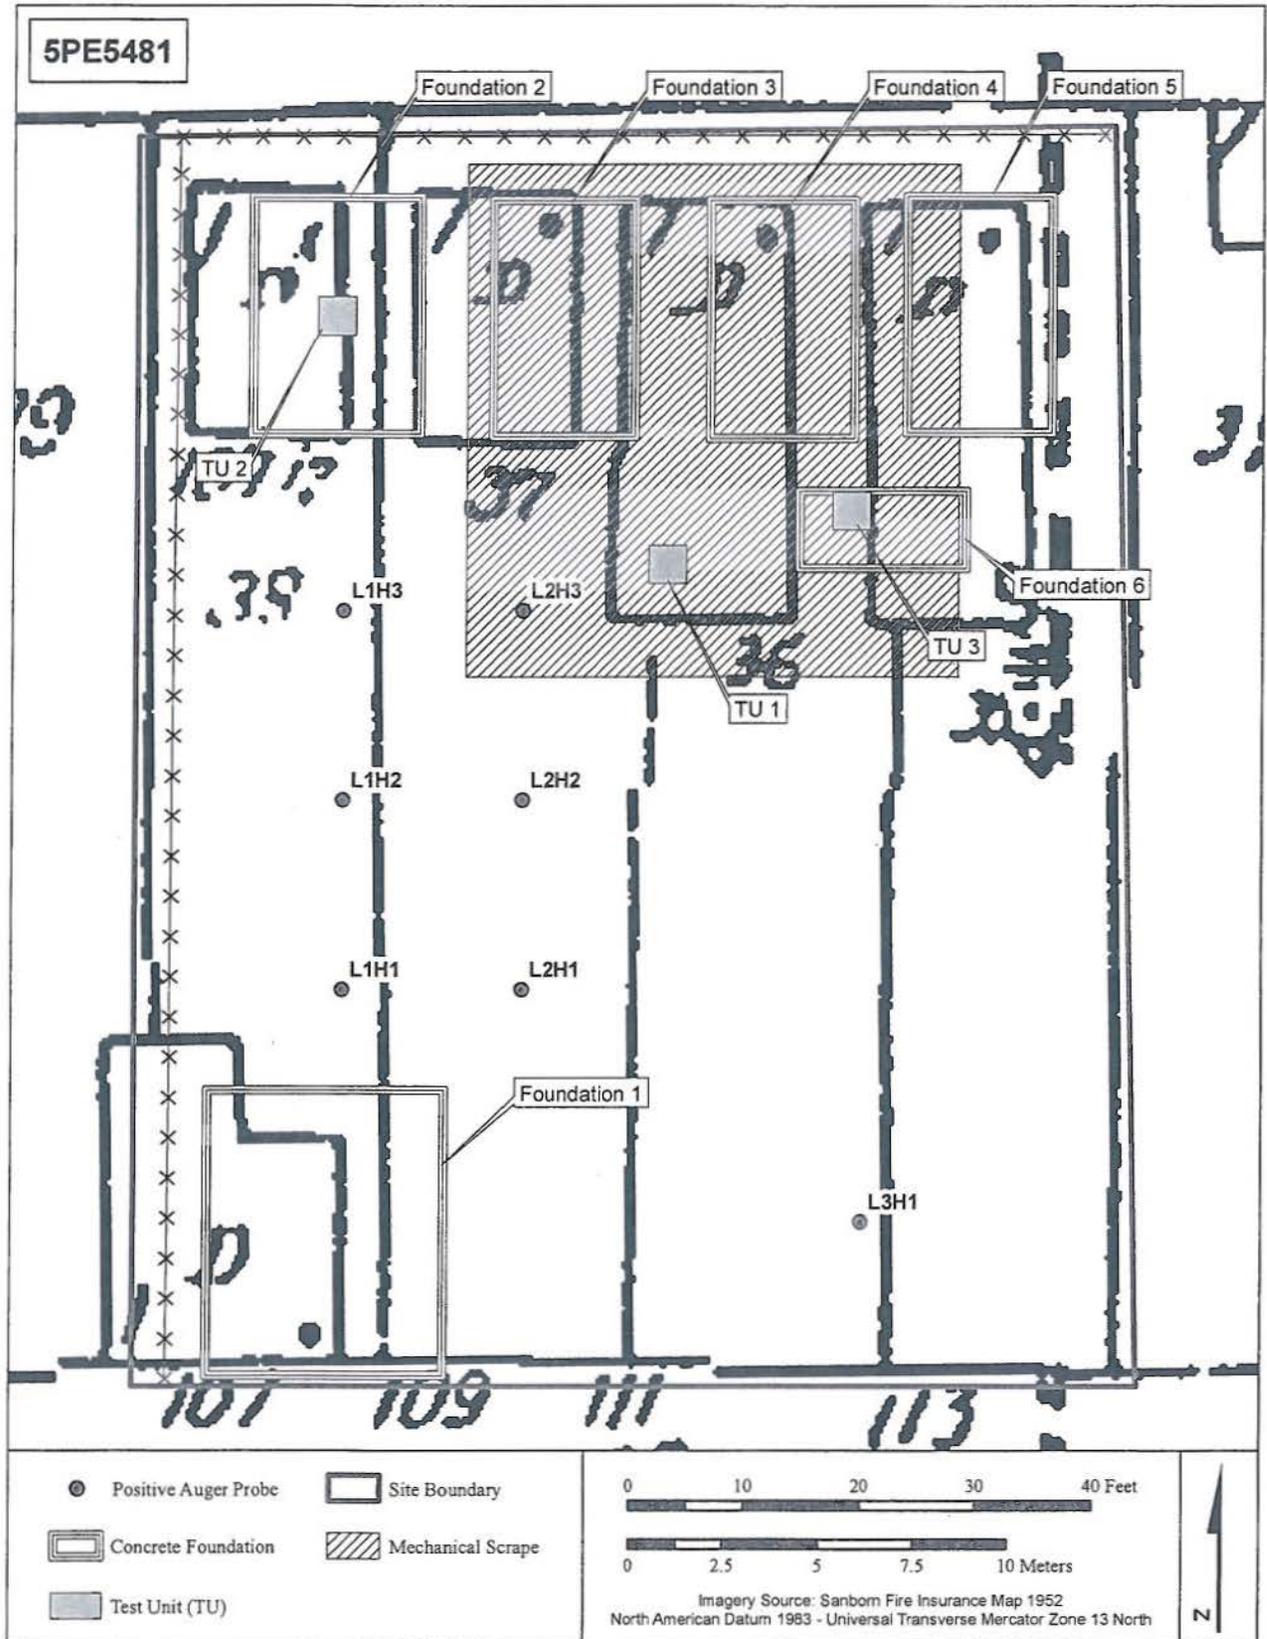
Figure 43. Site 5PE5481 plan map with 1952 Sanborn Fire Insurance map background.

An updated Sanborn Fire Insurance map from 1952 indicates several changes within the site boundary (Figure 43). All of the structures shown on the 1905 Sanborn map have been removed and replaced with five single-story wood-framed dwellings. In addition, the addresses for the four lots were modified on the 1952 map with Lot 35 corresponding with address 113/111, Lot 36 corresponding with address 111/109, Lot 37 corresponding with address 109, and Lot 38 corresponding with addresses 107 and 107½.

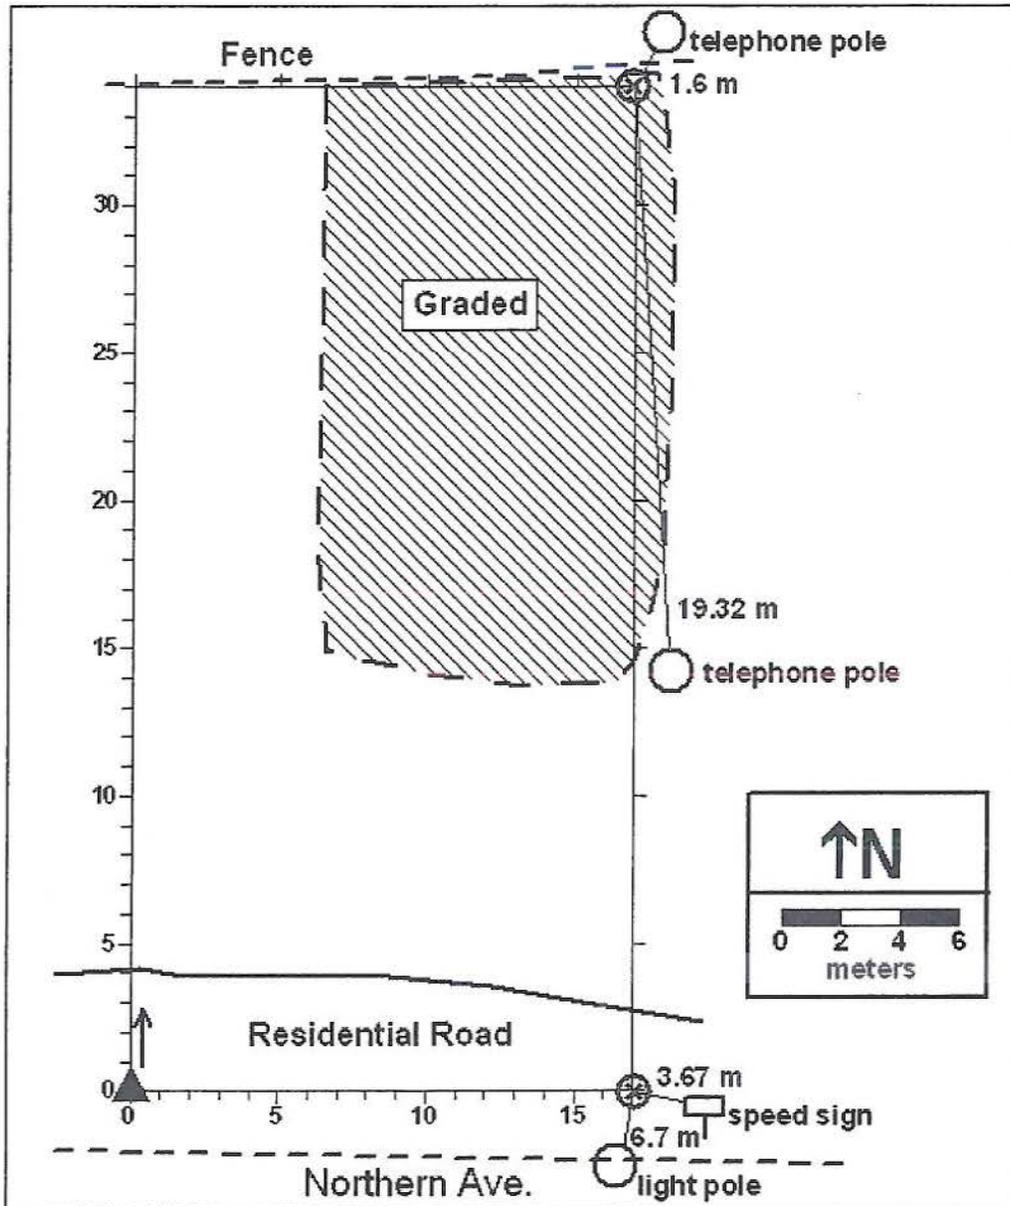
Figure 44: Sketch map of the GPR grid collected at site SPE5481, with some of the construction activity areas noted. Also shown are measurements from the northeastern and southeastern corners of the grid to nearby features.

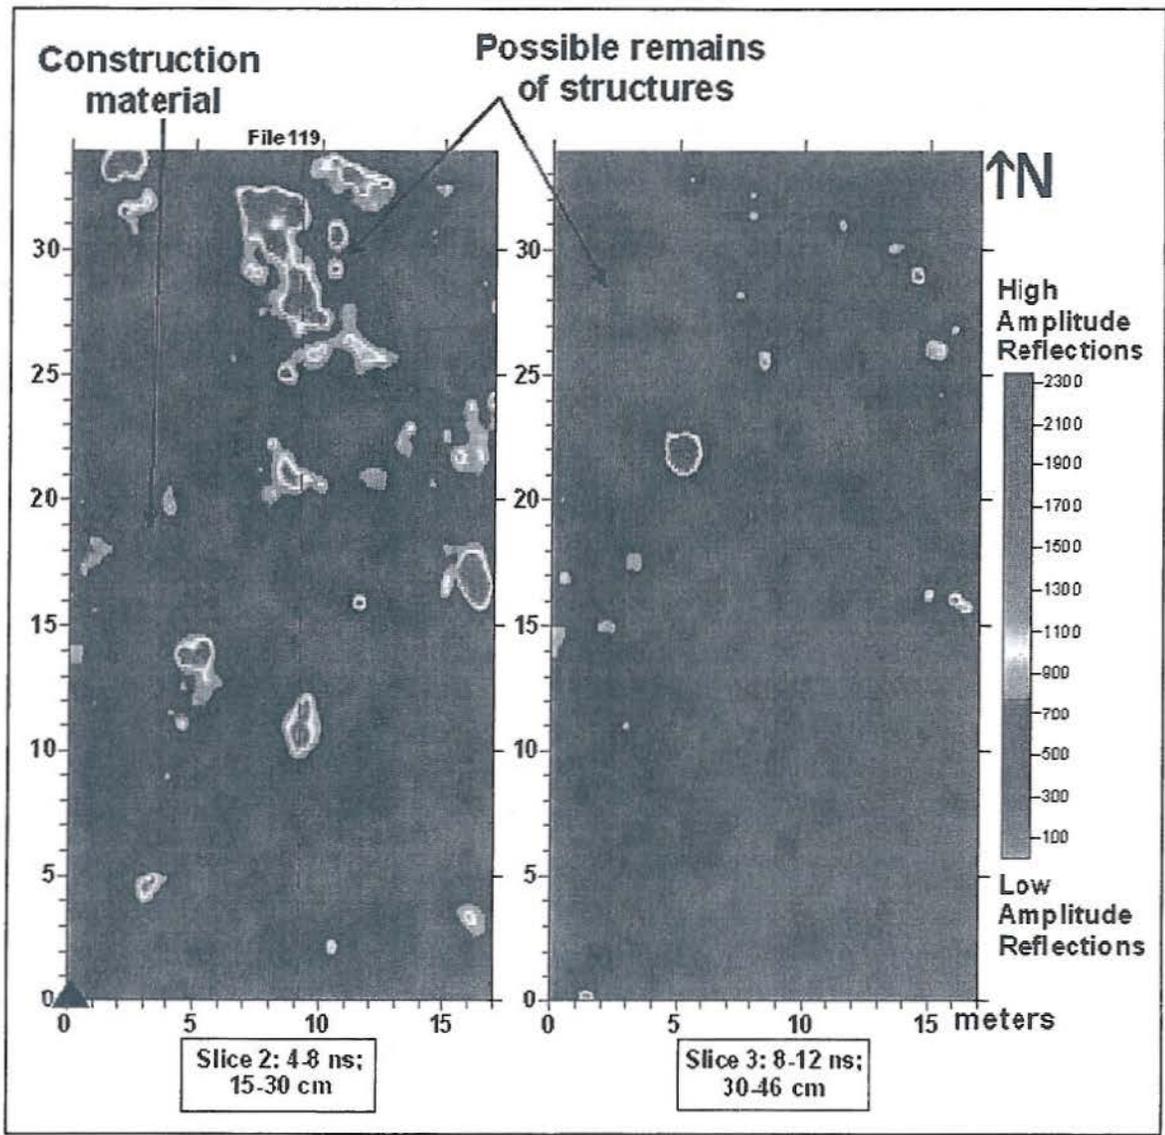
Figure 45: Amplitude slice-maps from site 5PE5481, showing linear reflections from possible structures in the northern half of the survey area. The concentration of high amplitude reflections associated with these linear reflections may be due to previous demolition or construction activities in this area. Other areas of high amplitude reflections in this grid may also be related to construction activities. The location of reflection profile 119 (Figure 46, below) is also noted. These slice-maps represent a total depth of 4 - 12 ns, or approximately 15 - 46 cm.

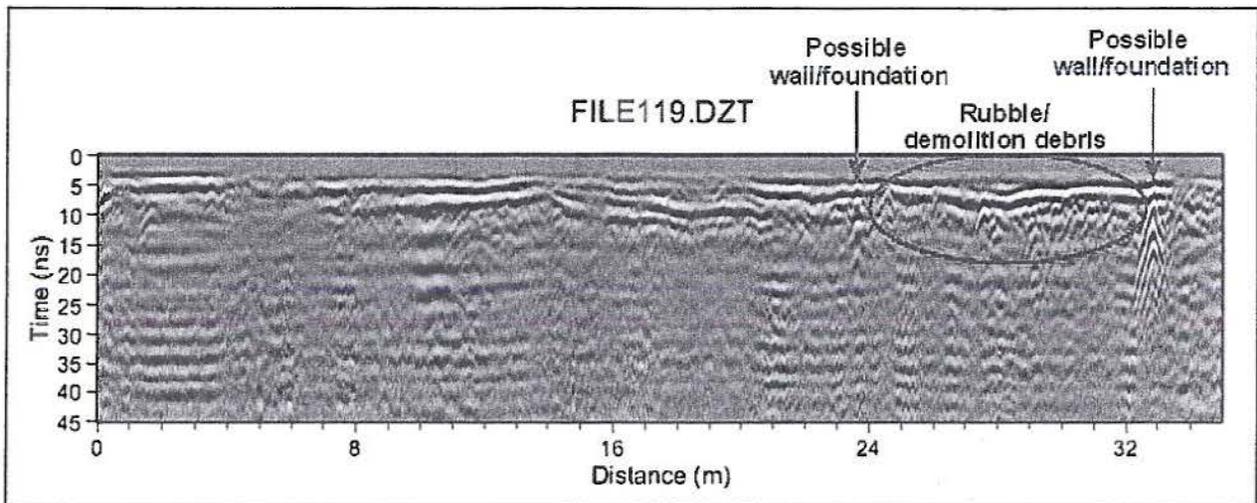
Figure 46. Reflection profile from site 5PE5481, showing the strong, hyperbolic reflections from possible walls/foundations, and the associated rubble and debris from demolition.

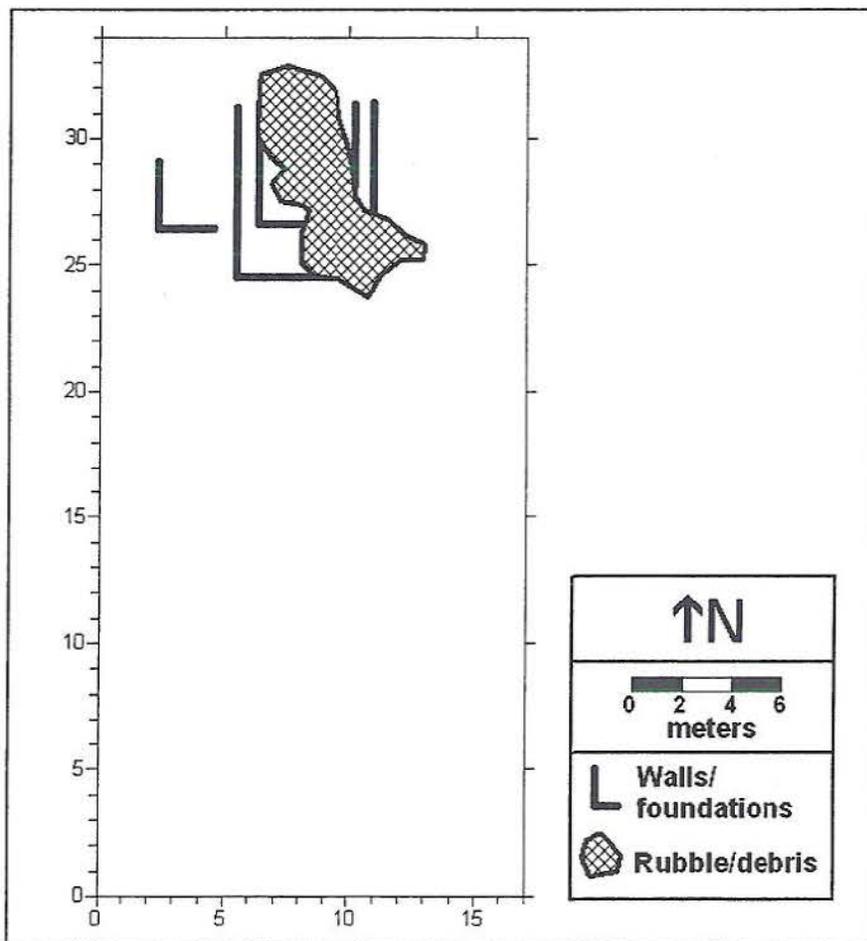
Figure 47. Interpretive map summarizing the results of the GPR survey at site 5PE5481. The walls/foundations and rubble/debris associated with demolition of these possible structures are noted.

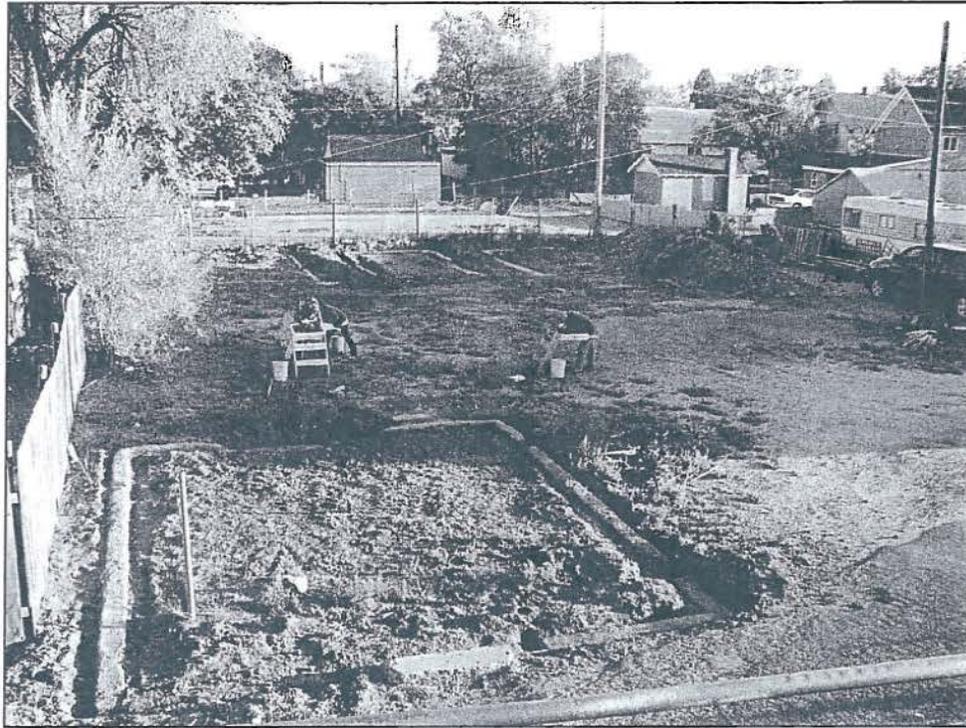
Figure 48. Overview of foundations at site 5PE5481, looking northeast.

**Trenching and Scraping:** Six concrete footers representing six individual structures were exposed through a combination of mechanical and manual scraping and trenching (Figure 48). Two of these foundations were visible on the ground surface and one appears on recent aerial photographs. Soil removal concentrated on defining the length and orientation of the footers as well as the width, depth, and construction technique.

**Foundation 1:** This feature consists of a complete rectangular poured concrete T-shaped foundation. The underlying footer measures 20 ft 10 in (E/W) x 25 ft (N/S) and is 18.5 in thick. The foundation, which was poured on the center of the footer, measures 20 ft (E/W) x 24 ft 2 in (N/S) and is 8.5 in wide. The foundation extends 21 inches below the surface, with a 12-inch-deep footer and a 9-inch-deep foundation. Two stoops are associated with Foundation 1. A small poured-concrete stoop is located on the north wall of the foundation and is offset 18 inches from the east corner. This stoop measures 4 ft (E/W) x 16 in (N/S). A second stoop measuring 4 ft (N/S) x 16 in (E/W) was exposed at the center of the south wall of the foundation.

**Foundation 2:** This feature is a rectangular poured-concrete T-shaped foundation made up of a lower footer and upper foundation. This foundation, which is 95% complete, is similar in morphology to Foundation 1 but exhibits slightly different dimensions. The footer measures 20 ft 10 in (N/S) x 14 ft 10 in (E/W) x 18 in wide. The foundation is centered

on the footer with dimensions of 20 ft (N/S) x 14 ft (E/W) x 8 in wide, thereby leaving a rim of footer that extends approximately 5 inches on either side of the foundation. At the northwestern corner, the foundation/footer extends to a depth of 13 inches, with an 8-inch-deep footer and a 5-inch-deep foundation. One 3 ft 3 in (E/W) x 16 in (N/S) poured-concrete stoop is located on the north wall of this structure, and is offset approximately 20 in from the northeastern corner. A small brick patio was also exposed near the southeastern corner of Foundation 2, and measures 4 ft 2 in (E/W) x 3 ft 8 in (N/S).

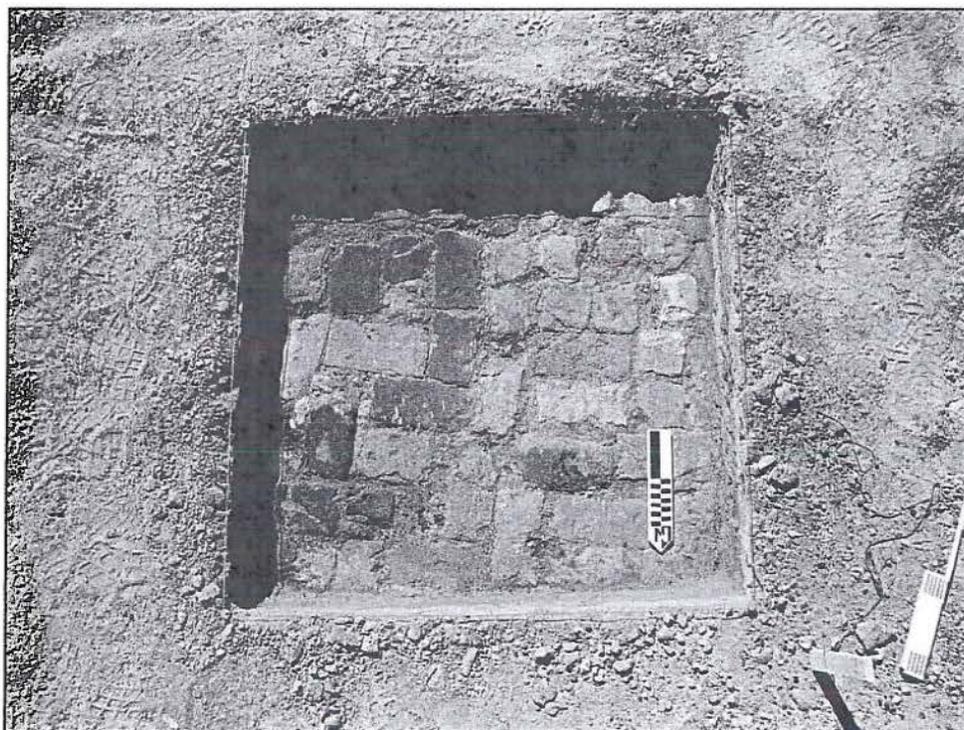
Figure 49. Detailed view of brick floor in Foundation 6 at site 5PE5481.

bone fragments. Modern plastic materials were located near the base of the level, as was a fully articulated cat skeleton wrapped in a plastic bag. Excavation in this unit was terminated at a floor of paved brick (Figure 49). Additional exploration underneath the floor was accomplished by removing one of the bricks, then extending an auger probe to 193 cm below the level of the floor. With the exception of a layer of clinkers and industrial slag encountered between 70 and 80 cm, this probe was sterile with no notable soil changes.

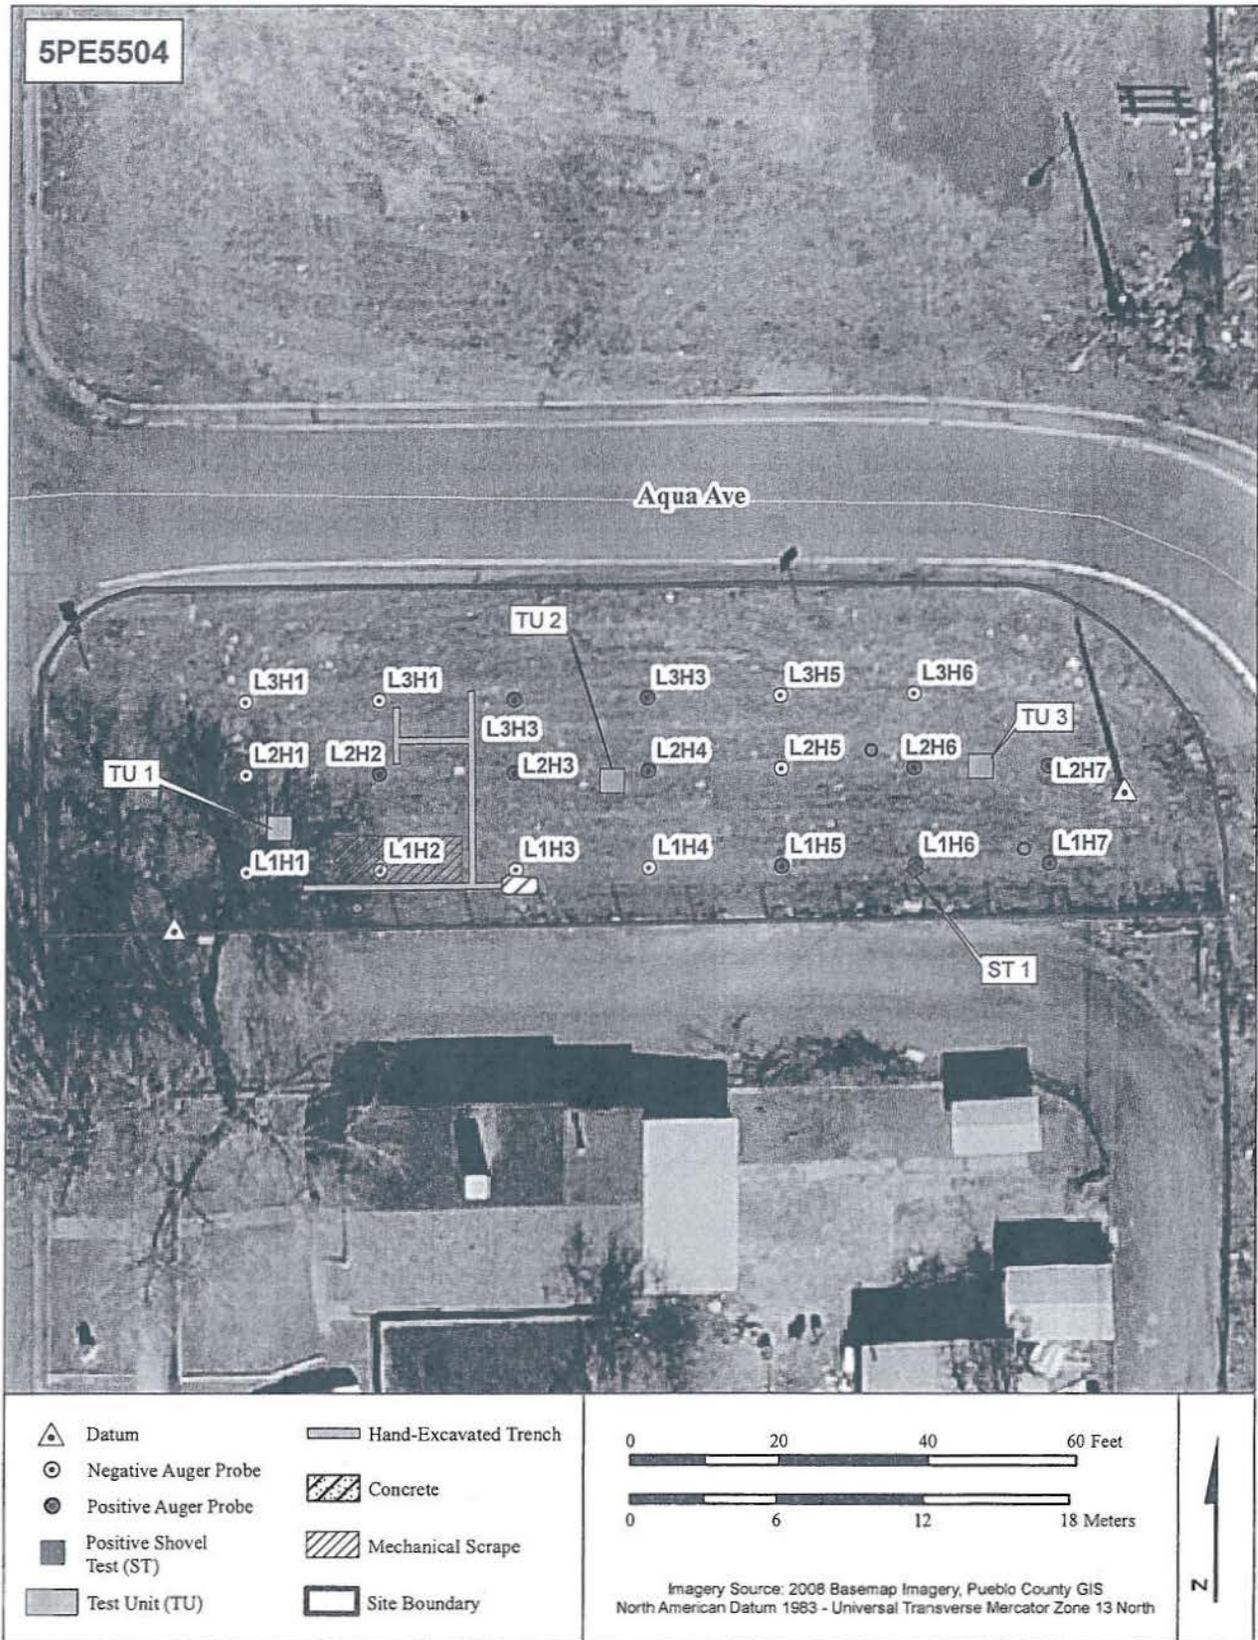
Figure 50. Site SPE5504 plan map.

This vacant lot is situated adjacent to the Aqua Avenue Pueblo I-25 on-ramp (Figure 50). It is depicted on the 1905 Sanborn Fire Insurance map as 318 Aqua Avenue/2202 East Evans Avenue (Figure 51). Aqua Avenue wraps around the property on the northern and eastern sides, and the lot has been mechanically graded on the northern margin. The site was not inventoried at the time that it was first recorded by WCRM, and no artifacts were reported to be visible from the perimeter of the area. Based on archival research of 1904-1905 Sanborn Fire Insurance maps, WCRM determined that at least one residential dwelling had been located early in the 20th century (although see following section). Site dimensions from the initial recording are listed as 149 ft (E/W) x 55 ft (N/S), with an area of 0.22 acre. The dimensions derived from the 2011 field recording are 159 ft (E/W) x 46 ft (N/S), encompassing 0.16 acre.

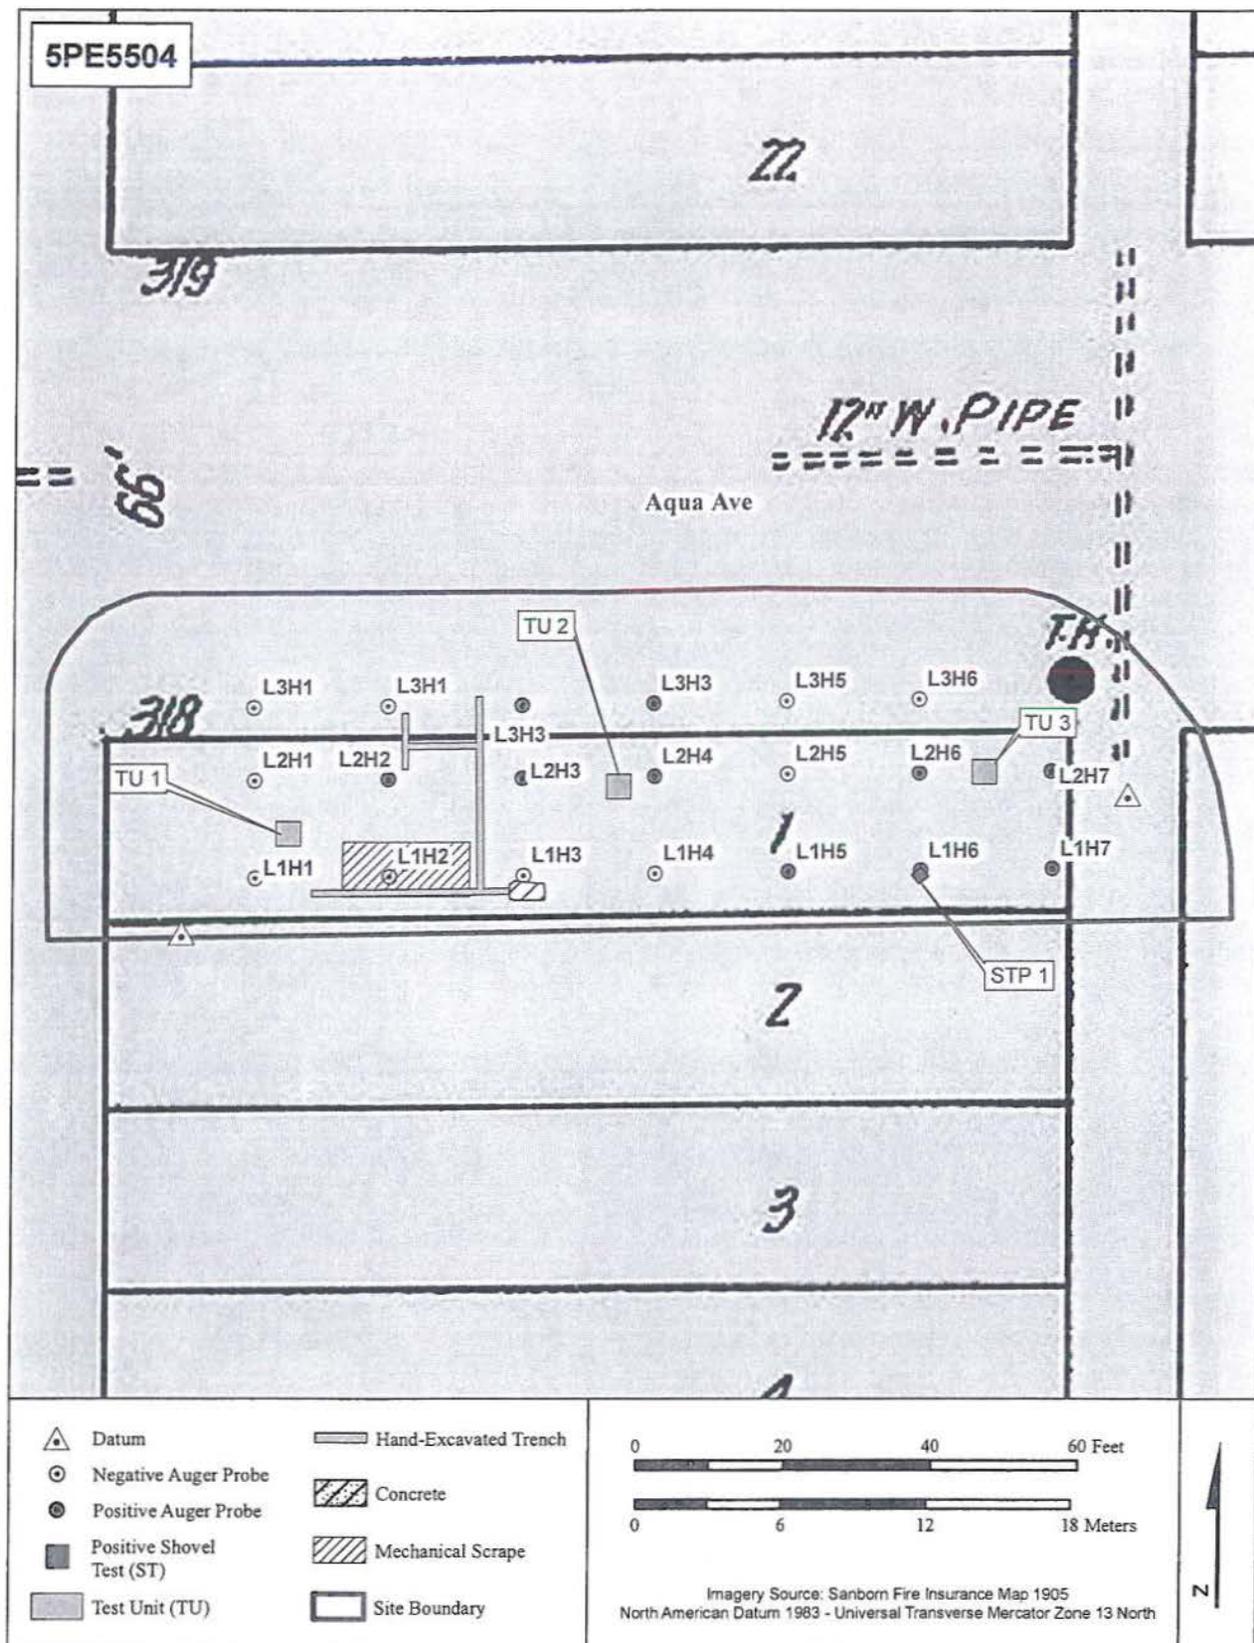
Figure 51. Site 5PE5504 plan map with 1905 Sanborn Fire Insurance map background.

The documentary data for site 5PE5504 indicate that no structures were present until well into the 20th century. Archival data for this site consist of historic maps including Sanborn Fire Insurance maps from 1905 and 1951 (Figures 51 and 52), Pueblo City maps, and information from the Pueblo City Directories. The earliest city map for this area depicts the site at the

extreme southern margin of South Pueblo (Figure 3). On this city map from 1897 the area within which the site is located is simply described as “uplands” (Figure 24). The 1905 Sanborn Fire Insurance map indicates that the site is located in the Minnequa Heights Addition (Figure 51). Based on the 1905 Sanborn and the 1907 Pueblo City map, no structures were present at the site. The 1939 Pueblo City map, which consists of an aerial mosaic, clearly shows that no structures were present in the vicinity of the site (Figure 53). However, the 1951 Sanborn Fire Insurance map indicates that the site had two structures consisting of single-story dwellings (Figure 52).

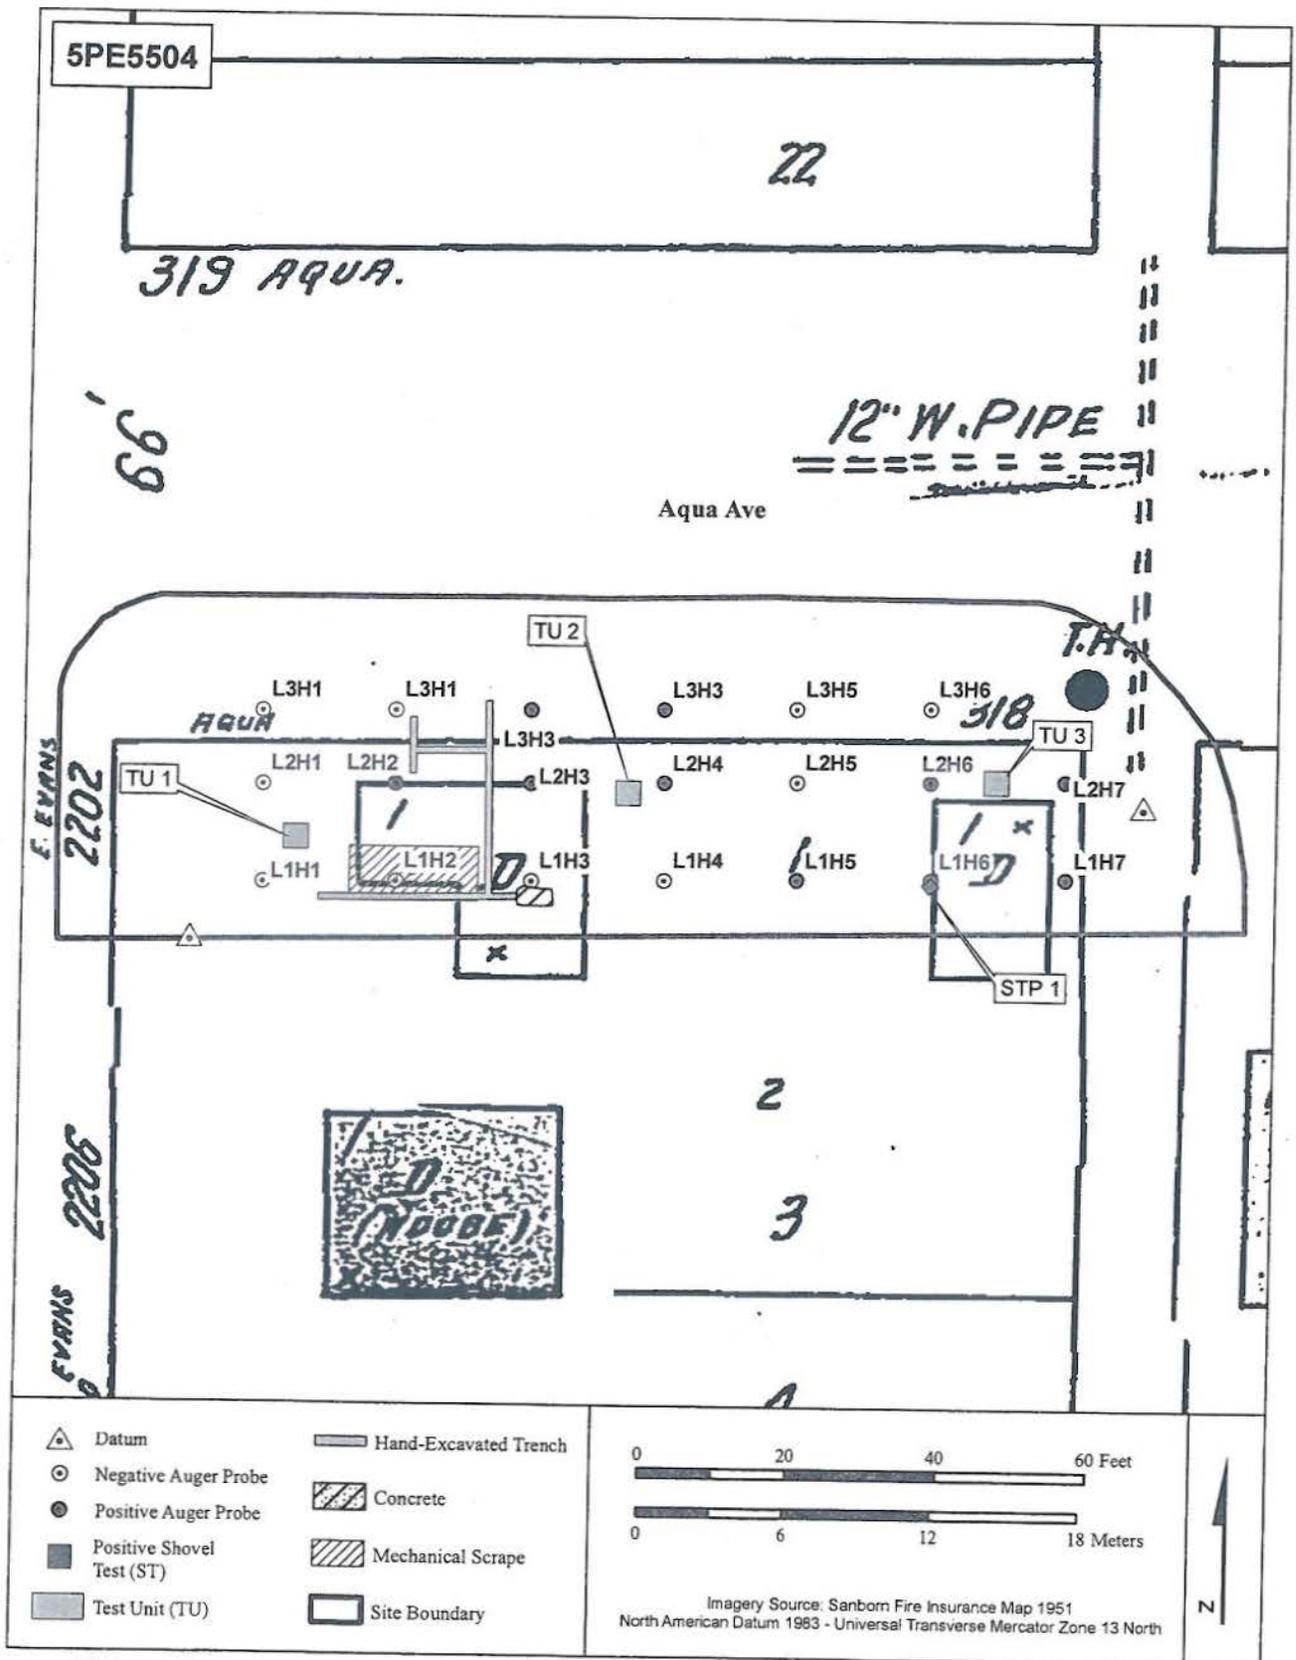
Figure 52. Site 5PE5504 plan map with 1951 Sanborn Fire Insurance map background.
