**EVALUATIVE TEST EXCAVATION OF ELEVEN  
HISTORIC SITES FOR THE COLORADO  
DEPARTMENT OF TRANSPORTATION  
INTERSTATE 25 NEW PUEBLO FREEWAY  
IMPROVEMENT PROJECT, PUEBLO COUNTY,  
COLORADO**

**Prepared for:**

**Colorado Department of Transportation  
Denver, Colorado**

**Centennial Archaeology, Inc.  
Fort Collins, Colorado**

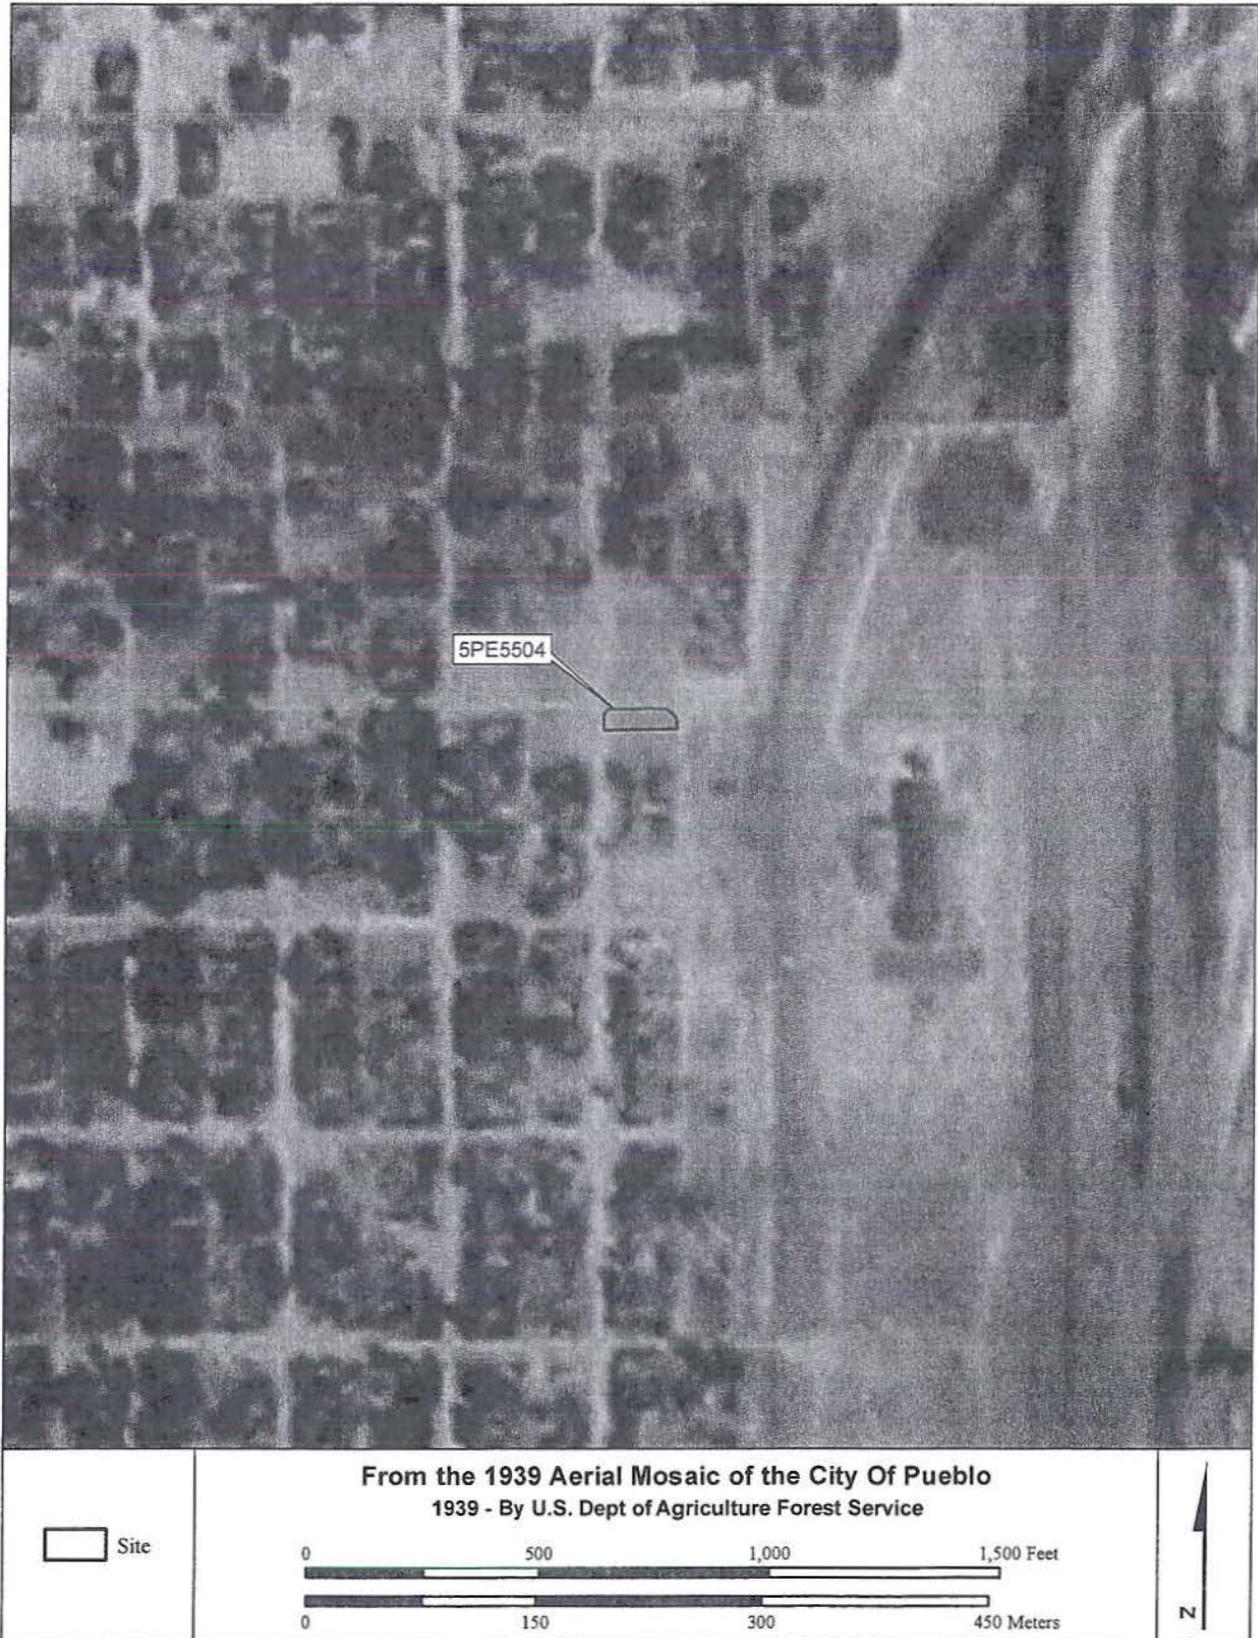
Figure 53. Site 5PE5504 with 1939 aerial mosaic of the City of Pueblo background.
