Report No. CDOH-DTD-R-90-5

GEOTEXTILES IN LANDFILLS

Final Report
August 1990

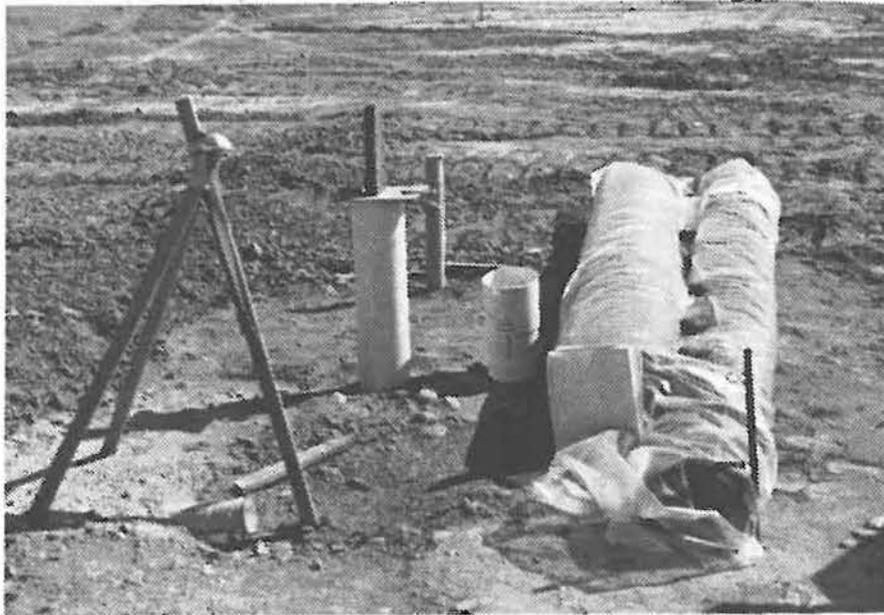
Figure 10. A Typical Read-Out Station For Both Vertical/Horizontal Inclometers And The Strain Gages.

Four strain gage readout stations were installed with a pair of readout boxes opposite to one another situated in a similar manner as the vertical inclinometer. A total of 41 strain gages were installed on the non-woven geofabric (Tynar, 3601) and both geogrids for measuring the strain of the reinforcing materials. Strain gages could not be glued on the woven geofabric (Supac, 4WS). Therefore, its stress-strain behavior was not detected after construction of the test embankment. Figures 8 through 10 show the installed vertical and horizontal inclinometers, as well as a strain gage read-out box. Table 2 shows the distribution of the instruments in each test section.

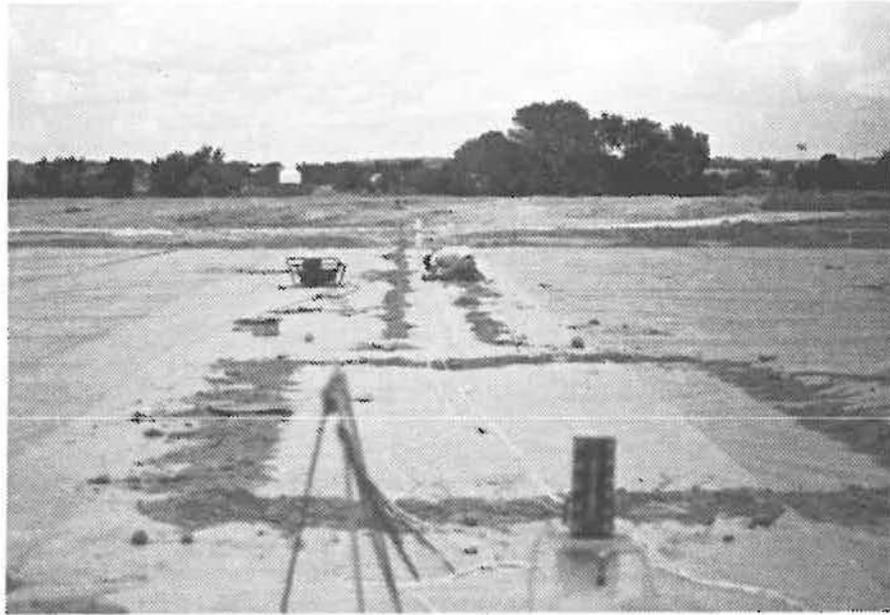
Figure 11. Attachments of strain gauge wires to the strain gauges on top of Typar 3601 (geofabric)

The Typar 3601, installed in test section No. 3, arrived at the site in rolls of 150 feet long by 13 feet wide. One roll of fabric was delivered to CDOH Materials Laboratory so that strain gages could be attached to the material in a clean controlled environment. This roll was to be located in the center of the test section directly above the horizontal inclinometer. Therefore, the instrumented roll was first installed, and it was located in such a way that strain gages on the fabric were offset from the surrounding disturbed material. The remaining fabric rolls were then laid out normal to the test embankment control line and sewed together using a double overlapped "J" seam. Figures 11 to 14 show the actual placement of the Typar 3601.

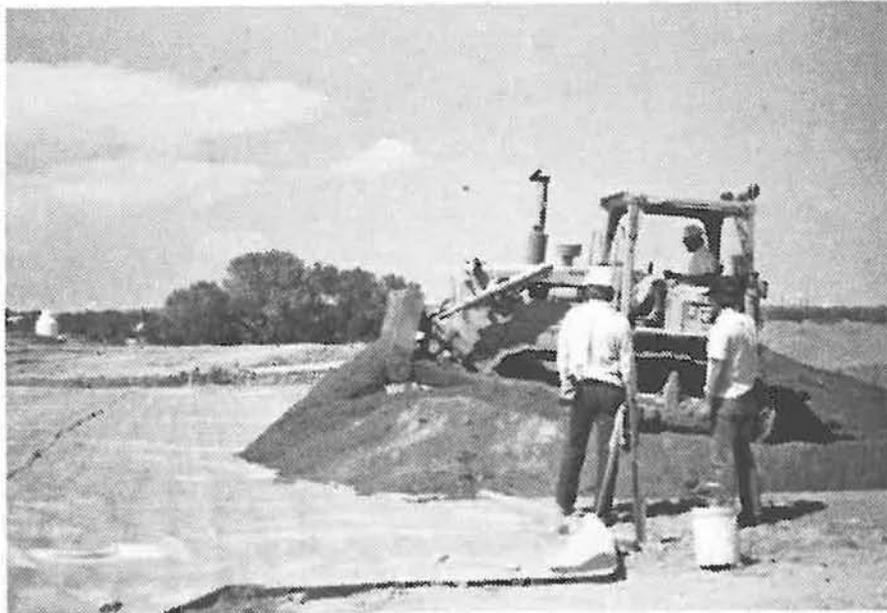
Figure 14. Extra Caution Was Excersized to Avoid The Direct Contact of Heavy Equipment and the Geofabrics

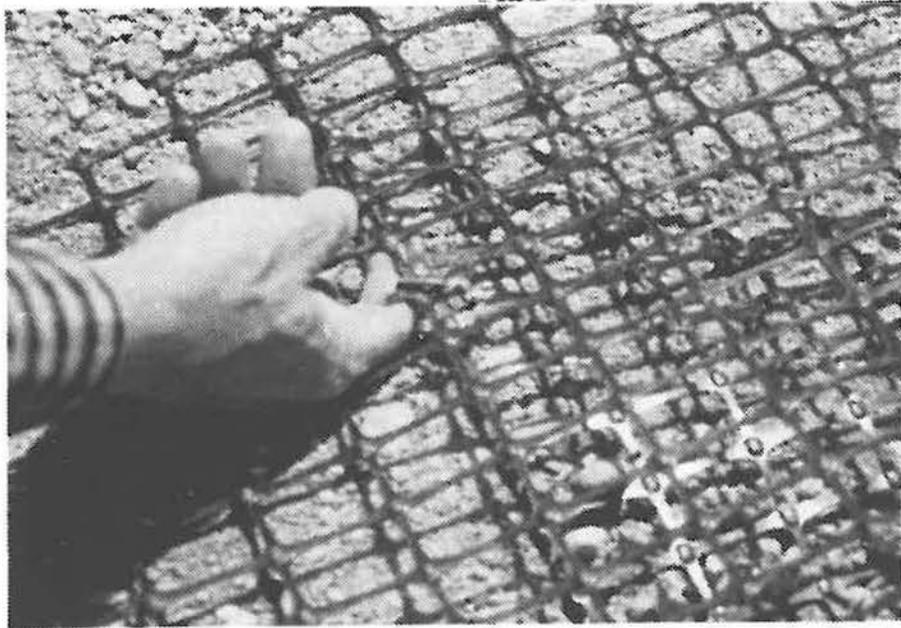
Figure 16. Metal Hog Ring Were Used to Connect Layers of Geogrid

Two types of geogrids were supplied by different manufacturers, and they were installed in test section No. 2. The north half of this test section contained Tensar SS-2 geogrid and the south half was covered with Mirafi 5T geogrid. Ten strain gages were installed on each geogrid prior to their delivery to the field. Both geogrids were oriented with their roll length running normal to the center line of the test embankment. The geogrids were overlapped by 1 foot and were physically connected to one another by various means of attachments such as metal hog rings, steel tie rods, and plastic tie bands. Several geogrid rolls were not physically attached, but simply overlapped. geogrid installation is shown in Figures 15 through 21.

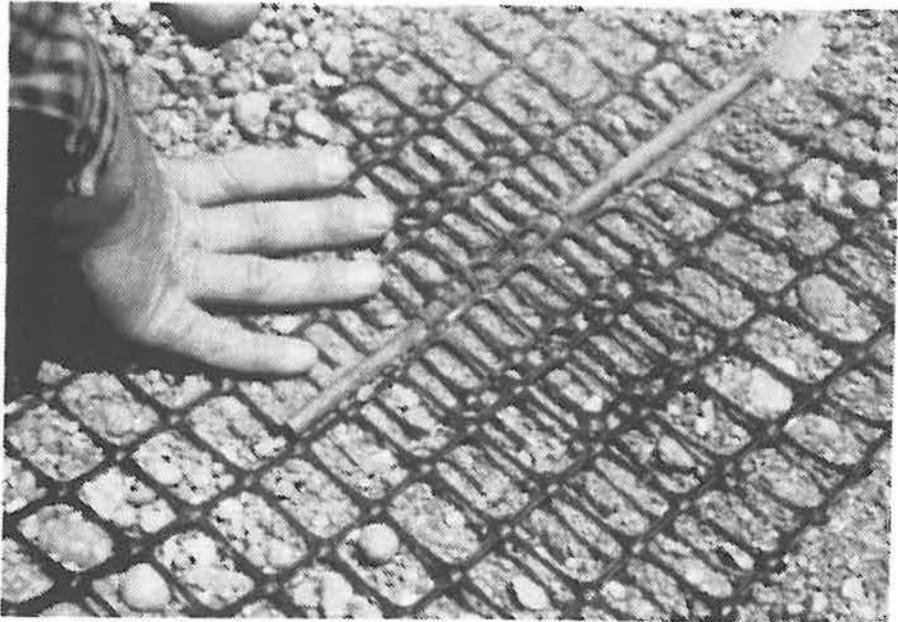
Figure 17. Steel rods were used to connect layers of Tensar SS-2, geogrid

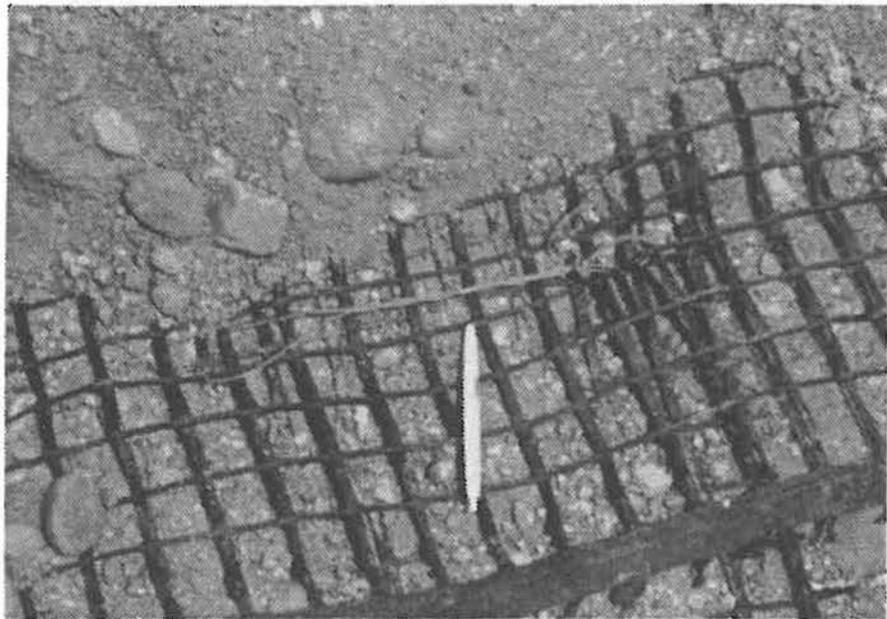
Figure 18. Metal wires connecting tow layers of Mirafi 5T, geogrid

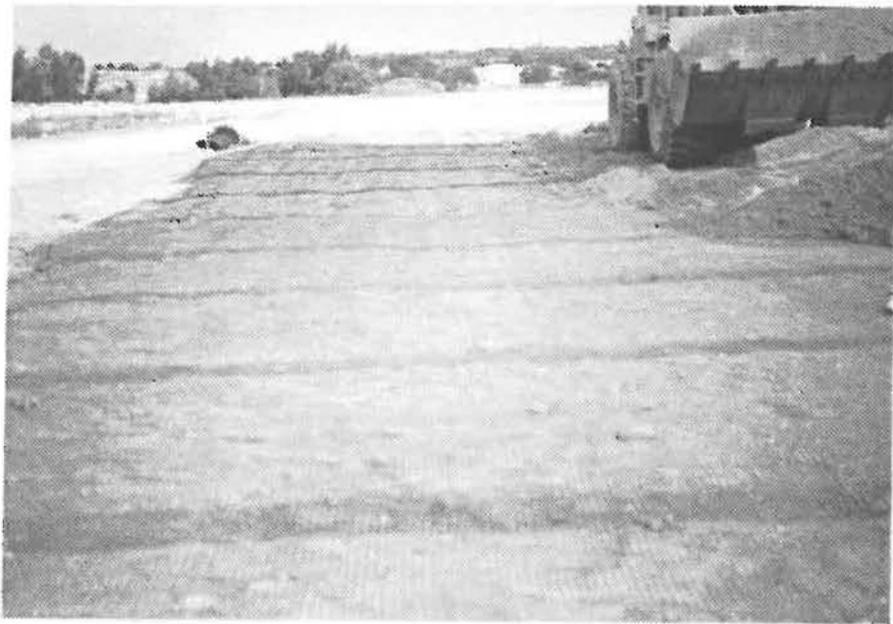
Figure 21. Placing backfill soil on top of the geogrid reinforced test section

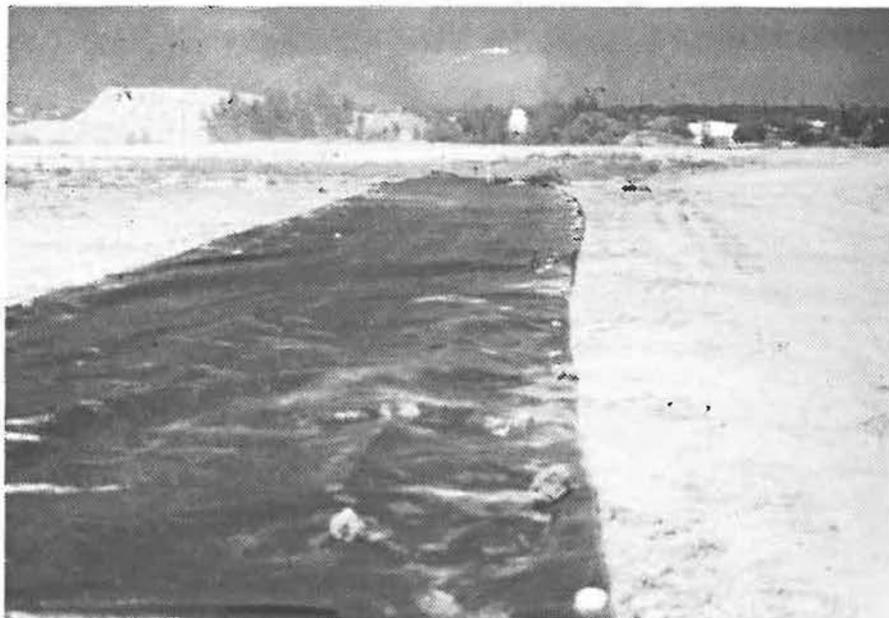
Figure 22. Placing the first layer of Supac 4WS directly on top of the horizontal inclinometer in test section no. 1

geofabric was placed in test section 1. It was laid out in a similar manner to the geogrids and the non-woven fabric, with the exception that the Supac WS was laid directly on the ground surface with no granular cushion material shielding the fabric from potential debris puncture. The same stitching pattern was used to sew the woven fabric panels. However, some of the woven panels were delivered to the job site with factory sewed seams. These seams were not sewed in the same manner as the double "J" seam, and consisted of a single overlap with double stitch. These factory seams were marked for future evaluation when the test embankment would be removed. None of the Supac 4WS rolls contained any strain gages since the texture and weave design of the fabric would not allow attachment of the gages by the methods employed on the non-woven fabric and the geogrids. Figure 22 shows the installation of the Supac 4WS rolls.
