Report No. CDOT-DTD-R-2005-2 Final Report

# TIRE BALES IN HIGHWAY APPLICATIONS: FEASIBILITY AND PROPERTIES EVALUATION

**March 2005**

COLORADO DEPARTMENT OF TRANSPORTATION RESEARCH BRANCH

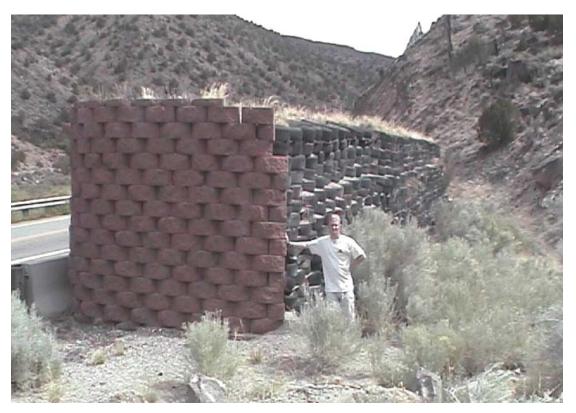
Figure 2.1 Geosynthetic reinforced soil (GRS) rockfall barrier with tire facing in New Mexico (Christopher, 2002)

Whole tires have also been used to form the face of reinforced soil structures, using a similar technique to the residential wall construction with geosynthetic reinforcement placed between the tire layers. This technique has been used to construct rockfall barriers as shown in Figure 2.1, with the tire facing providing significant energy dissipation.

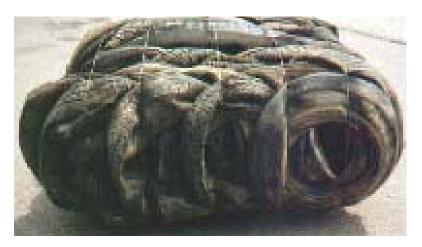
Figure 3.1 Typical tire bale

Tire bales are fabricated by a lightweight tire baling machine, which is readily transportable and easily moved by towing with a truck. It should be noted that some cardboard baling machines have been used for forming tire bales. This practice is questionable because a cardboard baler may not be designed for the loads and stresses associated with "conventional" machines specifically designed for baling scrap tires. (Encore Systems, Inc.). The baling machine typically compresses approximately 100 waste auto tires into a 1.5 m<sup>3</sup>, 0.9 metric ton (2 cubic yard, 1-ton) bale. Tires are usually "laced" with half the tires overlapped in each layer prior to compression and tying. Each bale is typically fastened with a series of galvanized or stainless steel baling wire (Encore Systems, Inc.). Tire baling results in a 5:1 volume reduction of loose tires. Figure 3.1 shows a typical tire bale with tires that have been laced.

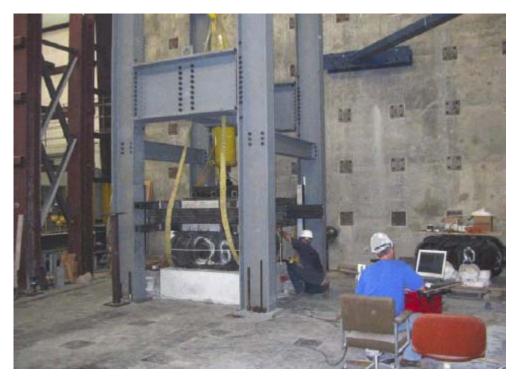
Figure 4.1 Typical tire bale compression test setup

A minimum of three vertical deformation measurements were made to an accuracy of 2.5 mm (0.1 in.), by gages located within equal distances around the sample (e.g., 3 gages located at the third points around the sample.) Lateral movement was also measured in at least three equally spaced (from top to bottom) vertical locations on all four sides of the sample. A calibrated load cell was used to measure the applied load. Both continuous data monitoring (with data acquisition methods) and manual readings were used to check vertical and horizontal deformation as a minimum at every 45 kN (10 kips) up to 450 kN (100 kips) and at every 112.5 kN (25 kips) up to the full load condition. An unload–reload test was performed on one tire bale.

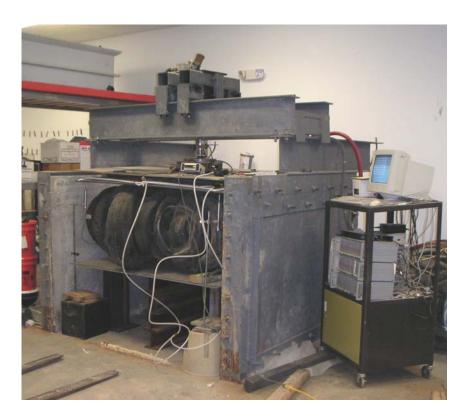
Figure 4.5. Creep test setup.

The tire bale creep tests consisted of placing a constant load on a single, "fresh" (i.e., previously not used) unconfined tire bale and monitoring the deformation response for a period of up to 1,000 hrs (1.39 months) at a constant room temperature. The test setup is shown in Figure 4.5. As shown in the figure, the tire bale was placed on the base of a concrete box, which provided the reaction. A 25 mm (1 in.) thick steel plate with an area greater than the compressed tire bale was placed over the bale as a load platen. Twin air bags were used to sustain the required load. A second steel plate was placed above the air bags, and a load cell was placed between the upper steel plate and a reaction beam to monitor the applied stress. The vertical deformation measurements were made using three gages, with an accuracy of 0.0254 mm (0.001 in.) placed evenly (at the third points) around the sample. Three tests were performed. One tire bale was tested with an applied load of 36 kN (8 kips), equivalent to a vertical stress of 15 kPa (314 psf) based on the cross sectional area of the bale, for a period of 60 hours. This stress simulates a normal cover thickness over the bales [i.e., 0.6 to 1 m (2 to 3 ft) of cover soil]. The other two tests were loaded to 90 kN (20 kips), equivalent to a vertical stress of 39 kPa (815 psf),

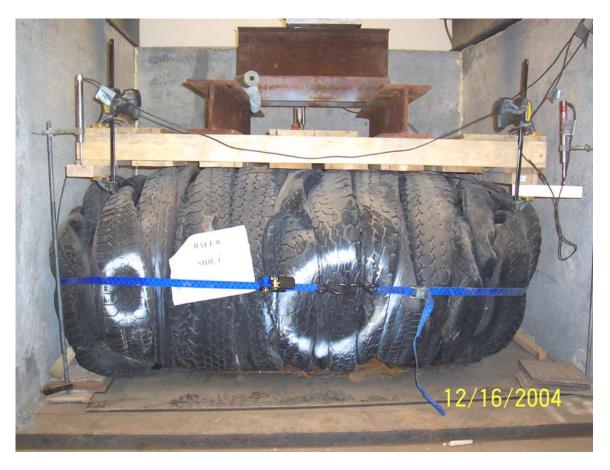
Figure 4.8. Rebound test on tire bales showing lateral expansion in the first test

Tests were performed to investigate the long-term performance of tire bales (before the end of service life) when there is a possibility that tie wires around the tire bales could break, allowing the tire bales to swell. Wire breakage would primarily be of concern for the upper level bales and bales near the sides where vertical and lateral earth pressures are low. In order to evaluate the uplift potential of tire bales, two tests were performed, one to evaluate free swell and the other to evaluate swell pressure. In the first test, a rigid piston with a load cell was placed on the sample using a wooden pallet as a platen to facilitate cutting of the wires. The five vertical tie wires were then cut and the load required to prevent any upward vertical movement was measured. The load to prevent uplift was relatively small and stabilized within an hour at 1.6 kN (360 lbs), which is equivalent to a normal stress of only 0.70 kPa (14 psf). However, after cutting of the wires, significant lateral movement was observed and continued after the load had stabilized. After no increase in upward pressure was observed, the load was released and the upward vertical movement was monitored until no additional movement occurred. A relatively small average vertical movement of 25 mm (1 in.) was measured. The lateral movement was significant with almost 600 mm (2 ft) of movement observed in the band width direction [300 mm (1 ft) on each side], until the bale was restrained by the sides of the 2 m wide (6.6 ft) container as shown in Figure 4.8.

Due to the significant lateral movement observed during the first test, the second test was performed by restraining the lateral movement with several lifting straps, simulating confinement by adjacent tire bales. All five vertical tie wires on a tire bale were cut and the upward vertical movement monitored. The vertical movement appeared to stabilize within the first few hours at approximately 36 mm (1.4 in). Monitoring continued for a period of 4 days with no additional movement observed. These results indicate that the band width direction, which is the direction of compression loading during fabrication, is the most critical direction in terms of swelling movements and pressures. The bales used in the test were manufactured at different times. However, due to differences in test setup, no observations could be made concerning age of the bales. In future rebound tests, aging should be evaluated and an effort should be made to evaluate the stress required to laterally constrain the bales (i.e., prevent lateral movement).

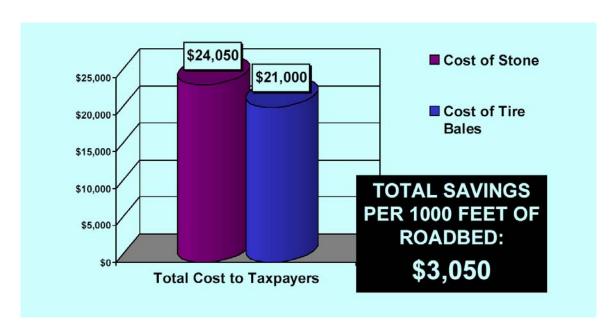
Figure 7.2 Total savings per 1000 feet of roadbed

An example of the costs and savings associated with the use of waste tires in Western New York state is provided in Case Study 2 in Appendix B. On that project the total taxpayer savings was estimated as \$1.60 per tire, or approximately \$160 for a "standard tire bale" (~\$80/cy). This corresponds to the difference between the normal disposal cost of tires and the cost associated with the use of tire bales (Figure 7.1). The cost savings associated with tire bales instead of conventional earthwork material in Case Study 2 was reported as \$3,050 per 300 m (1000 ft) of roadbed (Figure 7.2). (Chautauqua County, 2001). A summary of Chautauqua County's experience on four consecutive projects from 1999 to 2002 is included in Appendix B.

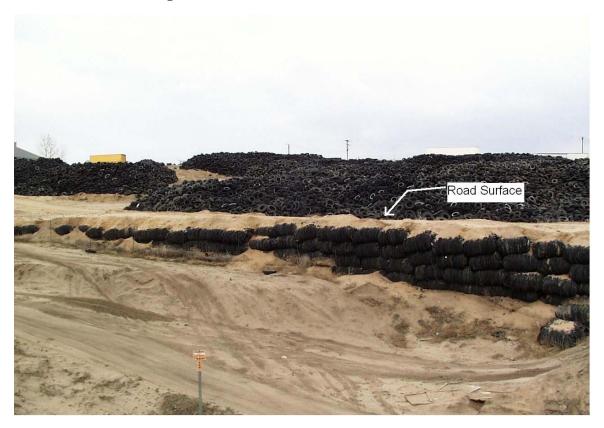
Figure B3. Road built from stacked tire bales.

Construction of the road involved an initial excavation into the slope (i.e. a "cut" excavation), which was conducted to define a relatively flat surface in order to place the tire bales. Next, the tire bales were stacked in a "brick-like" fashion using a forklift. Once the stacked bales reached the desired height for the roadway, the bales were compacted using a frontend loader. In addition to soil, tire shreds were spread over the surface of the tire bale layers in an effort to level the roadway. Finally, soil was placed in uniform layers above the final layer of tire bales and compacted. A view of the road at this Sedalia facility is shown in Figure B3.

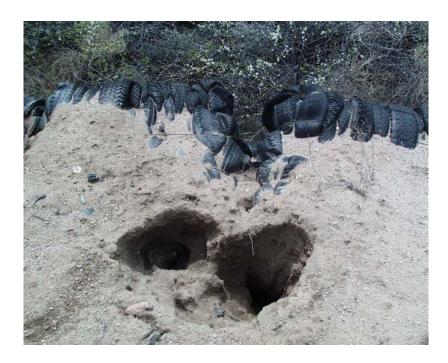
Figure B4. Typical sinkhole.

Visual inspection of the road indicates that the structure has performed very well so far, with little need for maintenance. The only reported maintenance need involved the repair of some small sinkholes that developed near the edges of the roadway. Figure B4 shows a typical sinkhole. The mechanism for sinkhole generation is attributed to incomplete filling the voids of the tire bales with soil. The sinkholes developed because tire shreds were not initially spread in their vicinity after stacking the bales. Maintenance operations involved filling and compacting the sinkholes with soil (Welle, 2003, personal communication). In spite of the development of few sinkholes, the road has performed extremely well even though it is subjected to daily heavy truck traffic (e.g. semi with trailers) and occasionally large construction equipment (e.g. front-end loaders and scrapers).

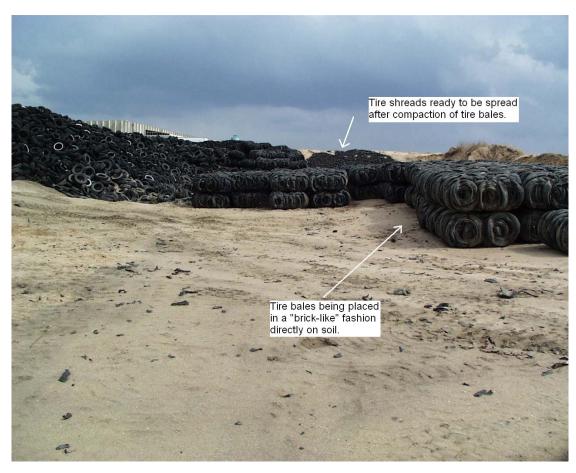
Figure B5. Roadway construction using tire bales.

Recent Colorado state laws required that the company divide some of the existing tire and tire shred piles in case of an emergency fire situation. As a result of this regulation, the company has begun to divide a few of his large piles with roadways wide enough for a fire engine to circulate. Because of the successful performance of the first tire bale road, additional roads with tire bales are in the process of being constructed. One of these roads is shown in Figure B5. However, it should be noted that the tire bales that are being

placed are on top of compacted soil that is underlain by another layer of tire bales.

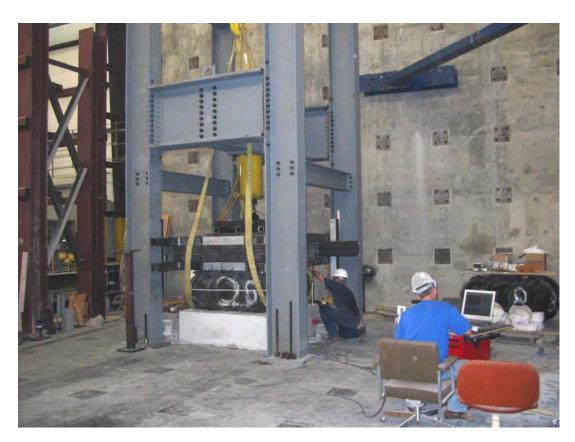
Figure 1: Test setup

A structural steel frame with columns forming an eight foot square was positioned and posttensioned to the concrete structural test floor. Two square concrete platens measuring 66" wide by 20" deep were used for top and bottom load bearing surfaces positioned in the middle of the steel frame as shown in Figure 1. In the first test it was found that the top platen was over rotating due to the non-uniformity of the tire bale. The problem was mitigated by attaching outriggers to all four sides of the top platen. A 1000 kip actuator was positioned in the center of the columns and applied the load to the top platen which distributed the load evenly to the tire bale. A 700 kip load cell was attached to the actuator to measure the applied load. Four 40-in. string potentiometers were positioned at the corners to measure vertical deformation. Vertical deformation at the corners also was measured using a measuring tape accurate to 1/16-inch. The circumference was measured by hand using a flexible metal measuring tape threaded through eye hooks around the middle of the tire bales to ensure consistency of measurements. Measurements were taken every 10 kips through 100 kips and then every 25 kips thereafter.

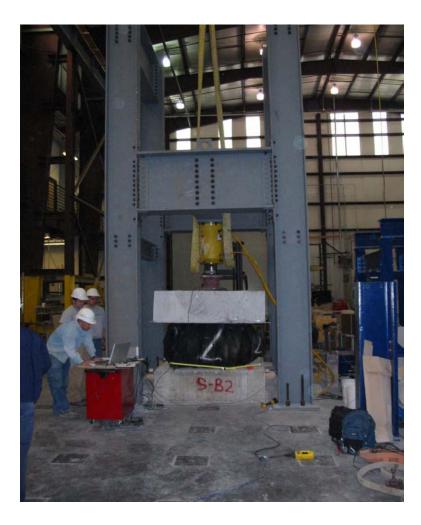
Figure 2: Tire Bale #7, Test #1

Test No.1 on Tire bale #7 was conducted on March 24<sup>th</sup>. Bale dimensions were recorded as well as vertical displacements at the four corners of the platen and circumference was taken at the middle and top and bottom quarter heights. Initial dimensions are given in Table 1. Figure 2 shows the initial test setup. Figures 3 through 5 present load versus vertical and circumferential graphs.

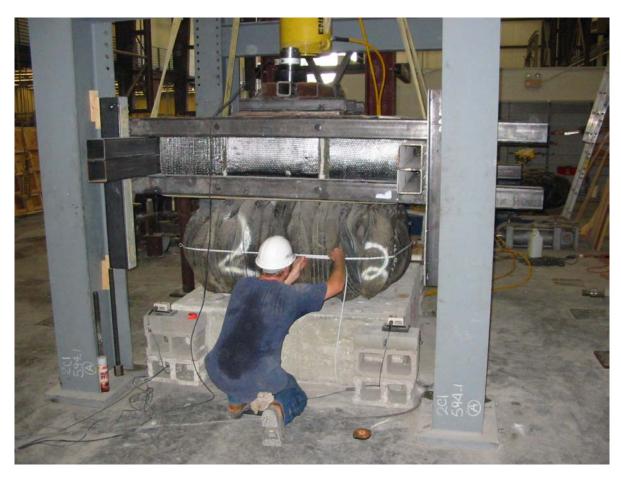
Figure 6: Circumferential measurements. Outriggers mitigated rotation problem.

Test #2 was conducted on May 24<sup>th</sup> on Tire bale #7. Bale dimensions were recorded as well as vertical displacements at the four corners of the platen and the circumference was taken at the middle. Circumferential measurements were only taken at the middle due to the inaccuracy of the results from Test # 1 at the top and bottom quarter heights. Initial dimensions are given in Table 2. Figure 6 shows the test setup. Figures 7 through 9 present load versus vertical and circumferential graphs.

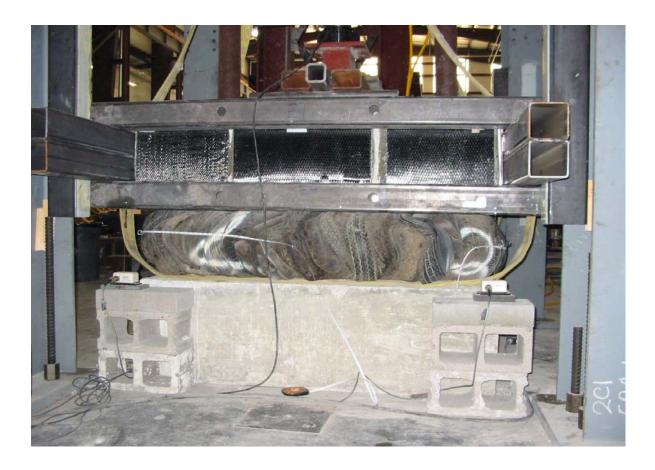
Figure 10: Tire Bale # 2 loaded to 500 kips

Tire Bale # 2 was tested on July 21<sup>st</sup>. Bale dimensions were recorded as well as vertical displacements at the four corners of the platen and circumference was taken at the middle. Initial dimensions are given in Table 3. Figure 10 shows Tire Bale #2 loaded to 500 kips. Figures 11 through 13 present load versus vertical and circumferential graphs.

Tire Bale # 2 was loaded to 510 kips. Two of the bale's metal wires broke. Bale # 2 underwent 5.3 in. of permanent vertical deformation and 16 in. of permanent circumferential deformation.

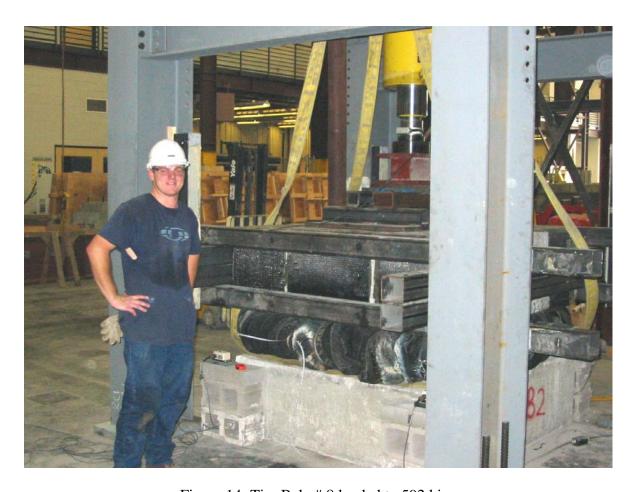
Figure 14: Tire Bale # 8 loaded to 592 kips

Tire Bale # 8 was tested on July 22<sup>nd</sup>. Bale dimensions were recorded as well as vertical displacements at the four corners of the platen and circumference was taken at the middle. Initial dimensions are given in Table 4. Figure 14 shows Tire Bale #8 loaded to 592 kips. Figures 15 through 17 present load versus vertical and circumferential graphs.

Tire Bale # 8 was loaded to 592 kips. Metal wires broke at 62 kips and 175 kips. Bale # 8 underwent 3 in. of permanent vertical deformation and 19.4 in. of permanent circumferential deformation.
