# **ROADS AND CONNECTIVITY IN COLORADO: ANIMAL-VEHICLE COLLISIONS, WILDLIFE MITIGATION STRUCTURES, AND LYNX-ROADWAY INTERACTIONS**

**March 2008**

**COLORADO DEPARTMENT OF TRANSPORTATION  
RESEARCH BRANCH**

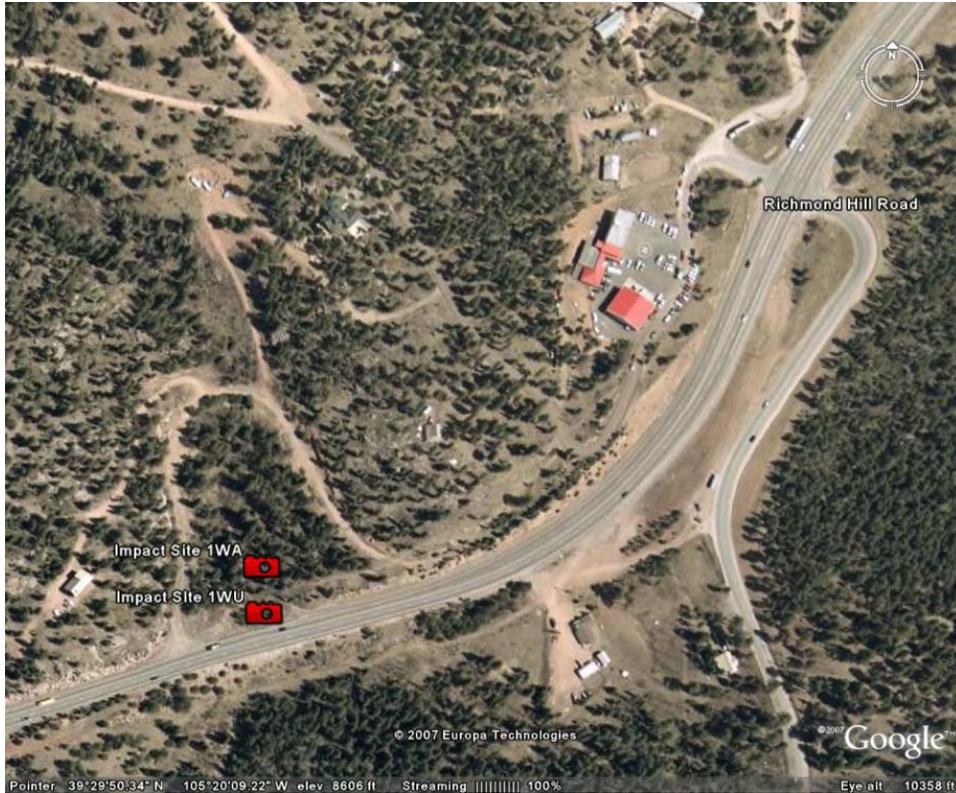
a) Impact site overview and transects (no transect at Impact Site 3)

**Figure 15. Aerial images of U.S. 285 Conifer-Bailey a) impact site and b) control site, including a site overview and transect close-up. Station labels include: west approach (WA), west underpass (WU), east underpass (EU), and east approach (EA).**

Figures 15 (aerial image) and 16 (schematic diagram) show the locations of the impact site monitoring stations. Figure 15 provides detail of the positioning of the camera stations relative to the surrounding habitat, and GPS coordinates of each station are provided in Appendix B.1. Impact Site 1 had two cameras (one roadside camera and one approach camera) on the western side of the highway. Cameras were not placed on the eastern side of the highway due to ongoing construction activities (see *Monitoring Schedule* section below). Impact Site 2 consisted of four camera stations placed along a transect perpendicular to the highway. Two of these cameras were located at approaches on both the east and west side of the highway and two cameras were placed at opposing entrances to a small 2 ft diameter metal pipe culvert. The location of this culvert was planned for the Green Valley Grill underpass designed to provide movement for a variety of larger-bodied wildlife species, particularly elk and mule deer. This underpass was constructed during the course of this study. Impact Site 3 consisted of a single camera located at the western approach to the highway at MP 234.4. Representative site photos are shown in Appendix B.2.

Figures 15 (aerial images) and 16 (schematic diagram) show the locations of the impact site monitoring stations. Figure 15 provides detail of the positioning of the camera stations relative to the surrounding habitat, and GPS coordinates of each station are provided in Appendix B.1. Control Site 1 consisted of four camera stations placed along a transect perpendicular to the highway. Two of these cameras were located at approaches on both the east and west side of the highway and two cameras were placed at opposing entrances to the Deer Creek bridge. Control Site 2 also consisted of four camera stations placed along a transect perpendicular to the highway. Two of these cameras were located at approaches on both the east and west side of the highway and two cameras were placed at opposing entrances to the 8 ft diameter metal pipe culvert. Although these two structures were not be redesigned during the current phase of construction in the impact site, they are slated for improvement during future phases of the U.S. 285 highway improvement project between Conifer and Bailey. While the dimensions of the proposed Deer Creek bridge structure have not been presented, the Roland Gulch culvert will be replaced by a bridge approximately 600 ft in width and approximately 30-40 ft in height. Although it is unknown as to when this phase of highway construction will begin, monitoring these sites will provide valuable baseline data as to the rate of wildlife movement through and surrounding the existing underpass locations. Representative site photos are shown in Appendix B.2.

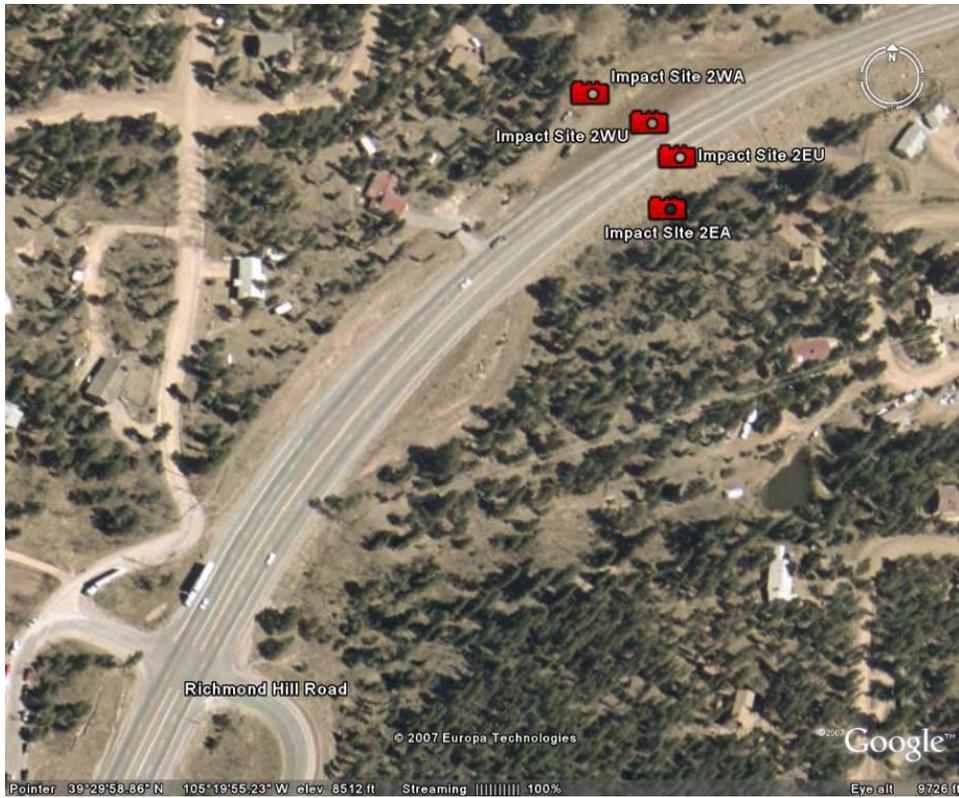
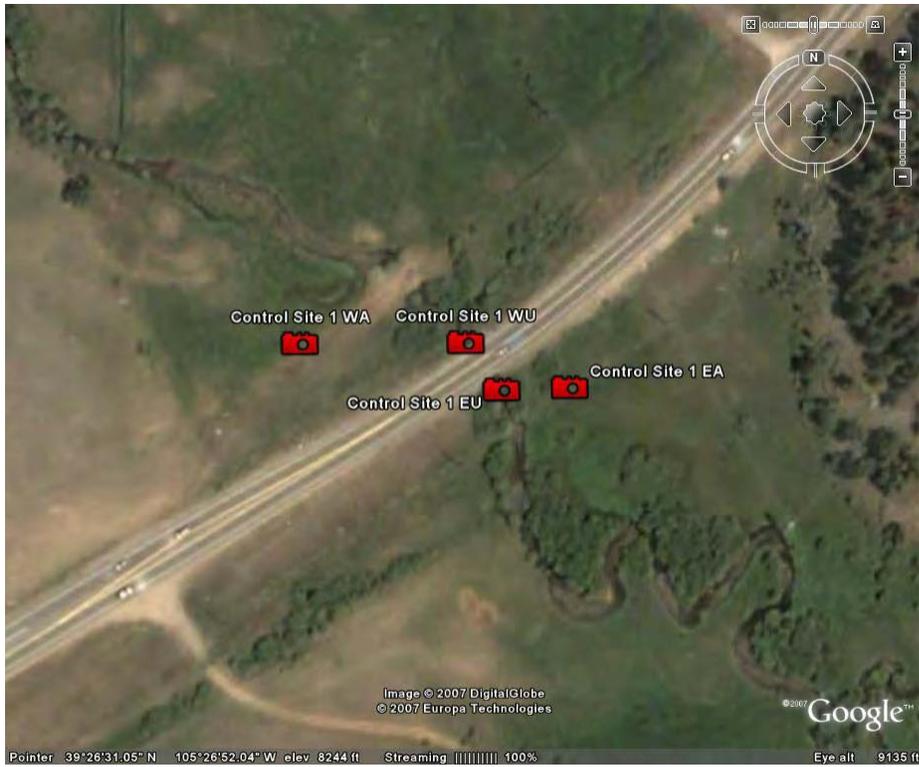
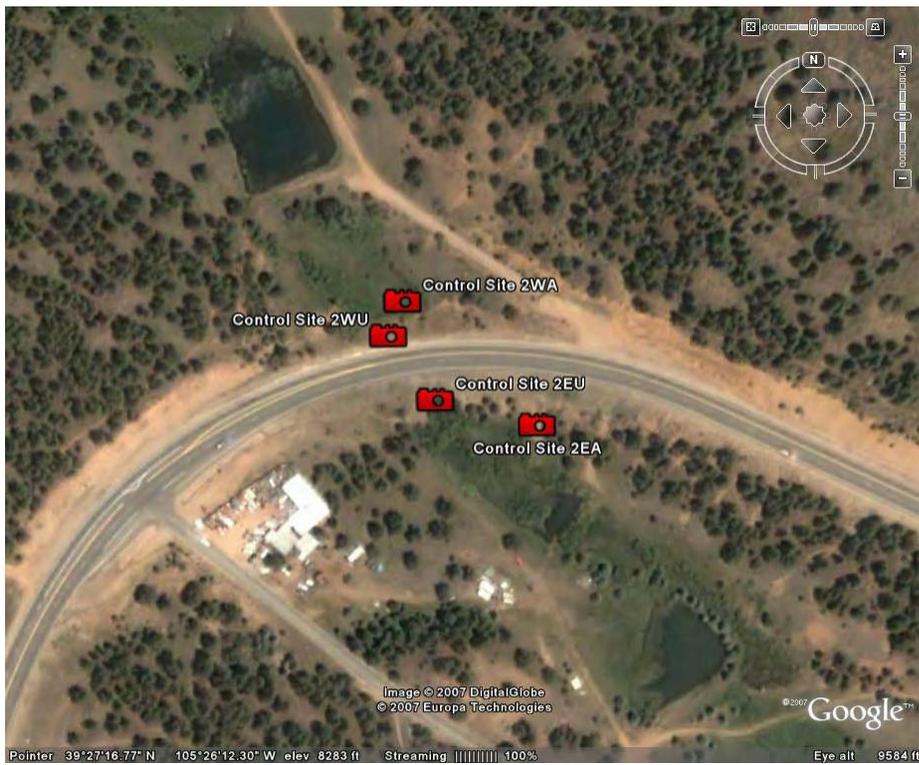
b) Control site overview and transects

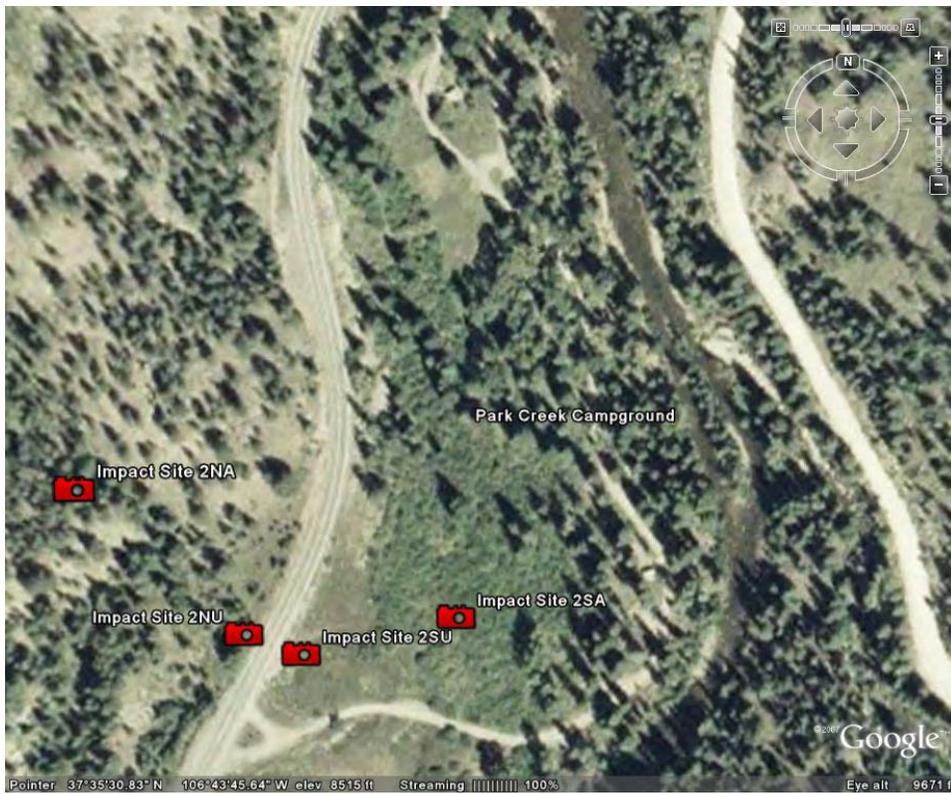
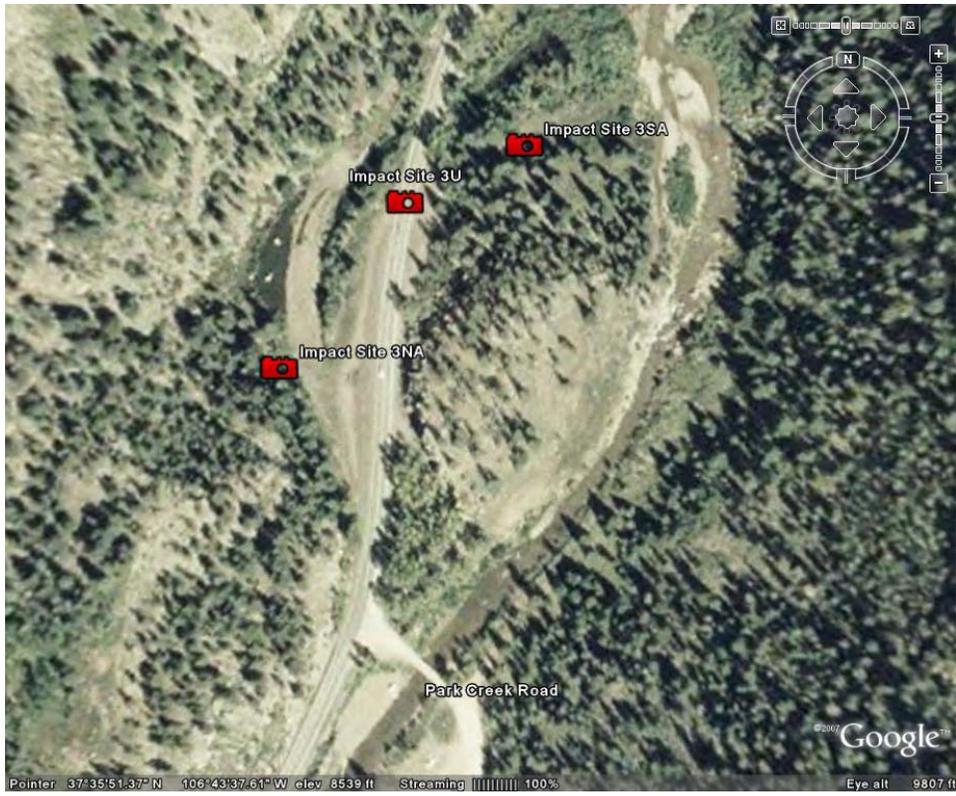
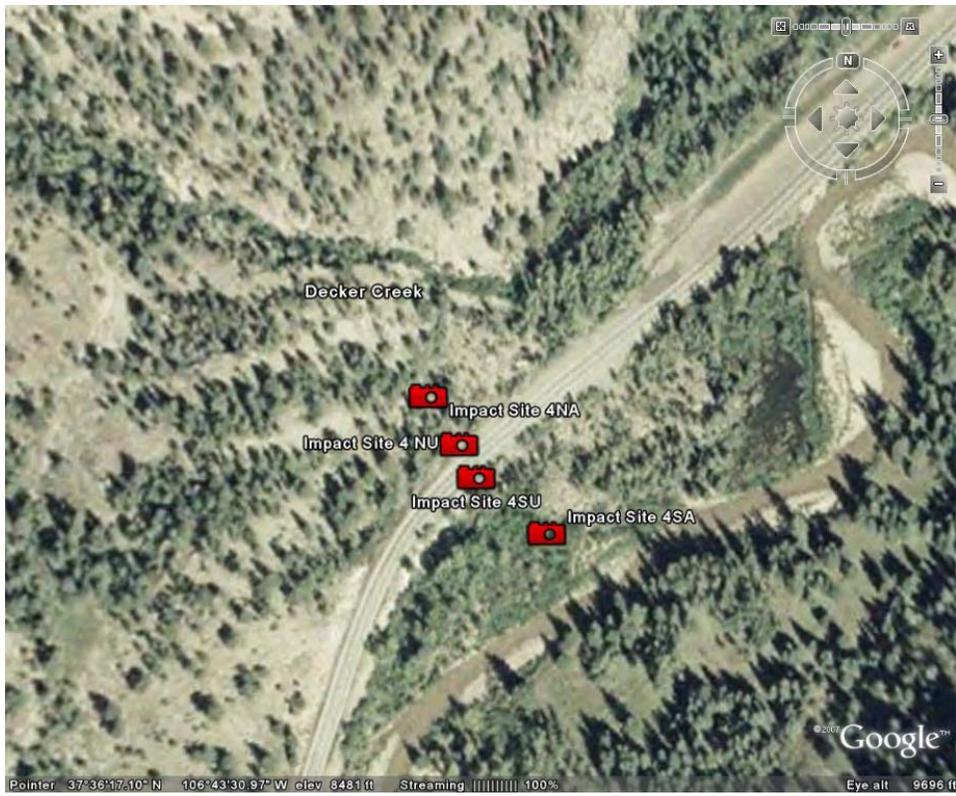
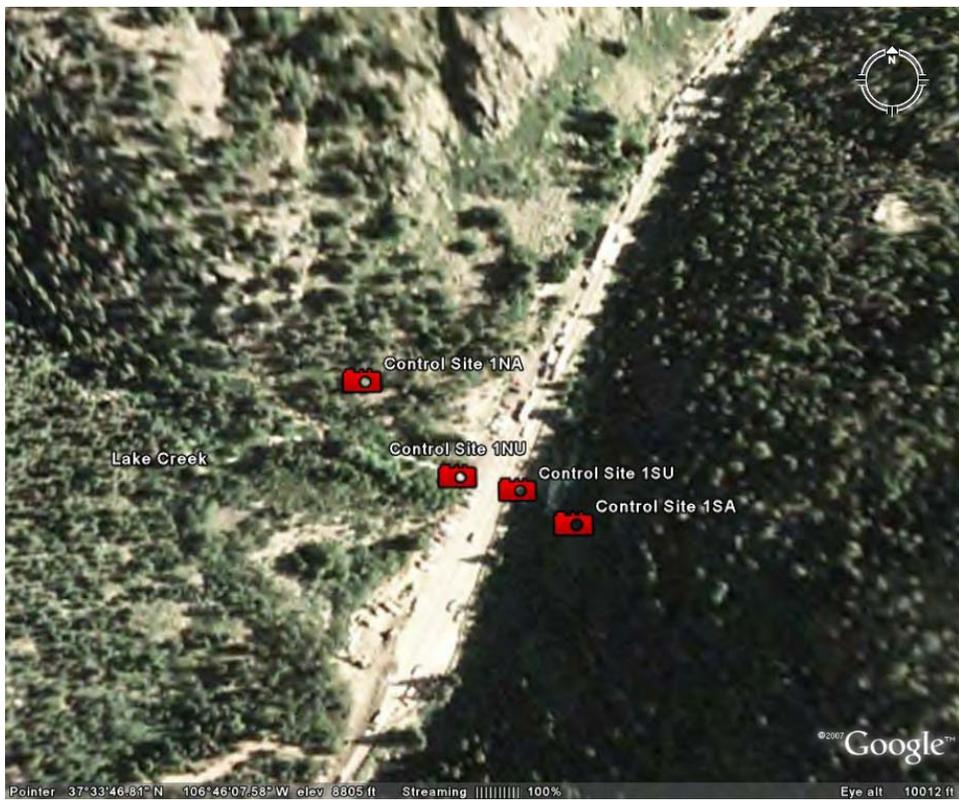
a) Impact site overview and transects (no transect at Impact Site 1)

b) Control site overview and transects, including Impact Site 5

**Figure 18. Aerial image of U.S. 160 Wolf Creek Pass a) impact site and b) control site, including a site overview and transect close-up. Station labels include: north approach (NA), north underpass (NU), south underpass (SU), and south approach (SA).**

Figures 18 (aerial images) and 19 (schematic diagram) show the locations of the impact site monitoring stations. Figure 18 provides detail of the positioning of the camera stations relative to the surrounding habitat, and GPS coordinates of each station are provided in Appendix B.3. Impact Site 1 had one camera positioned along a powerline corridor on the western side of the highway.

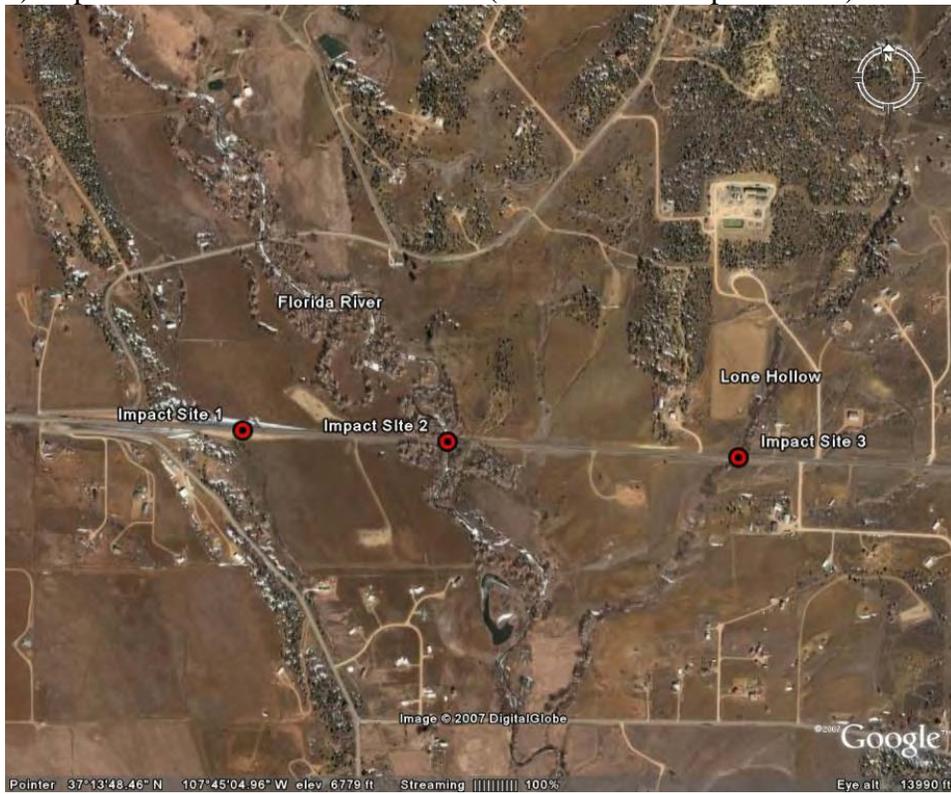
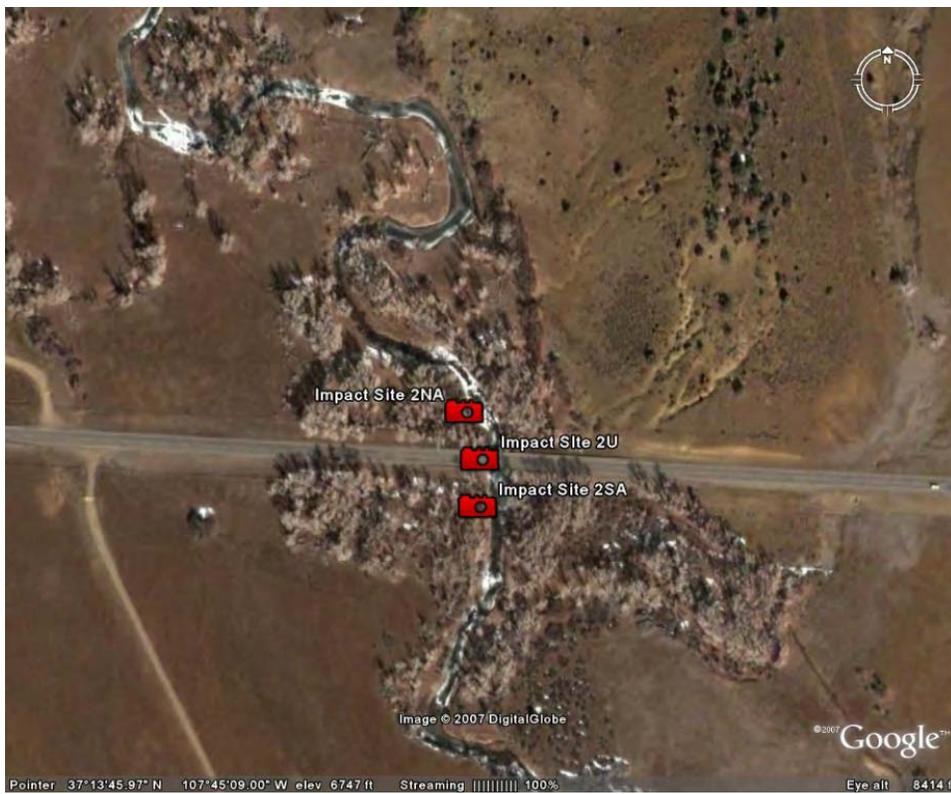
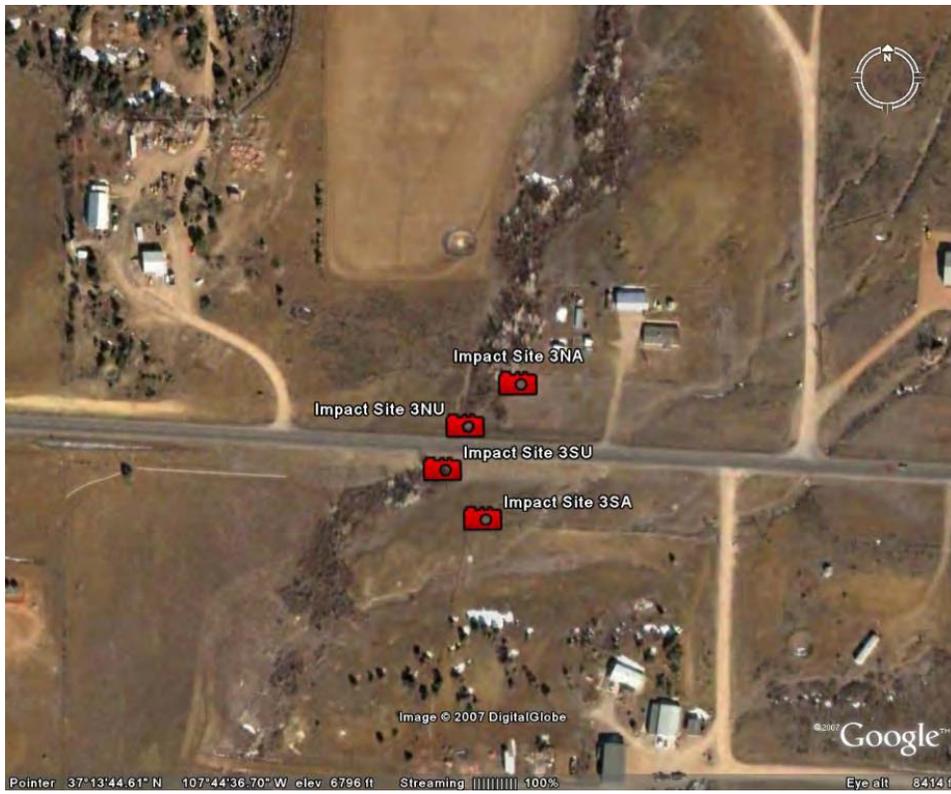
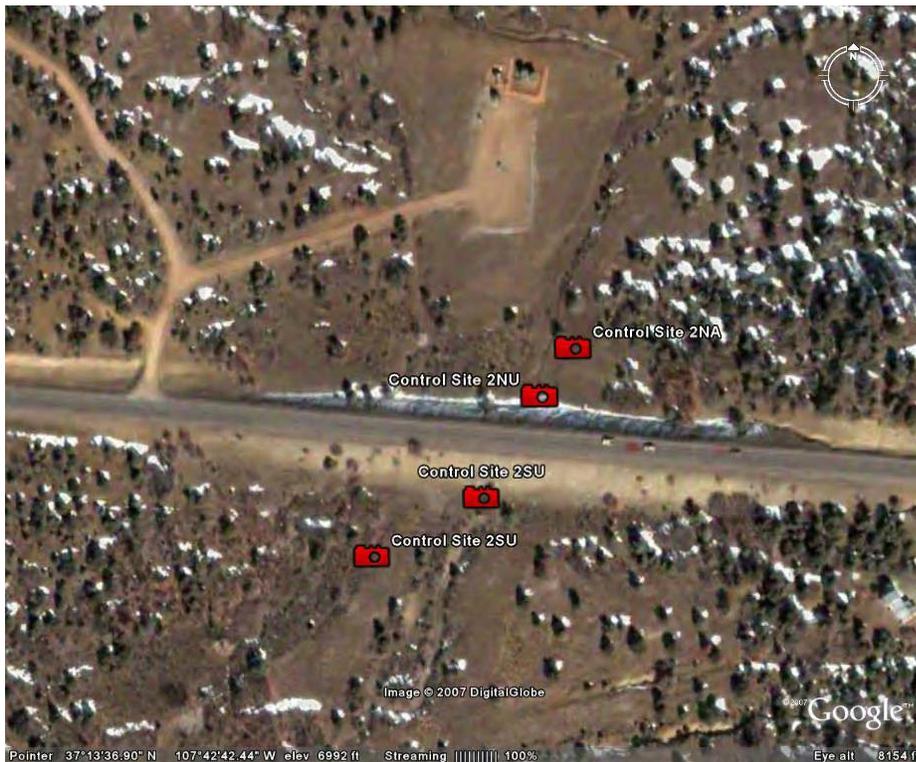
a) Impact site overview and transects (no transect at Impact Site 1)

b) Control Site overview and transects

**Figure 22. Aerial image of U.S. 160 Durango-Bayfield a) impact site and b) control site, including a site overview and transect close-up. Station labels include: north approach (NA), north underpass (NU), south underpass (SU), and south approach (SA).**

Figures 22 (aerial images) and 23 (schematic diagram) show the locations of the impact site monitoring stations. Figure 22 provides detail of the positioning of the camera stations relative to the surrounding habitat, and GPS coordinates of each station are provided in Appendix B.5. Impact Site 1 consisted of a single camera positioned at the base of a long fill

Figures 22 (aerial images) and 23 (schematic diagram) show the locations of the impact site monitoring stations. Figure 22 provides detail of the positioning of the camera stations relative to the surrounding habitat and GPS coordinates of each station are provided in Appendix B.5. Control Site 1 consisted of four camera stations placed along a transect perpendicular to the highway, with the midpoint represented by a small pipe culvert 2 ft in diameter. Two of these cameras were located at approaches on both the north and south side of the highway and two cameras were placed at opposing entrances to the structure. Two remotely-triggered video cameras were also placed on each side of the highway between the underpass and approach digital cameras in order to record surface crossings over U.S. 160 by wildlife. This fill slope is proposed to have a 120 ft long x 36 ft wide x 14 ft high arch culvert installed during a future construction phase on this segment of the highway. Control Site 2 consisted of four cameras placed along a transect perpendicular to the highway, with the midpoint represented by a 145 ft long x 7 ft wide x 7 ft high metal culvert. Two remotely-triggered cameras were located at

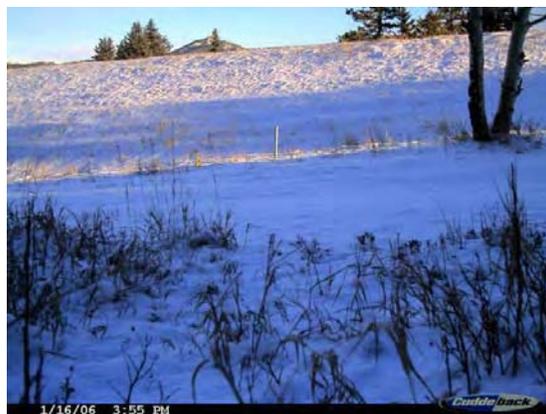
Impact Site 2: Green Valley Grill underpass before construction

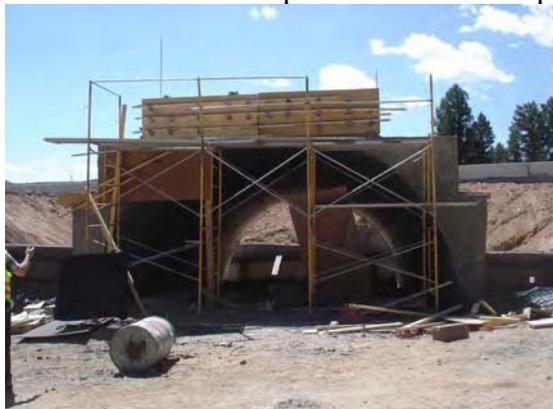
Impact Site 2 during construction of the southbound U.S. 285 portion of the underpass

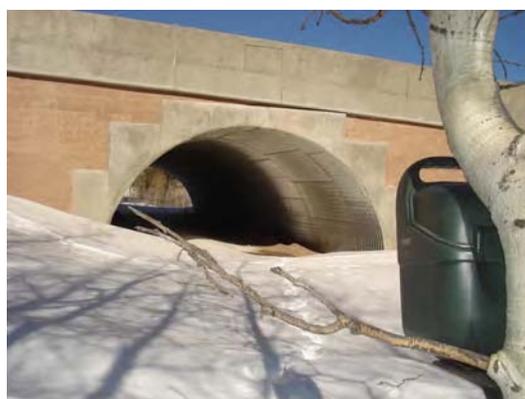
Impact Site 2 after construction

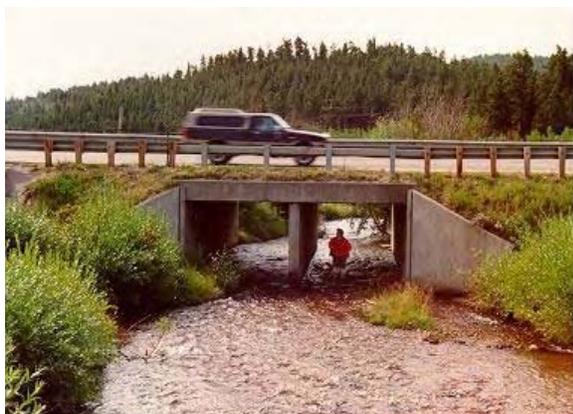
Control Site 1: Deer Creek span bridge<sup>1</sup>

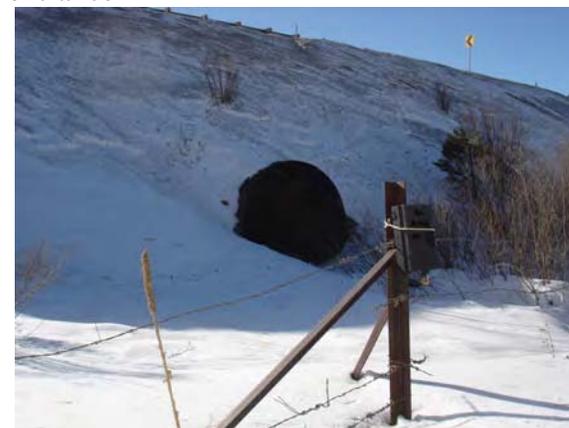
Control Site 2: Roland Gulch culvert, west entrance

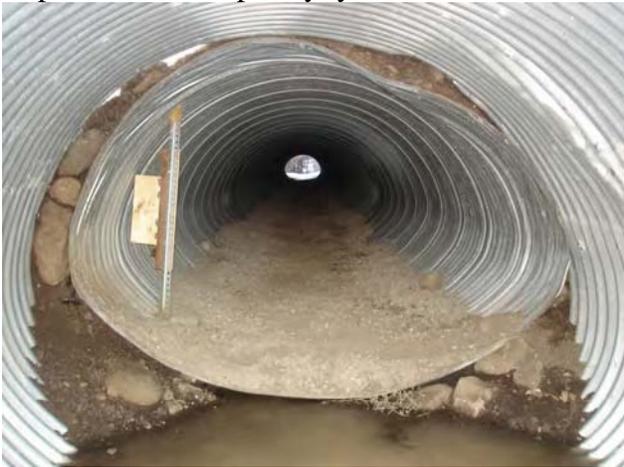
Impact Site 3: temporary lynx structure

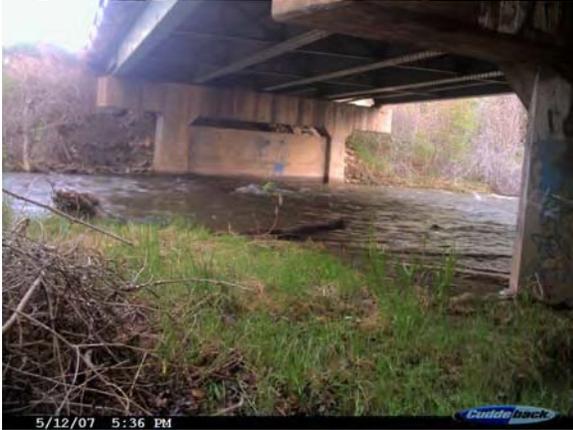
Impact Site 2: Florida River bridge

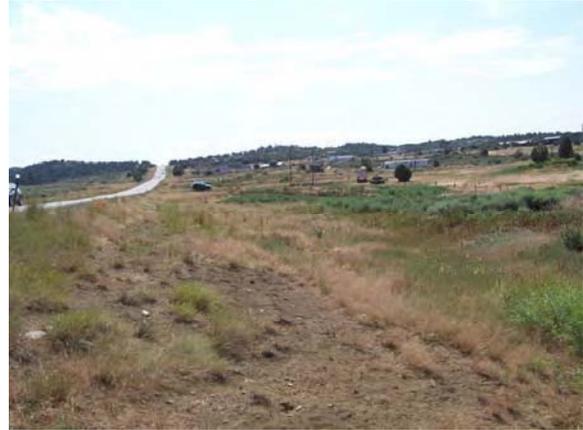
Impact Site 3: Long Hollow culvert<sup>2</sup>

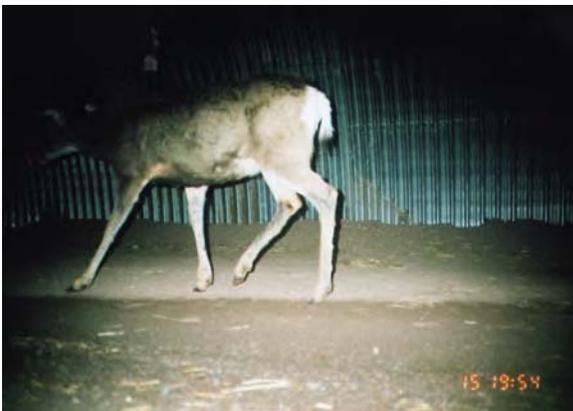
Mule deer using Green Valley Grill underpass

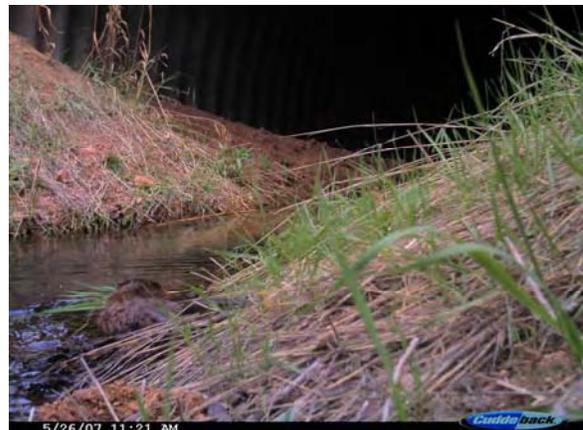
Muskat: Control Site 2 SU station, Roland Gulch culvert

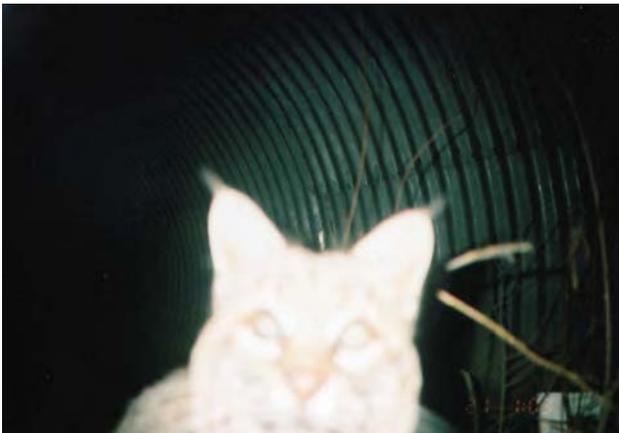
Bobcat: Impact Site 3 SU stations, Long Hollow Culvert

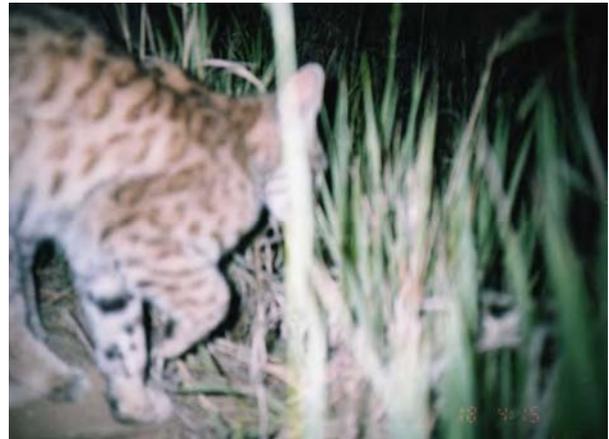
Bobcat: Control Site 1 NU station, culvert

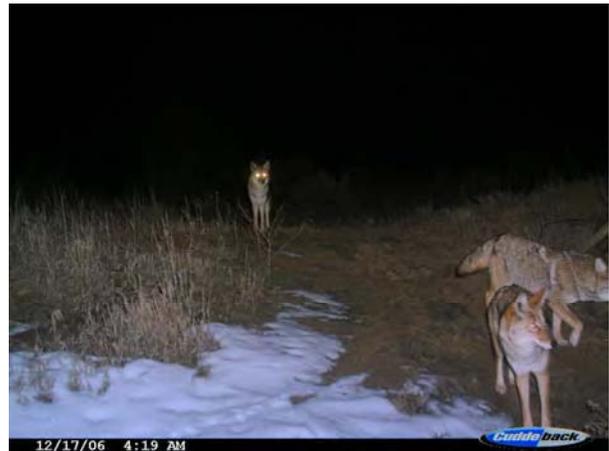
Coyotes: Control Site 2 NU station, at culvert entrance

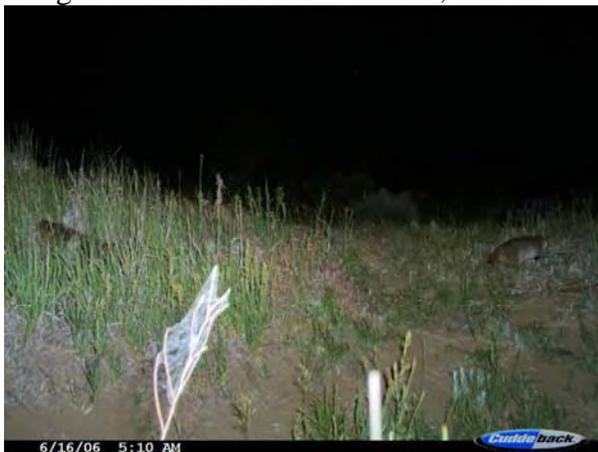
Badger: Control Site 2 NU station, culvert

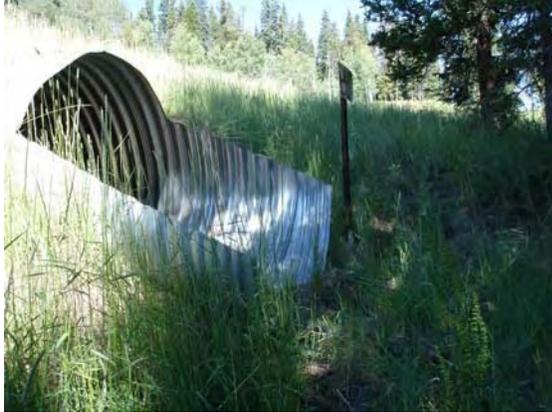
**Appendix C.3. Representative site photos and underpass conditions at the U.S. 40, Muddy Pass MP1 underpass.**

August 2005 (grass regeneration east side)

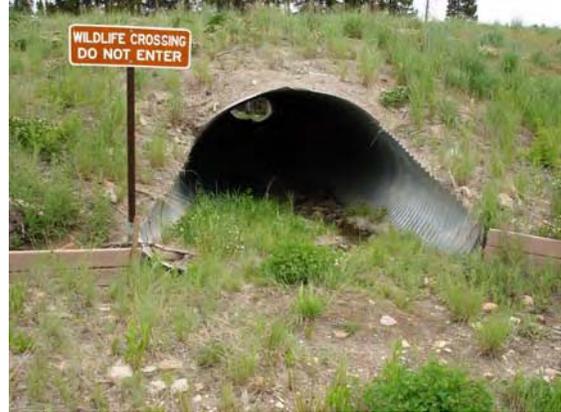
August 2006 (grass regeneration west side)

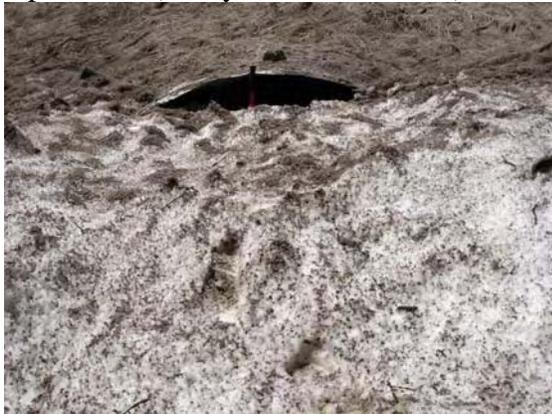
April 2006 (heavy snow conditions)

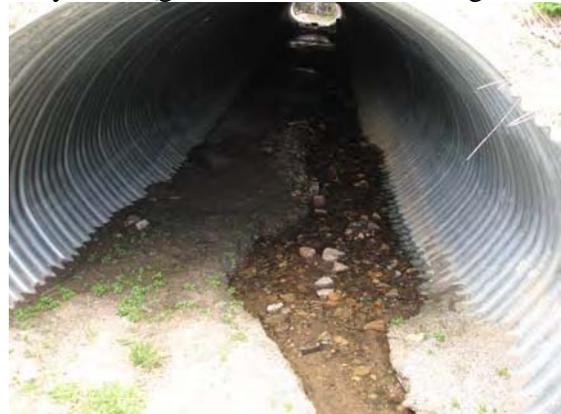
May 2006 (ground water flow through tunnel)

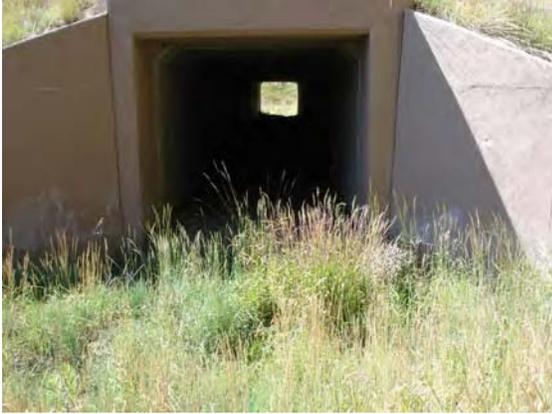
**Appendix C.5. Representative site photos and underpass conditions at the U.S. 40, Muddy Pass MP1 underpass.**

August 2006 (grass regeneration east side)

Representative site photos and underpass conditions are shown in Appendix C.5.

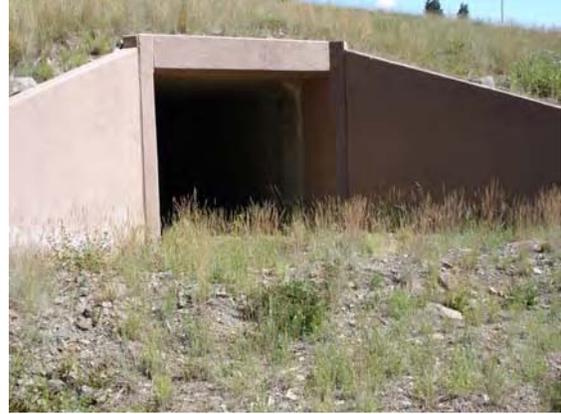
August 2006 (grass regeneration west side)

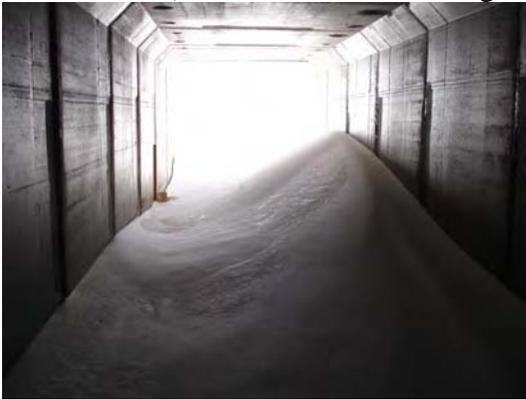
March 2006 (snow drift inside looking west)

- The tunnel was muddy again through the early summer months
- Dry conditions were present again throughout the summer months and early fall of 2006
- Snow levels during winter 2006-2007 were not as high as the previous winter

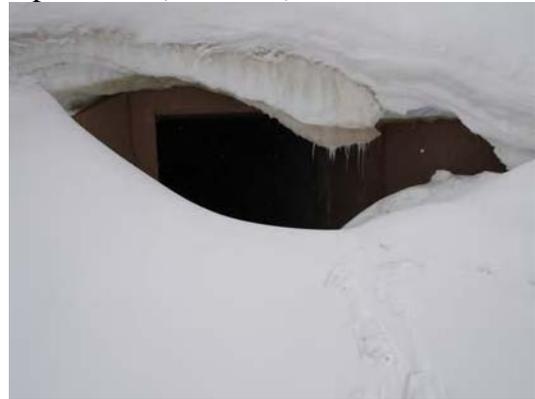
April 2006 (west side)

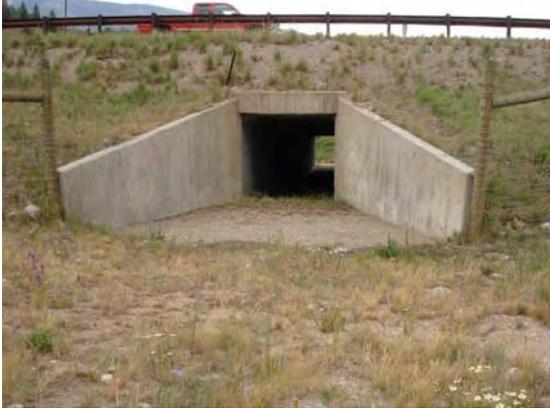
**Appendix C.7. Representative site photos and underpass conditions at the SH 9, Silverthorne S1 underpass.**

July 2006 (grass regeneration west side)

Representative site photos and underpass conditions are shown in Appendix C.7.

The local topography was well suited for wildlife movement on the west side of the underpass. The hills and gully that border the west side naturally channel wildlife towards the underpass. However, the east side of the underpass borders the Blue River, which may act as a barrier for smaller animals, especially during periods of high runoff. The height and width of the tunnel was suitable for all species of wildlife and the length of the tunnel was sufficiently short for light to penetrate and illuminate the interior of the underpass. During the winter and spring months the icy conditions and slight slope of the underpass made it difficult to walk through the tunnel to check the camera station. This may be a limiting factor for larger bodied animals using the tunnel. Snow conditions were mild compared to other underpasses. Constant solar radiation along the east side of the tunnel kept snow levels fairly low and the only deep snow occurred on the west side in the shade. Similar to the underpass at Muddy Pass (MP1), human use was noticeable. Anglers and hunters and other pedestrians used the underpass often. Graffiti was found inside the east entrance in the spring of 2007. There are no signs outside the tunnel notifying the public that the tunnel is for wildlife use only. Overall, S1 seemed to be one of the best tunnels suited for wildlife passage.

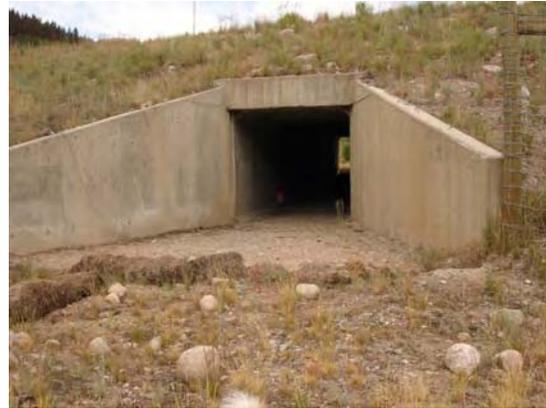
July 2006 (grass regeneration east side)

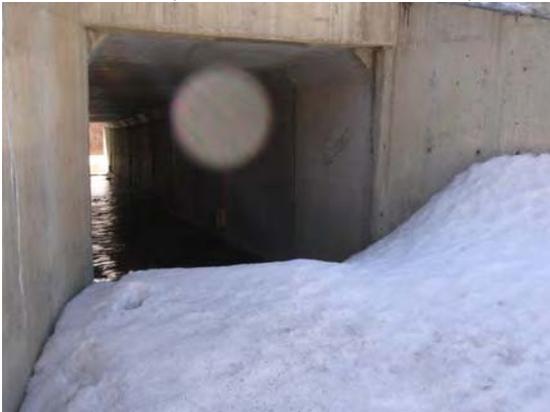
March 2007 (snow and ice west side)

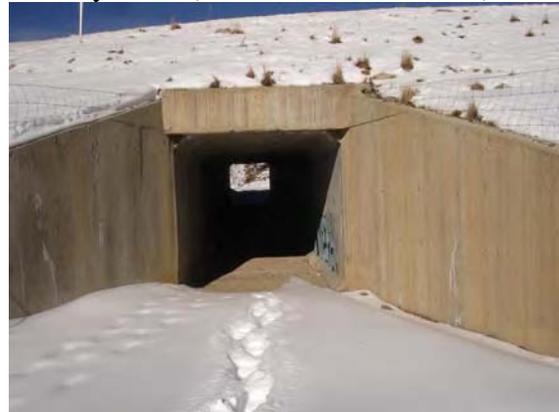
January 2007 (snow outside east side)

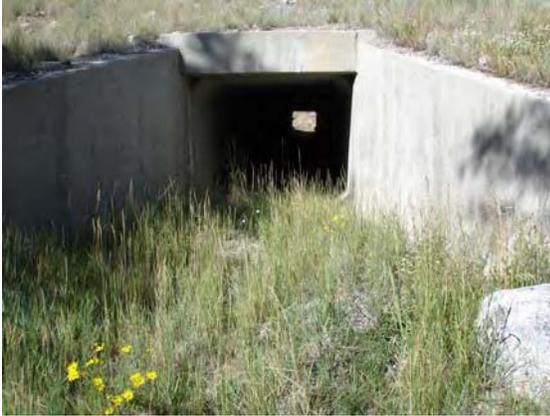
**Appendix C.9. Representative site photos and underpass conditions at the SH 9, Silverthorne S1 underpass.**

August 2006 (grass regeneration east side)

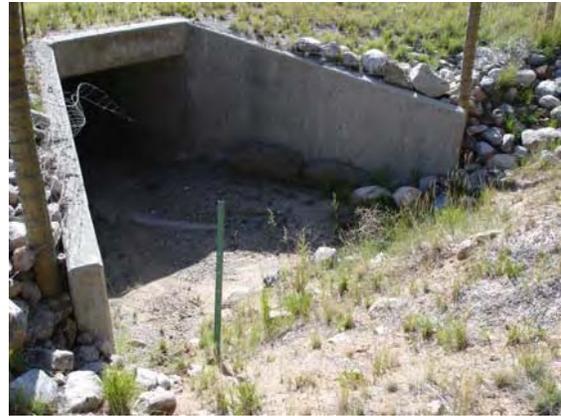
August 2006 (grass regeneration west side)

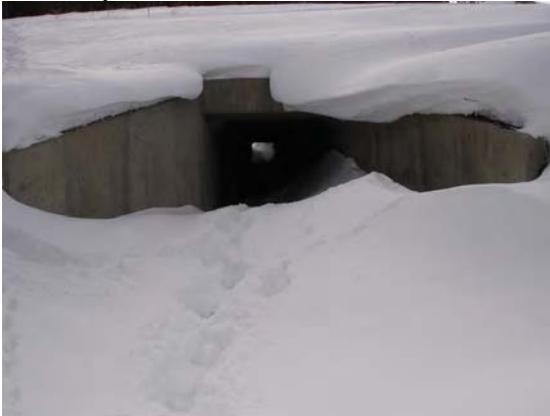
February 2006 (snow conditions east side)

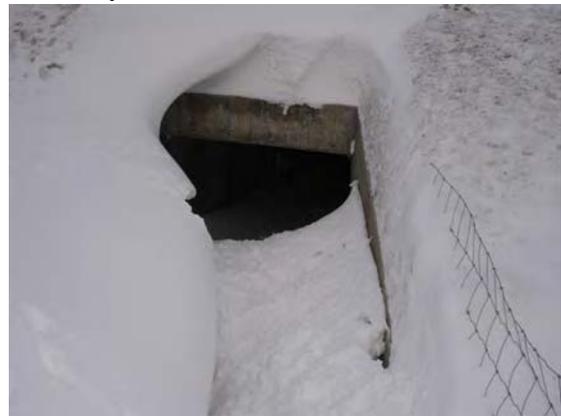
February 2006 (snow conditions west side)

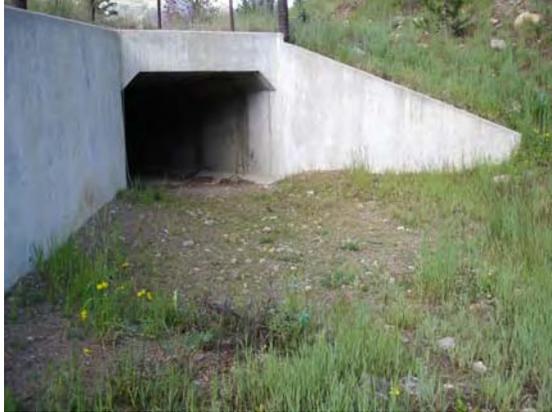
**Appendix C.10. Representative site photos and underpass conditions at the U.S. 40, Berthoud Pass BP1 underpass.**

August 2006 (grass regeneration north side)

Representative site photos and underpass conditions are shown in Appendix C.10.

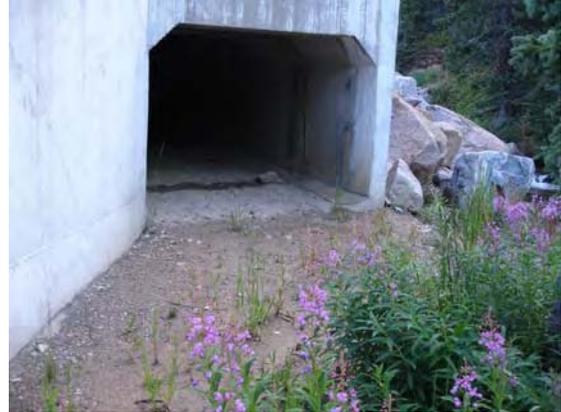
August 2006 (grass regeneration south side)

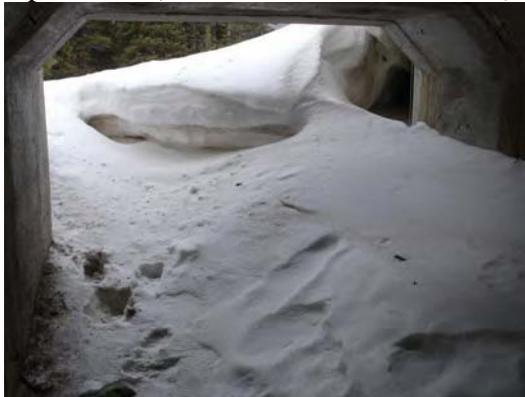
April 2006 (snow conditions north side)

- Late summer 2005: Mud inside tunnel no longer a problem
- Winter 2005 and 2006: Heavy drifting of snow inside north entrance, up to 30 ft inside tunnel
- Late spring 2006: Ice continues to build up over early spring months and lasts until late spring
- It is difficult to access the camera station on the north side due to the slope and ice conditions inside the tunnel which may also limit wildlife use
- Snow levels outside tunnel entrances ranged from 5ft to 6 ft in the winters of 2005 and 2006

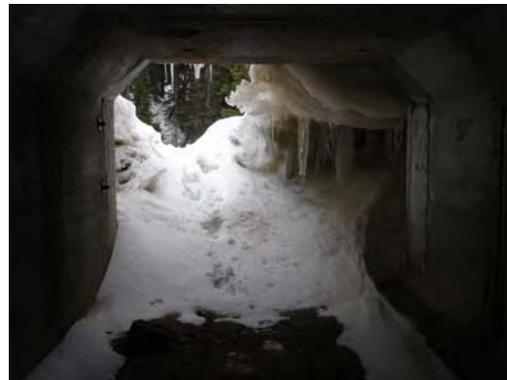
April 2006 (snow conditions south side)

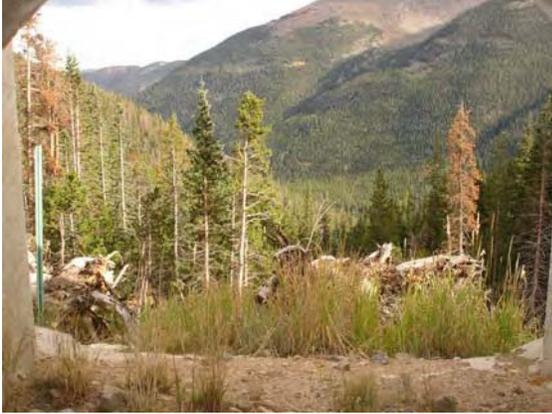
**Appendix C.11. Representative site photos and underpass conditions at the U.S. 40, Berthoud Pass BP2 underpass.**

September 2005 (grass regeneration south side)

Representative site photos and underpass conditions are shown in Appendix C.11.

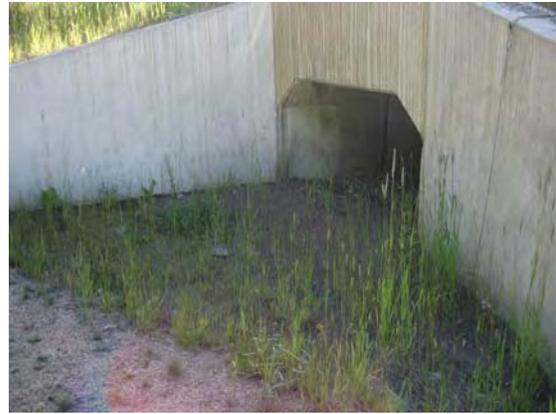
August 2006 (grass regeneration north side)

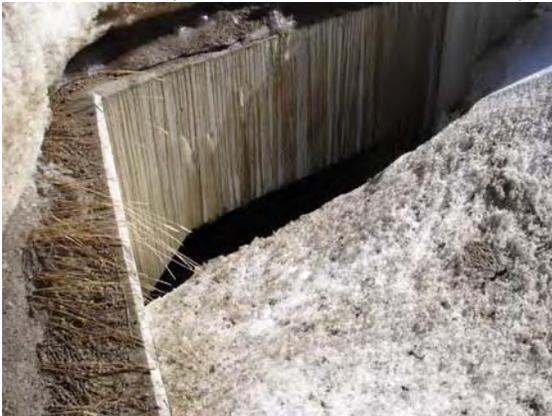
March 2006 (snow conditions north side)

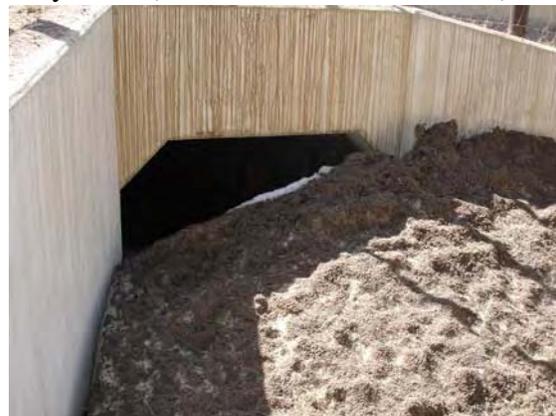
May 2007 (snow conditions north side)
