STATE HIGHWAY 9 WILDLIFE CROSSINGS MONITORING – YEAR 3 PROGRESS REPORT

December 2015 through April 2018

Study Number 115.01

Report to the Colorado Department of Transportation
Applied Research and Innovation Branch

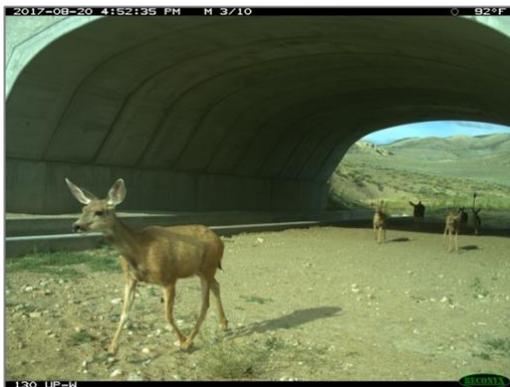
Figure 10. Example of mule deer success movement at the BVA Underpass.

Figure 9 presents mule deer total movements and success movements by month at the BVA Underpass. The peak in monthly movements in Year 2 was higher than the peak in Year 3; however, in Year 2 there was a single peak in February, while in Year 3, two peaks were observed in January and March, with a dip in activity in February and overall activity was higher throughout the winter months. Figure 10 depicts a success movement at the BVA Underpass. Mule deer use continued through the summer months.

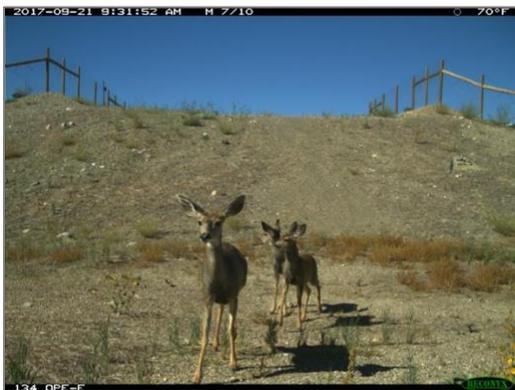
Figure 14. Mule deer doe with two fawns crossing the North Overpass.

Figure 13 presents mule deer total movements and success movements by month at the North Overpass. This is the only location where mule deer activity decreased from Year 1 to Year 3. The highest peak in success movements occurred in March 2016. Wintertime peaks in activity in Years 2 and 3 were substantially lower, although overall activity at this structure remained high. Mule deer use continued through the summer months. Figure 14 depicts a mule deer success movement at the North Overpass.

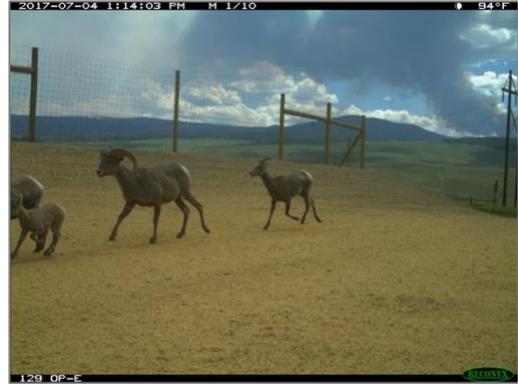
Figure 17. Bighorn sheep ewe, lamb, ram and yearling crossing the South Overpass.

Since the onset of this research, pronghorn and white-tailed deer have only been documented using the underpass structures. The majority of pronghorn success movements occurred at the BVA Underpass, while the majority of white-tailed deer success movements occurred at the North Underpass. Moose and bighorn sheep have made success movements at both underpasses and overpasses. The majority of bighorn sheep success movements occurred at crossing structures located in the southern portions of the project area, specifically, at the South Overpass and the Williams Peak Underpass. Of eight total success movements at the South Overpass, four of them were part of a single event by a family group (Fig. 17).

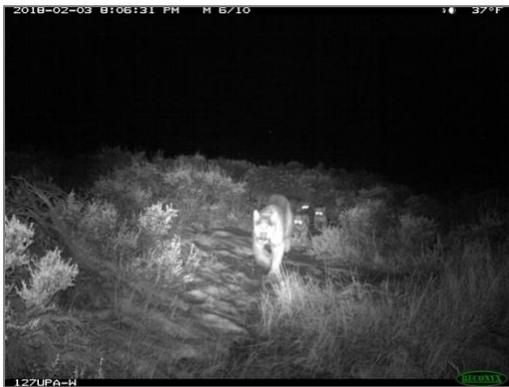
Figure 19. Mountain lion with 3 kittens approaching the Williams Peak Underpass.

same individual movement. Figure 19 depicts a mountain lion with three kittens approaching the habitat camera on the east side of the Williams Peak Underpass. In a few cases wildlife that were not captured at the habitat cameras were documented at the structure. However, these events occurred in low numbers and are expected as the habitat cameras are only able to capture a portion of the wildlife activity occurring in the vicinity of a structure.

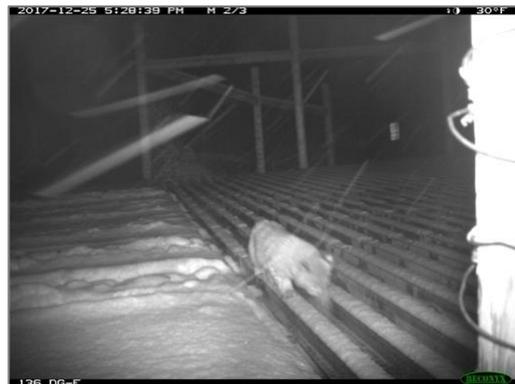
Figure 21. Bobcat entering into the vault at the County Road 33 Wildlife Guard.

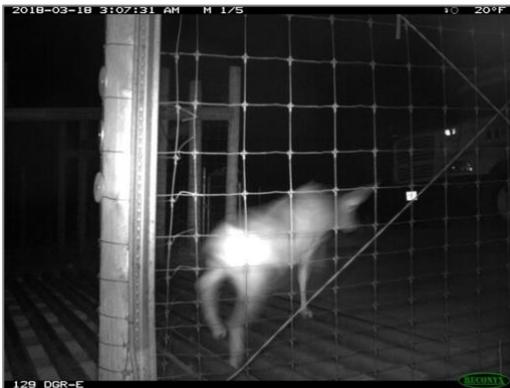
Figure 22. Mule deer breaching the Badger Road Wildlife Guard by attempting to walk on top of the round bars.

method of breaching, regardless of guard type, was jumping. On several occasions, deer were captured breaching a round bar guard by attempting to walk on top of the bars (Fig. 22) or walking on the support beams despite the presence of angle iron on the beams to prevent these types of breaches (Fig. 23).

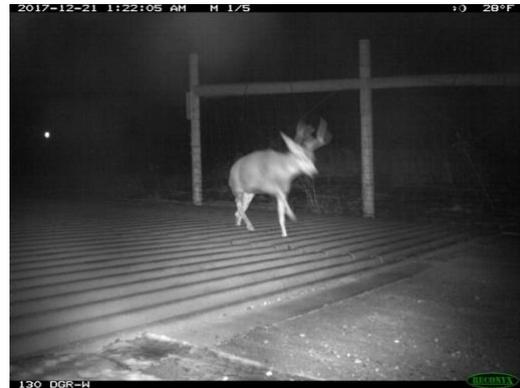
Figure 23. Mule deer breaching the County Road 1002 Wildlife Guard (round bar) by walking on the support beams.

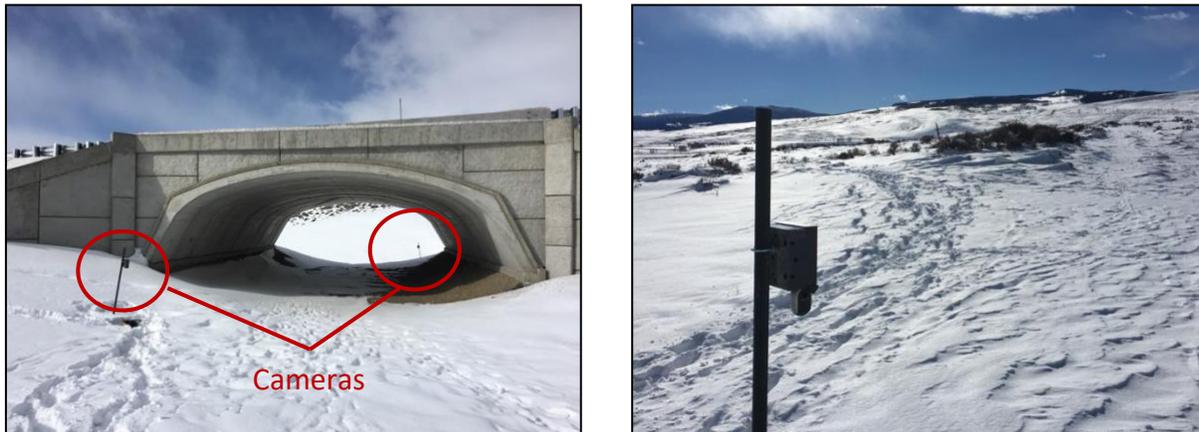
Figure A-1. Two cameras were positioned at each underpass at opposite corners (left). Habitat camera placed 50-100 feet in front of a structure, facing out into the adjacent habitat (right).

For post-construction monitoring, cameras were set up at each monitoring location to maximize capture rates and wildlife responses to the mitigation features. At crossing structures, cameras were placed to capture wildlife behavior at the entrance of the structure to distinguish success movements (passage through a crossing structure) from repels and parallel movements. Two cameras were placed at each arch underpass, at opposite corners. In addition, a habitat camera was placed on one side of each underpass, 50-100 feet from the structure entrance, directed toward the habitat facing away from the road (Fig. A-1). The two overpass structures have steep entrance slopes leading to the top of the structures, so in addition to the two cameras on top of each structure, additional cameras were placed at the bottom of the slopes on either side of the structure. These 'entrance' cameras were more likely to capture repels and parallel movements, while the structure cameras could be used to confirm through-passage. Habitat cameras were placed on each side of the overpass facing outward to capture wildlife movements in the adjacent habitat.

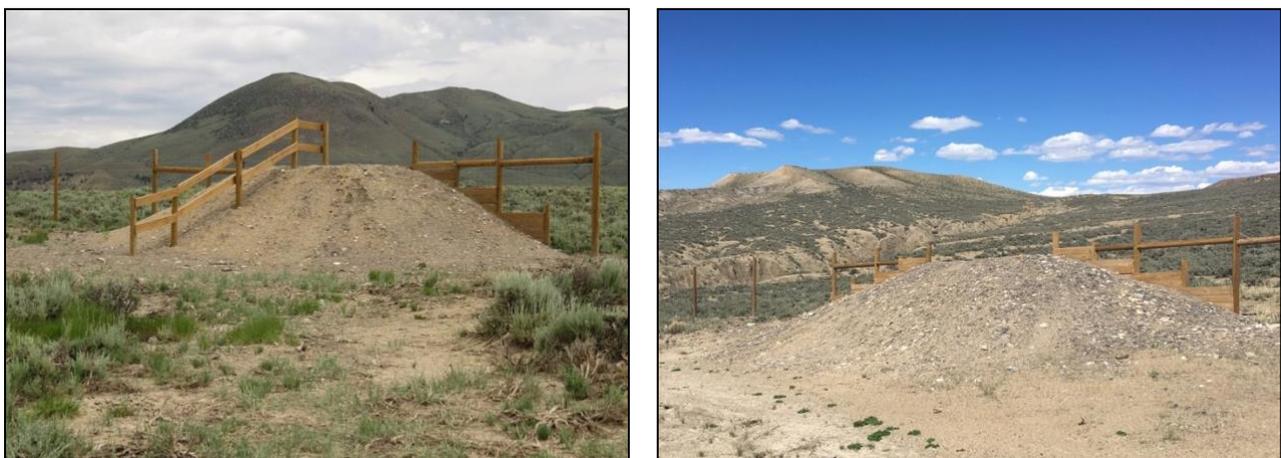
Figure 30. Example of an escape ramp with a 2:1 slope with perpendicular rail fence (left) and a ramp with a 3:1 slope with no rail fence (right).

wildlife at the top of the ramp, including successful jump downs as well as jump up attempts from the habitat side onto the ramp. Through Year 3, 13 escape ramps have been monitored for varying lengths of time. In the Phase 1 (north) segment, all ramps were constructed with a 2:1 slope and perpendicular rail fence, except for the North Overpass Escape Ramp, on which rail fence was not constructed. Based on preliminary observations and recommendations by the research team, during Phase 2 construction all ramps were constructed with a 3:1 slope instead of a 2:1 slope (Fig. 24). In general, ramps were constructed with perpendicular rail fence, except for select locations where rail fence was omitted per the request of the researchers, who wanted to evaluate the effectiveness of ramps with and without perpendicular rail fence. In addition, two new 3:1 slope escape ramps were constructed in the Phase 1 segment near existing 2:1 slope ramps. These two ramps are also situated at lower topographic positions relative to the roadway, while the 2:1 slope ramps are at higher topographic positions above the roadway. All of the ramps built in both construction phases are six feet high at the jumping off point, with a 16' wide fence gap.
