**Report No. CDOT-DTD-R-95-14**

# **A Documentation of Hot Mix Asphalt Overlays on I-25 in 1994**

**Colorado Department of Transportation  
4201 E. Arkansas Avenue  
Denver, Colorado 80222**

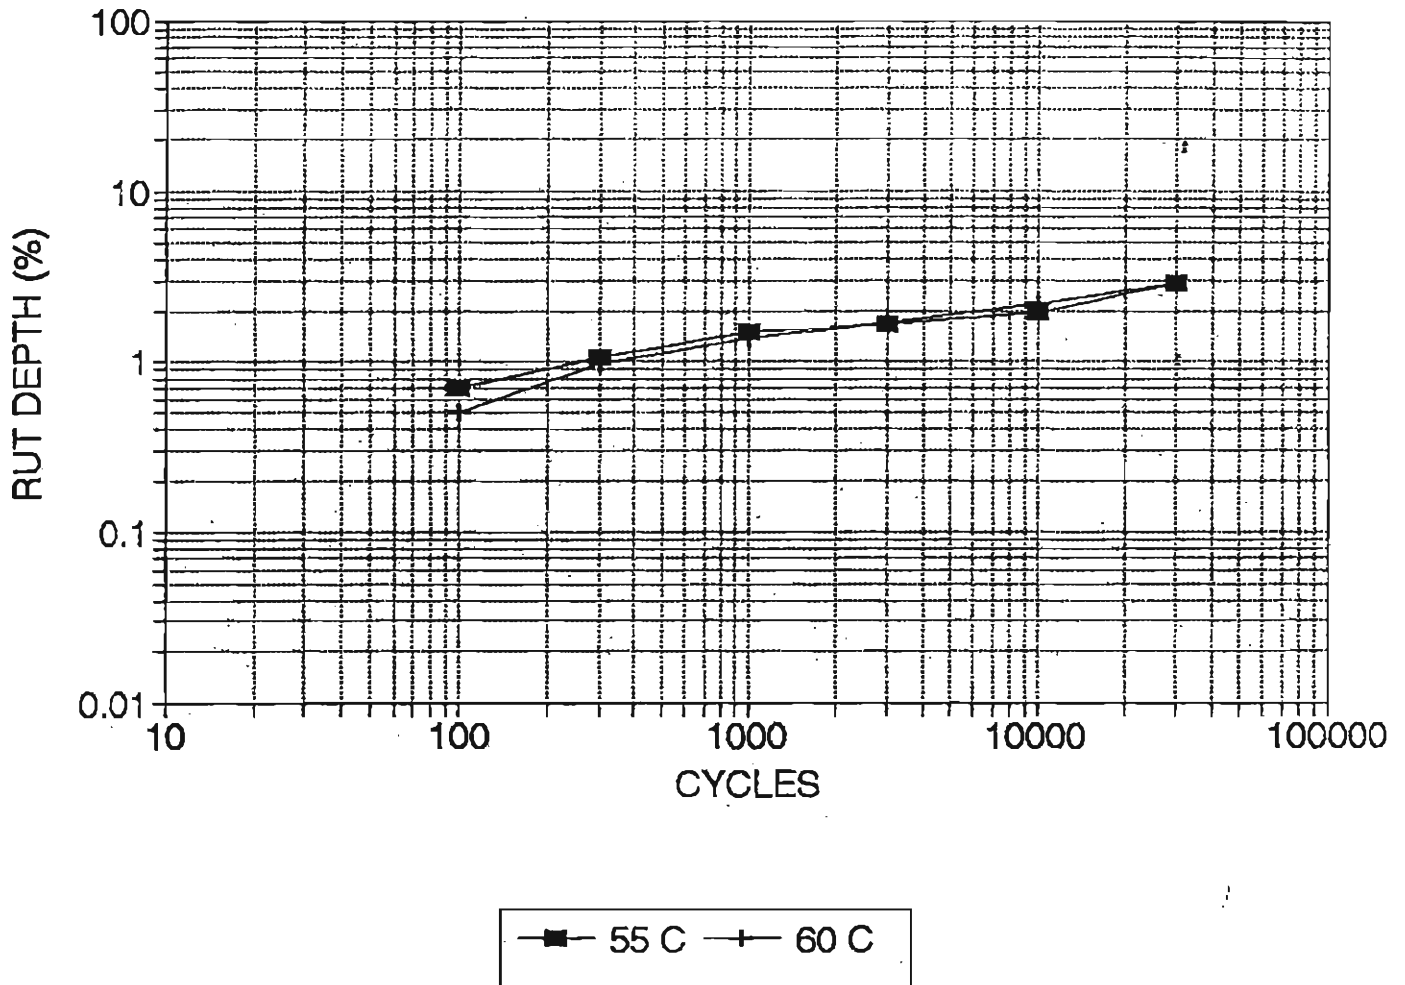
Temperature = 55°C  
Slope = 0.225  
Intercept = 1.303

Temperature = 60°C  
Slope = 0.283  
Intercept = 1.188

Figure 1. Results from the French Rutting Tester for the New Mexico Project

The results from the French rutting tester are shown in Figure 1 for the top lift. A passing result is less than 10%. The HMA passed at both the 55°C (131°F) and 60°C (140°F) test temperatures with a rutting depth of 2.9% at both temperatures. The test results indicate the HMA should be rut resistant.

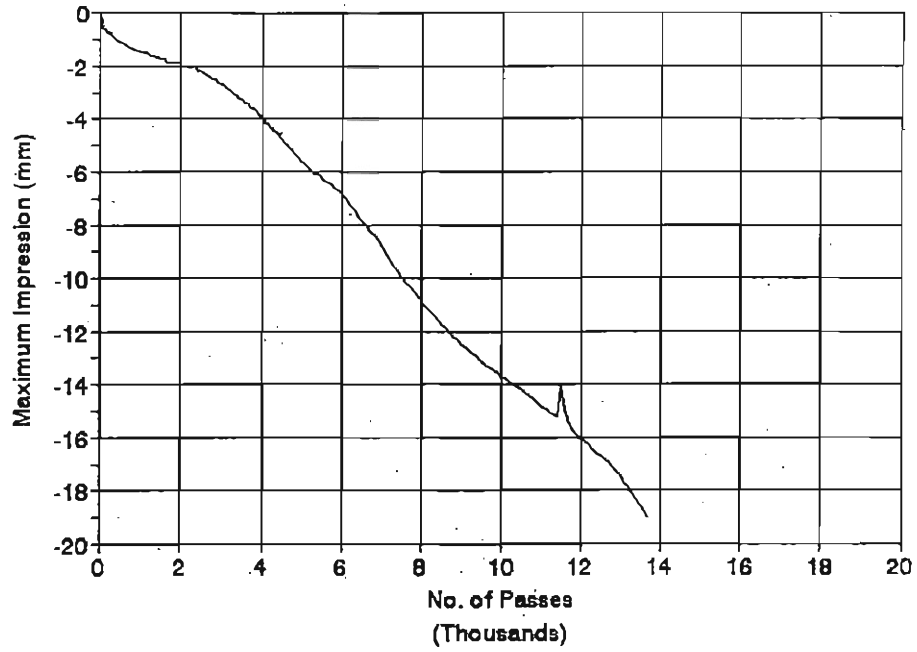
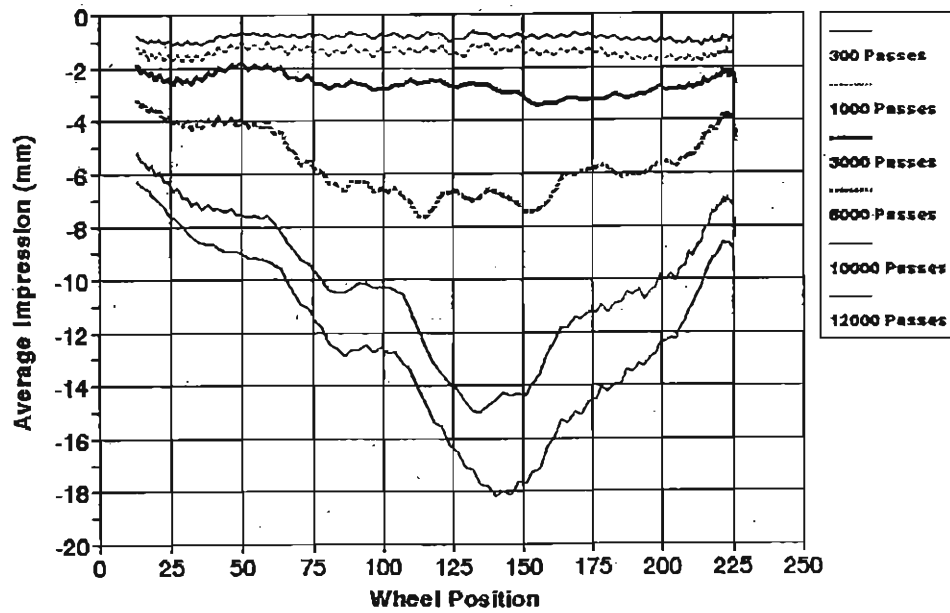
I-25, New Mexico S.L.  
Temperature = 45 C

Profiles  
Temperature = 45 C

Figure 2. Results from the Hamburg Wheel-Tracking Device for the New Mexico Project

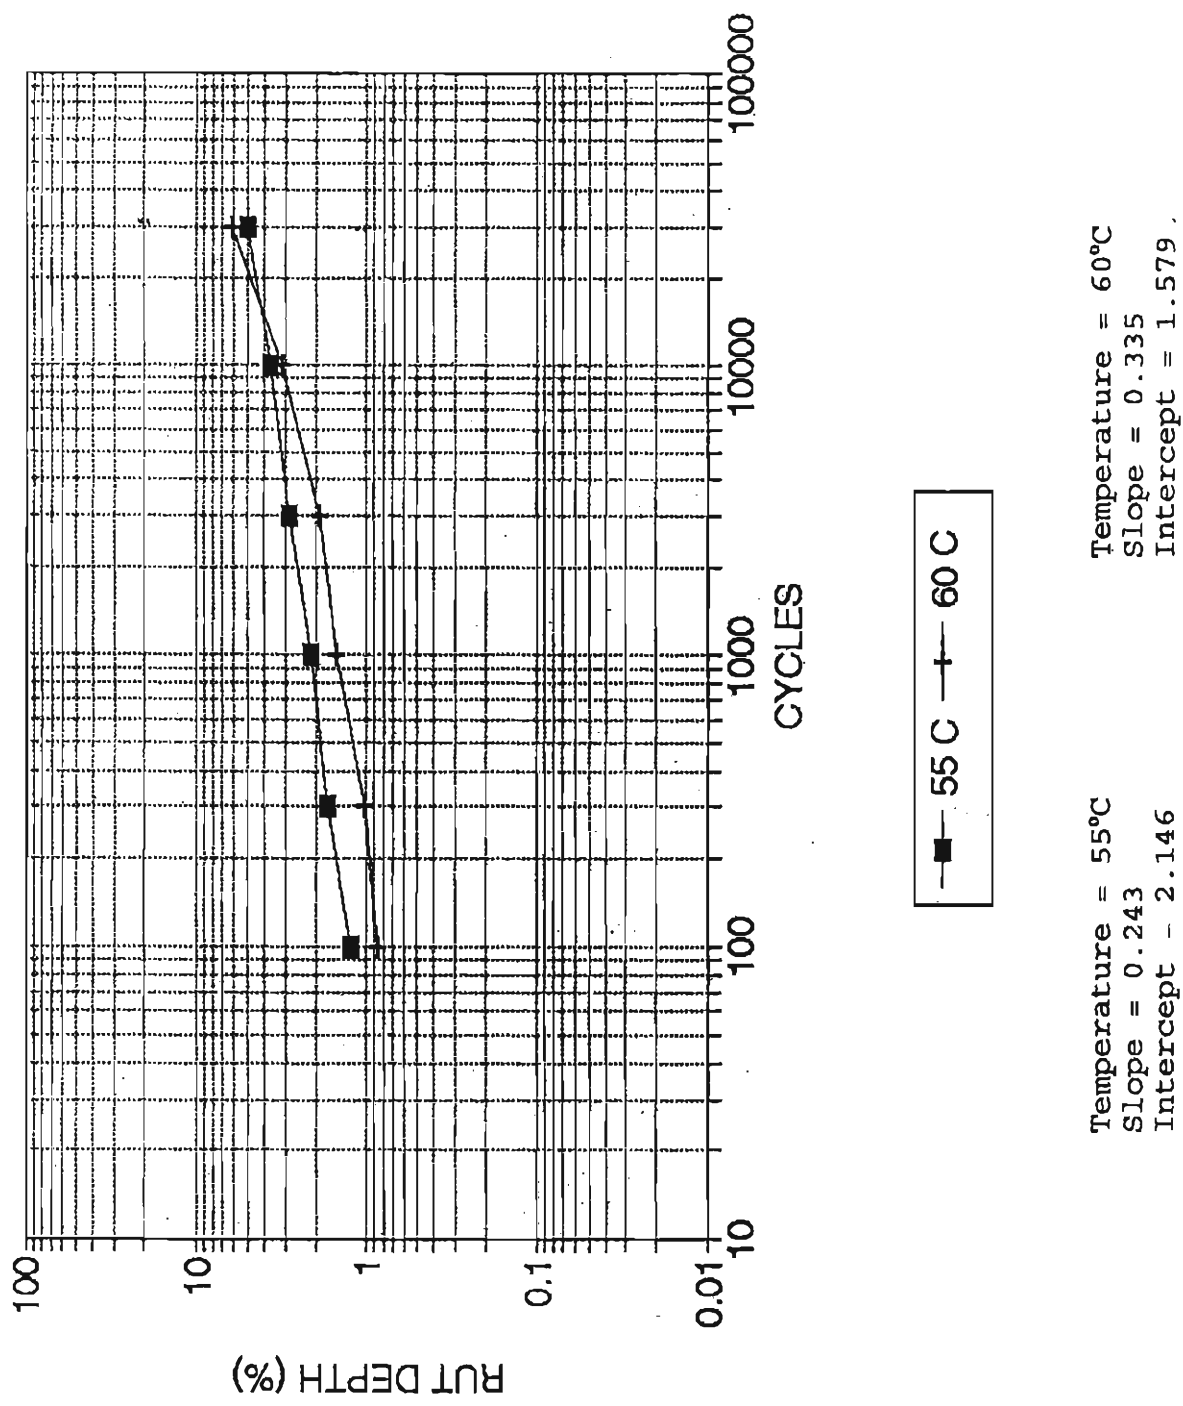
Figure 3. Results from the French Rutting Tester for the Trinidad Project

The results from the French rutting tester are shown in Figure 3. The HMA passed at both the 55°C (131°F) and 60°C (140°F) test temperatures with a rutting depth of 5.0% and 6.2%, respectively. The test results indicate the HMA should be rut resistant.

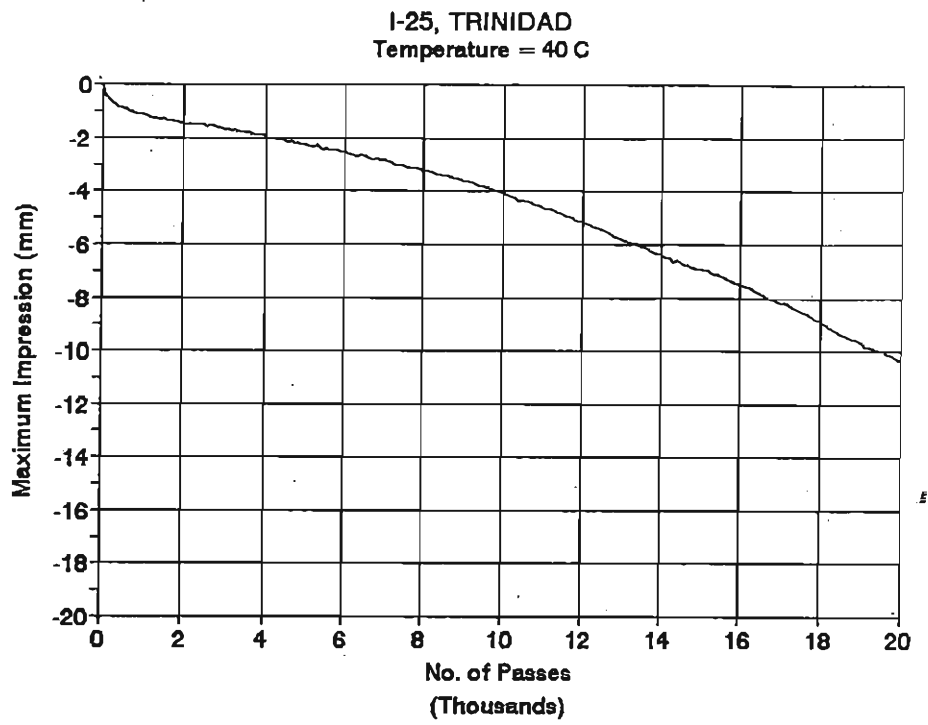
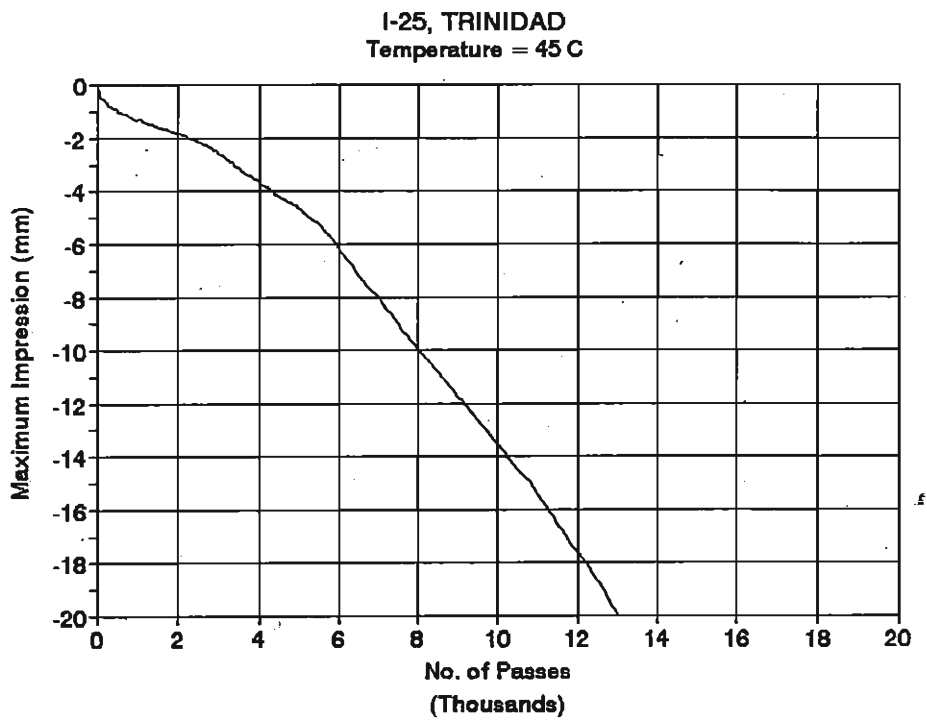
**Figure 4. Results from the Hamburg Wheel-Tracking Device for the Trinidad Project**

The results from the Hamburg wheel-tracking device are shown in Figure 4. The HMA failed at the 45°C (113°F) test temperature, and did not even make 20,000 passes. The stripping inflection point occurred at 4000 passes. The test results indicate that there may be moisture problems with the HMA. The Tortorice pit does have a history of providing moisture susceptible aggregates.

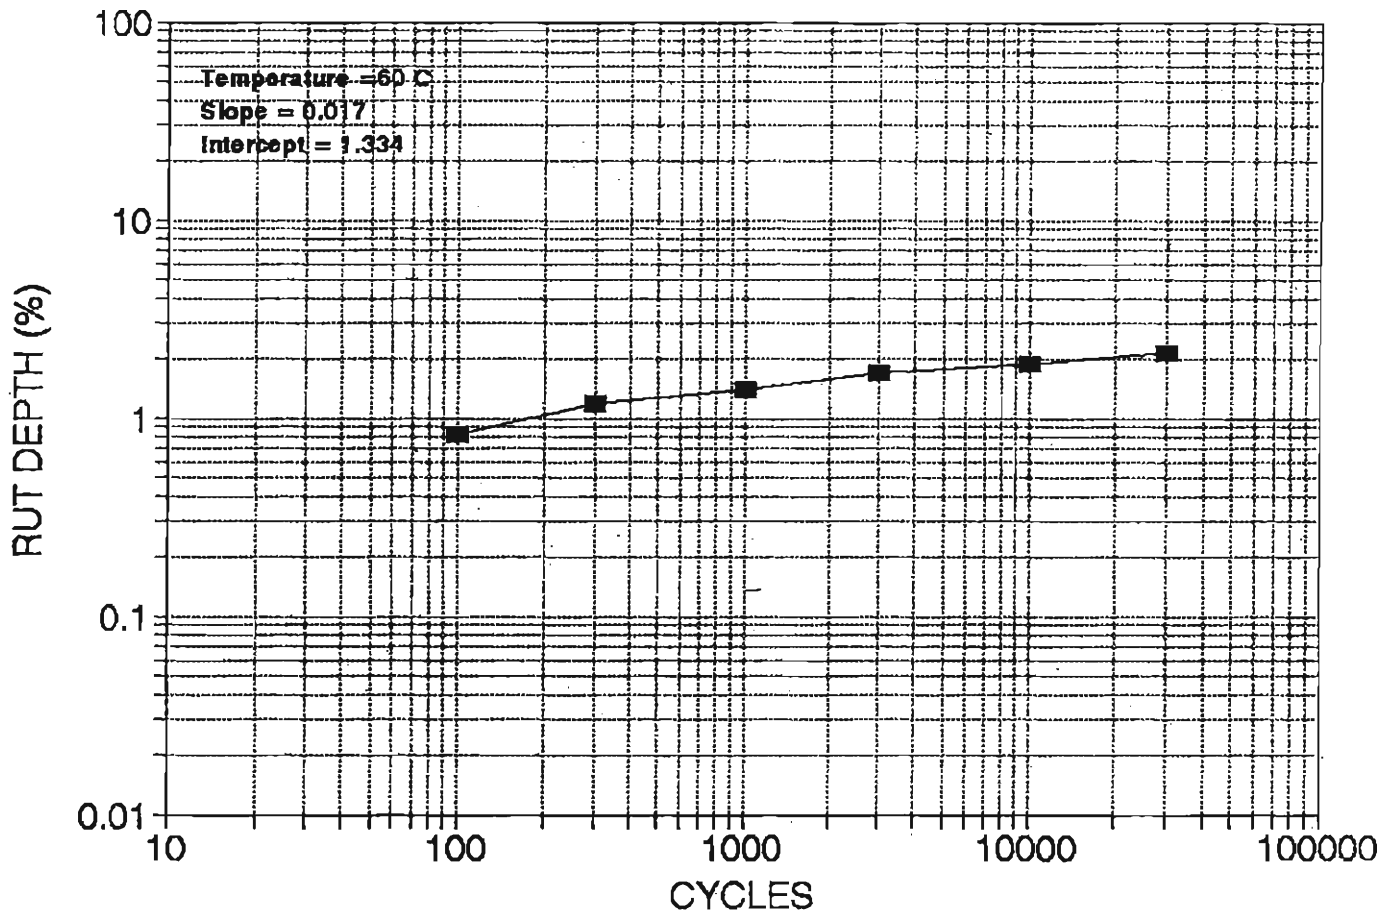
Figure 5. Results from the French Rutting Tester for the Walsenburg Project

The results from the French rutting tester are shown in Figure 5. The Grading CX passed at the 60°C (140°F) test temperatures with a rutting depth of 2.1%. The test results indicate the HMA should be resistant to rutting.

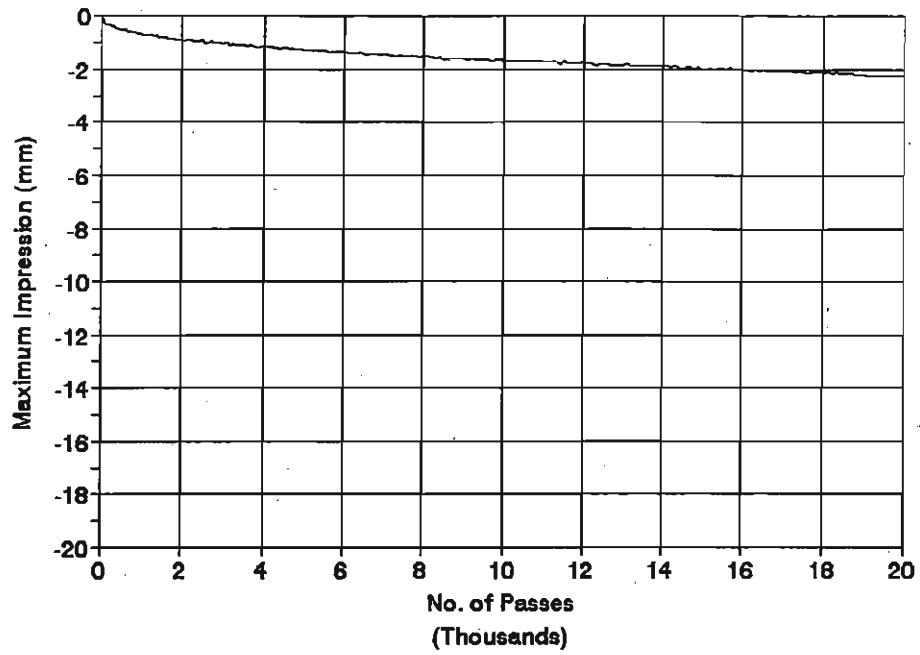
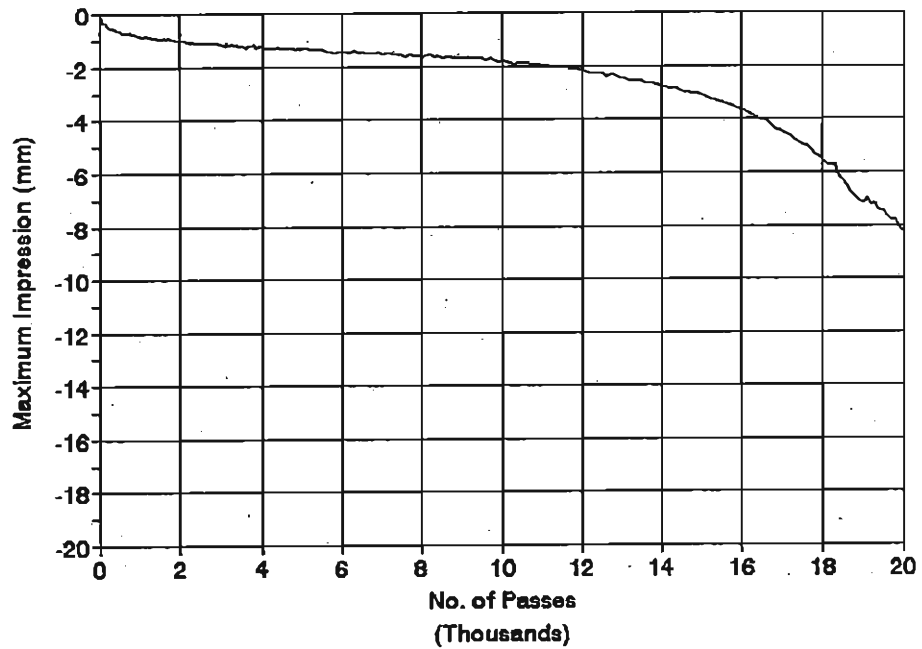
I-25, WALSENBURG  
Temperature = 50 C

I-25, WALSENBURG  
Temperature = 55 C

Figure 6. Results from the Hamburg Wheel-Tracking Device for the Walsenburg Project

The results from the Hamburg wheel-tracking device are shown in Figure 6. The Grading CX HMA was tested at the 50°C (122°F) and 55°C (131°F) test temperature and had a 2 mm and 8 mm rut depth, respectively. The test results indicate that the HMAs should be resistant to moisture damage.

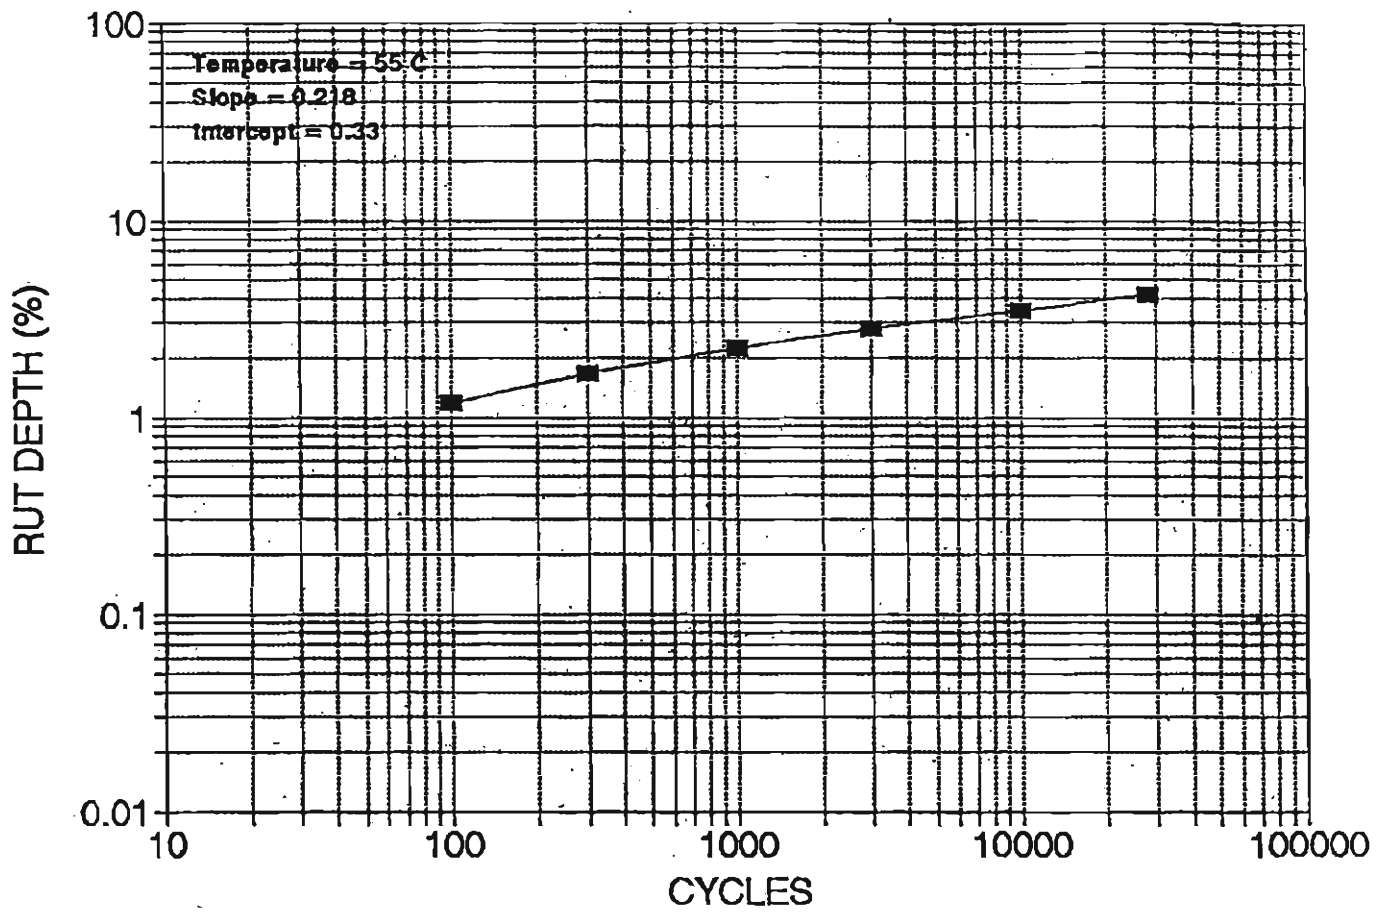
Figure 7. Results from the French Rutting Tester (Grading C) for the Colorado City Project

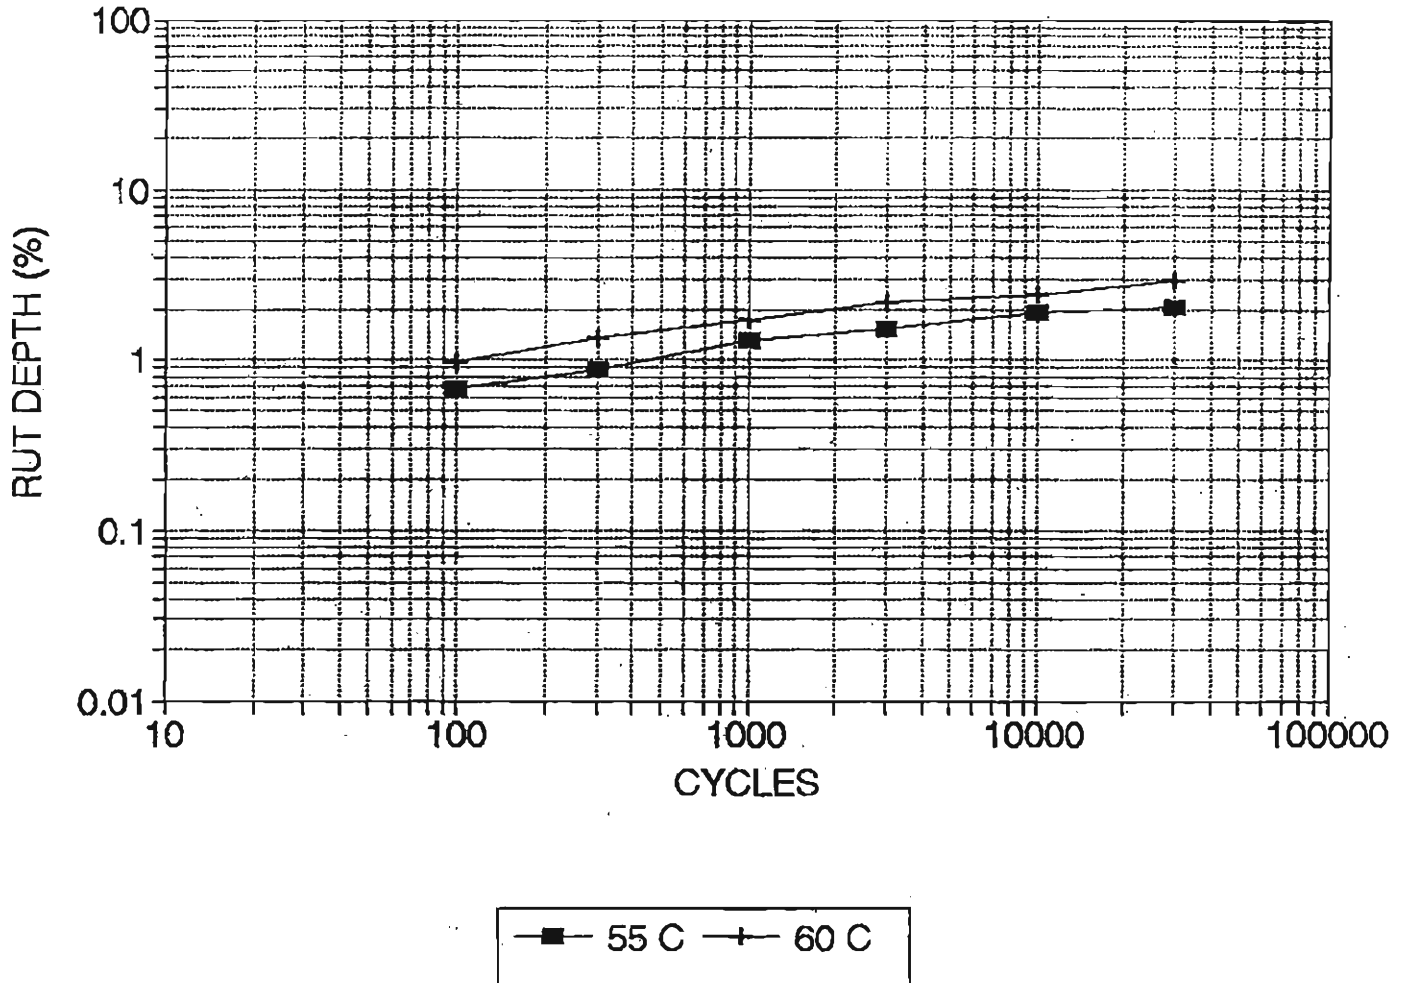
Temperature = 55°C  
Slope = 0.197  
Intercept = 1.157

Temperature = 60°C  
Slope = 0.186  
Intercept = 1.612

Figure 8. Results from the French Rutting Tester (Grading CX) for the Colorado City Project

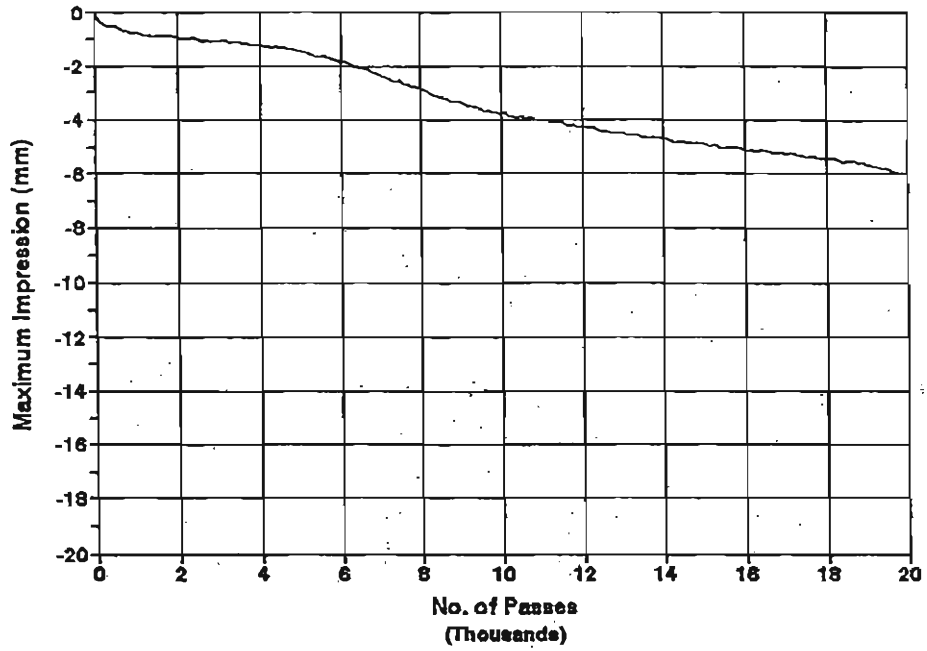
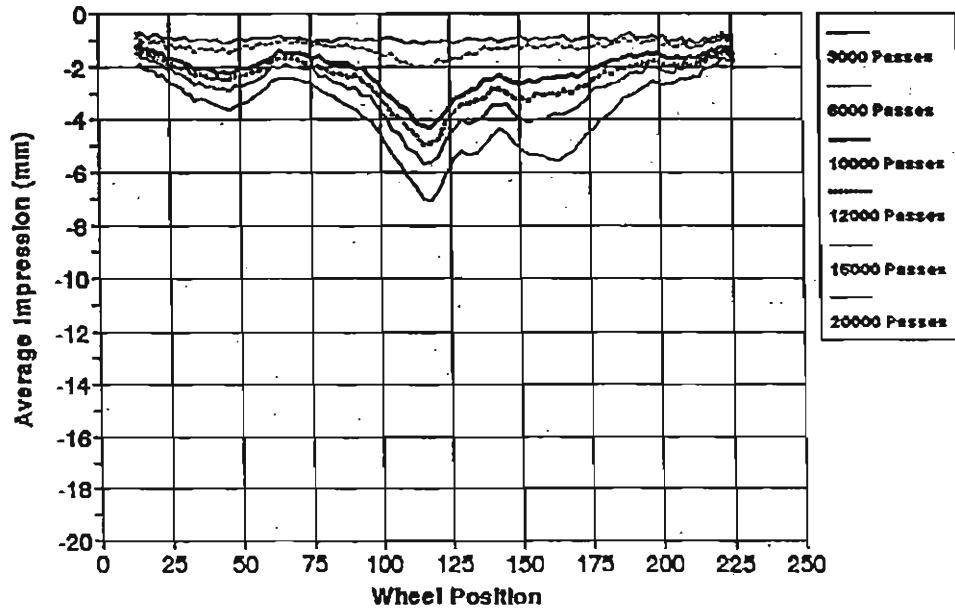
I25-COLORADO CITY  
Temp. 45 C

Figure 9. Results from the Hamburg Wheel-Tracking Device (Grading C) for the Colorado City Project

The results from the Hamburg wheel-tracking device are shown in Figures 9 and 10. The Grading C HMA had a rut depth of 6 mm at the 45°C (113°F) test temperature. The Grading CX HMA was tested at the 50°C (122°F) test temperature and had an 11 mm rut depth. The test results indicate that the HMAs should be resistant to moisture damage.

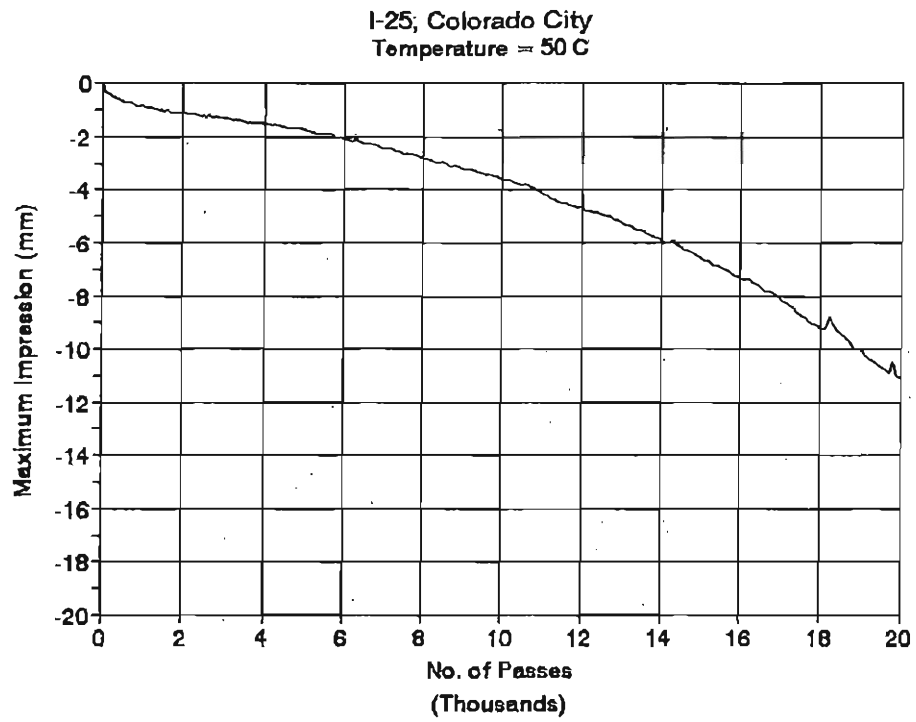
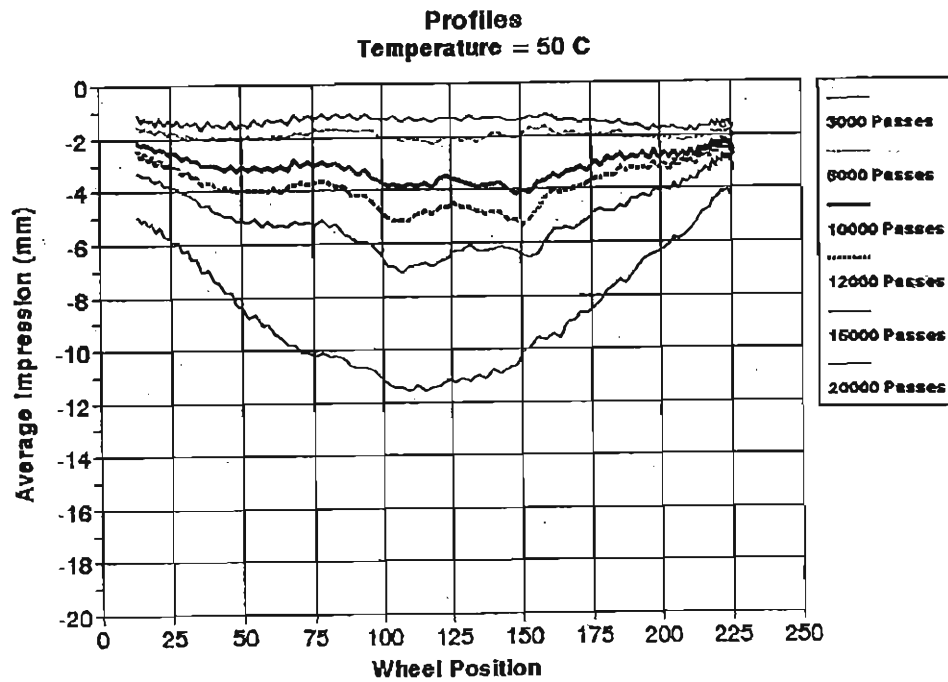
**Figure 10. Results from the Hamburg Wheel-Tracking Device (Grading CX) for the Colorado City Project**

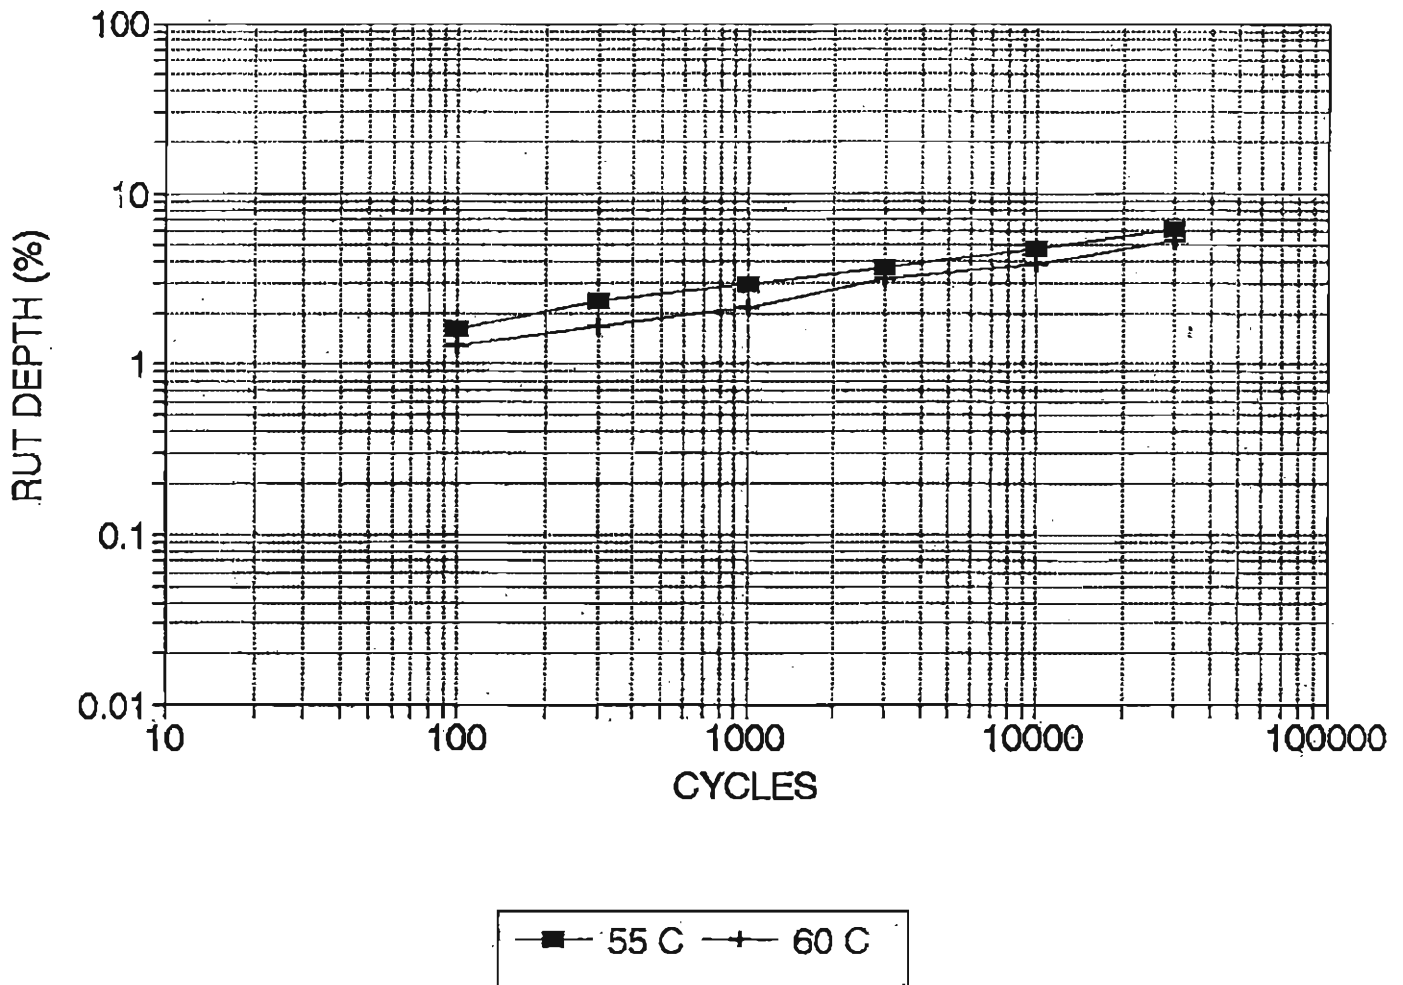
Temperature = 55°C  
Slope = 0.250  
Intercept = 2.232

Temperature = 60°C  
Slope = 0.226  
Intercept = 2.869

Figure 11. Results from the French Rutting Tester for the Colorado Springs Project

The results from the French rutting tester are shown in Figure 11. The Grading CX HMA passed at both the 55°C (131°F) and 60°C (140°F) test temperatures with a rutting depth of 5.3% and 6.2%, respectively. The test results indicate the HMAs should be resistant to rutting.

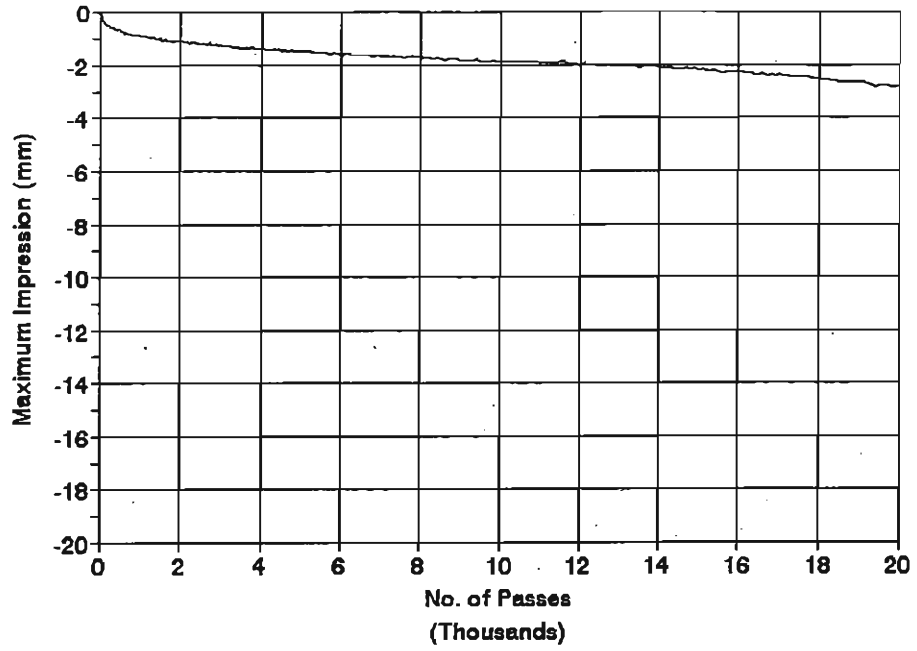
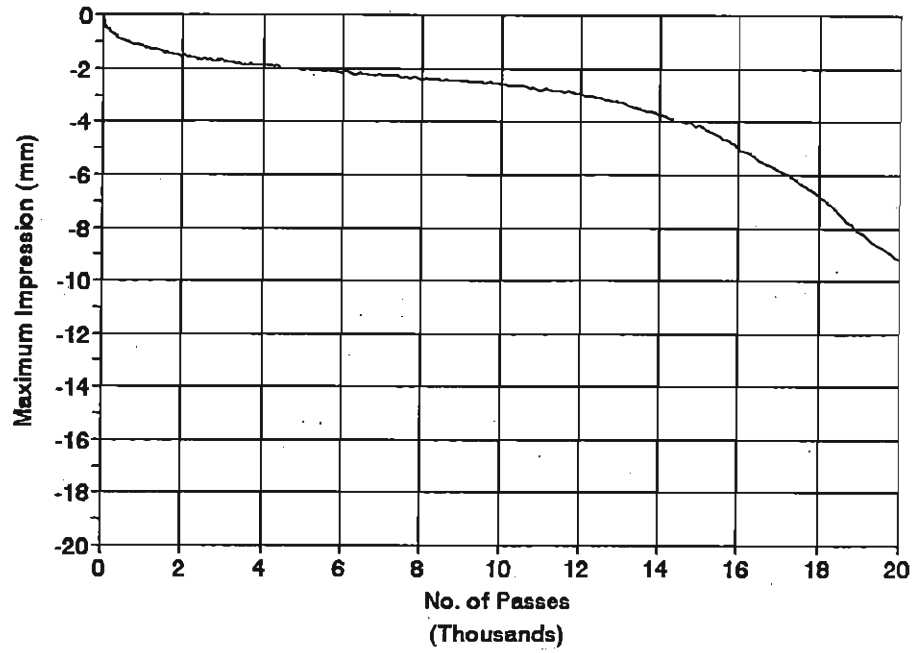
I-25, COLORADO SPRINGS  
Temperature = 40 C

I-25, COLORADO SPRINGS  
Temperature = 45 C

Figure 12. Results from the Hamburg Wheel-Tracking Device for the Colorado Springs Project

The results from the Hamburg wheel-tracking device are shown in Figure 12. The Grading CX HMA had a rut depth of 2.8 mm at the 40°C (104°F) test temperature and at the 45°C (113°F) test temperature had an 9.2 mm rut depth. The test results indicate that the HMAs should be resistant to moisture damage.

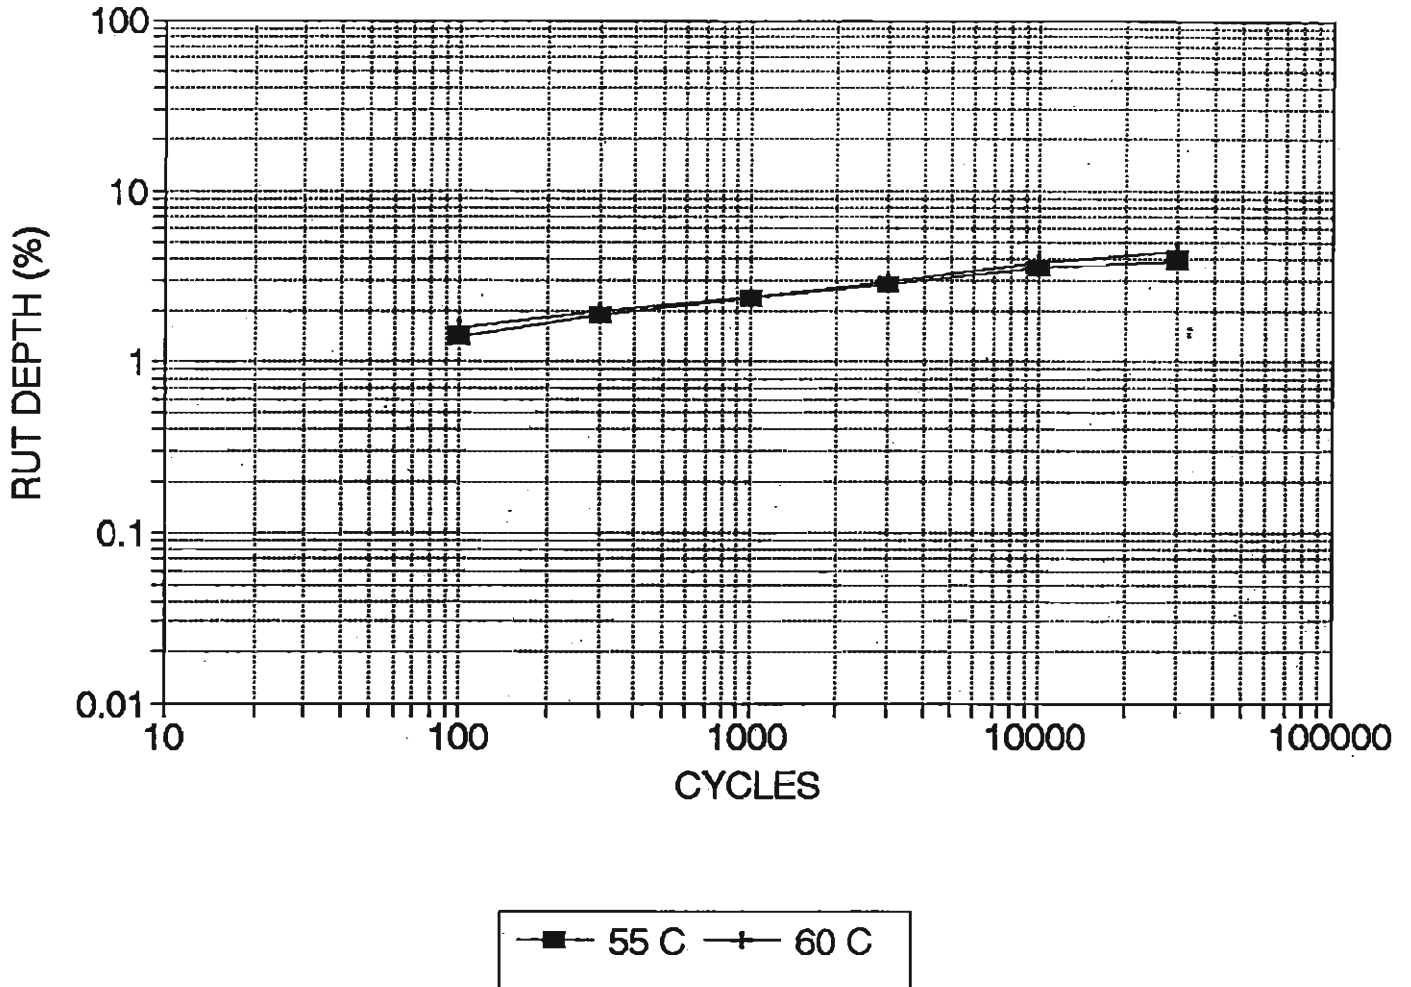
Temperature = 55°C  
Slope = 0.179  
Intercept = 2.244

Temperature = 60°C  
Slope = 0.182  
Intercept = 2.426

Figure 13. Results from the French Rutting Tester for the Air Force Academy Project

The results from the French rutting tester are shown in Figure 13. The Grading C HMA passed at both the 55°C (131°F) and 60°C (140°F) test temperatures with a rutting depth of 3.9% and 4.5%, respectively. The test results indicate the HMA should be resistant to rutting.

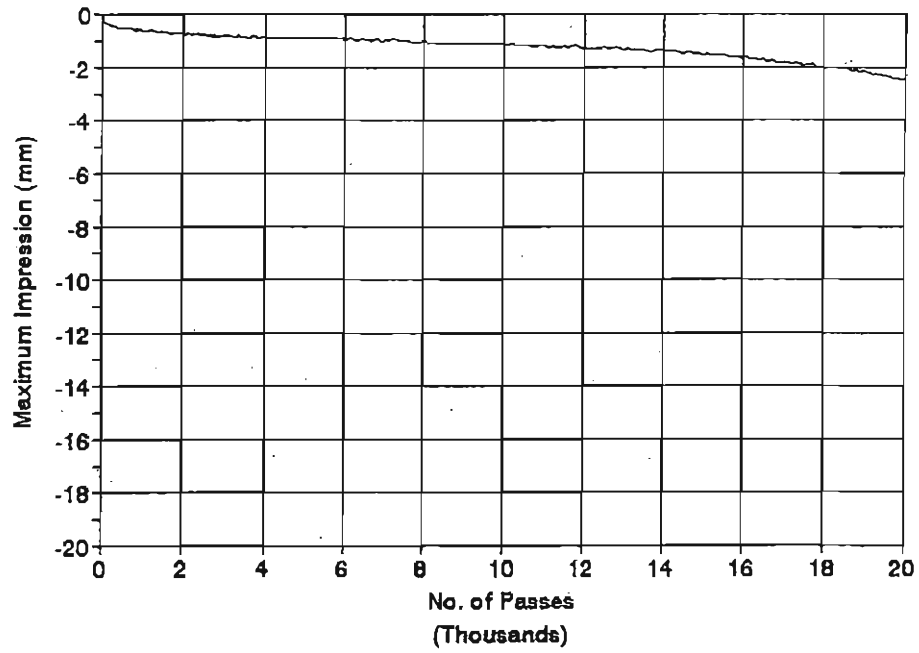
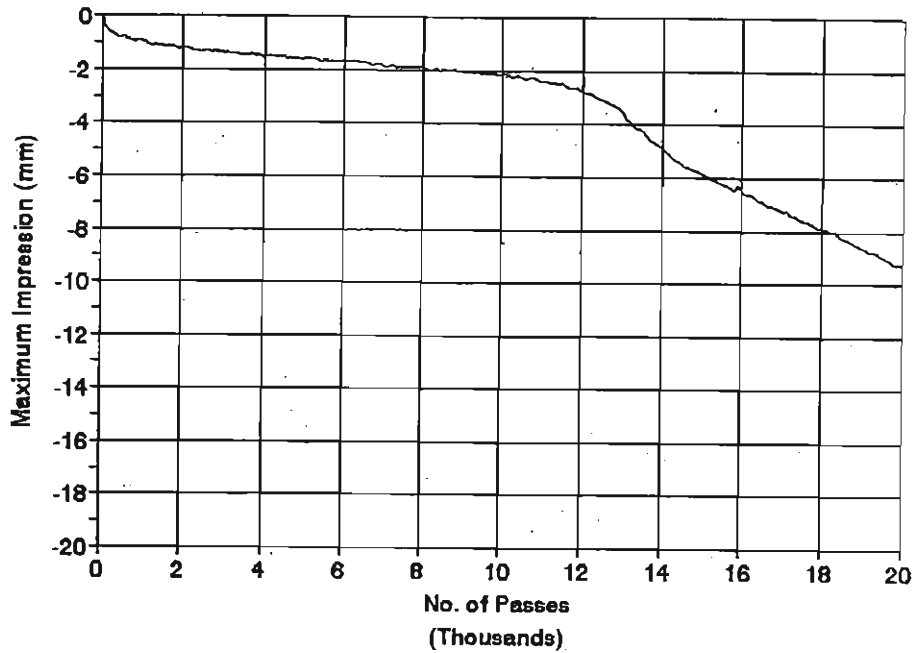
I-25 @ AFA  
Temperature = 45 C

I-25 @ AFA  
Temperature = 50 C

Figure 14. Results from the Hamburg Wheel-Tracking Device for the Air Force Academy Project

The results from the Hamburg wheel-tracking device are shown in Figure 14. The Grading C HMA had a rut depth of 2.4 mm at the 45°C (113°F) test temperature and at the 50°C (122°F) test temperature had an 9.3 mm rut depth. The test results indicate that the HMA should be resistant to moisture damage.

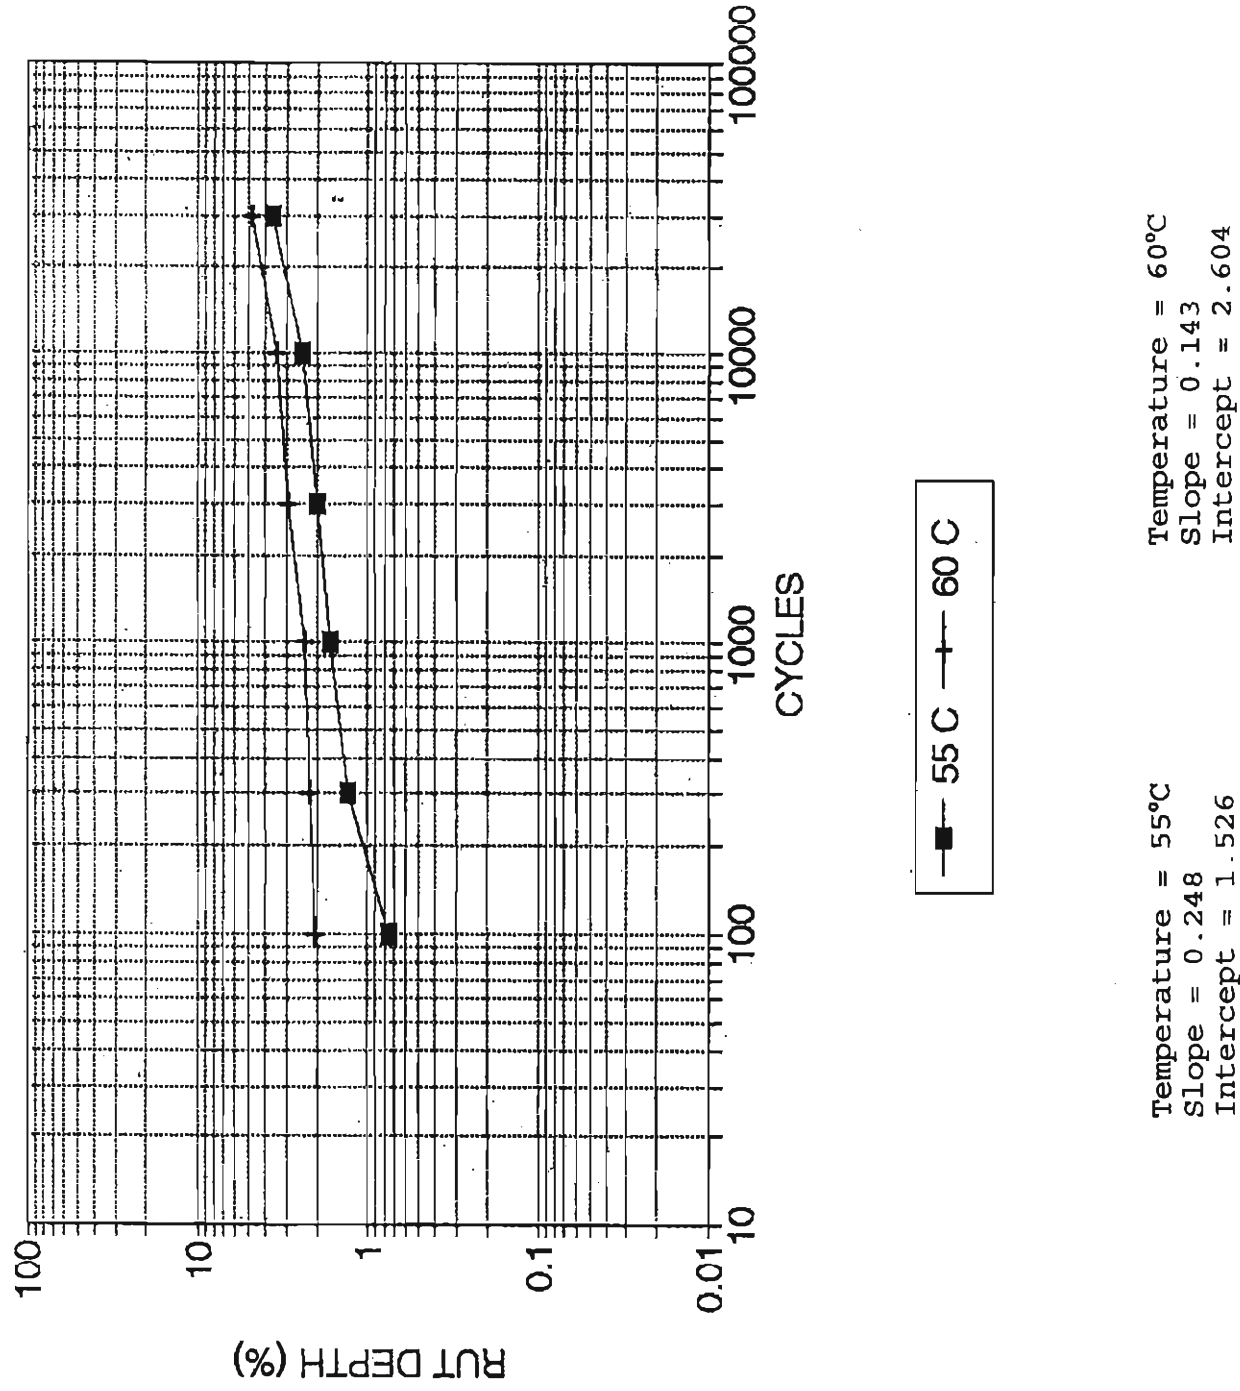
Figure 15. Results from the French Rutting Tester for the Monument Project

The results from the French rutting tester are shown in Figure 15. The Grading C HMA passed at both the 55°C (131°F) and 60°C (140°F) test temperatures with a rutting depth of 3.6% and 4.8%, respectively. The test results indicate the HMAs should be resistant to rutting.

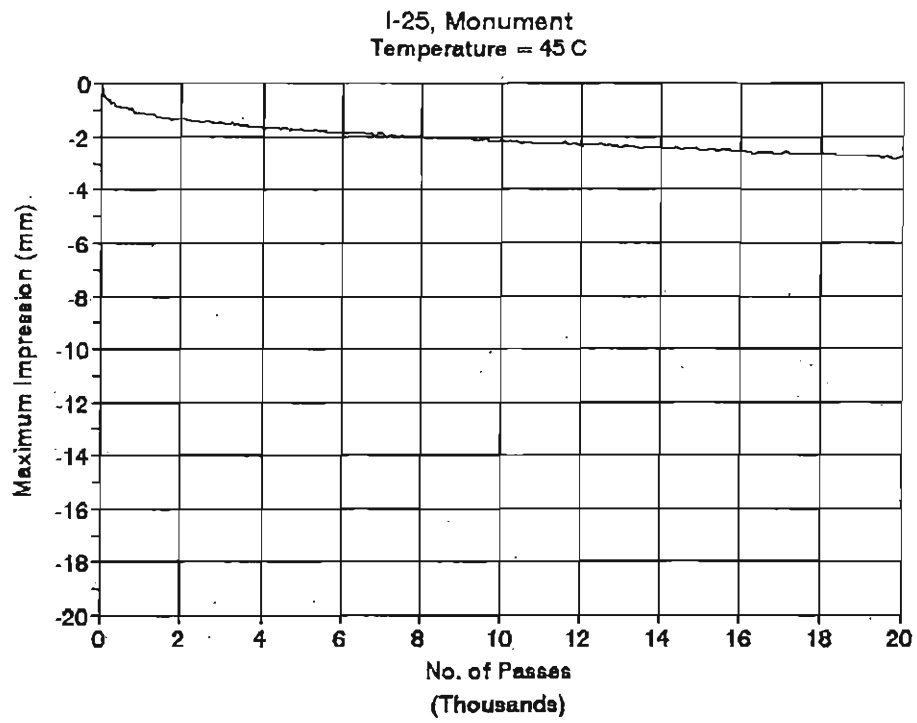
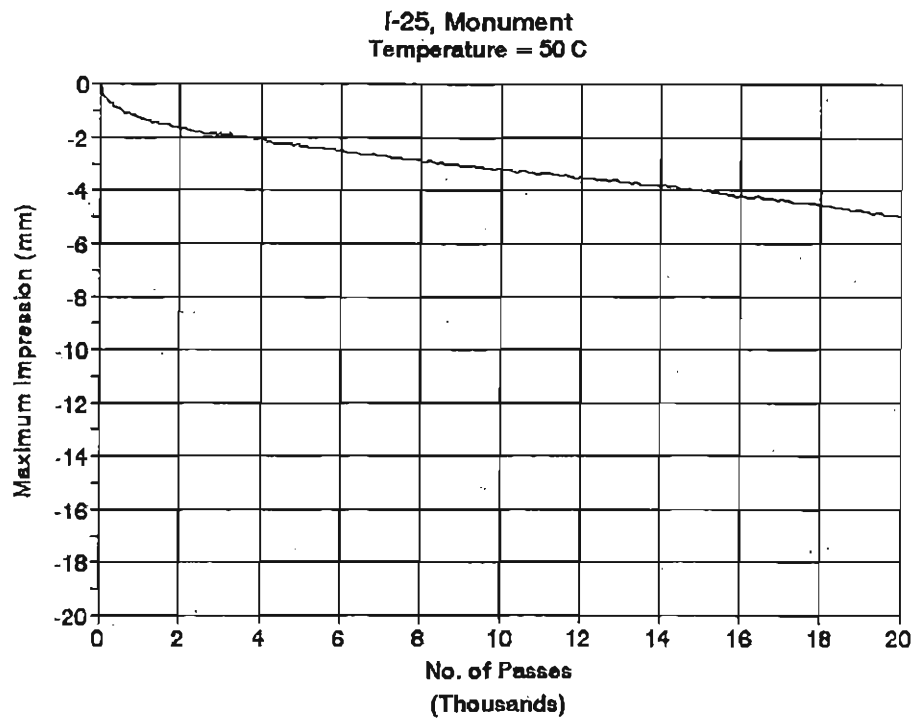
Figure 16. Results from the Hamburg Wheel-Tracking Device for the Monument Project

The results from the Hamburg wheel-tracking device are shown in Figure 16. The Grading C HMA had a rut depth of 2.8 mm at the 45°C (113°F) test temperature and at the 50°C (122°F) test temperature had an 5.0 mm rut depth. The test results indicate that the HMA should be resistant to moisture damage.
