**Report No. CDOT-DTD-R-95-14**

# **A Documentation of Hot Mix Asphalt Overlays on I-25 in 1994**

**Colorado Department of Transportation  
4201 E. Arkansas Avenue  
Denver, Colorado 80222**

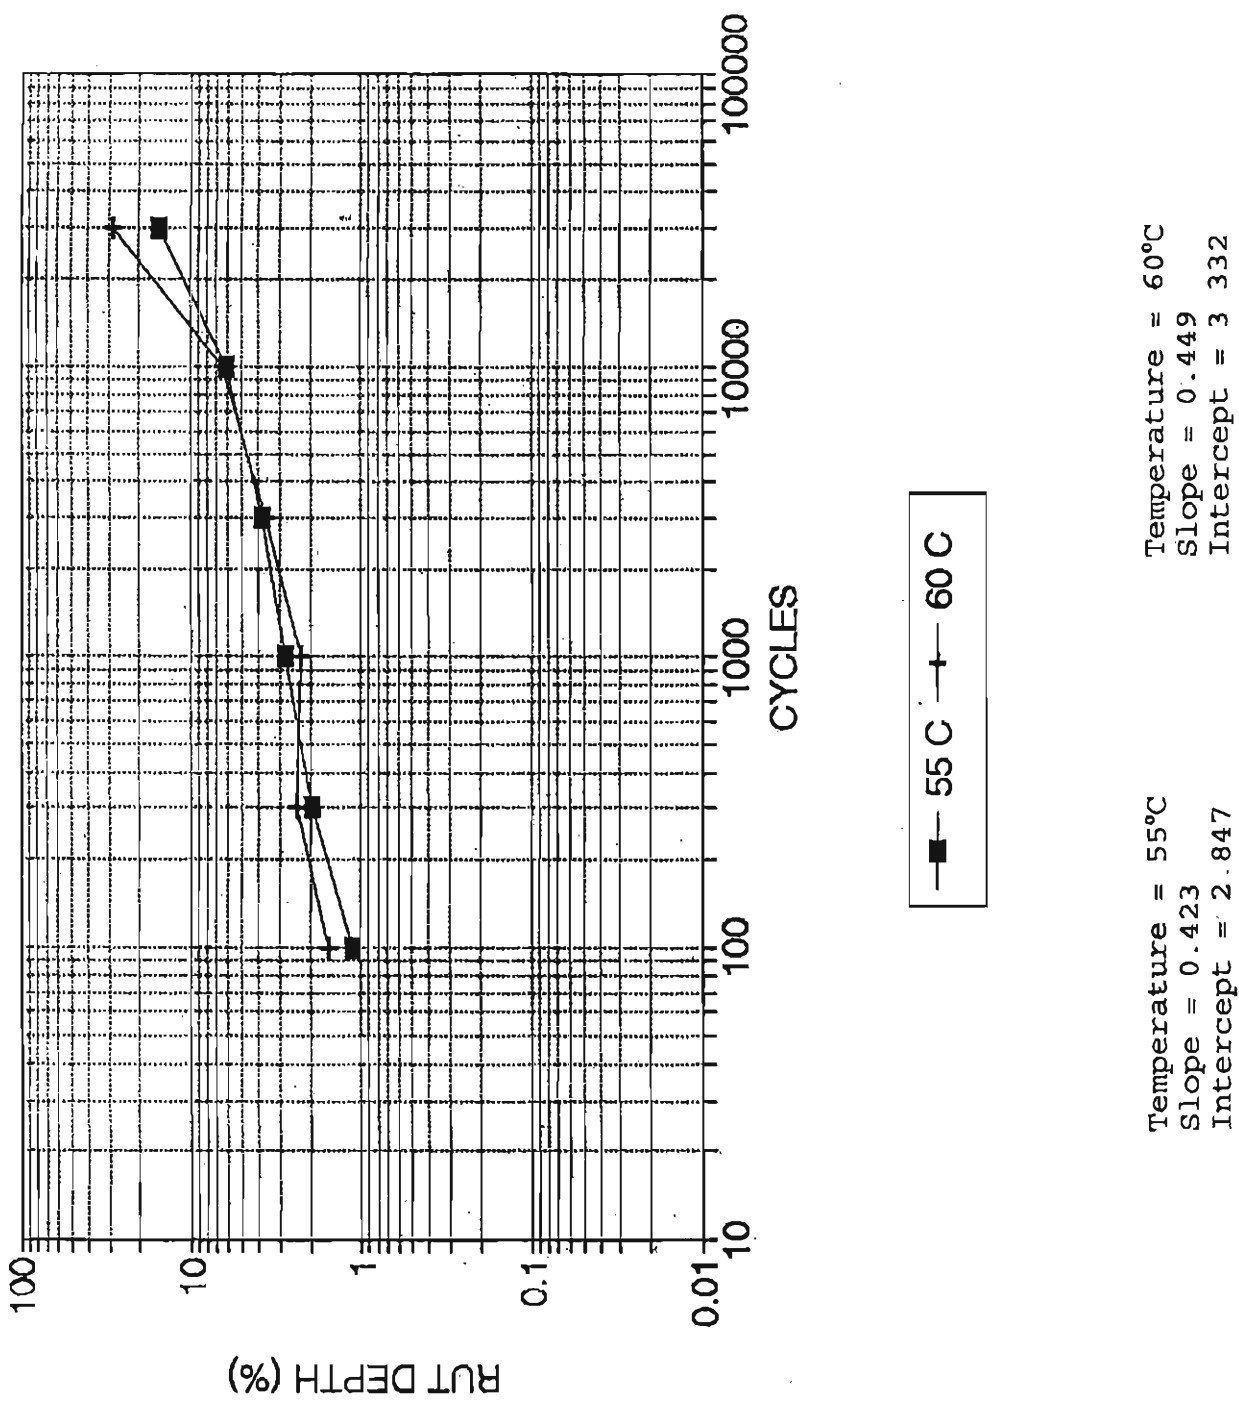
Figure 17. Results from the French Rutting Tester for the Denver Project

The results from the French rutting tester are shown in Figure 17. The HMA failed at both the 55°C (131°F) and 60°C (140°F) test temperatures with a rutting depth of 15.5% and 28.5%, respectively. These test results indicate that there may be problems with a rutting pavement in the future.

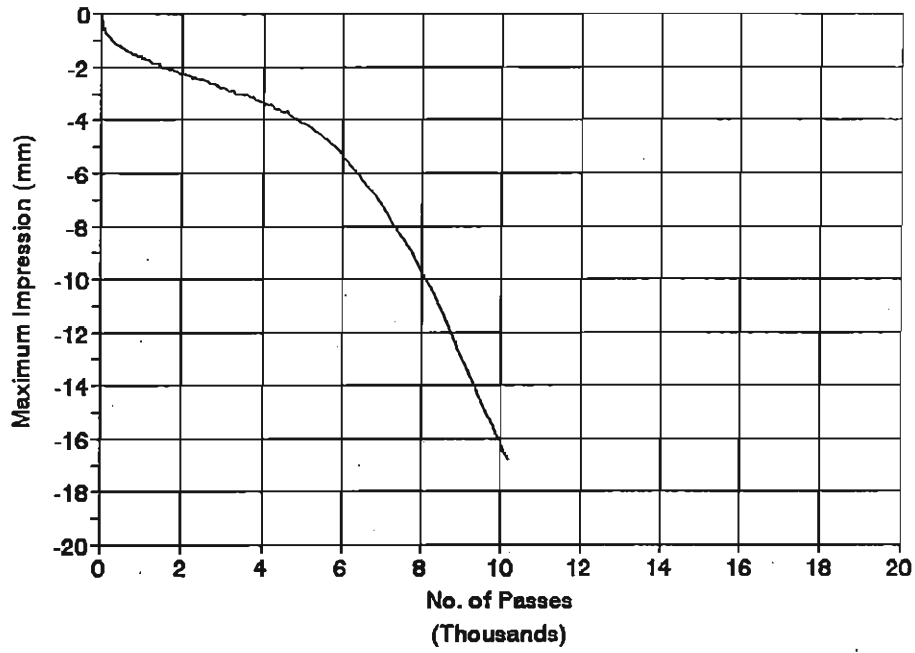
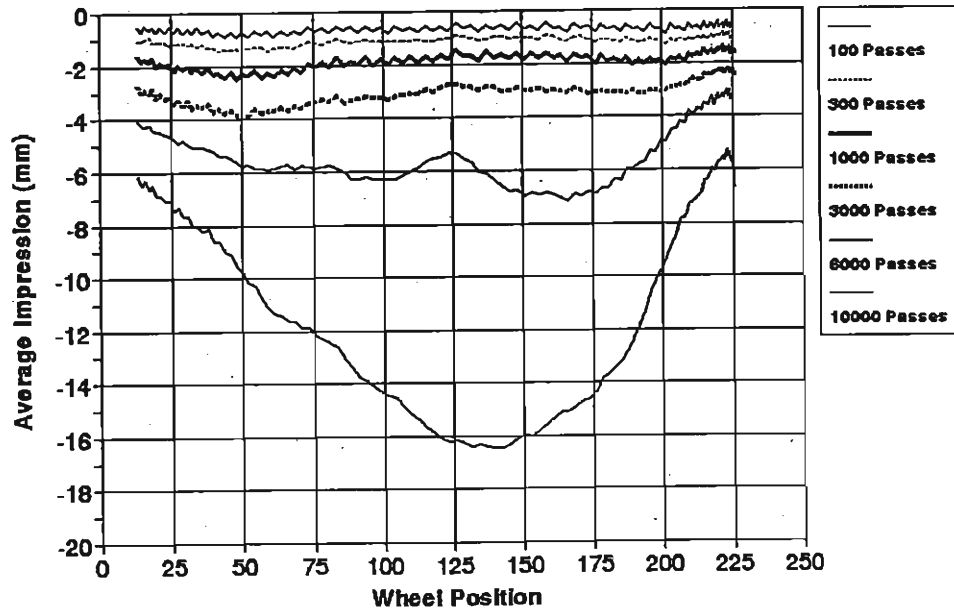
I-25, Denver  
 Temperature = 45 C

Figure 18. Results from the Hamburg Wheel-Tracking Device for the Denver Project

The results from the Hamburg wheel-tracking device are shown in Figure 17. The HMA failed at both the 40°C (104°F) and 45°C (113°F) test temperature. The stripping inflection point occurred at 5300 passes for the sample tested at 45°C.

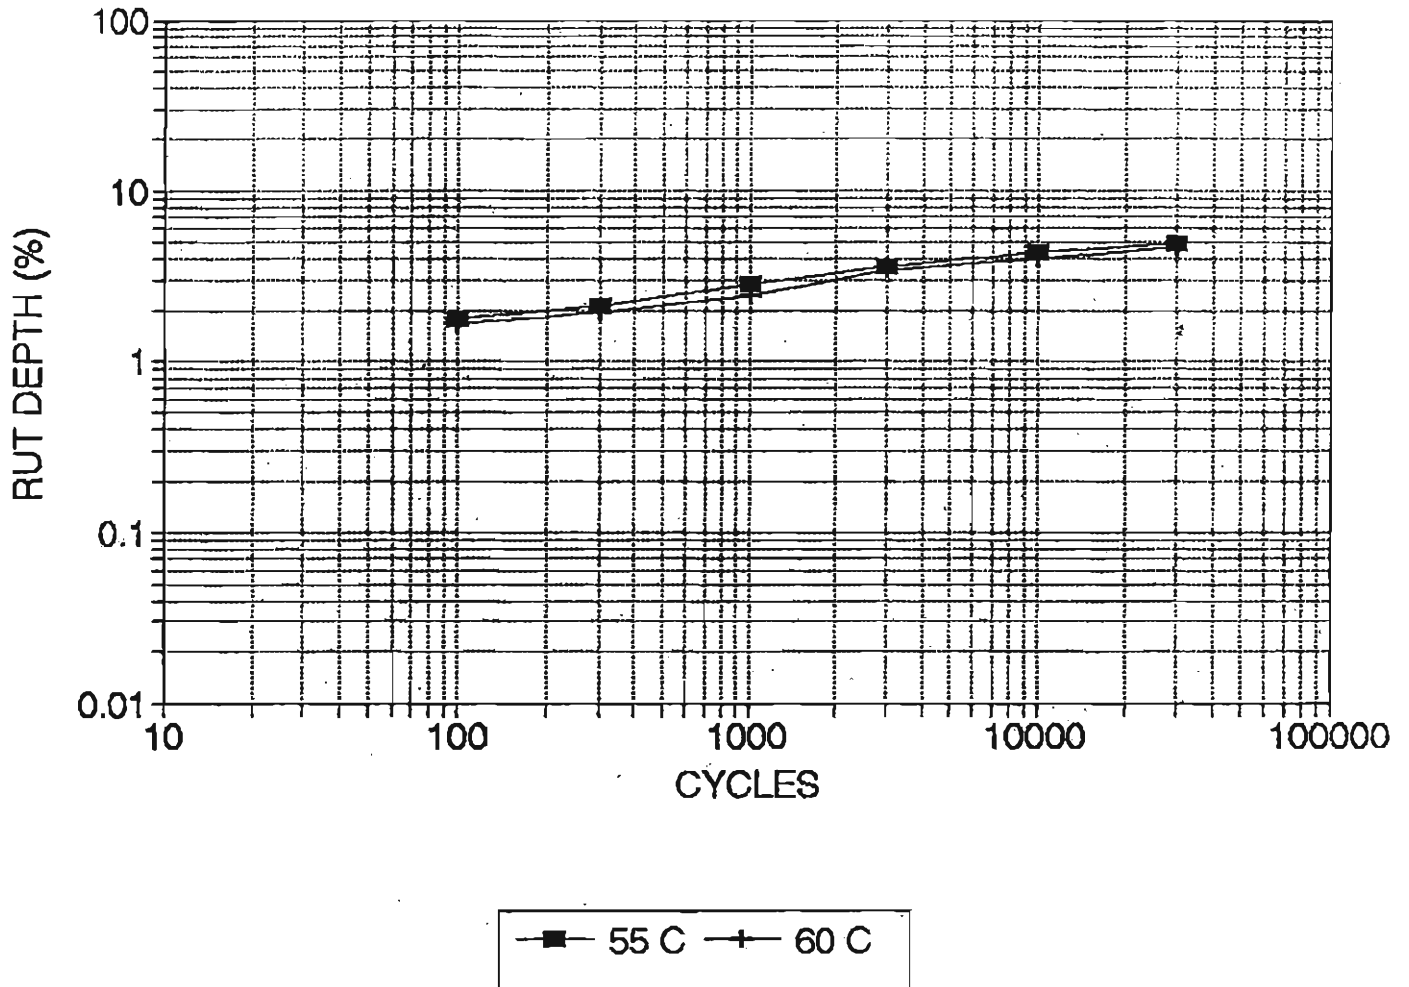
Temperature = 55°C  
Slope = 0.186  
Intercept = 2.767

Temperature = 60°C  
Slope = 0.193  
Intercept = 2.512

Figure 19. Results from the French Rutting Tester for the Longmont Project

The results from the French rutting tester are shown in Figure 19. The HMA passed at both the 55°C (131°F) and 60°C (140°F) test temperatures with a rutting depth of 4.9% and 4.6%, respectively. These test results indicate the HMA should be resistant to rutting.

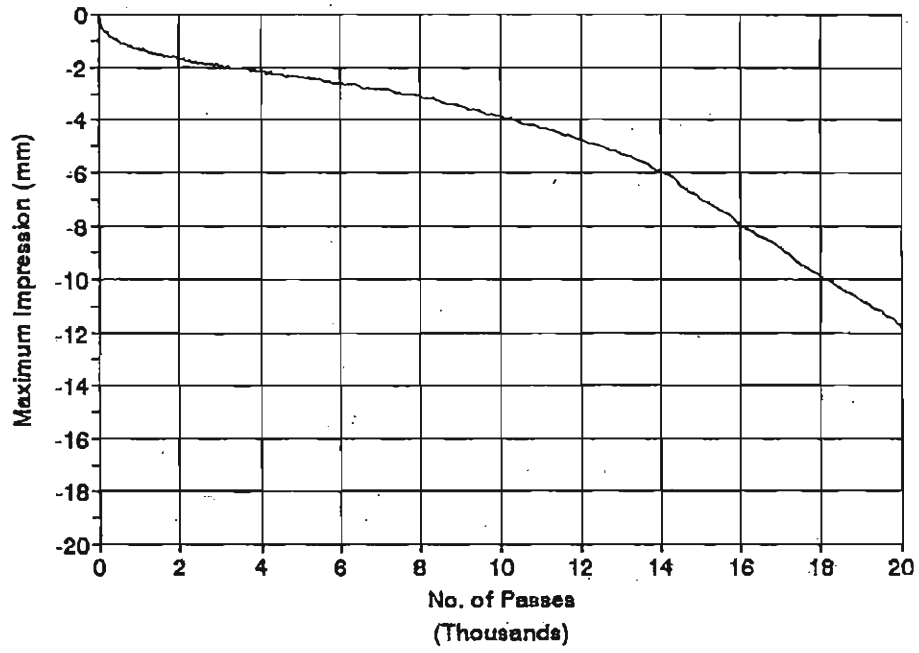
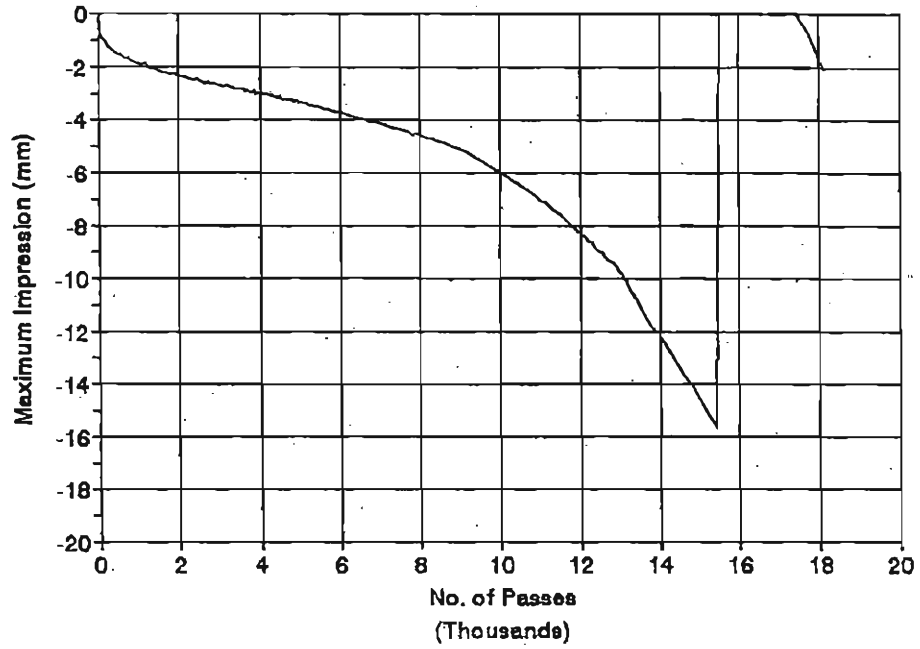
I-25, BRANNAN #5  
Temperature = 45 C

I-25, BRANNAN #5  
Temperature = 50 C

Figure 20. Results from the Hamburg Wheel-Tracking Device for the Longmont Project

specification would provide the contractor with a 5% incentive if the material produced for the project passed. Five tests were performed, and the most typical results are shown in Figure 20. The HMA failed at both the 45°C (113°F) and 50°C (122°F) test temperature. The 50°C test temperature was specified for the project. The stripping inflection point occurred at approximately 9000 passes for the sample tested at 50°C.

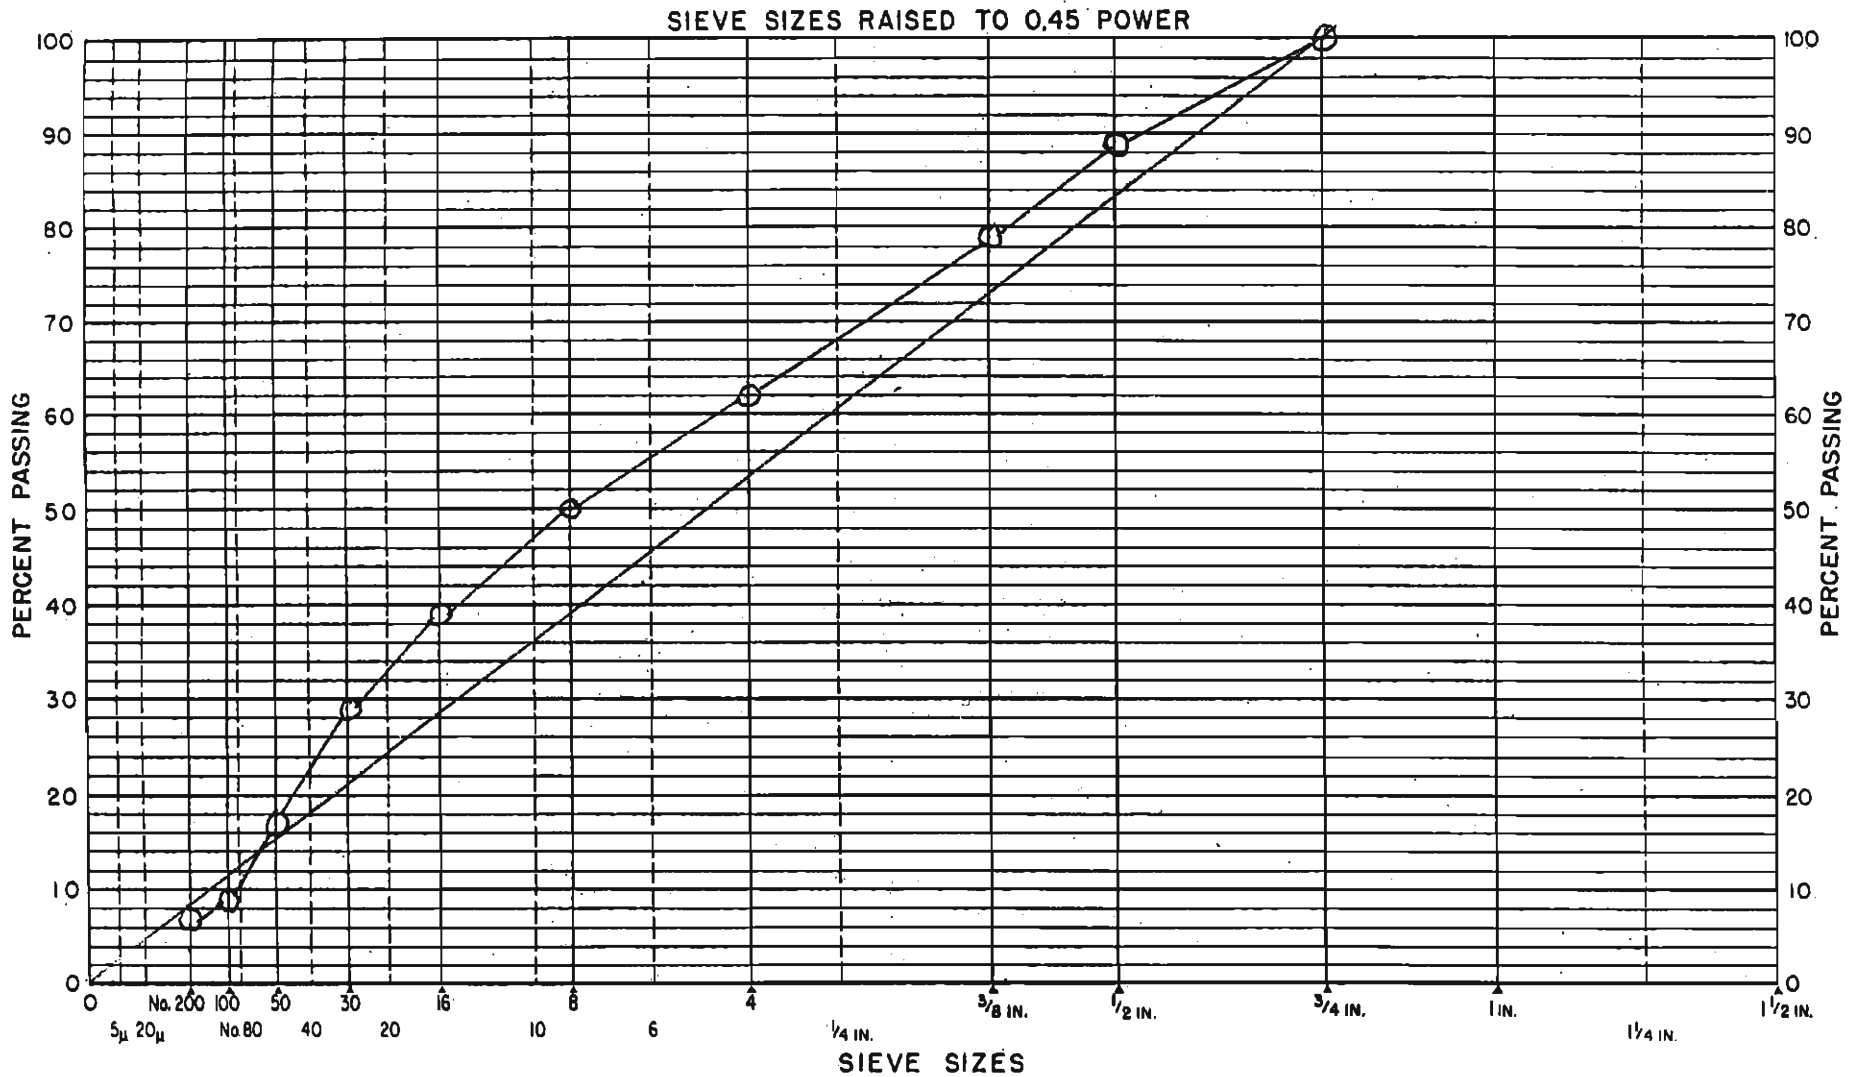
B-11

COLORADO DEPARTMENT OF TRANSPORTATION  
**GRADATION CHART**
