# Dynamic Modulus of Cold-in-Place Recycling (CIR) Material

Md Rashadul Islam, Sylvester A. Kalevela and Jill A. Rivera

Report No. CDOT 2018-13  
May 2018

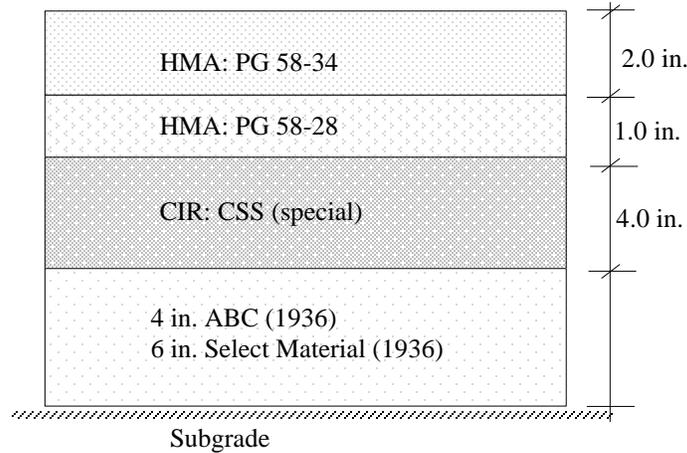
**Figure 1. Cross Section of Pavement Structure at the SH 9 Fairplay to Alma Site**

study, core samples were collected from MP 68.3 to MP 68.5. The cross-section, and the current view of the current CIR pavement section at SH 9 Fairplay to Alma are shown in Figure 1 and Figure 2 respectively. The Google map of the site is shown in Figure 3. The emulsion (CSS-Special) content used in the CIR layer is 2.0% by weight of the mix.

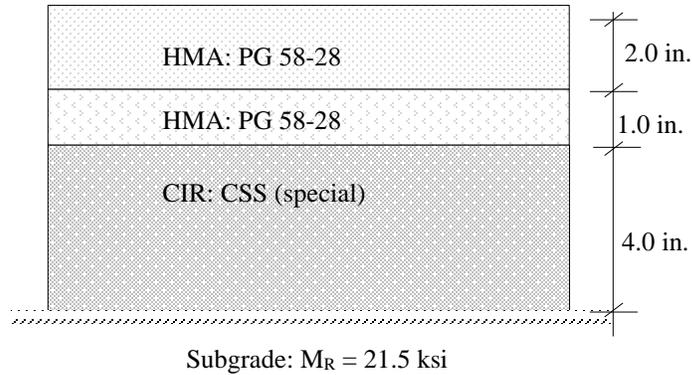
**Figure 4. Cross Section of Pavement at the SH 9 Hoosier Pass (Northbound)**

The roadway is located on State Highway 9 in Summit County, Colorado as shown in Figure 4. This roadway is classified as a minor arterial with an elevation of 10,428 feet, longitude of 39°23'34.89"N, and latitude of 106°03'10.61"W. The CIR project was constructed in 2008 (CDOT Project Number STA 009A-001, 16,366) and started at MP 79.0 and ended at MP 82.0. The 2015 AADT, single unit trucks, and combination trucks were 4,800, 150, and 120, respectively. For the purpose of the study, core samples were collected from MP 80.0 to MP 80. The cross-section, and the current view of the current CIR pavement section at SH 9 Hoosier Pass (Northbound) are shown in Figure 4, and Figure 5 respectively. Figure 6 shows the Google map of the site location. The emulsion (CSS-1P) content used in the CIR layer is 2.25% by weight of the mix.

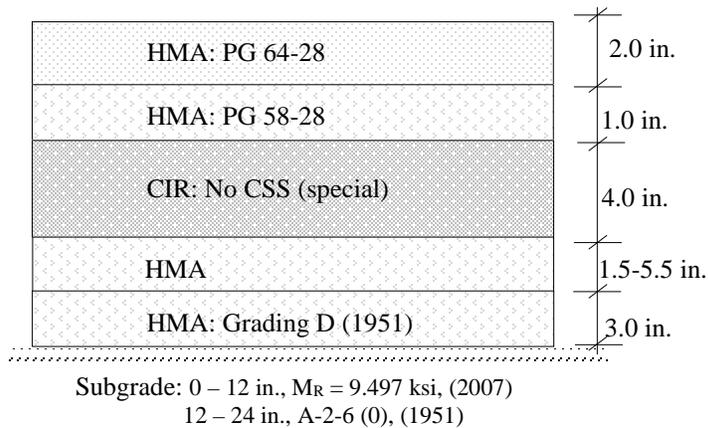
**Figure 7. Cross Section of Pavement Structure at the SH 86 East of Franktown**

The SH 86 East of Franktown site is located on State Highway 86 in Douglas County, Colorado. This roadway is classified as a minor arterial with an elevation of 6,714 feet, longitude of 39°22'07.64"N, and latitude of 104°40'43.26"W. The CIR project was constructed 2007 (CDOT Project Number STA 086A-045, 15710) and started at MP 6.9 and ended at MP 12.2. The 2015 AADT, single unit trucks, and combination trucks were 11,000, 250, and 120, respectively. For the purpose of the study, core samples were collected from MP 11.4 to MP 11.6. The cross-section, and the current view of the current CIR pavement section at SH 86 East of Franktown are shown in Figure 7, and Figure 8 respectively. The Google map of the site is shown in Figure 9. The emulsion (HFMS-2sp) content used in the CIR layer is 1.7% by weight of the mix.

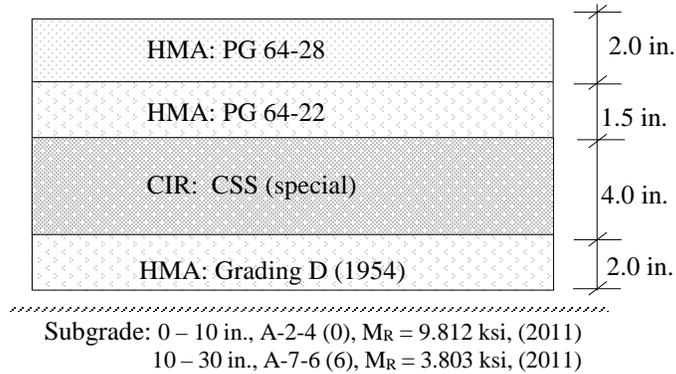
**Figure 10. Cross Section of Pavement Structure at the SH 86 Kiowa (Eastbound)**

and the current view of the current CIR pavement section at SH 86 Kiowa (Eastbound) Alma are shown in Figure 10, and Figure 11 respectively. Figure 12 shows the Google map of the site. The emulsion (CSS-1P) content used in the CIR layer is 2.5% by weight of the mix.

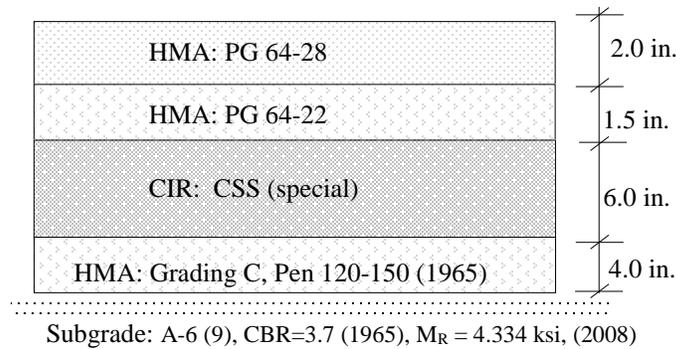
**Figure 13. Cross Section of Pavement Structure at the I-25 South of Colorado City to Cedarwood**

The South of Colorado City to Cedarwood site is located on Interstate 25 in Pueblo County, Colorado with an elevation of 5,323 feet, longitude of 38°05'01.97"N, and latitude of 104°42'04.56"W. The CIR project was constructed in 2008 (CDOT Project Number STU 0251-329, 16076B) and started at MP 79.6 and ended at MP 87.6. The 2015 AADT, single unit trucks, and combination trucks were 19,000, 840, and 1,700, respectively. For the purpose of the study, core samples were collected from MP 84.5 to MP 84.7. The cross-section, and the current view of the current CIR pavement section at I-25 South of Colorado City to Cedarwood are shown in Figure 13, and Figure 14 respectively. The Google map of the site is shown in Figure 15.

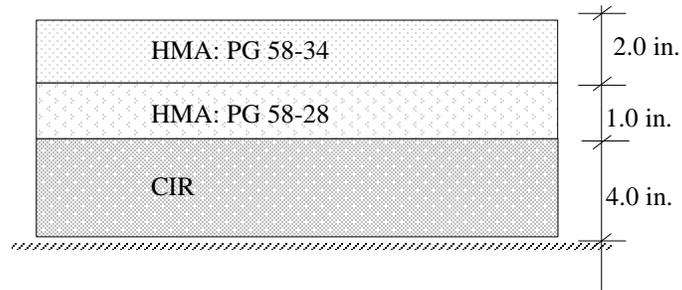
**Figure 16. Cross Section of Pavement Structure at the SH 50 Cerro Summit**

Summit Paving are shown in Figure 16, and Figure 17 respectively. The Google map of the site is shown in Figure 18.

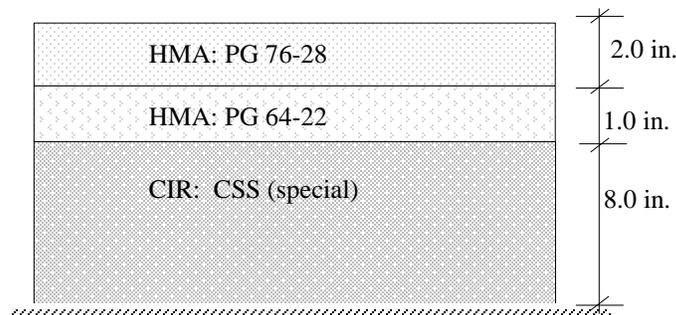
**Figure 19. Cross Section of Pavement Structure at the I-70 West of Mack**

The I-70 West of Mack site is located on Interstate 70 in Mesa County, Colorado with an elevation of 4,804 feet, longitude of 39°13'34.70"N, and latitude of 10855'36.51"W. The CIR project was constructed in 2005 (CDOT Project Number IM 0701-171, 15032). It started at MP 5.0 and ended at MP 11.6. The 2015 AADT, single unit trucks, and combination trucks were 7,400, 350, and 1,500 respectively. For the purpose of the study, core samples were collected from MP 7.0 to MP 7.2. The cross-section, and the current view of the current CIR pavement section at I-70 West of Mack are shown in Figure 19, and Figure 20 respectively. The Google map of the site is shown in Figure 21.

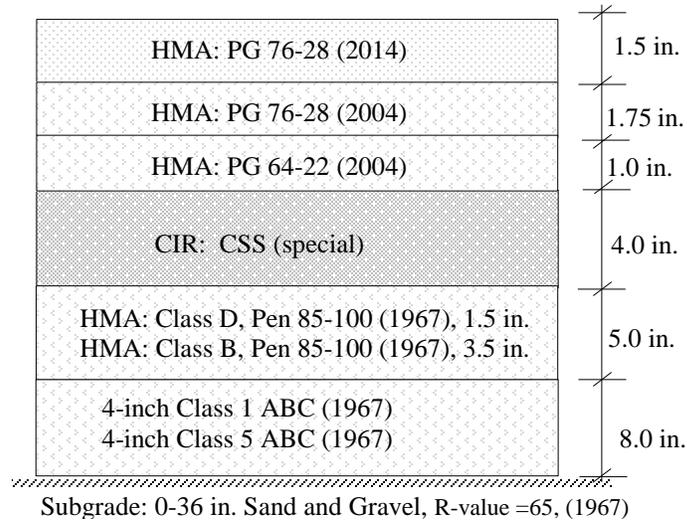
**Figure 22. Cross Section of Pavement Structure at the I-70 Fruita to Clifton**

The I-70 Fruita to Clifton site is located on Interstate 70 in Mesa County, Colorado with an elevation of 4,516 feet, longitude of 37°07'16.44"N, and latitude of 108°40'37.28"W. The CIR project was constructed in 2004 (CDOT Project Number IM 0701-157, 13535). It started at MP 22.0 and ended at MP 37.0. In 2014, a 1.5-inch overlay was placed from MP 16 to MP 37 (CDOT Project Number NHPP 0701-222, 19677). The 2015 AADT, single unit trucks, and combination trucks were 20,000, 560, and 2000 respectively. For the purpose of the study, core samples were collected from MP 23.5 to MP 23.7. The cross-section, and the current view of the current CIR pavement section at I-70 Fruita to Clifton are shown in Figure 22, and Figure 23 respectively. The Google map of the site is shown in Figure 24.

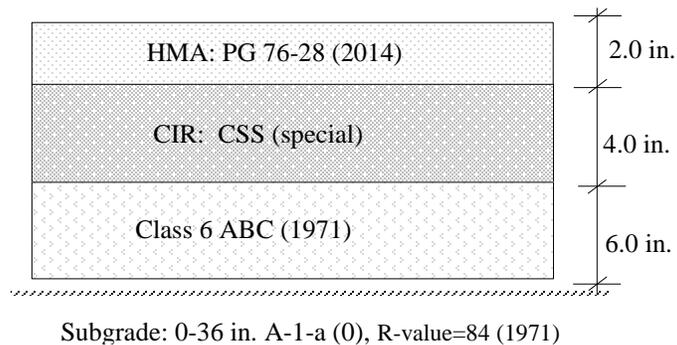
**Figure 25. Cross Section of Pavement Structure at the SH 92 Delta (Eastbound)**

The SH 92 Delta (Eastbound) site is located on State Highway 92 in Delta County Colorado. This roadway is classified as a principal arterial with an elevation of 5,004 feet, longitude of 38°45'30.70"N, and latitude of 108°01'37.53"W. The CIR project was constructed in 2003 (CDOT Project Number STA 092A-016, 14217) and started at MP 0.2 and ended at MP 4.2. The 2015 AADT, single unit trucks, and combination trucks were 12,000, 340, and 160 respectively. For the purpose of the study, core samples were collected from MP 3.0 to MP 3.2. The cross-section, and the current view of the current CIR pavement section at SH 92 Delta (Eastbound) are shown in Figure 25, and Figure 26 respectively. The Google map of the site is shown in Figure 27.

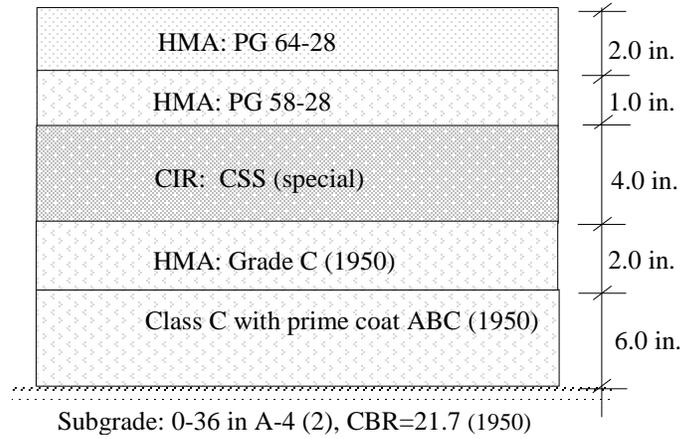
**Figure 28. Cross Section of Pavement Structure at the SH 133 North of Hotchkiss**

in Figure 28, and Figure 29 respectively. The Google map of the site is shown in Figure 30. The emulsion content used is the CIR layer is 2.5% by weight of the mix.

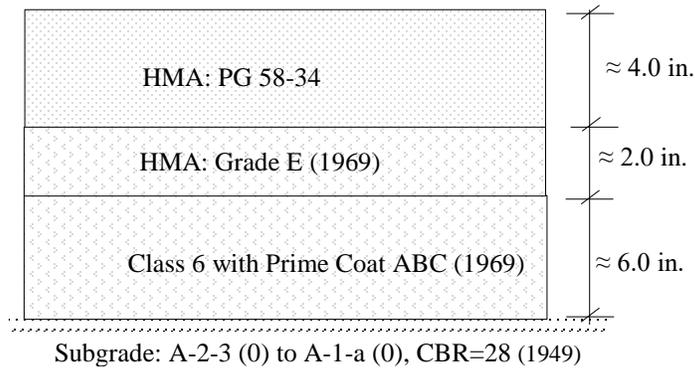
**Figure 31. Cross-section of Pavement Structure at Control Site #1**

Control Site #1 is located on State Highway 135 in Gunnison County, Colorado (CDOT Project Number HB 135A-024, 16446), and was constructed in 2008 from MP 18.8 to 27.2. Control Site #1 will be compared with the CIR Site #1 SH 9 Fairplay to Alma. This roadway is classified as a minor arterial with an elevation of 8,781 feet, longitude of 38°49'37.46"N, and latitude of 106°55'15.89"W. The 2015 AADT, single unit trucks, and combination trucks were 3,200, 100, and 160 respectively. A cross-section of the pavement structure is shown in Figure 31.

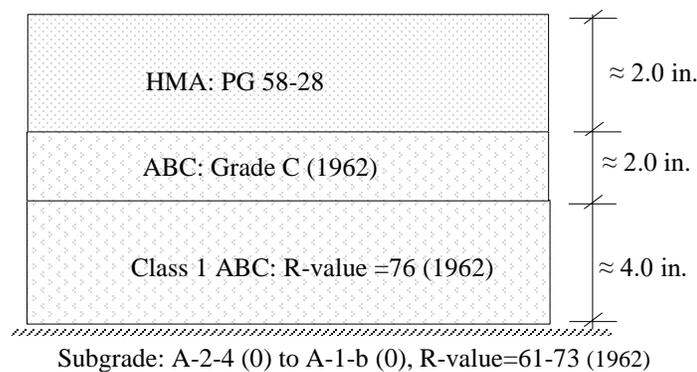
**Figure 32. Cross-section of Pavement Structure at Control Site #2**

Control Site #2 is located on State Highway 9 in Park County, Colorado (CDOT Project Number STA 009-027, 17048) constructed in 2009 from MP 73.0 to 76.0. Control Site #2 will be compared with the CIR Site #2 SH 9 Hoosier Pass (Northbound). This roadway is classified as a minor arterial with an elevation of 11,010 feet, longitude of 39°20'11.98"N, and latitude of 106°3'8.33"W. The 2015 AADT, single unit trucks, and combination trucks were 5,800, 160, and 140 respectively. A cross-section of the pavement structure is shown in Figure 32.

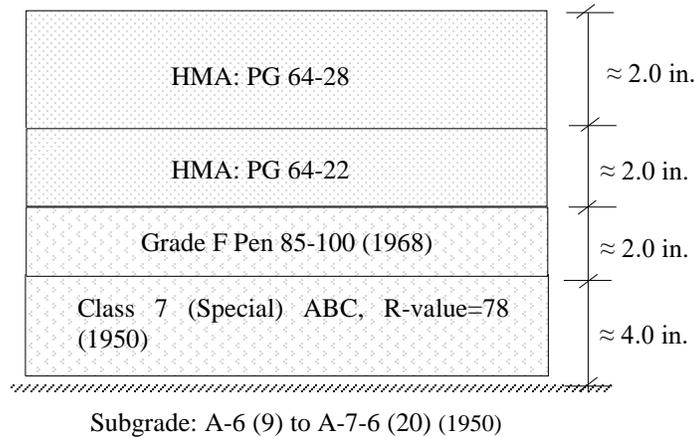
**Figure 33. Cross-section of Pavement Structure at Control Site #3**

Control Site #3 is located on State Highway 83 in El Paso County, Colorado (CDOT Project Number STA 0831-105, 16028) constructed in 2007 from MP 33.1 to 41.2. Control Site #3 will be compared with the CIR Site #3 SH 86 East of Franktown. This roadway is classified as a principal arterial with an elevation of 6,829 feet, longitude of 39°13'33.94"N, and latitude of 104°42'0.31"W. The 2015 AADT, single unit trucks, and combination trucks were 3,700, 120, and 240 respectively. A cross-section of the pavement structure is shown in Figure 33.

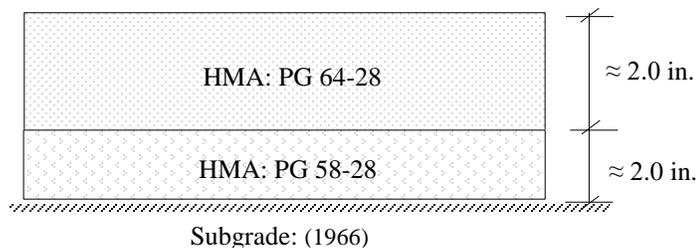
**Figure 34. Cross-section of Pavement Structure at Control Site #4**

Control Site #4 is located on US Highway 24 in Elbert County, Colorado (CDOT Project Number ES1 0243-079, 17616) constructed in 2010 from MP 364.6 to 375.4. Control Site #4 will be compared with the CIR Site #4 SH 86 Kiowa (Eastbound). This roadway is classified as a principal arterial with an elevation of 5,786 feet, longitude of 39°13'1.37"N, and latitude of 103°49'1.25"W. The 2015 AADT, single unit trucks, and combination trucks were 2,900, 90, and 220 respectively. A cross-section of the pavement structure is shown in Figure 34.

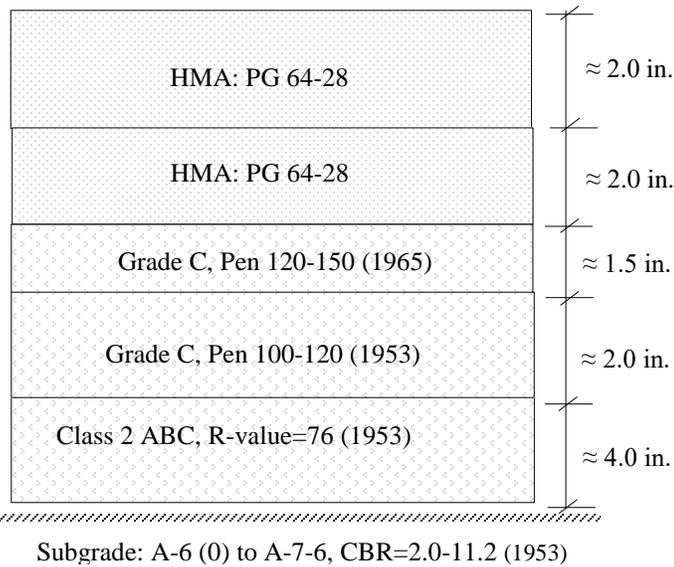
**Figure 35. Cross-section of Pavement Structure at Control Site #5**

Control Site #5 is located on Interstate 25 in Pueblo County, Colorado (CDOT Project Number IM 0252-378, 15160) constructed in 2006 from MP 102.6 to 109.0 with an elevation of 4,891 feet, longitude of 38°44'51.59"N, and latitude of 104°37'10.64"W. Control Site #5 will be compared with the CIR Site #5 I-25 South of Colorado City to Cedarwood. The 2015 AADT, single unit trucks, and combination trucks were 31,000, 990, and 2,700 respectively. A cross-section of the pavement structure is shown in Figure 35.

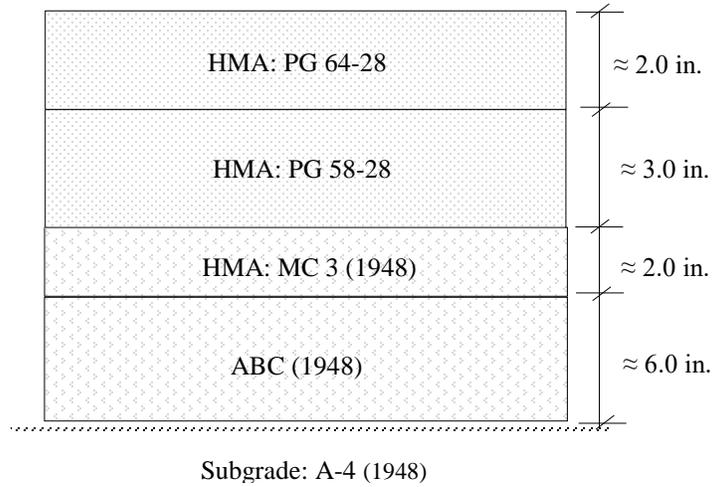
**Figure 36. Cross-section of Pavement Structure at Control Site #6**

Control Site #6 is located on State Highway 131 in Routt County, Colorado (CDOT Project Number STR 131A-029, 14214) constructed in 2006 from MP 61.4 to 64.5. Control Site #6 will be compared with the CIR Site #6 SH 50 Cerro Summit Paving. This roadway is classified as a minor arterial with an elevation of 6,906 feet, longitude of 40°21'59.1"N, and latitude of 106°50'52.8"W. The 2015 AADT, single unit trucks, and combination trucks were 4,300, 100, and 40 respectively. A cross-section of the pavement structure is shown in Figure 36.

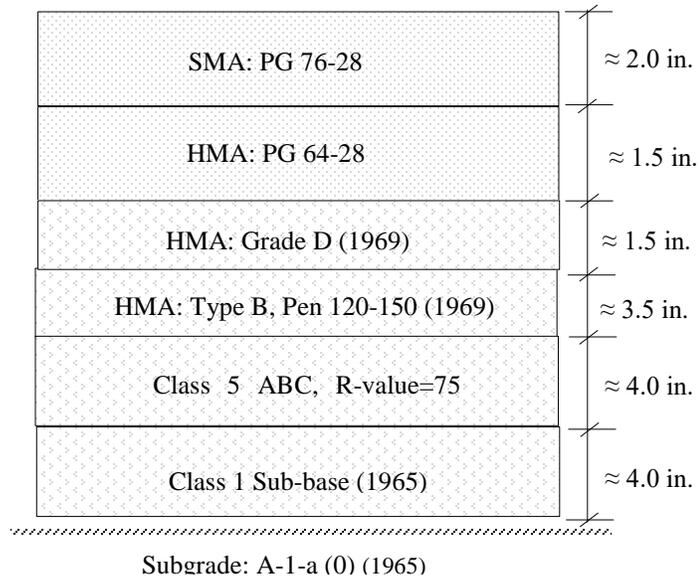
**Figure 37. Cross-section of Pavement Structure at Control Site #7**

Control Site #7 is located on Interstate 70 in Garfield County, Colorado (CDOT Project Number IM 0701-179, 15320) constructed in 2006 from MP 110.0 to 118.5 with an elevation of 5,722 feet, longitude of 39°33'41.48"N, and latitude of 107°22'0.83"W. Control Site #7 will be compared with the CIR Site #7 I-70 West of Mack. The 2015 AADT, single unit trucks, and combination trucks were 21,000, 480, and 2,100, respectively. A cross-section of the pavement structure is shown in Figure 37.

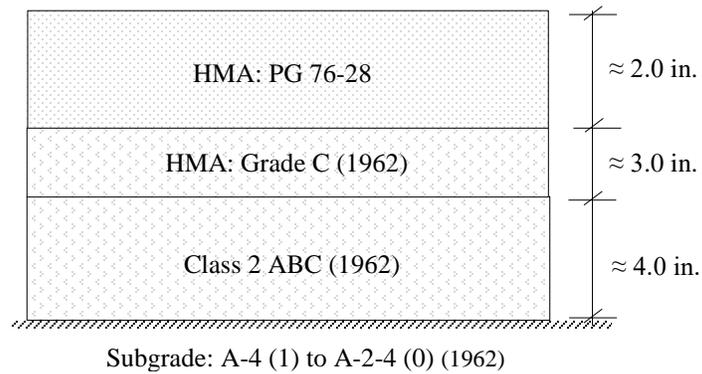
**Figure 38. Cross-section of Pavement Structure at Control Site #8**

Control Site #8 is located on Interstate 70 in Mesa County, Colorado (CDOT Project Number HB 0701-173, 15065) constructed in 2007 from MP 37.0 to 43.4 with an elevation of 4,814 feet, longitude of 39°7'4.23"N, and latitude of 108°23'16.39"W. Control Site #8 will be compared with the CIR Site #8 I-70 Fruita to Clifton. The 2015 AADT, single unit trucks, and combination trucks were 22,000, 570, and 2,400 respectively. A cross-section of the pavement structure is shown in Figure 38.

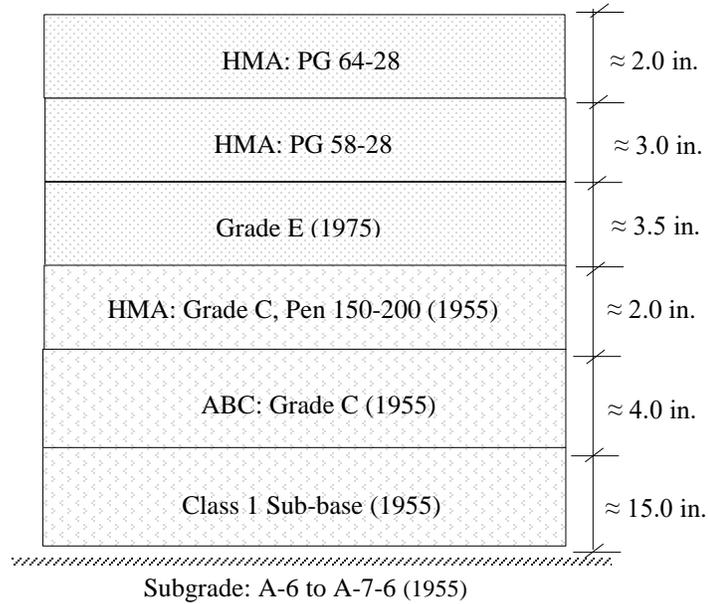
**Figure 39. Cross-section of Pavement Structure at Control Site #9**

Control Site #9 is located on US Highway 50 in Montrose County, Colorado (CDOT Project Number NH 0502-053, 13472) constructed in 2004 from MP 109.4 to 112.0. This roadway is classified as a principal arterial with an elevation of 7,287 feet, longitude of 38°26'16.93"N, and latitude of 107°35'16.94"W. Control Site #9 will be compared with the CIR Site #9 SH 92 Delta (Eastbound). The 2015 AADT, single unit trucks, and combination trucks were 3,000, 90, and 250 respectively. A cross-section of the pavement structure is shown in Figure 39.

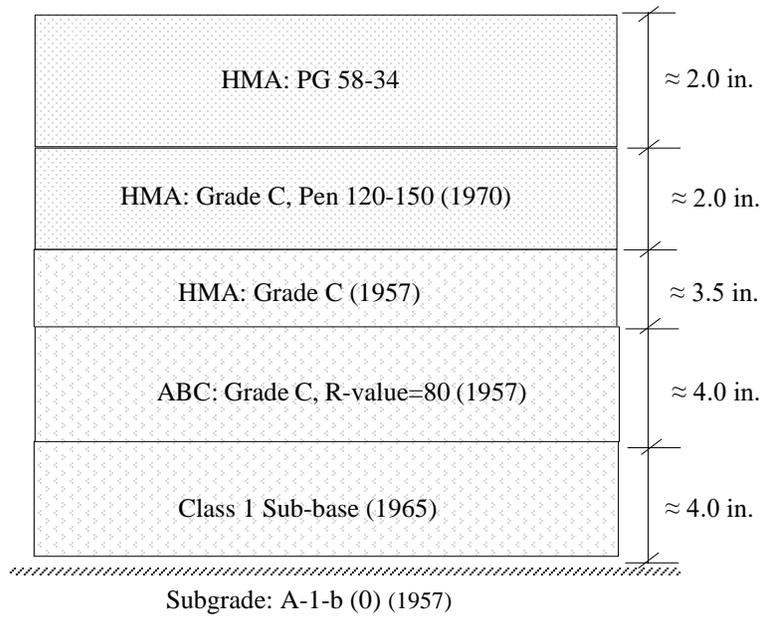
**Figure 40. Cross-section of Pavement Structure at Control Site #10**

Control Site #10 is located on US Highways 50 in Gunnison County, Colorado (CDOT Project Number NH 0501-055, 15924) constructed in 2007 from MP 156.0 to 158.0. Control Site #10 will be compared with the CIR Site #10 SH 133 North of Hotchkiss. This roadway is classified as a principal arterial with an elevation of 7,708 feet, longitude of 38°32'39.83"N, and latitude of 106°56'7.72"W. The 2015 AADT, single unit trucks, and combination trucks were 2,800, 80, and 30 respectively. A cross-section of the pavement structure is shown in Figure 40.

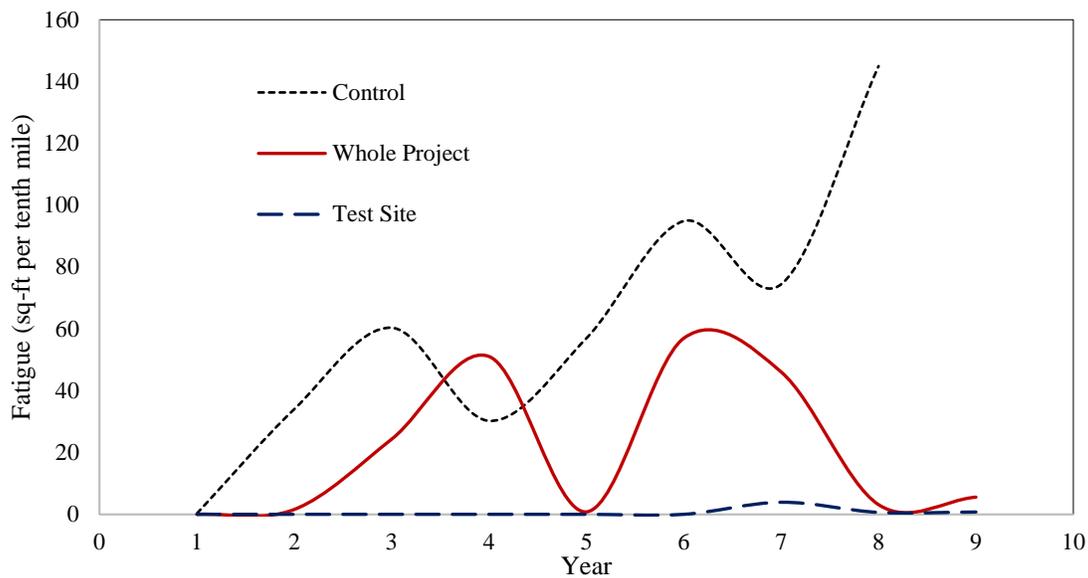
*Fatigue Cracking:* Fatigue cracking at the test site has no measurable cracking 9 years after construction, Figure 41. The control site has greater amount of cracking with a maximum value of 145 square feet per tenth-mile. The whole project and the test site have fatigue cracking averages of 57 and 4 square feet per tenth-mile respectively, these averages are less than one percent of the pavement lane and considered negligible. Figure 41 also shows the amount of fatigue cracking is not expected to increase rapidly over time for CIR pavement.

**Figure 41. Fatigue Cracking at Site #1 SH 9 Fairplay to Alma Showing Amount of Cracking at the Control Site, Test Site, and Whole Project**

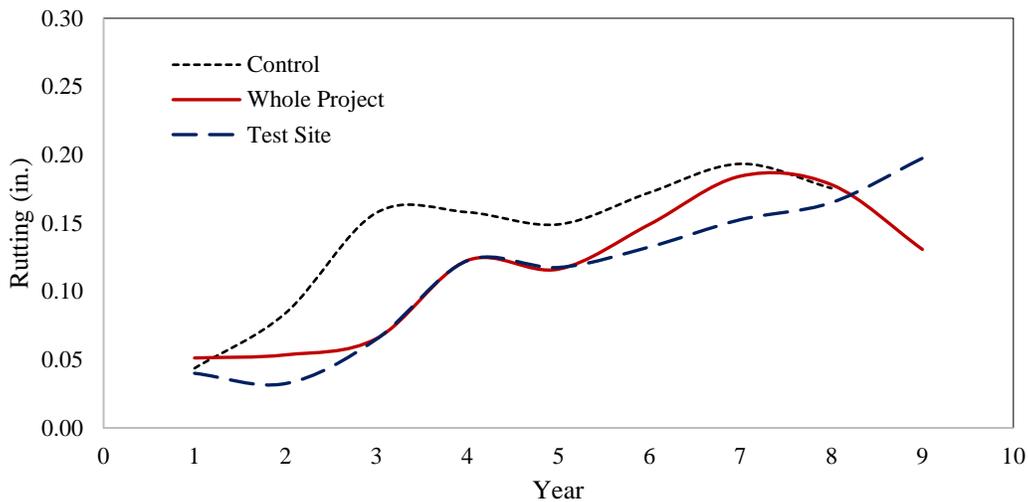
*Rutting:* The amount of rutting at the whole project, control site, and test site are very similar as depicted in Figure 42. Nine years after construction, rutting at the control site increased from 0.01 to 0.19 inches, at the whole project it increased from 0.04 to 0.18 inches, and at the test site it increased from 0.04 to 0.17 inches. Thus, the rutting measured at the test section versus the whole project is slightly less than the control project and shown a very slight benefit to using CIR. Figure 42 indicates that rutting is expected to grow with age, however will not exceed the terminal threshold value (used by PMED) of 0.5 inches for several years.

**Figure 42. Rutting at Site #1 SH 9 Fairplay to Alma Showing Amount of Rutting at the Control Site, Test Site, and Whole Project**

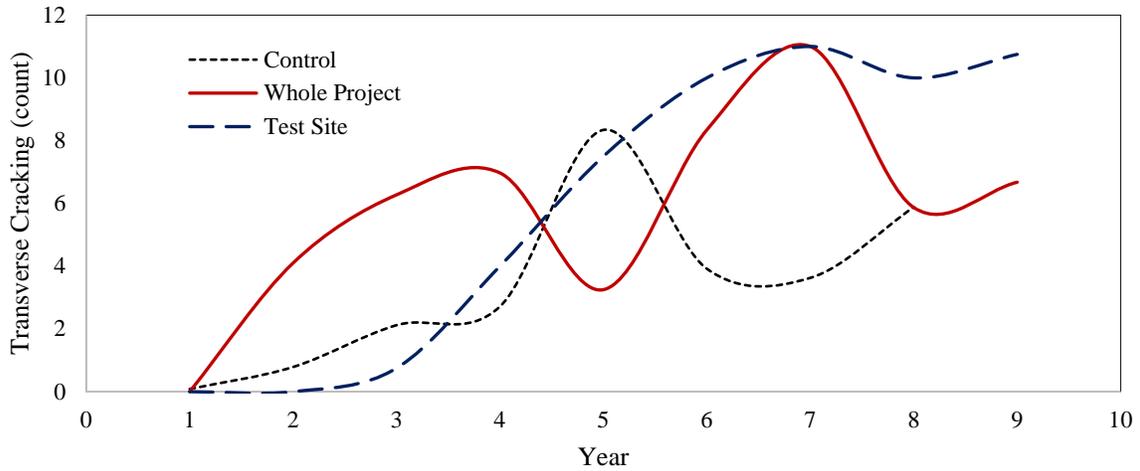
*Transverse Cracking:* Nine years after construction, the transverse cracking at the test site and whole project is greater than the cracking at the control site, Figure 43. The control project has a maximum of eight cracks (each 12 feet long) per tenth-mile, while each of the whole project and the test site has a maximum of 11 cracks per tenth-mile. The data shows the difference between the whole project and test site is negligible and that the project that used CIR performed poorer than conventional HMA. Transverse cracking is expected to increase over time, but will unlikely reach the terminal threshold value (used by PMED) of 1,500 feet per mile for several years.

**Figure 43. Transverse Cracking at Site #1 SH 9 Fairplay to Alma Showing Amount of Cracking at the Control Site, Test Site, and Whole Project**

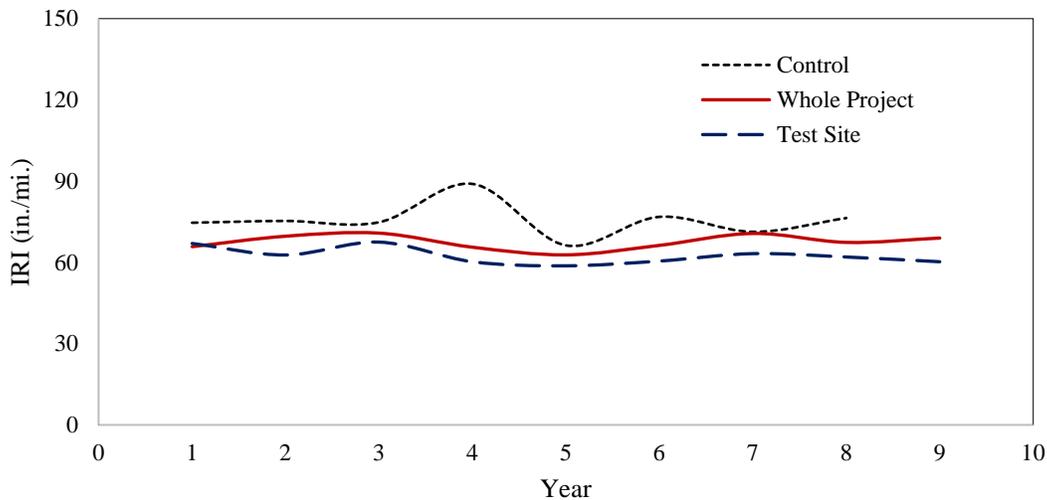
IRI: The IRI at the test site and whole project is less than that measured at the control site, Figure 44. Since the construction of the project nine years ago, the control site’s IRI ranged from 75 to 89 inches per mile. The whole project’s IRI was more consistent and ranged from 67 to 70 inches per mile, and the test site ranged from 58 to 67 inches per mile. Data shows the control site performed poorer than the test site and whole project and indicated the use of CIR may reduce a roadway’s IRI. The graph indicated IRI will not significantly increase over time and will unlikely meet the terminal threshold value PMED used of 200 inches per mile.

**Figure 44. IRI at Site #1 SH 9 Fairplay to Alma Showing Amount of IRI at the Control Site, Test Site, and Whole Project**

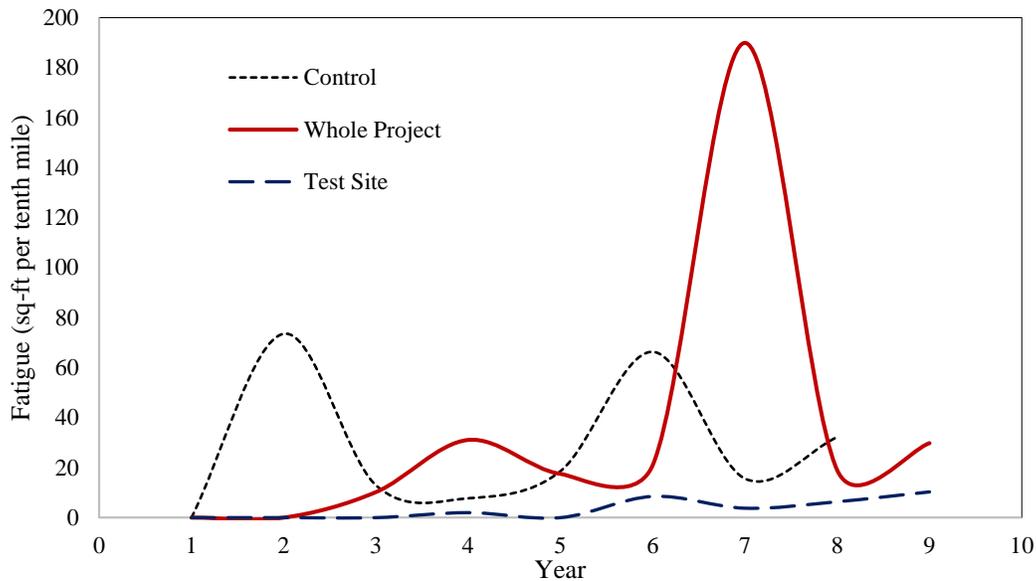
*Fatigue Cracking:* Similar to SH 9 Fairplay to Alma site, fatigue cracking at the test site of SH 9 Hoosier Pass (Northbound) has no measurable cracking 8 years after construction, Figure 45. The whole project has greater amount cracking with a maximum value of 190 square feet per tenth-mile compared to 74 square feet per tenth-mile at the control site. However, the whole project average fatigue cracking is less than one percent of the pavement lane and considered negligible. Figure 45 also shows the amount of fatigue cracking is not expected to increase rapidly over time.

**Figure 45. Fatigue Cracking at Site #2 SH 9 Hoosier Pass (Northbound) Showing Amount of Cracking at the Control Site, Test Site, and Whole Project**

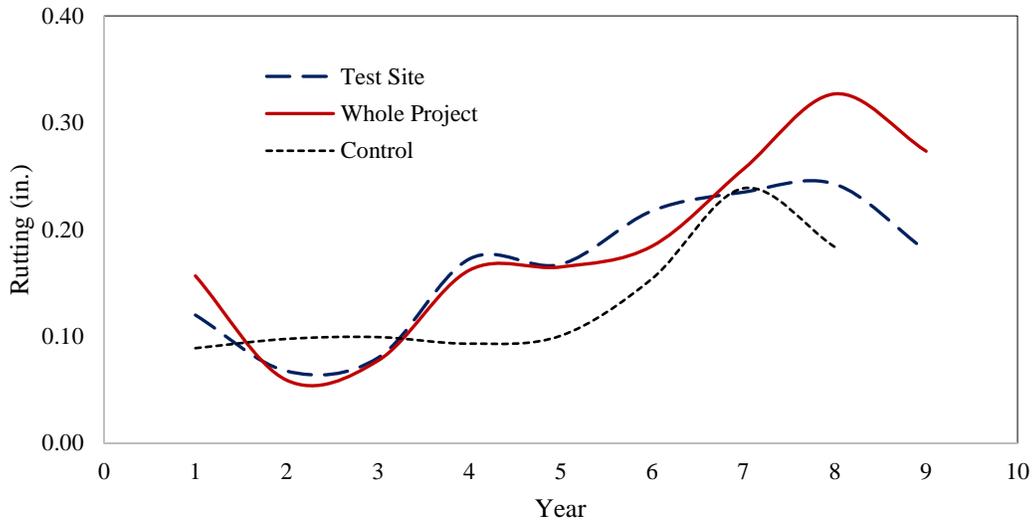
*Rutting:* The amount of rutting at the whole project, control site, and test site are very similar, Figure 46. Eight years after construction rutting at the control site increased from 0.01 to 0.24 inches, at the whole project it increased from 0.06 to 0.33 inches, and at the test site, it increased from 0.07 to 0.24 inches. Thus, the rutting measured at the whole project is slightly more than the control project. Figure 46 indicates that rutting is expected to grow with age, however will not exceed the terminal threshold value (used by PMED) of 0.5 inches for several years.

**Figure 46. Rutting at Site #2 SH 9 Hoosier Pass (Northbound) Showing Amount of Rutting at the Control Site, Test Site, and Whole Project**

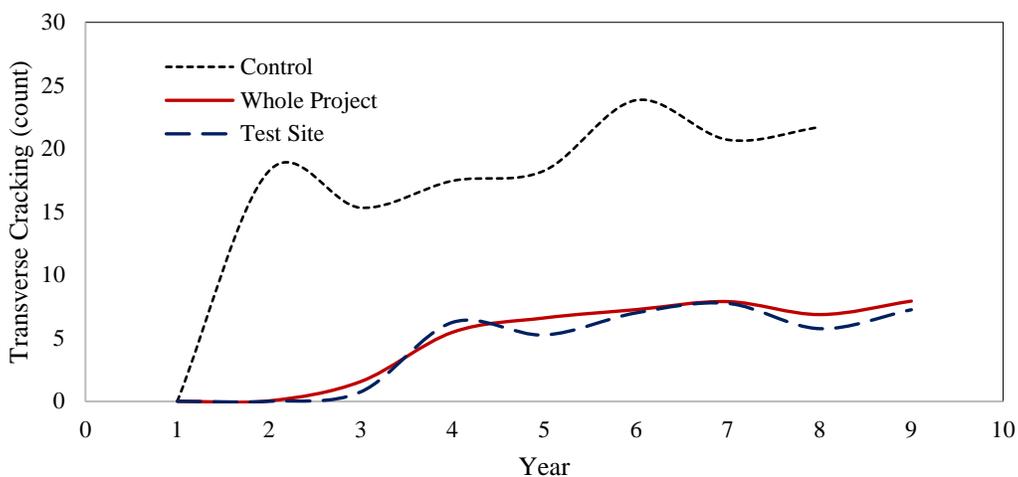
*Transverse Cracking:* Nine years after construction, the transverse cracking at the test site and whole project is much smaller than the cracking at the control site, Figure 47. The control project has a maximum of 24 cracks (each 12 feet long) per tenth-mile, while the whole project and the test site each has a maximum of 8 cracks per tenth-mile, and shows the benefit of using CIR. Transverse cracking is expected to increase over time, but will unlikely meet the terminal threshold value (used by PMED) of 1,500 feet per mile for several years.

**Figure 47. Transverse Cracking at Site #2 SH 9 Hoosier Pass (Northbound) Showing Amount of Cracking at the Control Site, Test Site, and Whole Project**

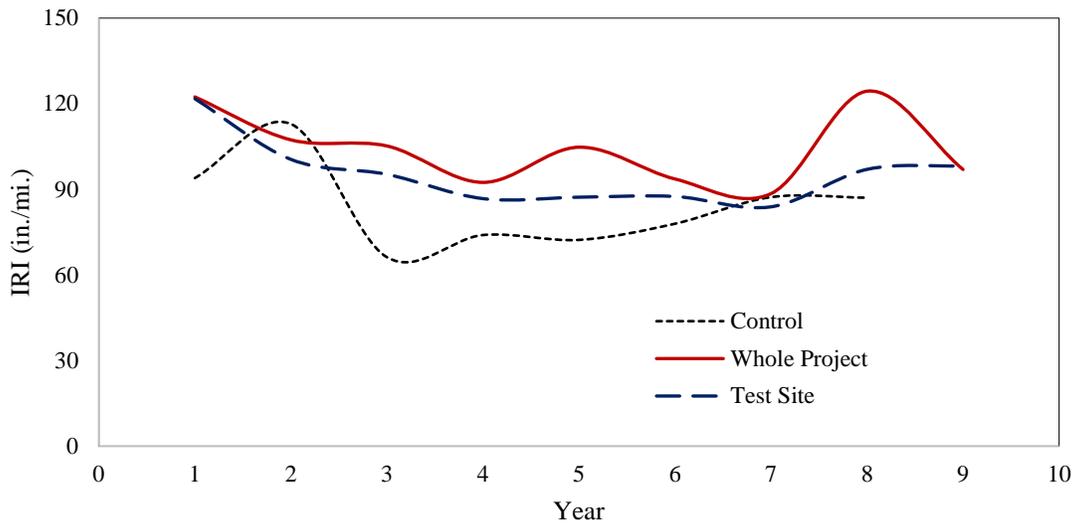
IRI: The IRI at the test site and whole project is more than that measured at the control site, Figure 48. Since the construction of the project nine years ago, the control site's IRI ranged from 66 to 113 inches per mile. The whole project's IRI was more consistent and ranged from 92 to 124 inches per mile, and the test site ranged from 84 to 122 inches per mile. Data shows the control site performed better than the test site and whole project. The graph indicated IRI will not significantly increase over time and will unlikely meet the terminal threshold value PMED used of 200 inches per mile.

**Figure 48. IRI at Site #2 SH 9 Hoosier Pass (Northbound) Showing Amount of IRI at the Control Site, Test Site, and Whole Project**

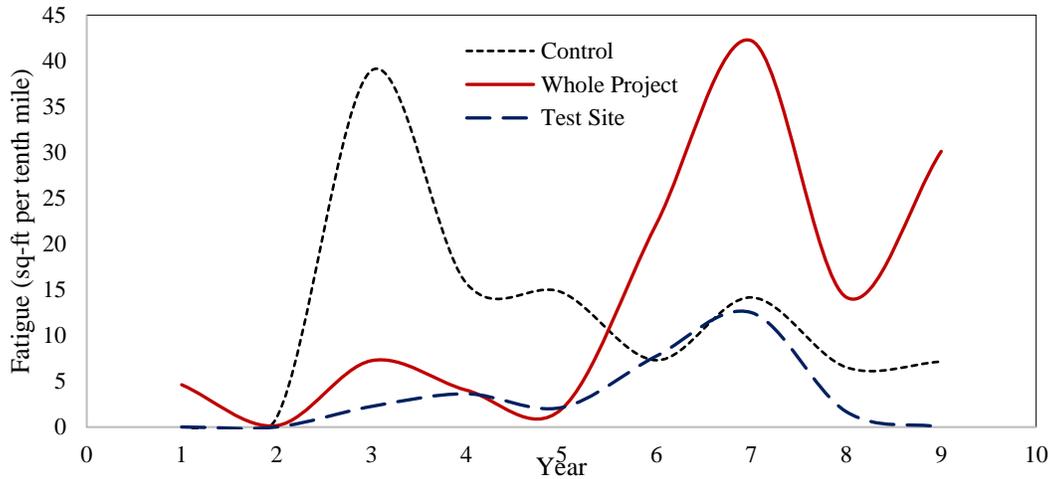
*Fatigue Cracking:* Fatigue cracking at the test site has no measurable cracking 9 years after construction, Figure 49. The whole project and control site has similar cracking with a maximum value of 39 square feet per tenth-mile. The whole project has an average fatigue cracking of 42 square feet per tenth-mile, which is less than one percent of the pavement lane and considered negligible. Figure 49 also shows the amount of fatigue cracking is not expected to increase rapidly over time.

**Figure 49. Fatigue Cracking at Site #3 SH 86 East of Franktown Showing Amount of Cracking at the Control Site, Test Site, and Whole Project**

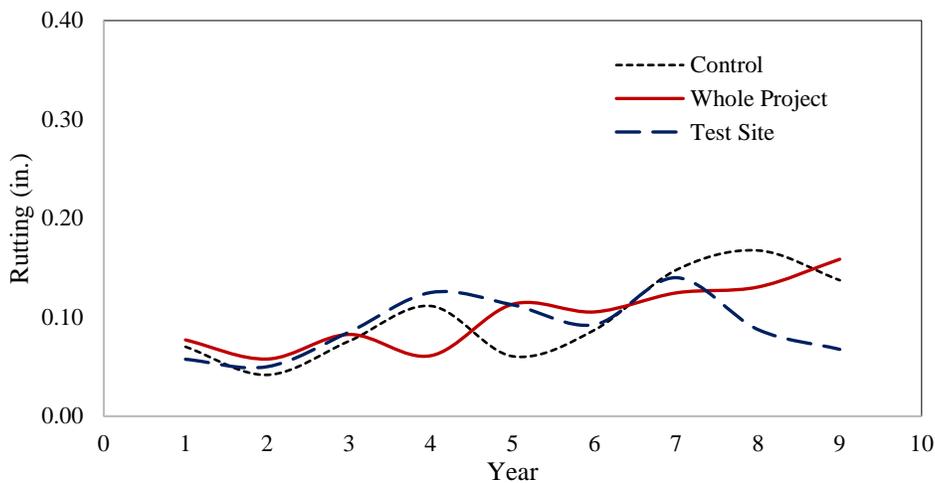
*Rutting:* The amount of rutting at the whole project, control site, and test site are very similar as shown in Figure 50. Nine years after construction rutting at the control site increased from 0.06 to 0.17 inches, at the whole project it increased from 0.06 to 0.16 inches, and at the test site, it increased from 0.05 to 0.14 inches. Thus, the rutting measured at the test section versus the whole project is slightly less than the control project showing a benefit to using CIR. Figure 50 indicates that rutting is expected to grow with age but will not exceed the terminal threshold value (used by PMED) of 0.5 inches for several years.

**Figure 50. Rutting at Site #3 SH 86 East of Franktown Showing Amount of Rutting at the Control Site, Test Site, and Whole Project**

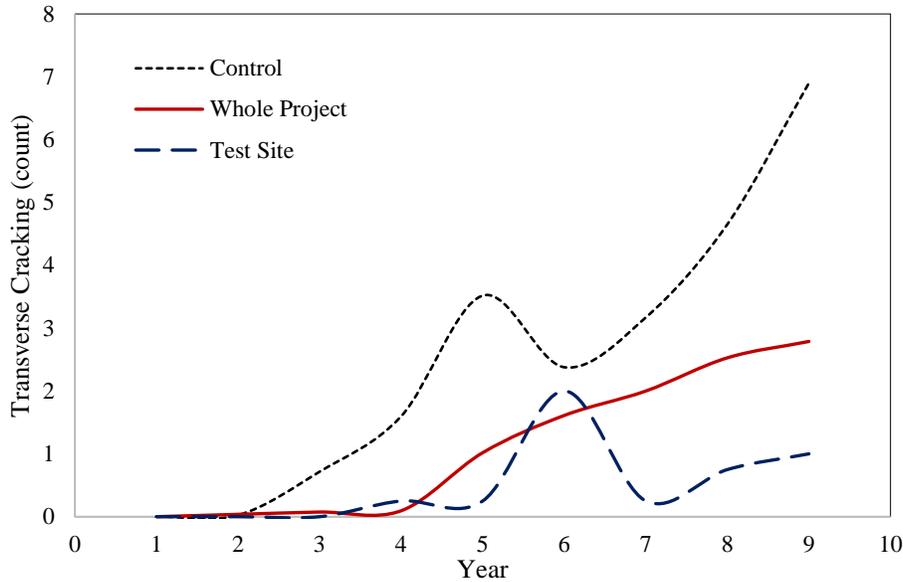
*Transverse Cracking:* Nine years after construction, the transverse cracking at the test site and whole project is smaller than the cracking at the control site, Figure 51. The control project has a maximum of seven cracks (each 12 feet long) per tenth-mile, while the whole project and the test site have maximum values of two and three cracks per tenth-mile respectively. Transverse cracking is expected to increase over time, but will unlikely meet the terminal threshold value (used by PMED) of 1,500 feet per mile for several years.

**Figure 51. Transverse Cracking at Site #3 SH 86 East of Franktown Showing Amount of Cracking at the Control Site, Test Site, and Whole Project**

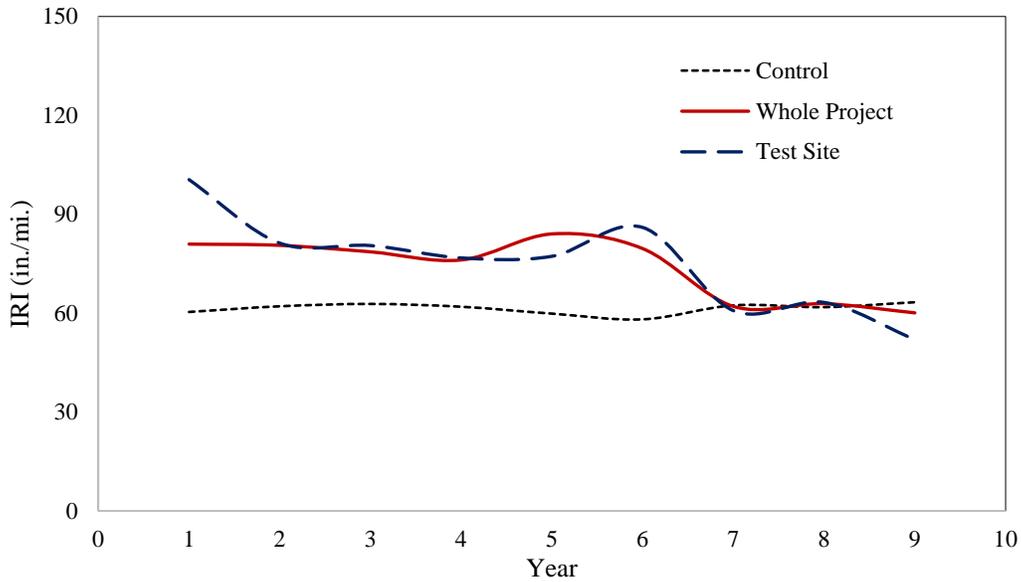
IRI: The IRI at the test site and whole project is more than that measured at the control site as shown in Figure 52. Since the construction of the project nine years ago, the control site’s IRI ranged from 58 to 63 inches per mile. The whole project’s IRI was more consistent and ranged from 60 to 84 inches per mile, and the test site ranged from 52 to 101 inches per mile. Data shows the control site performed better than the test site and whole project and indicated the use of CIR may reduce a roadway’s IRI. The graph indicated IRI will not significantly increase over time and will unlikely meet the terminal threshold value PMED used of 200 inches per mile.

**Figure 52. IRI at Site #3 SH 86 East of Franktown Showing Amount of IRI at the Control Site, Test Site, and Whole Project**

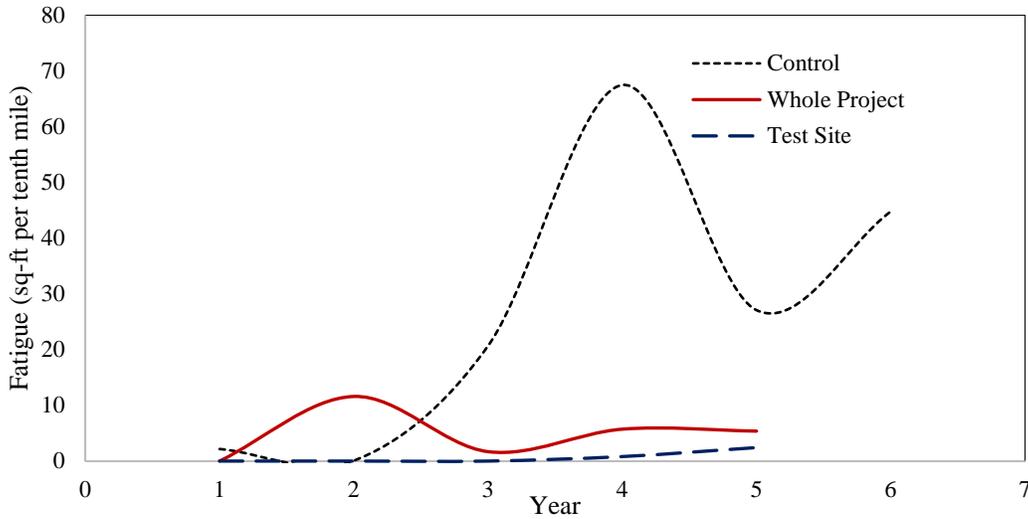
*Fatigue Cracking:* Fatigue cracking at the test site and whole project has no measurable cracking 5 years after construction as shown in Figure 53. The test site and whole project have similar cracking with maximum values of 2 and 12 square feet per tenth-mile respectively. The control site has an average fatigue cracking of 67 square feet per tenth-mile, which is much higher than the test site and whole project. Figure 53 also shows the amount of fatigue cracking is not expected to increase rapidly over time.

**Figure 53. Fatigue Cracking at Site #4 SH 86 Kiowa (Eastbound) Showing Amount of Cracking at the Control Site, Test Site, and Whole Project**

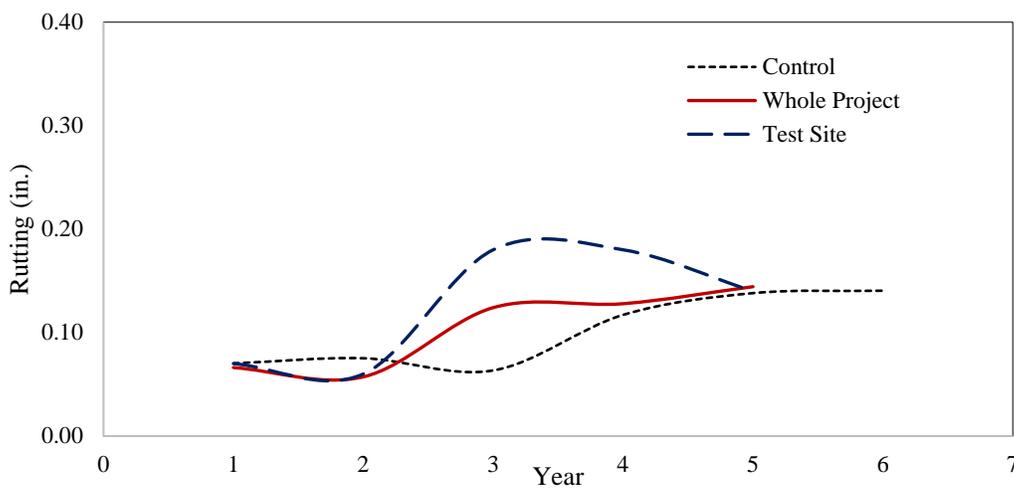
*Rutting:* The amount of rutting at the whole project, control site, and test site are very similar as shown in Figure 54. Nine years after construction rutting, at the control site increased from 0.08 to 0.14 inches, at the whole project it increased from 0.06 to 0.14 inches, and at the test site, it increased from 0.06 to 0.18 inches. Thus, the rutting measured at the test section is slightly more than the control project. Figure 54 indicates that rutting is expected to grow with age but will not exceed the terminal threshold value (used by PMED) of 0.5 inches for several years.

**Figure 54. Rutting at Site #4 SH 86 Kiowa (Eastbound) Showing Amount of Rutting at the Control Site, Test Site, and Whole Project**

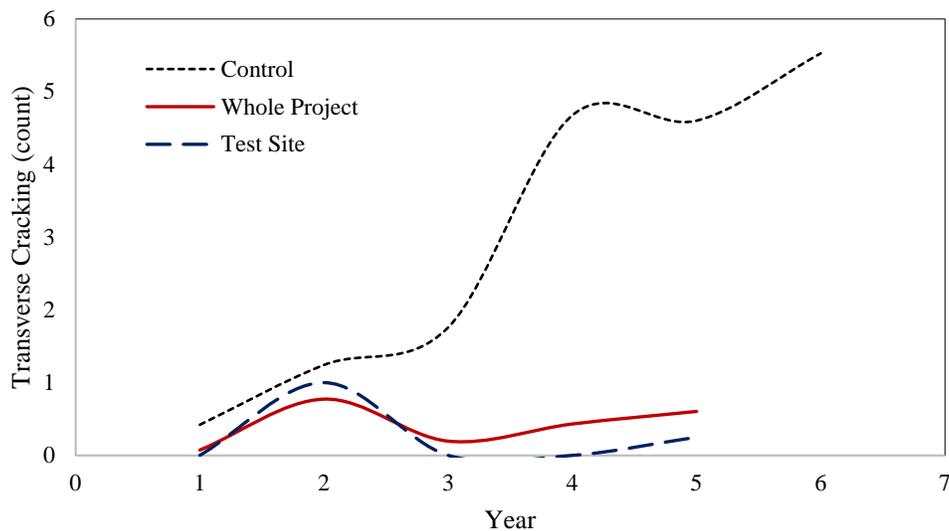
*Transverse Cracking:* Nine years after construction, the transverse cracking at the test site and whole project is less than the cracking at the control site as shown in Figure 55. The control project has a maximum of five cracks (each 12 feet long) per tenth-mile, while the whole project and the test site each has a maximum of one crack per tenth-mile. The data show that the difference between the whole project and test site is negligible and the project that used CIR performed better than conventional HMA. Transverse cracking is expected to increase over time, but will unlikely meet the terminal threshold value (used by PMED) of 1,500 feet per mile for several years.

**Figure 55. Transverse Cracking at Site #4 SH 86 Kiowa (Eastbound) Showing Amount of Cracking at the Control Site, Test Site, and Whole Project**

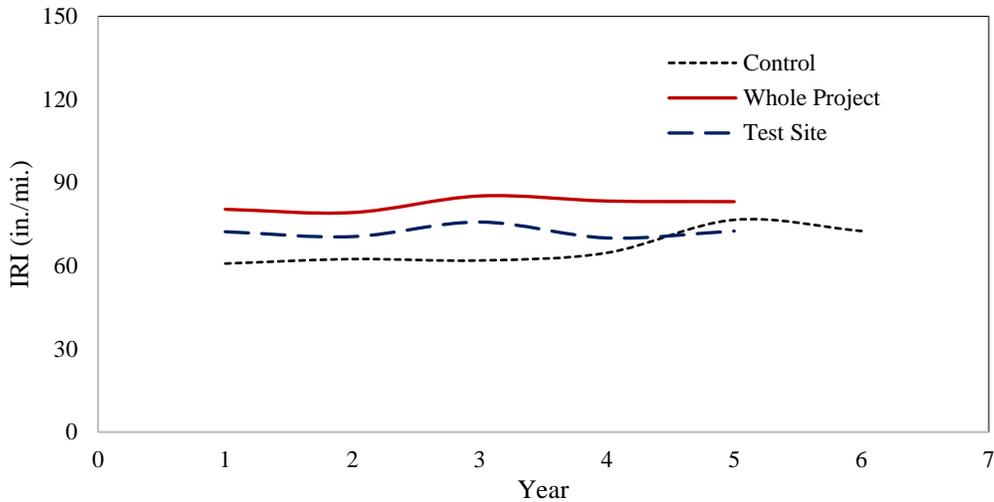
IRI: The IRI at the test site and control site has 76 inch per mile of IRI, after 5 years of construction as shown in Figure 56. The whole project has IRI of 85 inches per mile, which is more than that of test site and control site. Thus, the whole CIR site indicated that the use of CIR may cause an increase in the roadway’s IRI. The graph indicates that IRI will not significantly increase over time and will unlikely reach the terminal threshold value of 200 inches per mile used on the PMED.

**Figure 56. IRI at Site #4 SH 86 Kiowa (Eastbound) Showing Amount of IRI at the Control Site, Test Site, and Whole Project**

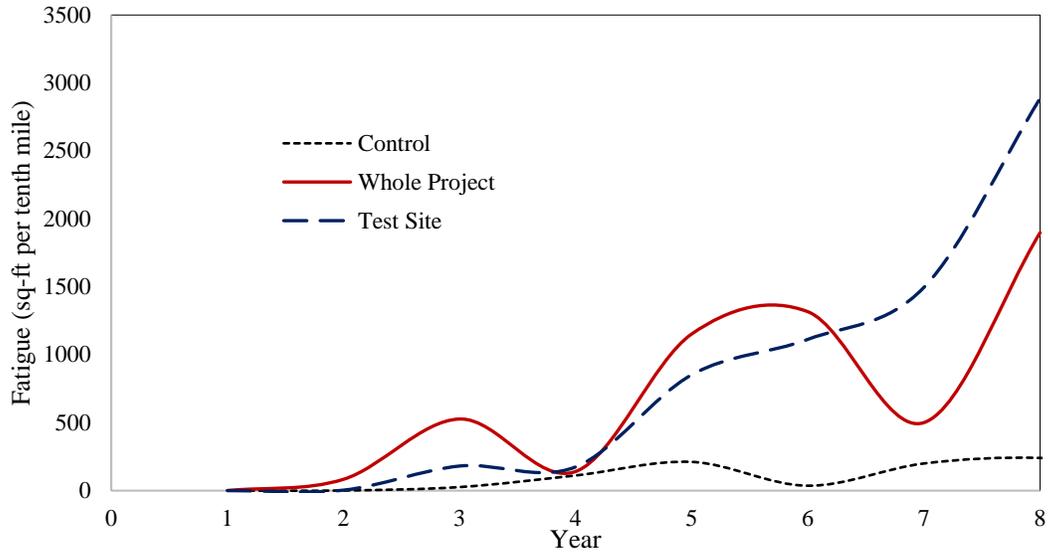
*Fatigue Cracking:* Fatigue cracking at the test site and whole project have good amount of fatigue cracking 8 years after construction as shown in Figure 57. The test site and whole project have similar cracking with maximum values of 2887 and 1889 square feet per tenth-mile, respectively. The control site has an average fatigue cracking of 240 square feet per tenth-mile. Figure 57 also shows that the amount of fatigue cracking is expected to increase rapidly over time.

**Figure 57. Fatigue Cracking at Site #5 I-25 South of Colorado City to Cedarwood Showing Amount of Cracking at the Control Site, Test Site, and Whole Project**
