# Dynamic Modulus of Cold-in-Place Recycling (CIR) Material

Md Rashadul Islam, Sylvester A. Kalevela and Jill A. Rivera

Report No. CDOT 2018-13  
May 2018

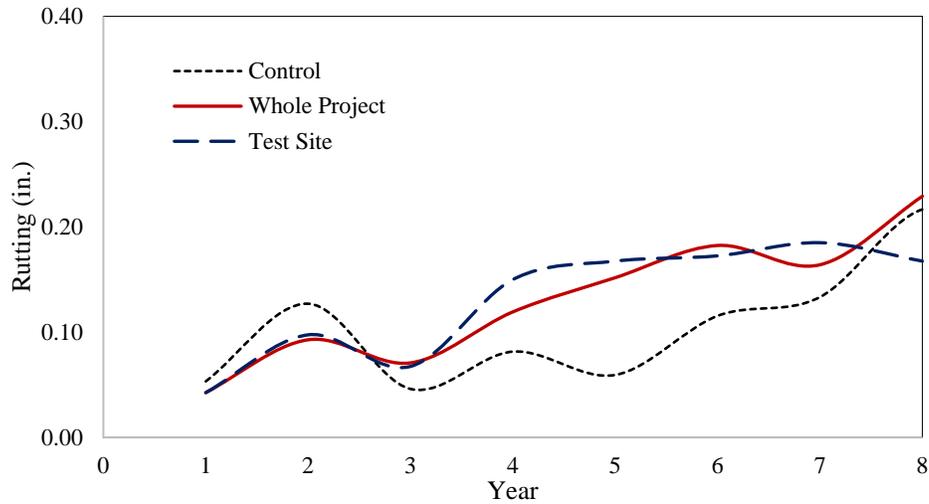
*Rutting:* The amount of rutting at the whole project, control site, and test site are very similar as shown in Figure 58. Eight years after construction rutting at the control site increased from 0.06 to 0.22 inches, at the whole project it increased from 0.04 to 0.23 inches, and at the test site, it increased from 0.04 to 0.19 inches. Thus, the rutting measured at whole project is slightly more than that of test site or control site. Figure 58 indicates that rutting is expected to grow with age but will not exceed the terminal threshold value (used by PMED) of 0.5 inches for several years.

**Figure 58. Rutting at Site #5 I-25 South of Colorado City to Cedarwood Showing Amount of Rutting at the Control Site, Test Site, and Whole Project**

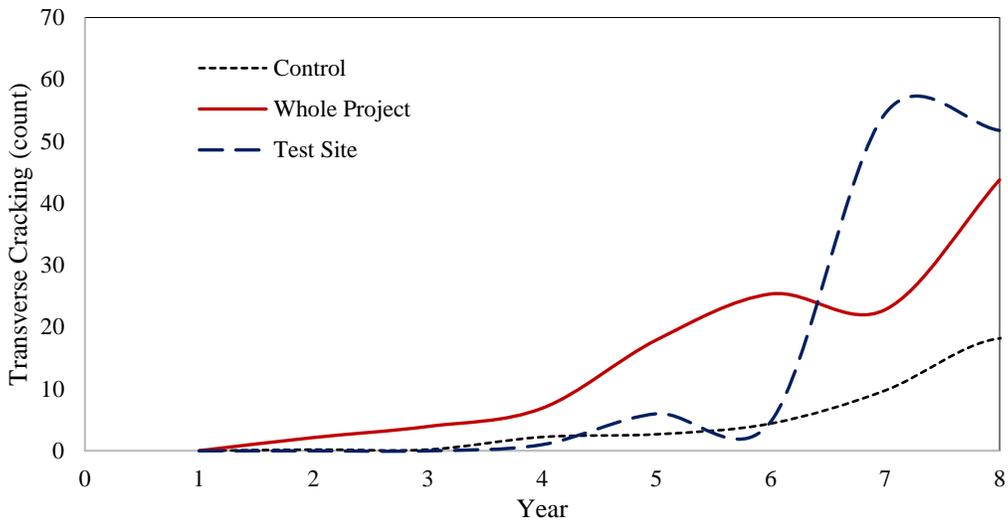
*Transverse Cracking:* Eight years after construction, the transverse cracking at the test site and whole project is greater than the cracking at the control site as shown in Figure 59. The control site has a maximum of 18 cracks (each 12 feet long) per tenth-mile, while the whole project and the test site have maximum values of 44 and 55 cracks per tenth-mile, respectively.

**Figure 59. Transverse Cracking at Site #5 I-25 South of Colorado City to Cedarwood Showing Amount of Cracking at the Control Site, Test Site, and Whole Project**

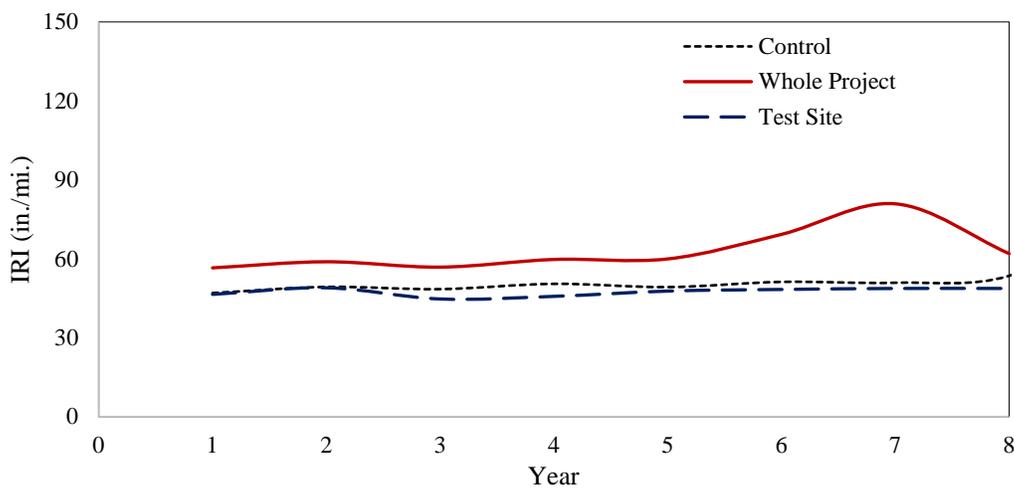
IRI: Eight years after construction, the IRI at the test site and control site is less than that measured at the whole project as shown in Figure 60. The IRI values at the control site ranged from 47 to 54 inches per mile. The whole project's IRI values ranged from 56 to 80 inches per mile, and the test site ranged from 44 to 49 inches per mile. The field data show that the whole project performed poorer than the test site and control site. They also indicated that the use of CIR may cause an increase in the roadway's IRI. The graph indicates that the IRI will not significantly increase over time and will unlikely reach the terminal threshold value PMED used of 200 inches per mile.

**Figure 60. IRI at Site #5 I-25 South of Colorado City to Cedarwood Showing Amount of IRI at the Control Site, Test Site, and Whole Project**

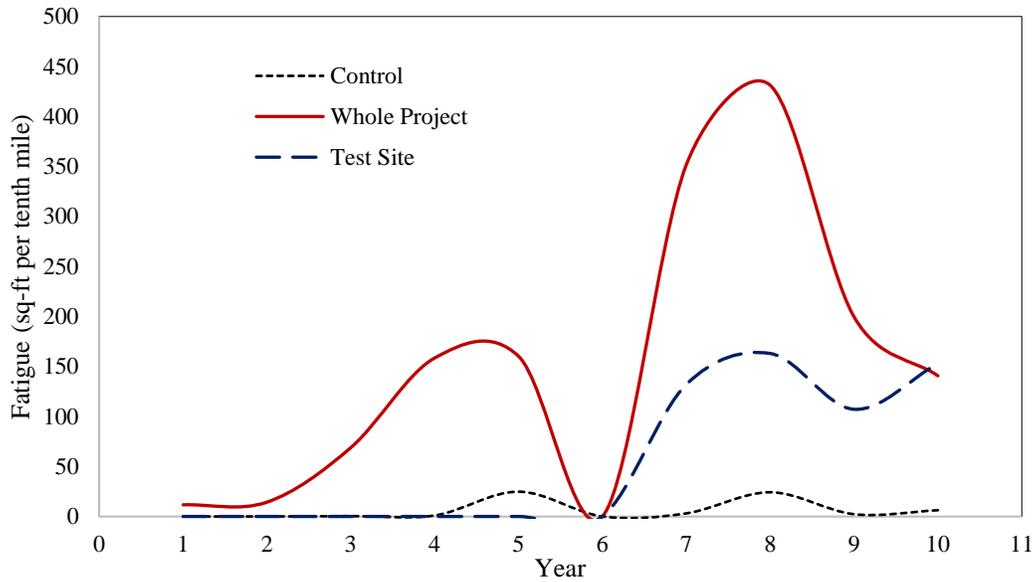
*Fatigue Cracking:* Ten years after construction, the fatigue cracking values for the test site and whole project are greater than for the control site as shown in Figure 61. The test site and whole project have maximum values of 163 and 431 square feet per tenth-mile, respectively. The control site has a maximum fatigue cracking of 25 square feet per tenth-mile, which is less than that of the test site and whole project.

**Figure 61. Fatigue Cracking at Site #6 SH 50 Cerro Summit Paving Showing Amount of Cracking at the Control Site, Test Site, and Whole Project**

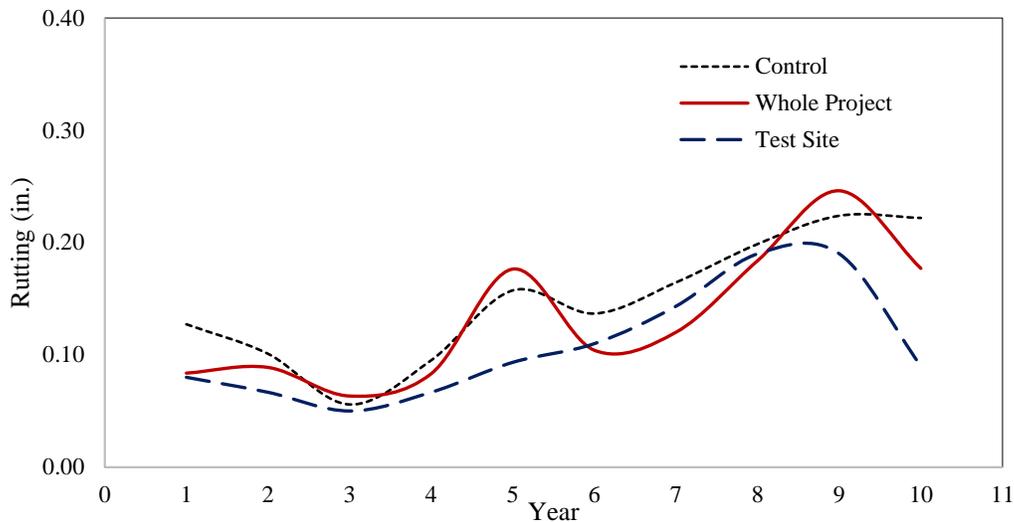
*Rutting:* The maximum amount of rutting at the whole project, control site, and test site are 0.24, 0.22, and 0.19 inches, respectively as shown in Figure 62. Thus, the rutting measured at the whole project is more than the others. Figure 62 also indicates that rutting is expected to grow with age but will not exceed the terminal threshold value (used by PMED) of 0.5 inches for several years.

**Figure 62. Rutting at Site #6 SH 50 Cerro Summit Paving Showing Amount of Rutting at the Control Site, Test Site, and Whole Project**

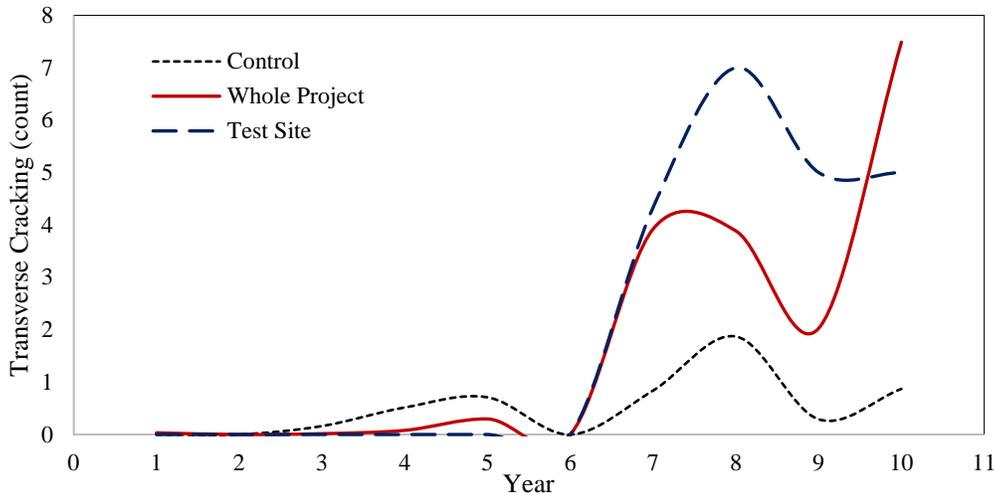
*Transverse Cracking:* Ten years after construction, the transverse cracking at the test site and whole project is greater than the cracking at the control site as shown in Figure 63. The control site has a maximum of two cracks (each 12 feet long) per tenth-mile, while the whole project and the test site each has a maximum of seven cracks per tenth-mile. The data show that the difference between the whole project and test site is negligible, and that the project that used CIR performed poorer than conventional HMA.

**Figure 63. Transverse Cracking at Site #6 SH 50 Cerro Summit Paving Showing Amount of Cracking at the Control Site, Test Site, and Whole Project**

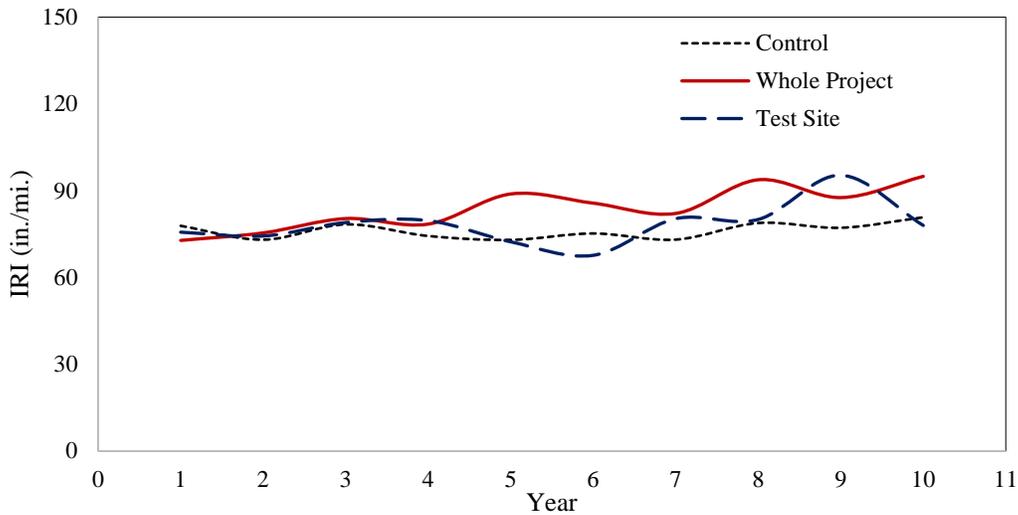
**Figure 64. IRI at Site #6 SH 50 Cerro Summit Paving Showing Amount of IRI at the Control Site, Test Site, and Whole Project**

IRI: The IRI at the test site and whole project is more than that measured at the control site as shown in Figure 64. Since the construction of the project ten years ago, the control site's IRI ranged from 73 to 81 inches per mile. The whole project's IRI ranged from 73 to 95 inches per mile, and the test site ranged from 68 to 95 inches per mile. The field data show that the control site performed better than the test site and whole project and indicate that the use of CIR may cause an increase in the roadway's IRI.

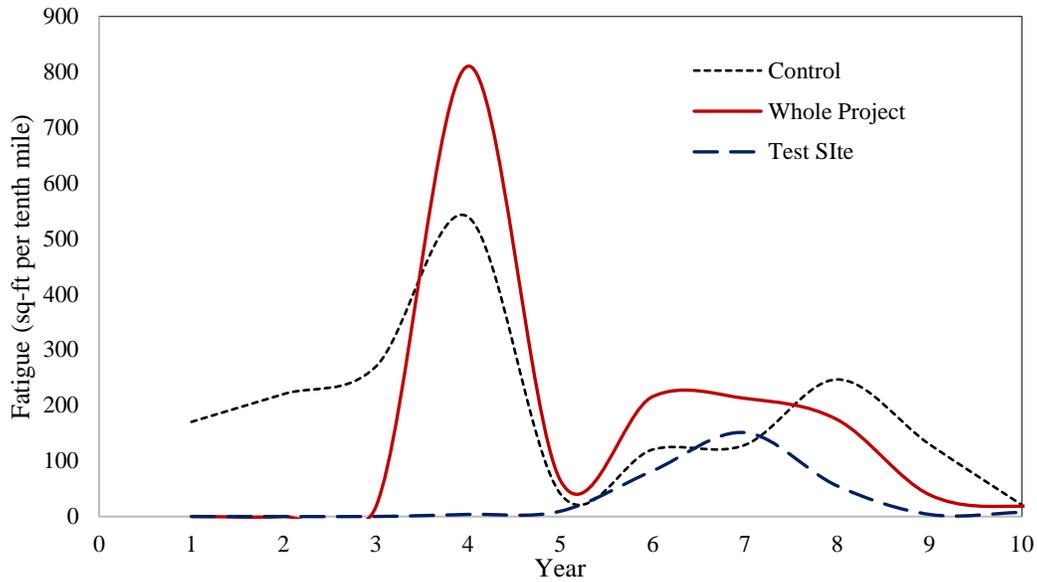
**Figure 65. Fatigue Cracking at Site #7 I-70 West of Mack Showing Amount of Cracking at the Control Site, Test Site, and Whole Project**

*Fatigue Cracking:* The test site has only 151 square feet per tenth-mile of cracking 10 years after construction as shown in Figure 65. The whole project has cracking with a maximum value of 811 square feet per tenth-mile. However, the control site has cracking of with a maximum of 539 square feet per tenth-mile, which is in between the test site and whole project. Thus, it can be said that the whole project produced higher amount of cracking compared to the control site. Figure 65 also shows the amount of fatigue cracking is not expected to increase rapidly over time.

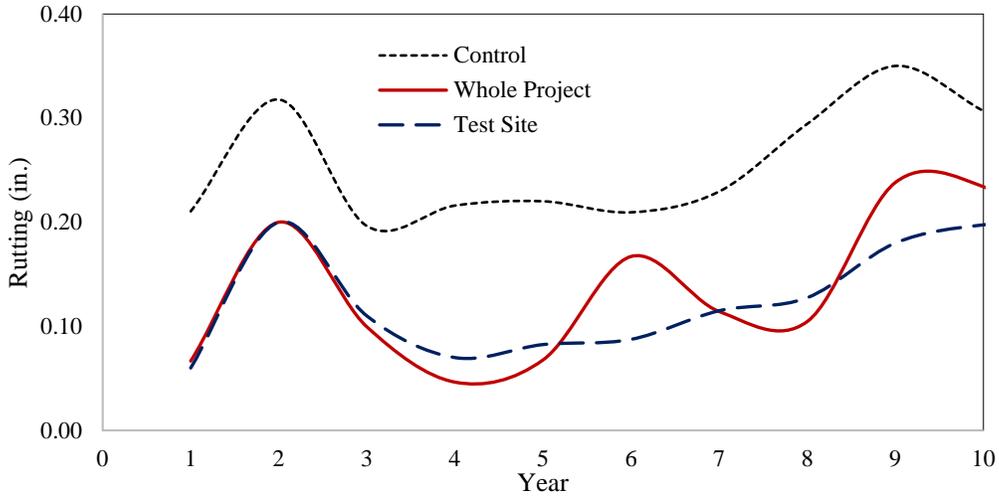
**Figure 66. Rutting at Site #7 I-70 West of Mack Showing Amount of Rutting at the Control Site, Test Site, and Whole Project**

*Rutting:* The amount of rutting at the test site and whole project are smaller than the control site as shown in Figure 66. Ten years after construction, rutting at the control site increased from 0.2 to 0.35 inches, at the whole project it increased from 0.07 to 0.24 inches, and at the test site, it increased from 0.07 to 0.20 inches. Thus, the rutting measured at the test section and the whole project is slightly less than at the control project and shown a very slight benefit to using CIR. Figure 66 indicates that rutting is expected to grow with age but will not exceed the terminal threshold value (used by PMED) of 0.5 inches for several years.

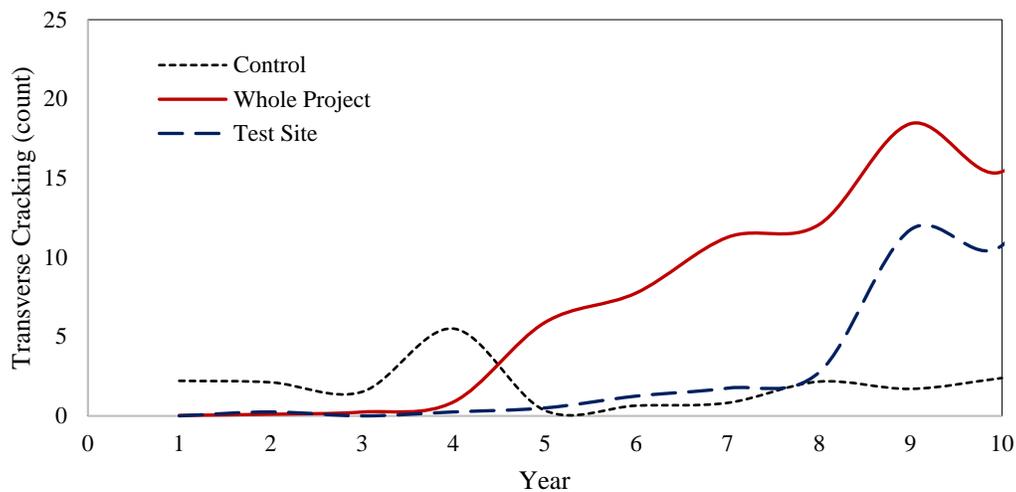
**Figure 67. Transverse Cracking at Site #7 I-70 West of Mack Showing Amount of Cracking at the Control Site, Test Site, and Whole Project**

*Transverse Cracking:* Ten years after construction, the transverse cracking at the test site and whole project are greater than the cracking at the control site, Figure 67. The control project has a maximum of six cracks (each 12 feet long) per tenth-mile, while the whole project and the test site each has a maximum of 18, and 12 cracks per tenth-mile, respectively. Transverse cracking is expected to increase over time but will unlikely meet the terminal threshold value (used by PMED) of 1,500 feet per mile for several years.

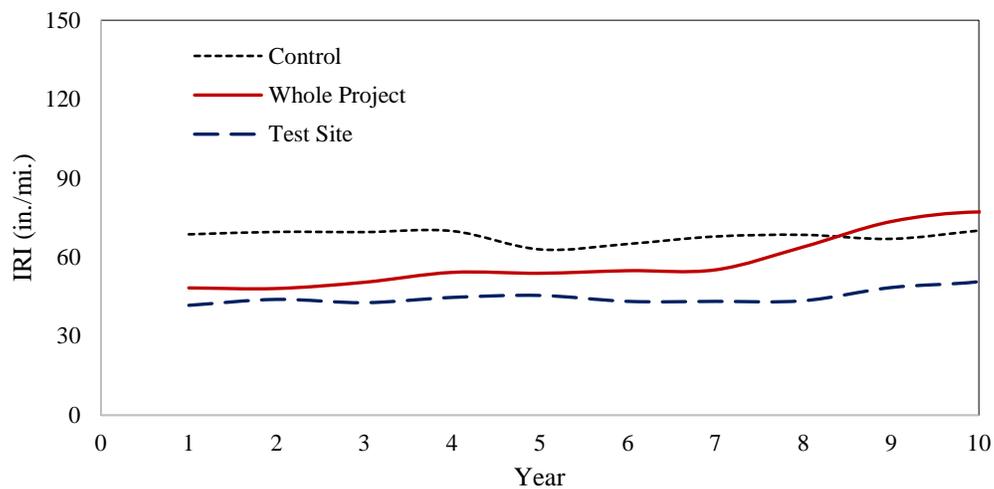
**Figure 68. IRI at Site #7 I-70 West of Mack Showing Amount of IRI at the Control Site, Test Site, and Whole Project**

IRI: The IRI at the whole project is more than that measured at the control site and the test site as shown in Figure 68. Since the construction of the project ten years ago, the control site's IRI values range from 63 to 70 inches per mile. The whole project's IRI values ranged from 48 to 77 inches per mile, and the test site ranged from 43 to 51 inches per mile. The field data show that the control site performed better than the whole project and indicate that the use of CIR may cause an increase in the roadway's IRI. The graph indicates that the IRI will not significantly increase over time and will unlikely reach the terminal threshold value PMED used of 200 inches per mile.

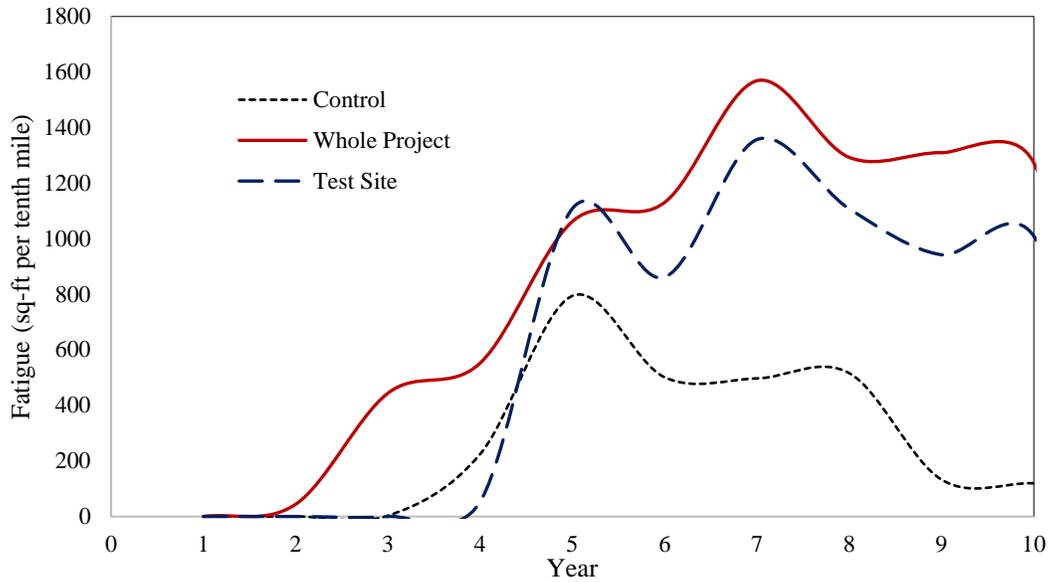
**Figure 69. Fatigue Cracking at Site #8 I-70 Fruita to Clifton Showing Amount of Cracking at the Control Site, Test Site, and Whole Project**

*Fatigue Cracking:* The test site and whole project have more fatigue cracking than the control site 10 years after construction as shown in Figure 69. The test site and the whole project have cracking with maximum values of 1357, and 1569 square feet per tenth-mile, respectively. The control site has a maximum fatigue cracking value of 794 square feet per tenth-mile, which is less than the test site and whole project. Figure 69 also shows the amount of fatigue cracking is not expected to increase rapidly over time.

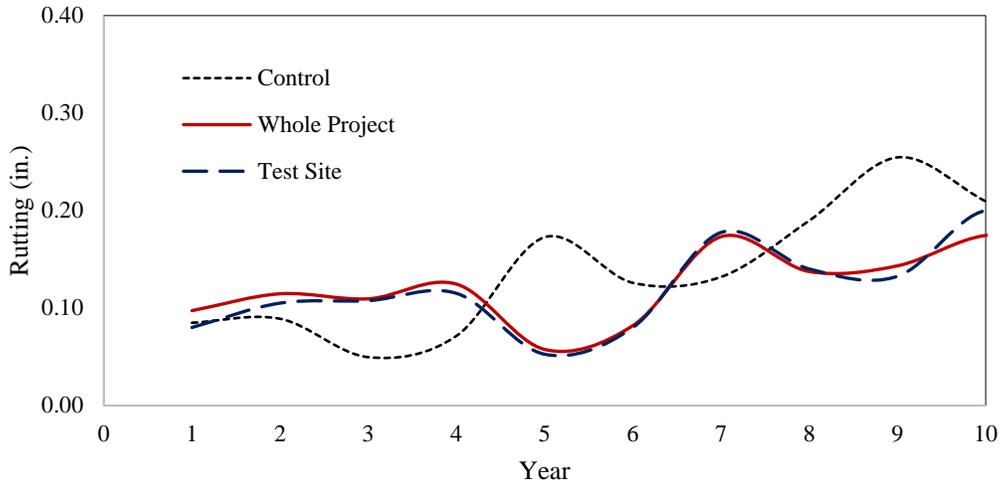
**Figure 70. Rutting at Site #8 I-70 Fruita to Clifton Showing Amount of Rutting at the Control Site, Test Site, and Whole Project**

*Rutting:* The amount of rutting at the test site and whole project are less than the control site, Figure 70. Ten years after construction rutting at the control site increased from 0.05 to 0.25 inches, at the whole project it increased from 0.06 to 0.17 inches, and at the test site, it increased from 0.05 to 0.20 inches. Thus, the rutting measured at the test site and whole project is slightly less than the control project and shown a very slight benefit to using CIR. Figure 70 indicates that rutting is expected to grow with age, however will not exceed the terminal threshold value (used by PMED) of 0.5 inches for several years.

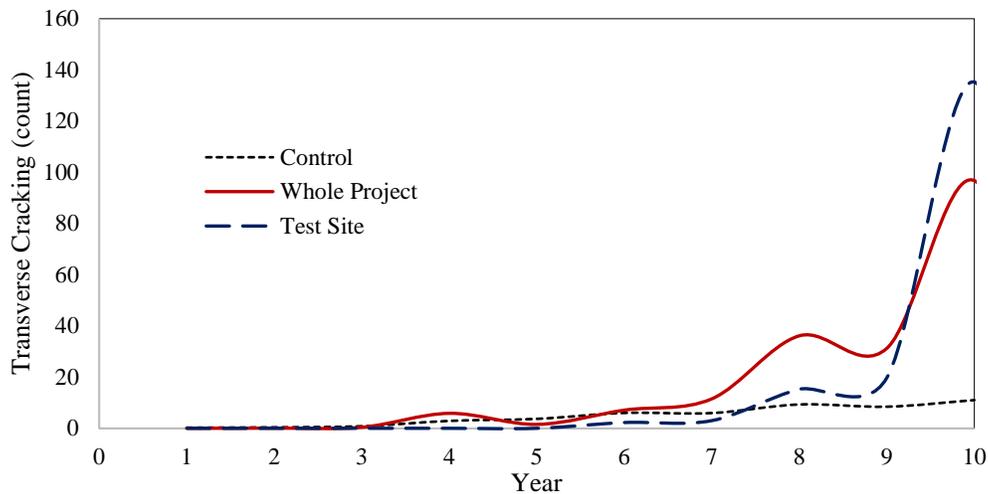
**Figure 71. Transverse Cracking at Site #8 I-70 Fruita to Clifton Showing Amount of Cracking at the Control Site, Test Site, and Whole Project**

*Transverse Cracking:* Ten years after construction, the transverse cracking at the test site and whole project is greater than the cracking at the control site as shown in Figure 71. The control project has a maximum of 11 cracks (each 12 feet long) per tenth-mile, while the whole project and the test site have maximum values of 135, and 97 cracks per tenth-mile, respectively. Transverse cracking is expected to increase over time but will unlikely reach the terminal threshold value (used by PMED) of 1,500 feet per mile for several years.

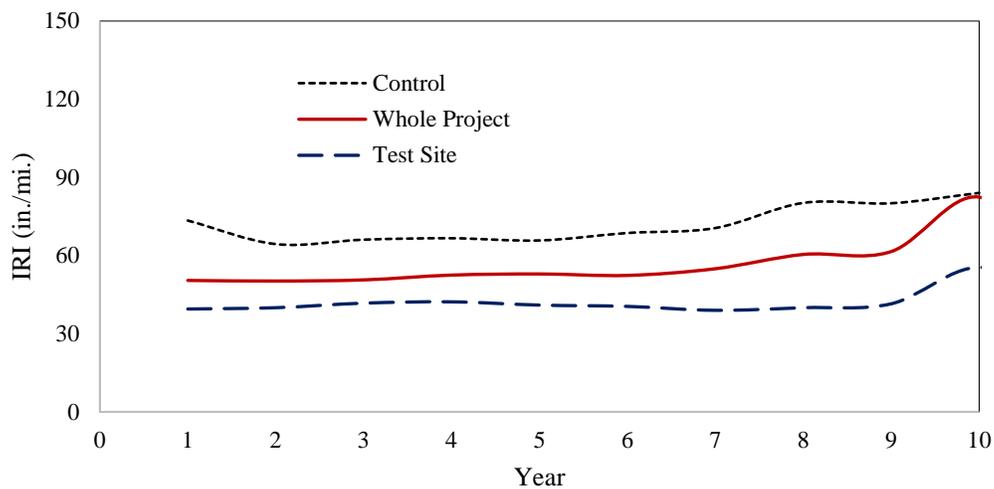
**Figure 72. IRI at Site #8 I-70 Fruita to Clifton Showing Amount of IRI at the Control Site, Test Site, and Whole Project**

IRI: The IRI values at the test site and whole project are less than that measured at the control site as shown in Figure 72. Since the construction of the project ten years ago, the control site's IRI values ranged from 66 to 84 inches per mile. The whole project's IRI values ranged from 50 to 82 inches per mile and the test site ranged from 39 to 55 inches per mile. The field data show that the control site performed poorer than the test site and whole project indicating that the use of CIR may reduce a roadway's IRI. The graph indicates that IRI will not significantly increase over time and will unlikely reach the terminal threshold value PMED used of 200 inches per mile.

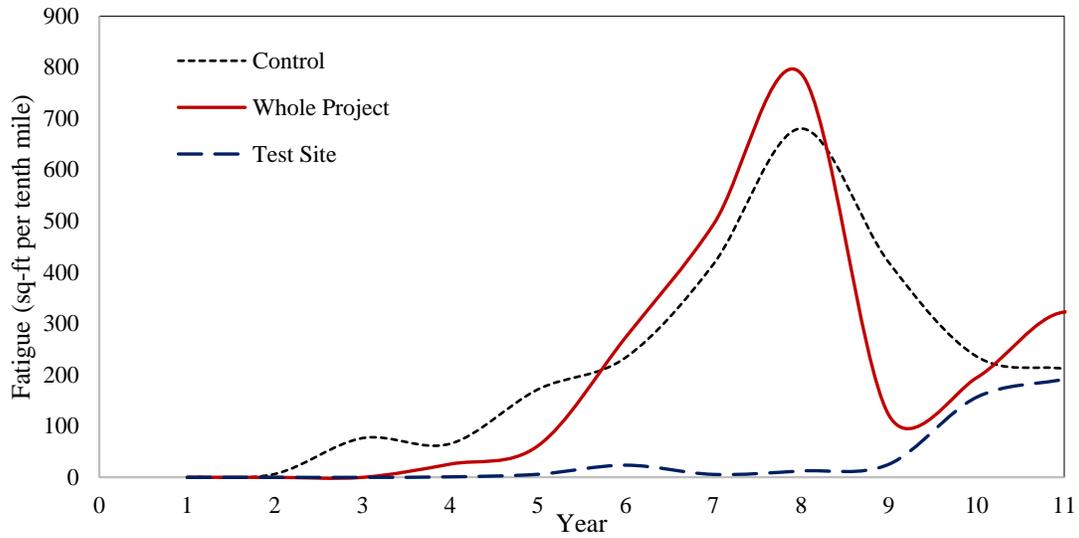
**Figure 73. Fatigue Cracking at Site #9 SH 92 Delta (Eastbound) Showing Amount of Cracking at the Control Site, Test Site, and Whole Project**

*Fatigue Cracking:* The test site has no measurable fatigue cracking 11 years after construction as shown in Figure 73. The whole project has cracking with a maximum value of 788 square feet per tenth-mile compared to 681 square feet per tenth-mile for the control site. The whole project has more cracking than the control site. Figure 73 also shows that the amount of fatigue cracking is not expected to increase rapidly over time.

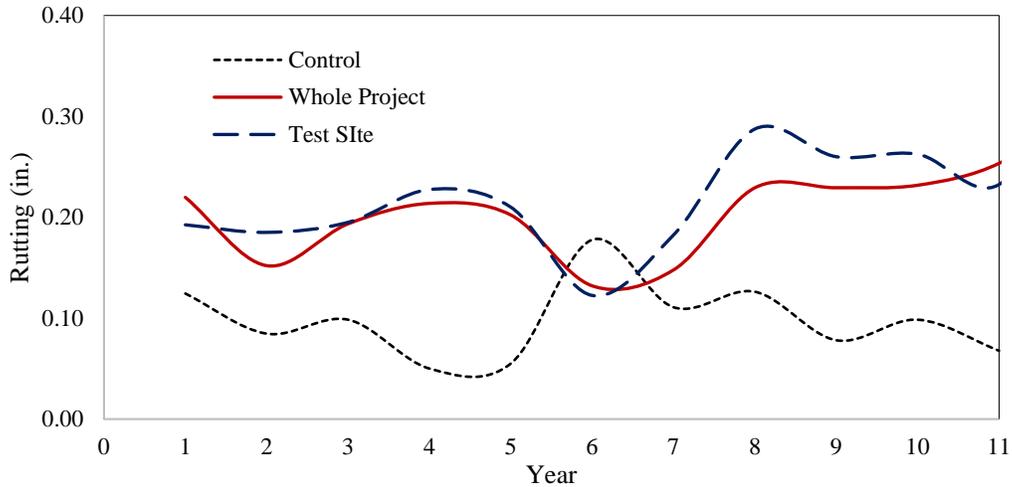
**Figure 74. Rutting at Site #9 SH 92 Delta (Eastbound) Showing Amount of Rutting at the Control Site, Test Site, and Whole Project**

*Rutting:* The amounts of rutting at the test site and whole project are higher than at the control site as shown in Figure 74. Eleven years after construction, rutting at the control site increased from 0.05 to 0.18 inches, at the whole project it increased from 0.13 to 0.25 inches, and at the test site, it increased from 0.12 to 0.29 inches. Thus, the rutting values measured at the test site and whole project are slightly higher than at the control site and slightly no benefit to using CIR. Figure 74 indicates that rutting is expected to grow with age but will not exceed the terminal threshold value (used by PMED) of 0.5 inches for several years.

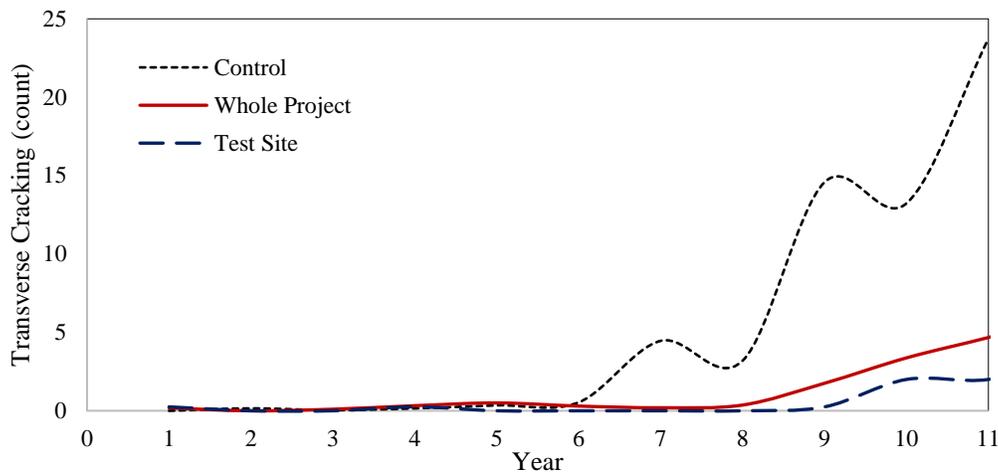
**Figure 75. Transverse Cracking at Site #9 SH 92 Delta (Eastbound) Showing Amount of Cracking at the Control Site, Test Site, and Whole Project**

*Transverse Cracking:* Eleven years after construction, the transverse cracking at the test site and whole project is smaller than the cracking at the control site as shown in Figure 75. The control project has a maximum of 24 cracks (each 12 feet long) per tenth-mile while the whole project and the test site have maximum values of 5 and 2 cracks per tenth-mile, respectively. The filed data show that the difference between the whole project and test site is negligible and that the project that used CIR performed better than conventional HMA. Transverse cracking is expected to increase over time but will unlikely meet the terminal threshold value (used by PMED) of 1,500 feet per mile for several years.

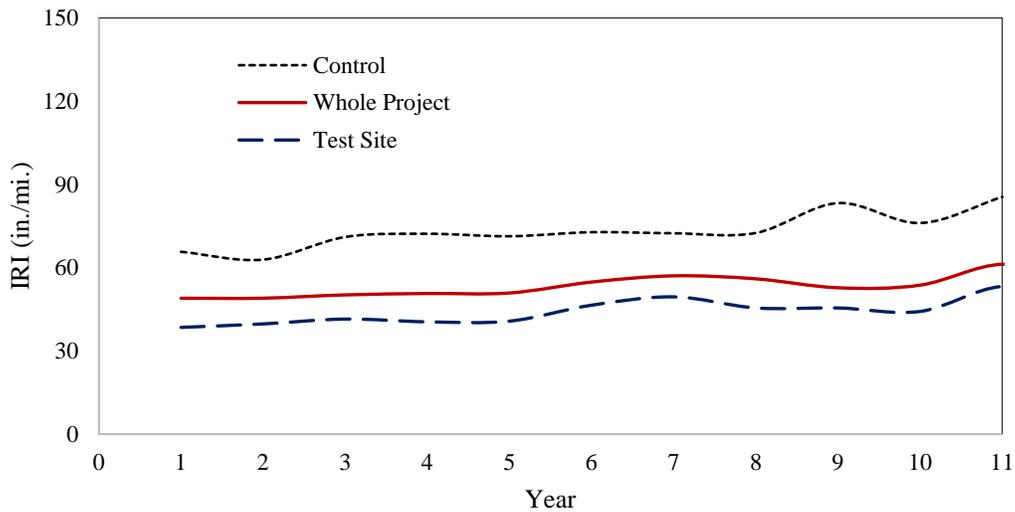
**Figure 76. IRI at Site #9 SH 92 Delta (Eastbound) Showing Amount of IRI at the Control Site, Test Site, and Whole Project**

IRI: The IRI values at the test site and whole project are less than that measured at the control site as shown in Figure 76. Since the construction of the project 11 years ago, the control site's IRI values ranged from 63 to 86 inches per mile. The whole project's IRI values ranged from 49 to 61 inches per mile, and the test site ranged from 39 to 53 inches per mile. The data show that the control site performed poorer than the test site and whole project and indicated that the use of CIR may reduce the roadway's IRI. The graph indicated IRI will not significantly increase over time and will unlikely reach the terminal threshold value PMED used of 200 inches per mile.

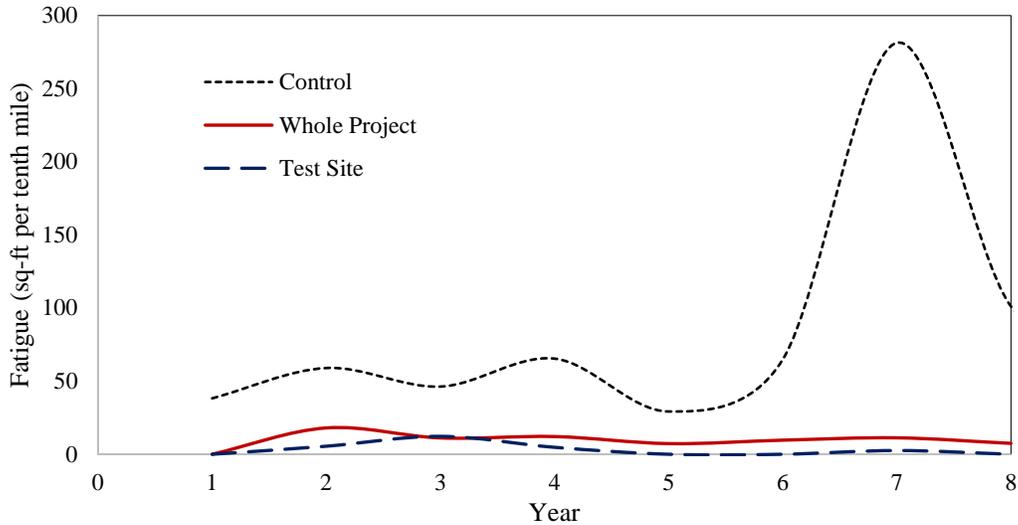
**Figure 77. Fatigue Cracking at Site #10 SH 133 North of Hotchkiss Showing Amount of Cracking at the Control Site, Test Site, and Whole Project**

*Fatigue Cracking:* The test site and whole project have no measurable cracking 8 years after construction as shown in Figure 77. The whole project and test site have similar cracking with maximum values of 18, and 12 square feet per tenth-mile, respectively. The control site has fatigue cracking with a maximum value of 281 square feet per tenth-mile, which is more than that of test site and whole project. Figure 77 also shows that the amount of fatigue cracking is not expected to increase rapidly over time.

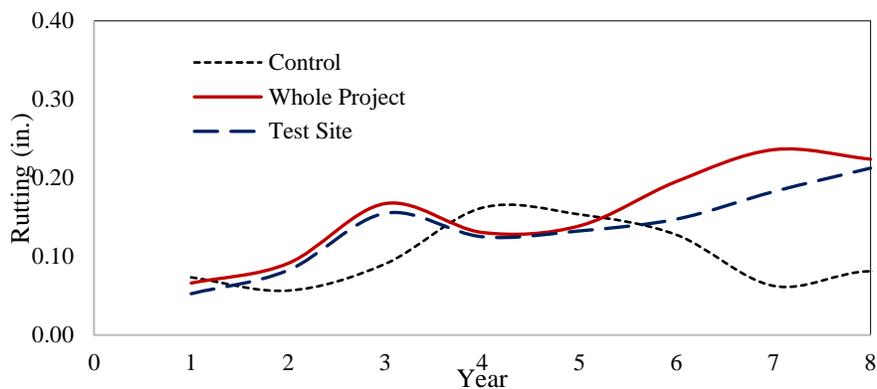
**Figure 78. Rutting at Site #10 SH 133 North of Hotchkiss Showing Amount of Rutting at the Control Site, Test Site, and Whole Project**

*Rutting:* The amount of rutting at the test site and whole project are slightly larger than at the control site as shown in Figure 78. During eight years after construction, rutting at the control site increased from 0.06 to 0.16 inches, at the whole project, it increased from 0.07 to 0.24 inches, and at the test site, it increased from 0.05 to 0.21 inches. Thus, the rutting measured at the test section versus the whole project is slightly more than at the control project and slightly shows a no benefit to using CIR. Figure 78 indicates that rutting is expected to grow with age but will not exceed the terminal threshold value (used by PMED) of 0.5 inches for several years.

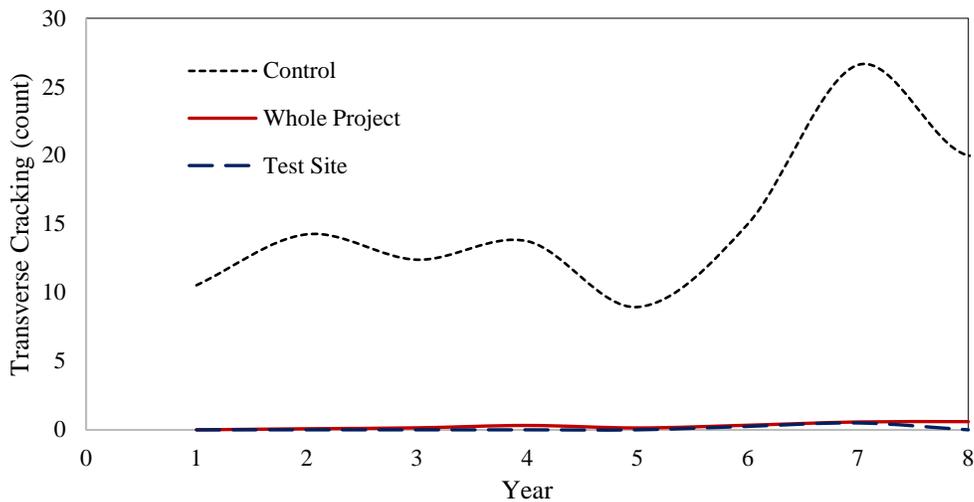
**Figure 79. Transverse Cracking at Site #10 SH 133 North of Hotchkiss Showing Amount of Cracking at the Control Site, Test Site, and Whole Project**

*Transverse Cracking:* Eight years after construction, the transverse cracking at the test site and whole project is smaller than the cracking at the control site as shown in Figure 79. The control project has a maximum of 27 cracks (each 12 feet long) per tenth-mile, while the whole project and the test site have a maximum value of one crack per tenth-mile each. The data show that the difference between the whole project and test site is negligible and the project that used CIR performed better than conventional HMA. Transverse cracking is expected to increase over time but will unlikely reach the terminal threshold value (used by PMED) of 1,500 feet per mile for several years.

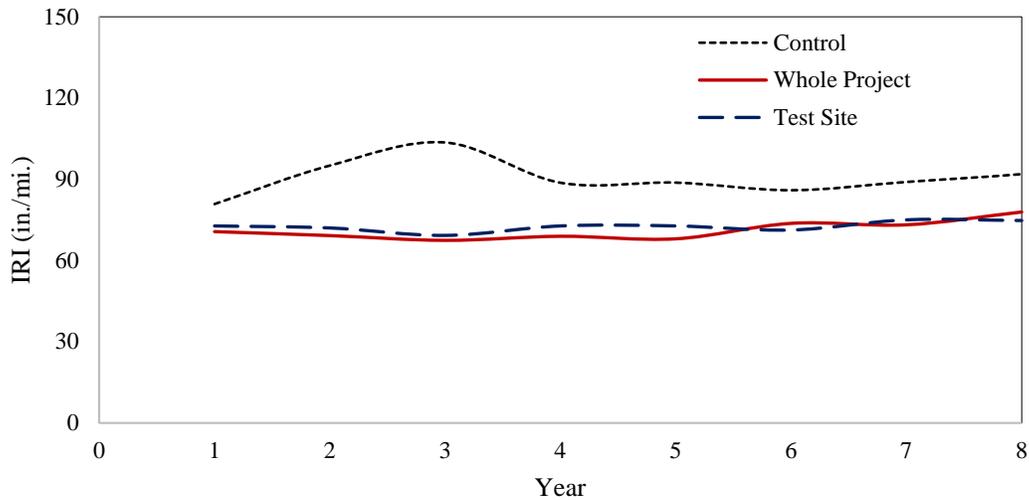
**Figure 80. IRI at Site #10 SH 133 North of Hotchkiss Showing Amount of IRI at the Control Site, Test Site, and Whole Project**

IRI: The IRI values at the test site and whole project are less than that measured at the control site as shown in Figure 80. Since the construction of the project eight years ago, the control site’s IRI values ranged from 81 to 104 inches per mile. The whole project’s IRI values ranged from 67 to 78 inches per mile, and the test site IRI values ranged from 69 to 75 inches per mile. The data show that the control site performed poorer than the test site and whole project and indicated the use of CIR may reduce the roadway’s IRI. The graph indicated that IRI will not significantly increase over time and will unlikely reach the terminal threshold value PMED used of 200 inches per mile.

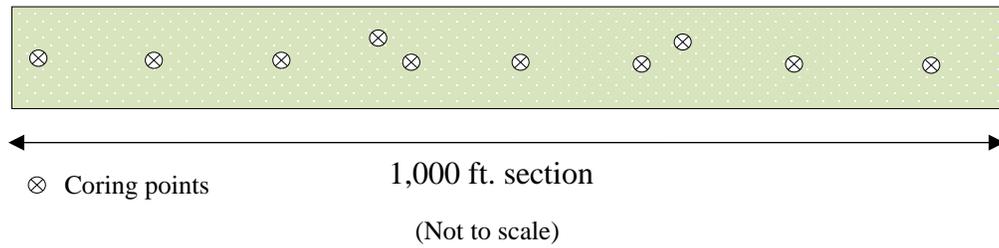
**Figure 81. Approximate Coring Locations at Each Site**

Ten asphalt cores were collected from each site. Coring layout, coring operation, and cored samples from a test site are shown in Figures 81-83.

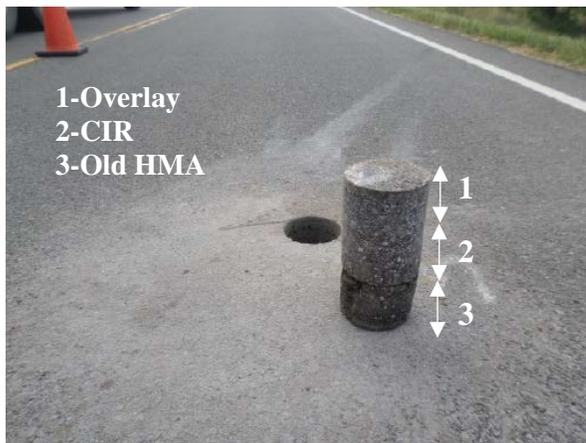
**Figure 83. Cored Asphalt Samples from the SH 86 Kiowa East**

Samples collected had the following characteristics: (1) CIR cores were bound materials, (2) layer separation between the CIR and underlying HMA bonding was common, and (3) the bottom layer

(old asphalt layer) had deteriorated. Since the CIR layer was a bound material, it was possible to conduct dynamic modulus tests.

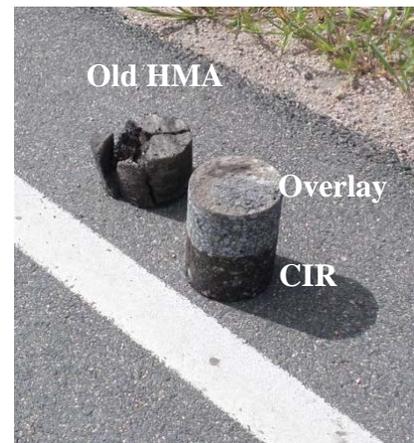
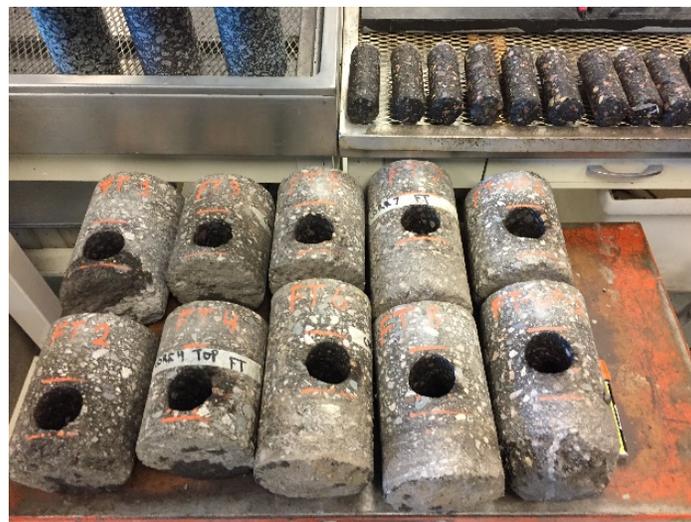
**Figure 84. AMPT Sample Preparation and Test Setup**

- a) Label each 6-inch core and identify the cold-in-place layer using construction data and by visually inspecting each core.
- b) Cut a 50-mm diameter core horizontally out of the cold-in-place layer as shown in Figure 84.
- c) Trim the cores to 110-mm in height.
- d) Record the exact measurements of each 110-mm specimen.
- e) Attach the gauge points for an AMPT instrumentation.
- f) Run the Dynamic Modulus test on each specimen at 4 °C, 20 °C, and 35 °C at 0.1 Hz, 1 Hz, and 10 Hz each.

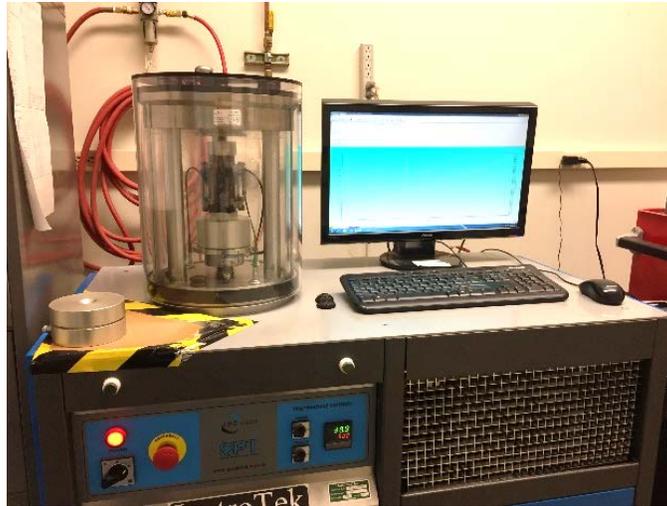
**Figure 85. AMPT Test Setup**

The AMPT test setup is shown in Figure 85.

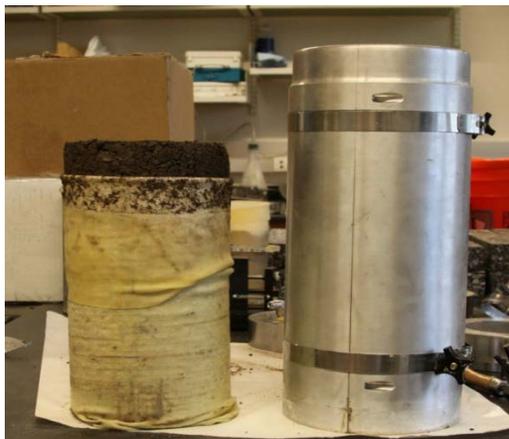
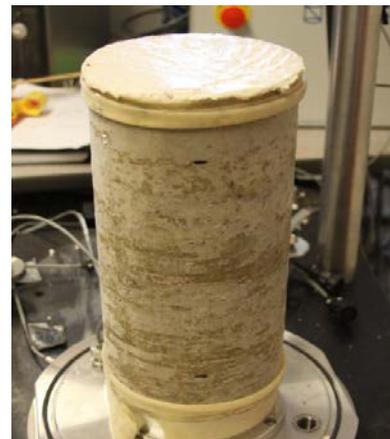
**Figure 86. Resilient Modulus Sample Preparation**

where  $S_{cyclic}$  is the applied cyclic axial stress and  $\epsilon_r$  is the resilient axial deformation. The resilient modulus sample preparation and testing setup are shown in Figure 86 and Figure 87 respectively.

(a) Compacted 150 mm diameter sample

(b) Test-ready sample

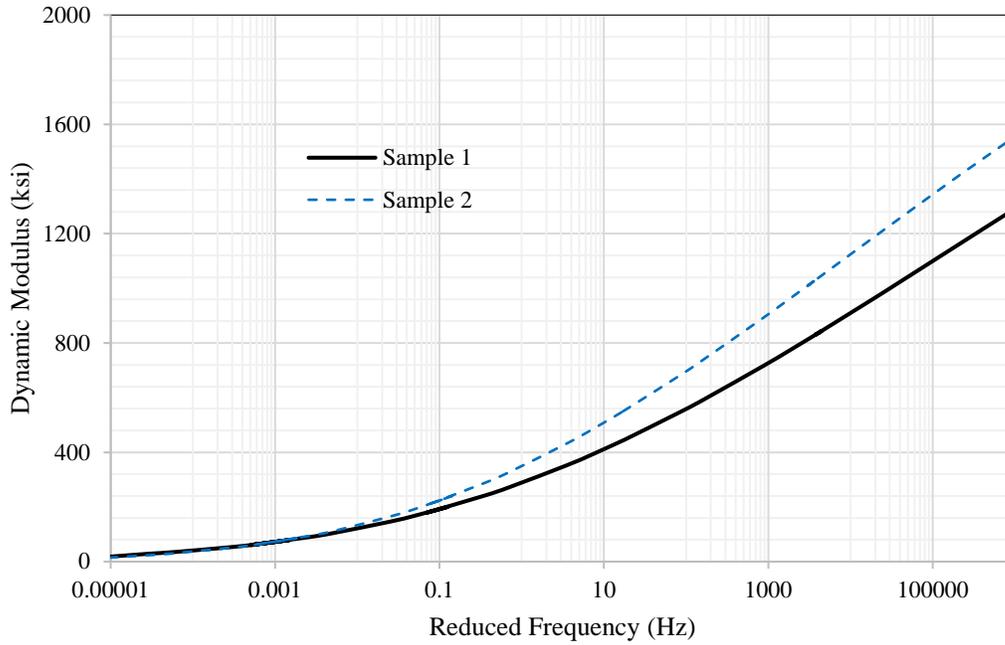
**Figure 88. Dynamic Moduli of Samples from SH 9 From Fairplay to Alma**

Two CIR cores were tested for this site. The sample-wise modulus and the average modulus are listed in Table 6. Figure 88 shows the dynamic moduli variation with the reduced frequency of both samples.

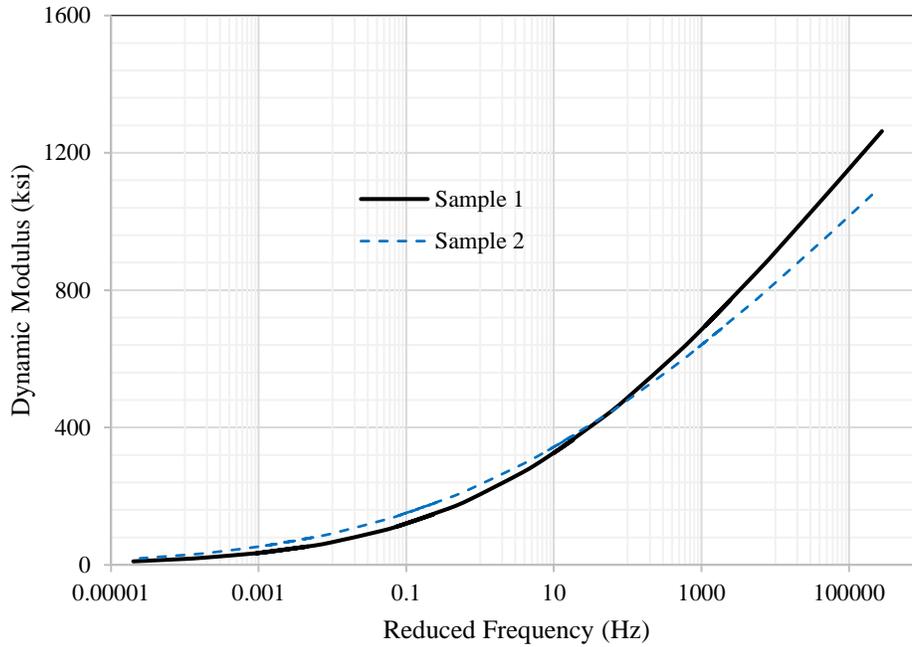
**Figure 89. Dynamic Moduli of Samples from Hoosier Pass (Northbound)**

Two CIR cores were tested for this site. The sample-wise modulus and the average modulus are listed in Table 7. Figure 89 also shows the dynamic moduli variation with the reduced frequency of both samples.

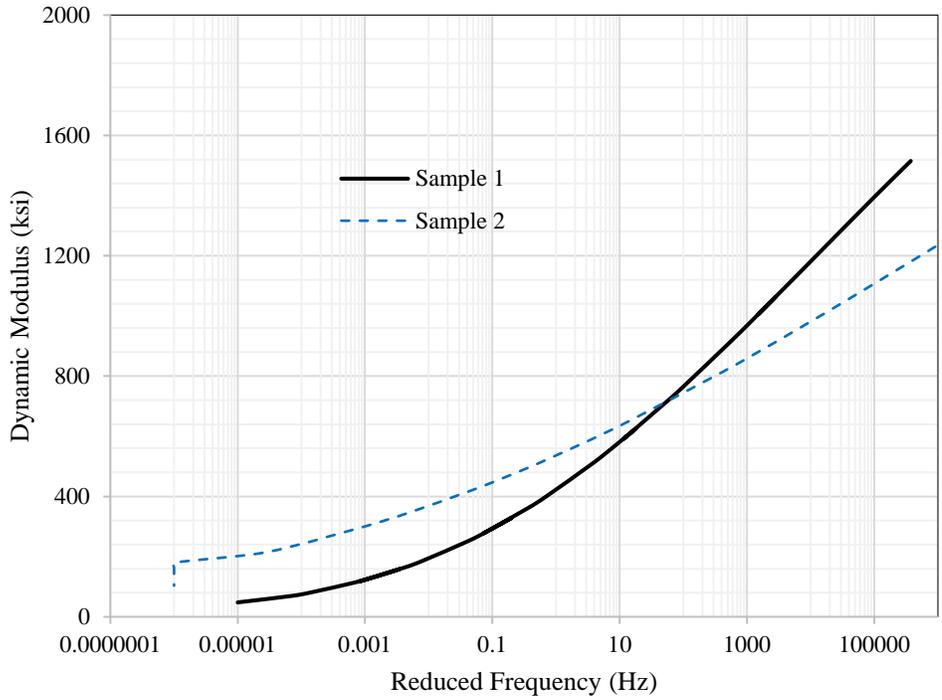
**Figure 90. Dynamic Moduli of Samples from SH 86 East of Franktown**

Two CIR cores were tested for this site. The sample-wise modulus and the average modulus are listed in Table 8. Figure 90 shows the dynamic moduli variation with the reduced frequency of both samples.

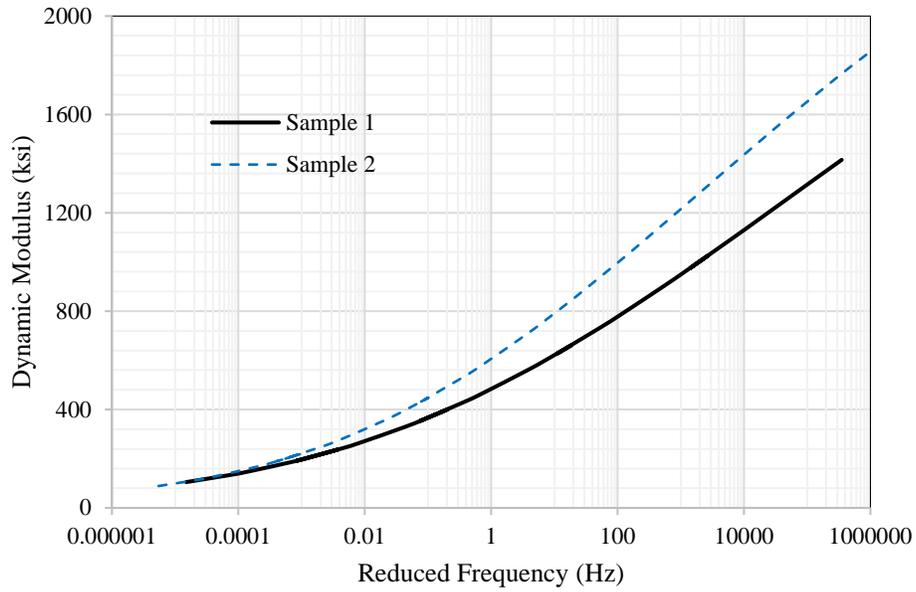
**Figure 91. Dynamic Moduli of Samples from Kiowa (Eastbound)**

Two CIR cores were tested for this site. The sample-wise modulus and the average modulus are listed in Table 9. Figure 91 also shows the dynamic moduli variation with the reduced frequency of both samples.

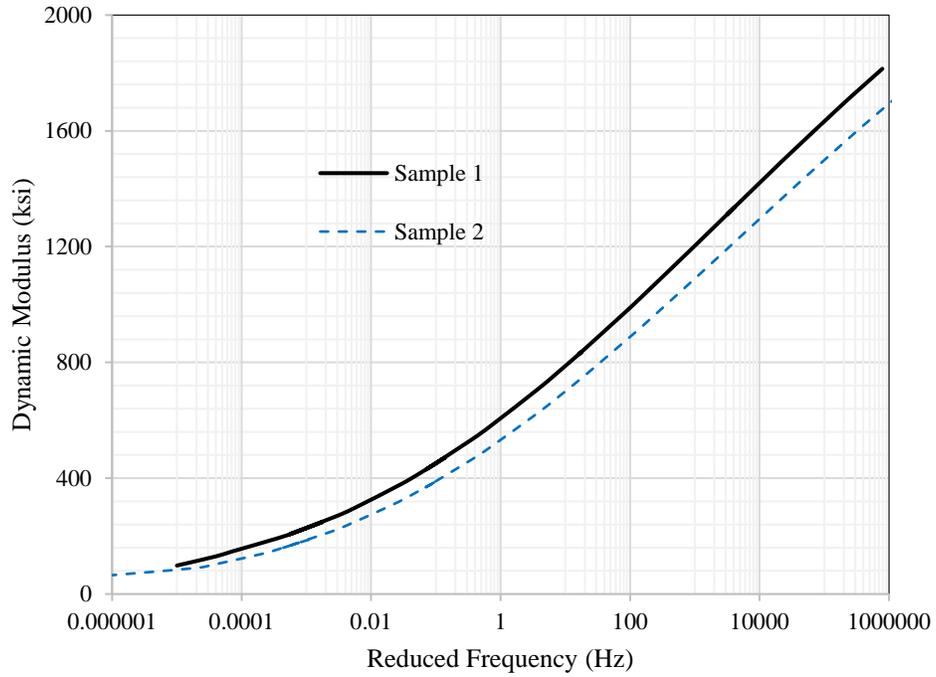
**Figure 92. Dynamic Moduli of Samples from I-25 South of Colorado City to Cedarwood**

Two CIR cores were tested for this site. The sample-wise modulus and the average modulus are listed in Table 10. Figure 92 also shows the dynamic moduli variation with the reduced frequency of both samples.

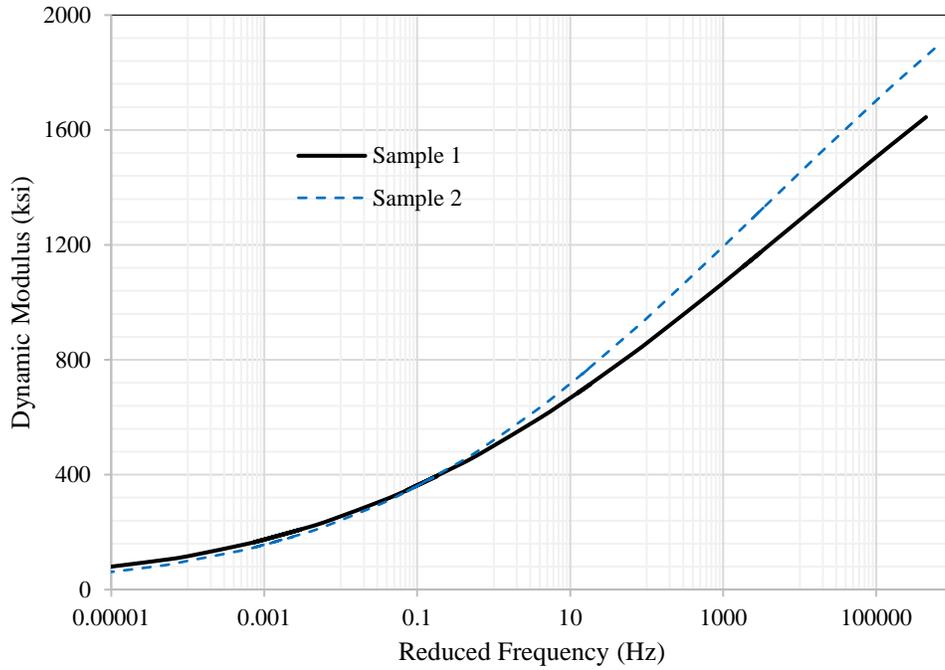
**Figure 93. Dynamic Moduli of Samples from Cerro Summit Paving**

Two CIR cores were tested for this site. The sample-wise modulus and the average modulus are listed in Table 11. Figure 93 also shows the dynamic moduli variation with the reduced frequency of both samples.
